West Virginia Office of Miners' Health, Safety and Training

February 6, 2009

Report of Investigation  
Surface Coal Mine Fatality  
(Haulage Accident)

Medford Trucking, LLC, Contractor ID Number C-6067  
Contractor for  
Elk Run Coal Company, Inc. dba Republic Energy  
Republic Energy Surface, Permit Number S-3021-95

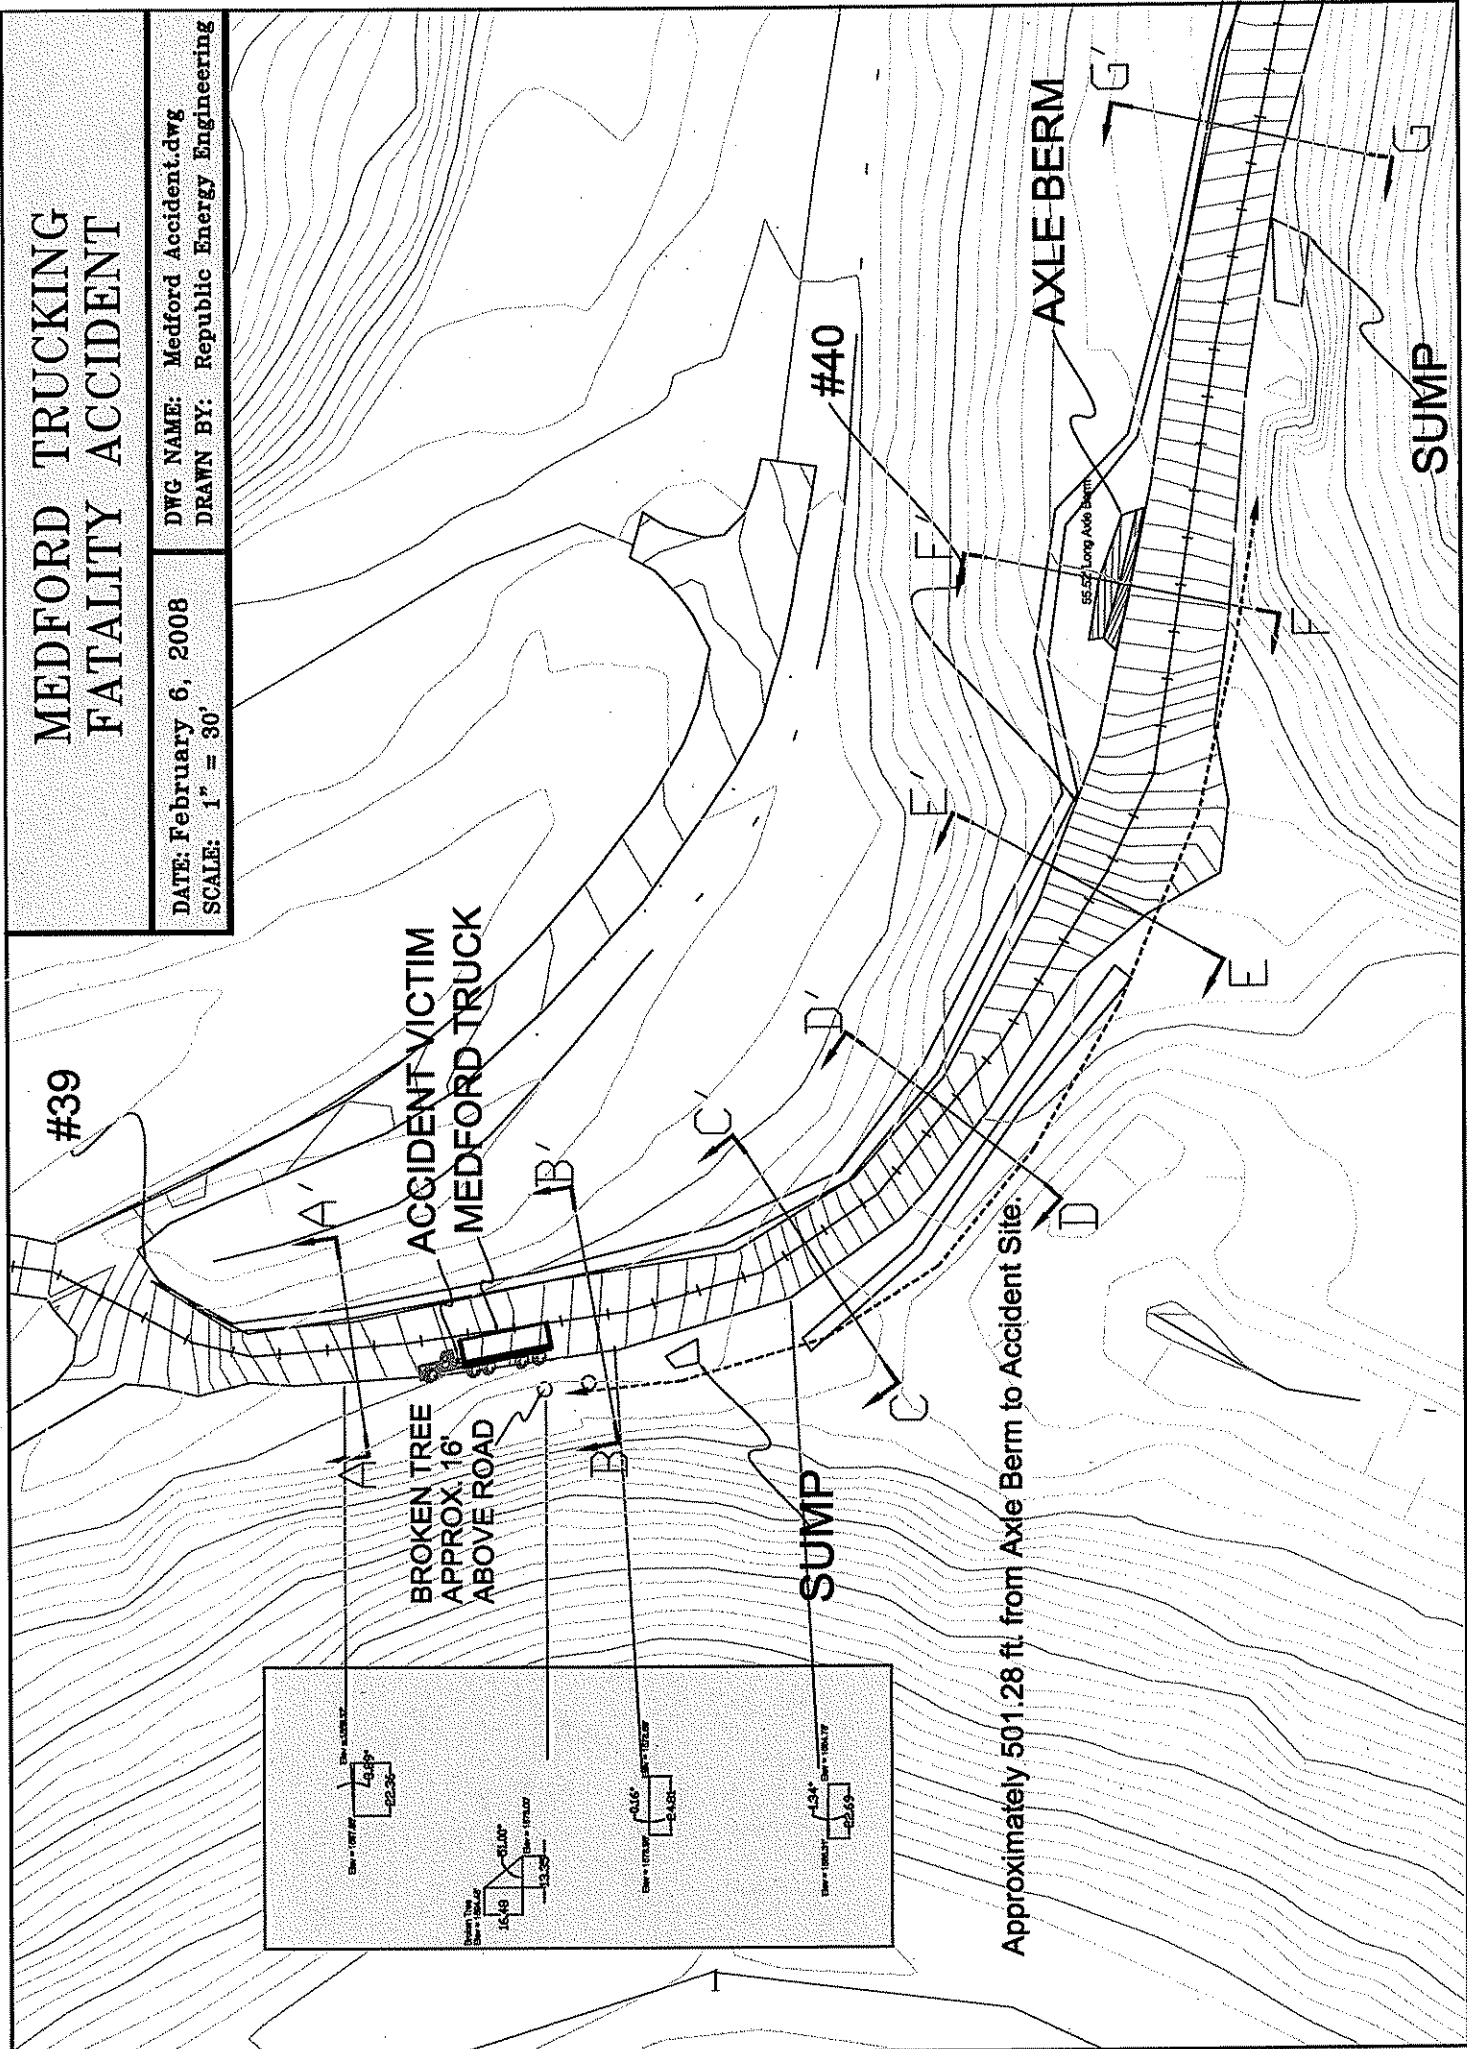
# MEDFORD TRUCKING FATALITY ACCIDENT

Approximately 501.28 ft. from Axle Berm to Accident Site.
