West Virginia Office of Miners' Health, Safety and Training

Report Of A Roof Fall Fatality
(Underground Coal Mine)

Island Fork Construction, LTD, Permit No. C-2404P
(contractor for)
Midland Trail Resources, LLC
Mine No. 2
Permit No. U-3063-88A

Map Showing Area of Fatal Accident
 Midland Trail Resources, LLC
 Mine No. 2
 ID# 46-08814 Permit# U-3063-88A
 Situate on the waters of Rader Run
 Meadow Bluff District of Greenbrier County
 West Virginia
 February 21, 2002 Scale: 1" = 50'
 Date of Fatality: February 20, 2002
 Approximately 2:30 P.M.

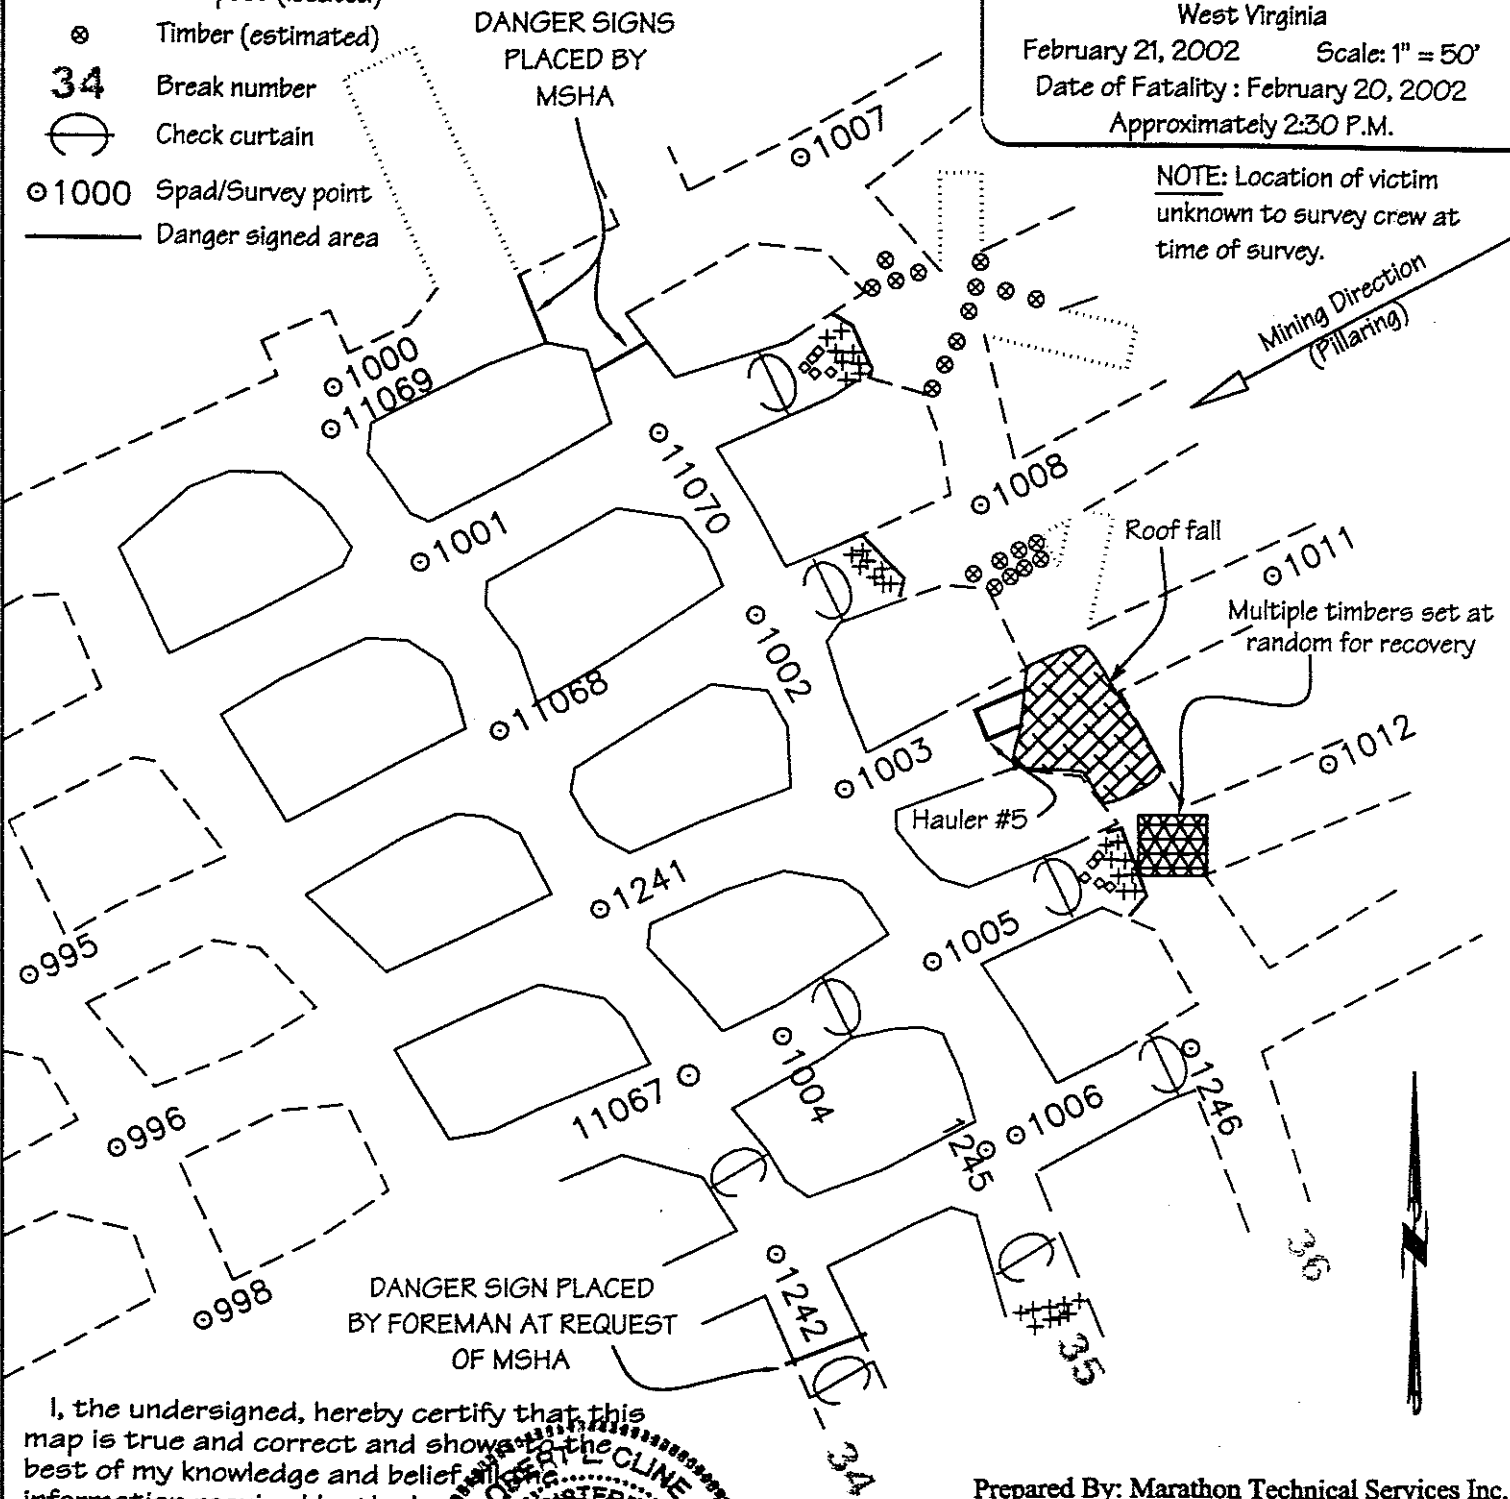
MAP OF SURVEY

NOTE: Location of victim unknown to survey crew at time of survey.

3. The roof fall encompassed the entire intersection of the No. 4 entry at the entrance to the pillar line and extended for a distance of approximately 20 feet into the crosscut toward the No. 5 entry and approximately 20 feet outby the intersection in the No. 4 entry. The maximum height of the fall was estimated to be at least 6 to 8 feet. Exact measurements were not possible under the circumstances.
