**WEST VIRGINIA OFFICE OF MINERS' HEALTH, SAFETY AND TRAINING**

February 10, 2004

Fatal Haulage Accident Investigation Report  
Raw Coal Mining Company, Inc.  
Cucumber Mine  
Permit No. U-4016-94B

Region Two - Welch Office  
891 Stewart Street  
Welch, WV 24801  
Fred B. Stinson, Inspector-at-Large

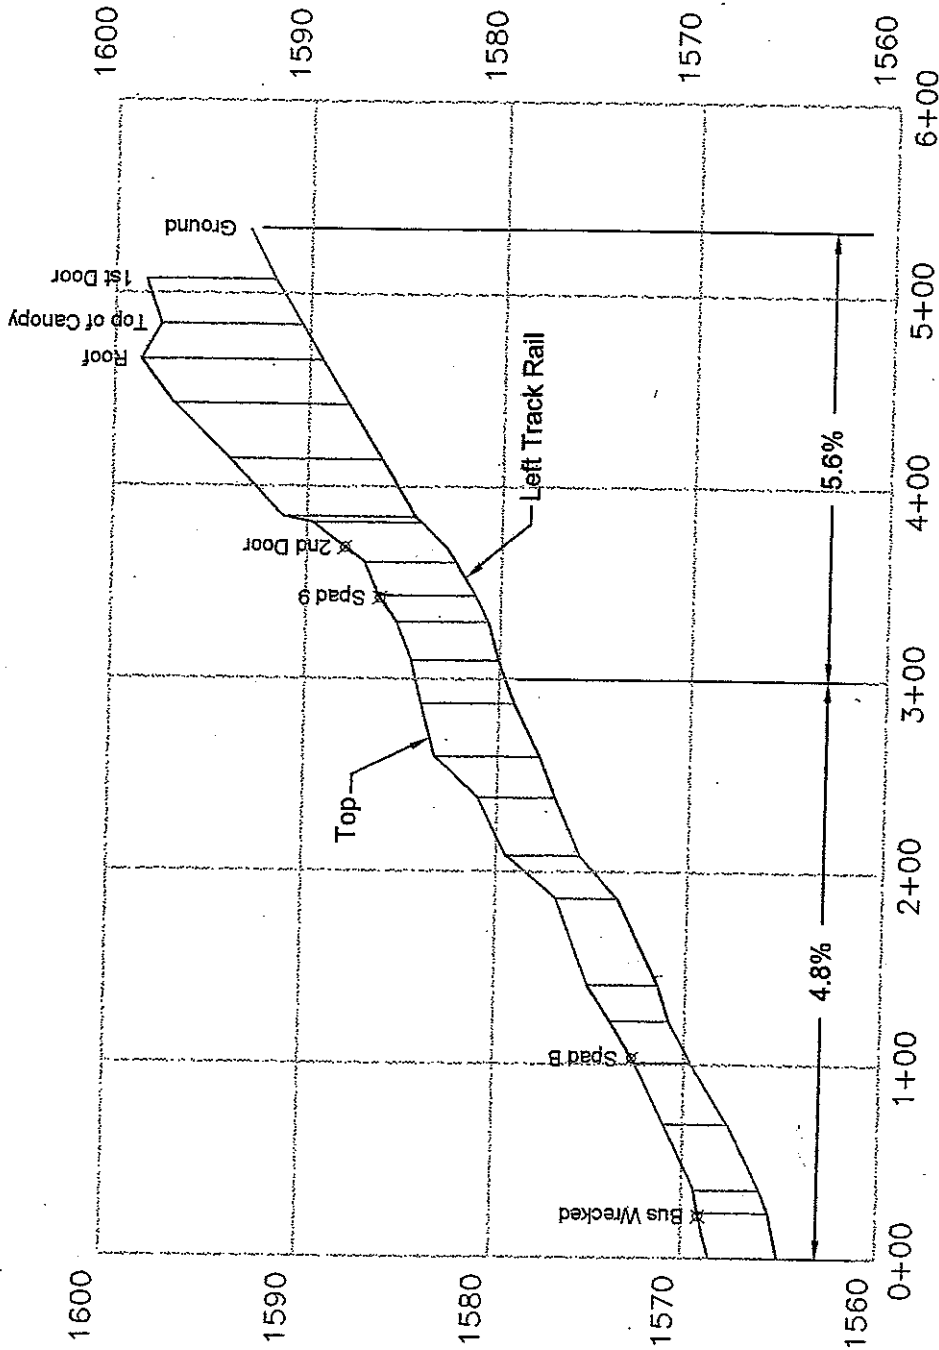
FEBRUARY 10, 2004  
 ACCIDENT  
 TRACK ROOF PROFILE

and second doors. Both doors had been constructed of sheet and channel metal with rubber flaps around the outer edges to facilitate a proper seal. Beginning at a point approximately 25 feet in by the first door the track entry descends at a 21.2% grade for a distance of approximately 20 feet. The dip or grade then averages 10.8% to the second door.

- Airlock doors were located in the track entry drift opening. The first door was located under the portal canopy where it connects to the highwall. The second door was located approximately 140 feet inby. Beginning at a point approximately 25 feet inby the first door, the slope of the mine floor descended at 21.2 % for a distance of 20 feet. The slope then averaged 10.8 % to the second door (see Drawings on pages iii and iv).

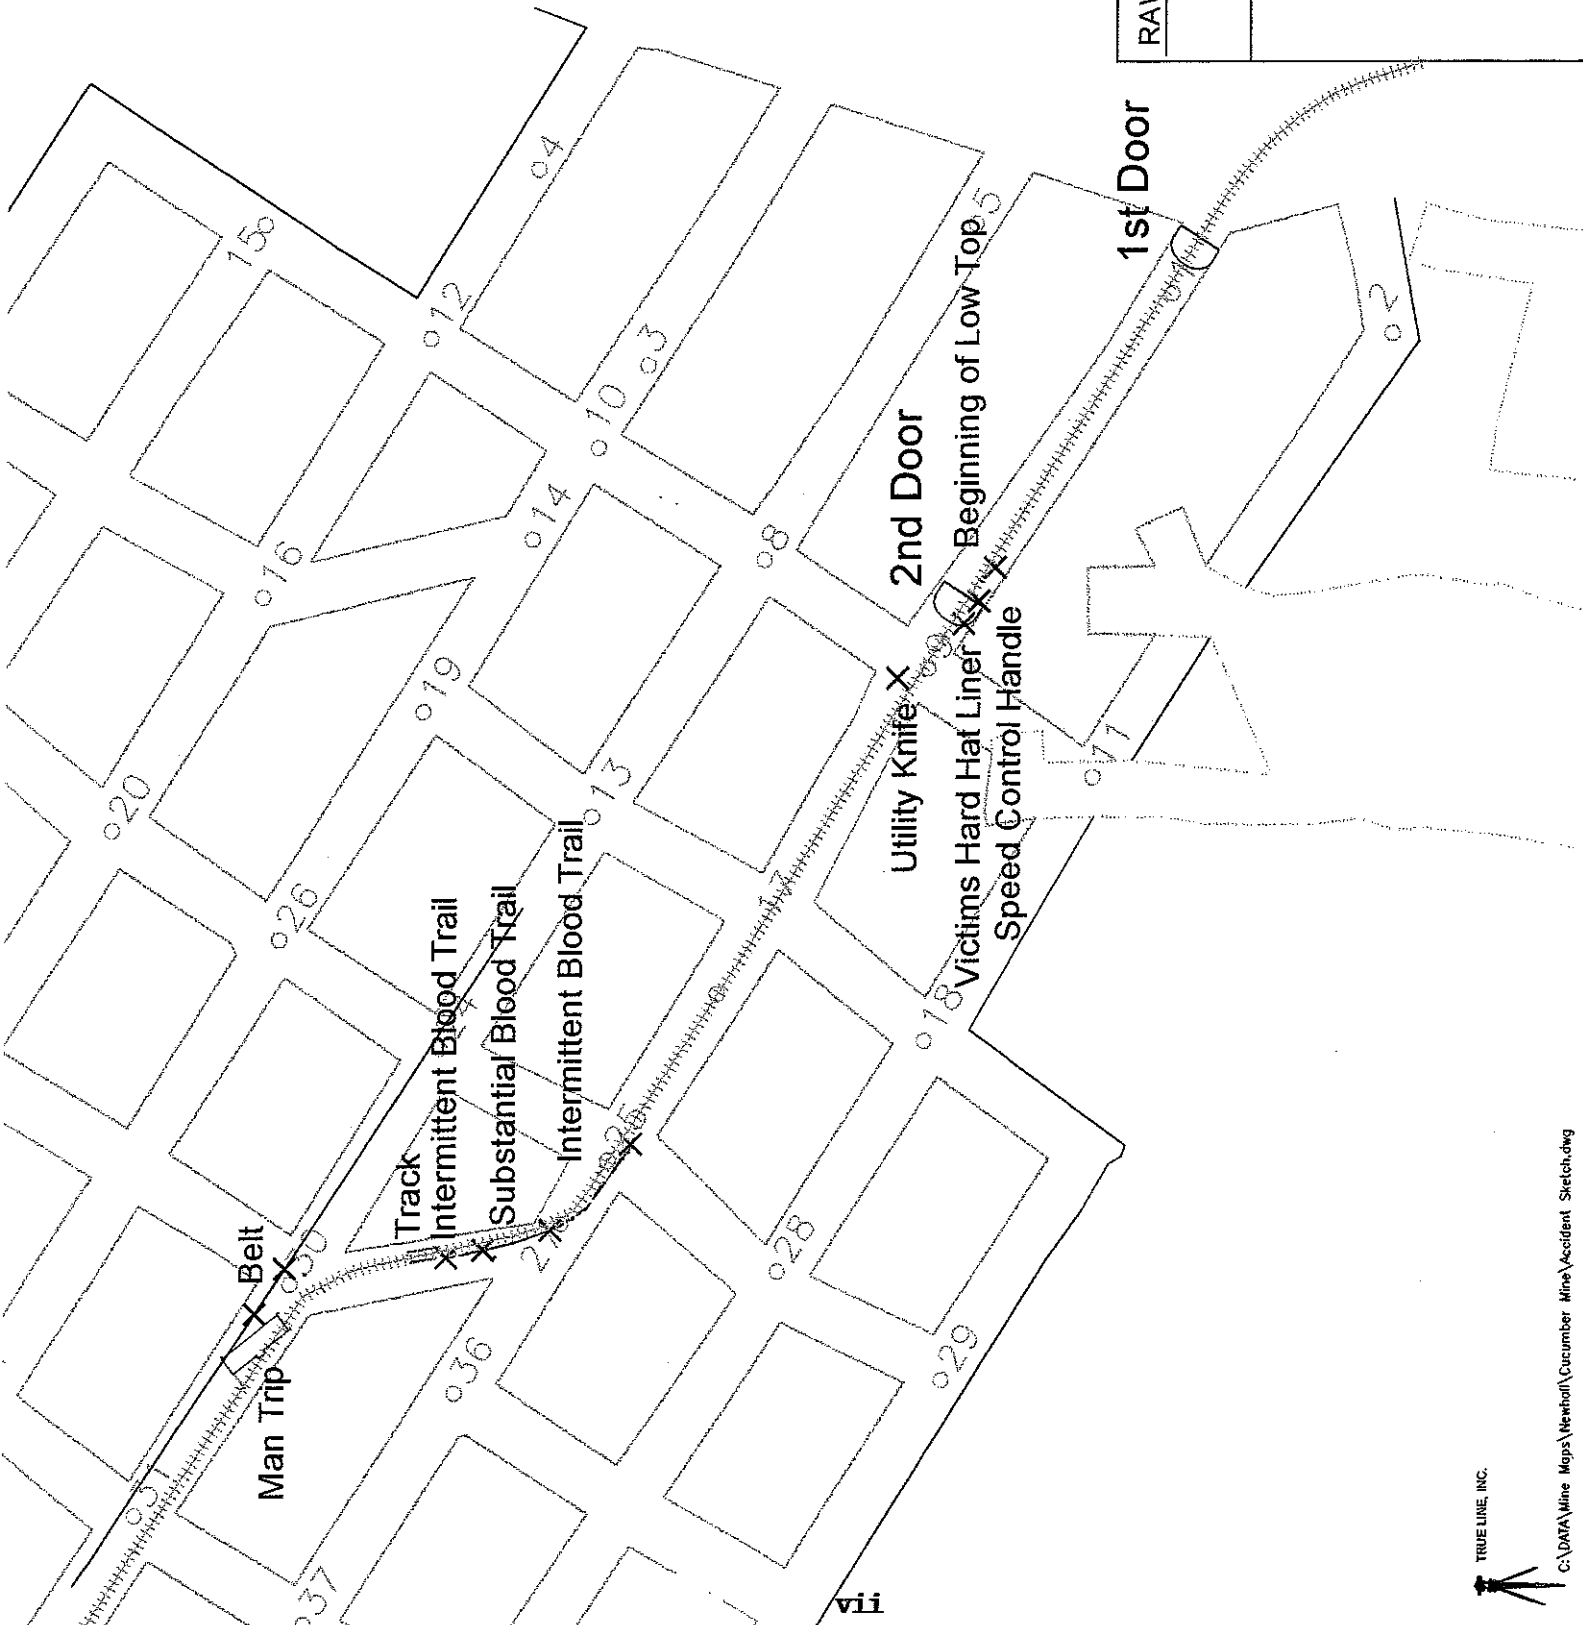
FEBRUARY 10, 2004  
ACCIDENT SKETCH

The track-mounted mantrip vehicle operated by Mr. Addair started underground at approximately 7:35 a.m. The general description by all persons aboard the vehicle was that the vehicle started to accelerate when it began its descent toward the second door. Descriptions and/or opinions as to whether the vehicle's wheels locked up and slid or rolled freely during the descent varied. Campbell, who was a passenger in the other track-mounted vehicle, stated that Mr. Addair was sitting upright as the vehicle entered the mine. Stinson stated that he heard Mr. Addair call out that he "had no brakes" just before the vehicle struck the second door. Stinson, who was positioned in the vehicle's left front passenger compartment, stated that the door bounced up and over the heads of those in the vehicle's front compartment. The vehicle then continued for a distance of approximately 250 feet where it made a right turn. The vehicle then continued for approximately 80 feet where it derailed in a left turn. Mr. Addair was found lying atop the outby end of the vehicle with his legs extending down into the operator's deck. Based on the evidence at the scene, the fatal injuries were caused at the time the vehicle struck the door.

Gary S. Addair, Roof Bolter/Mantrip Operator, received fatal injuries when he lost control of the track mantrip he was operating and ran through a metal airlock door.
