**State of West Virginia  
Office of Miners' Health, Safety & Training  
205 Marion Square  
Fairmont, West Virginia 26554**

**May 11, 2005**

**Fatal Power Haulage Accident  
(Underground Coal Mine)**

**Consolidation Coal Company  
Shoemaker Mine  
Permit No. D-4791**

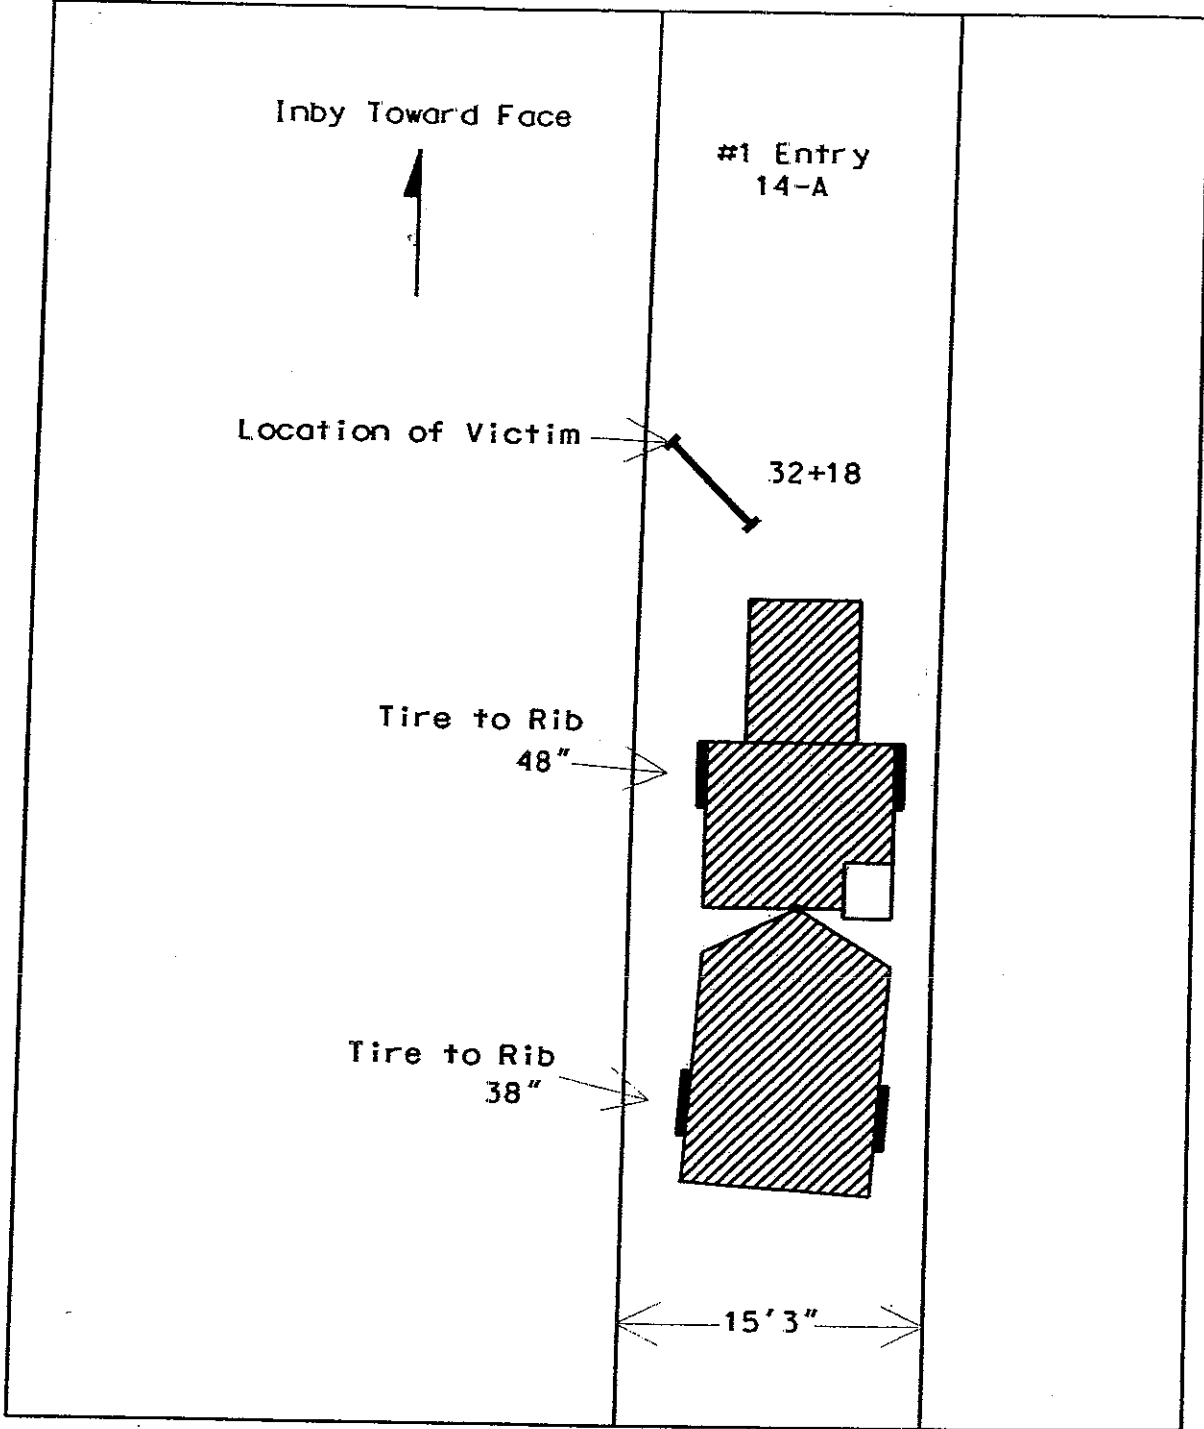
14-A Accident Scene:

While delivering blocking material in the number one entry on the 14-A Longwall Section, at 32+14, the victim received multiple serious injuries when he was struck by an Eimco scoop. At approximately 8:15 P.M., Mr. Willis died during the surgery to correct these injuries. The victim was positioned in close proximity to a moving piece of equipment.
