West Virginia Office of Miners' Health, Safety and Training

May 16, 2008

Fatal Mine Electrocution Investigation Report  
Aracoma Coal Company, Inc.  
Aracoma Alma No. 1  
Permit No. U-5006-99

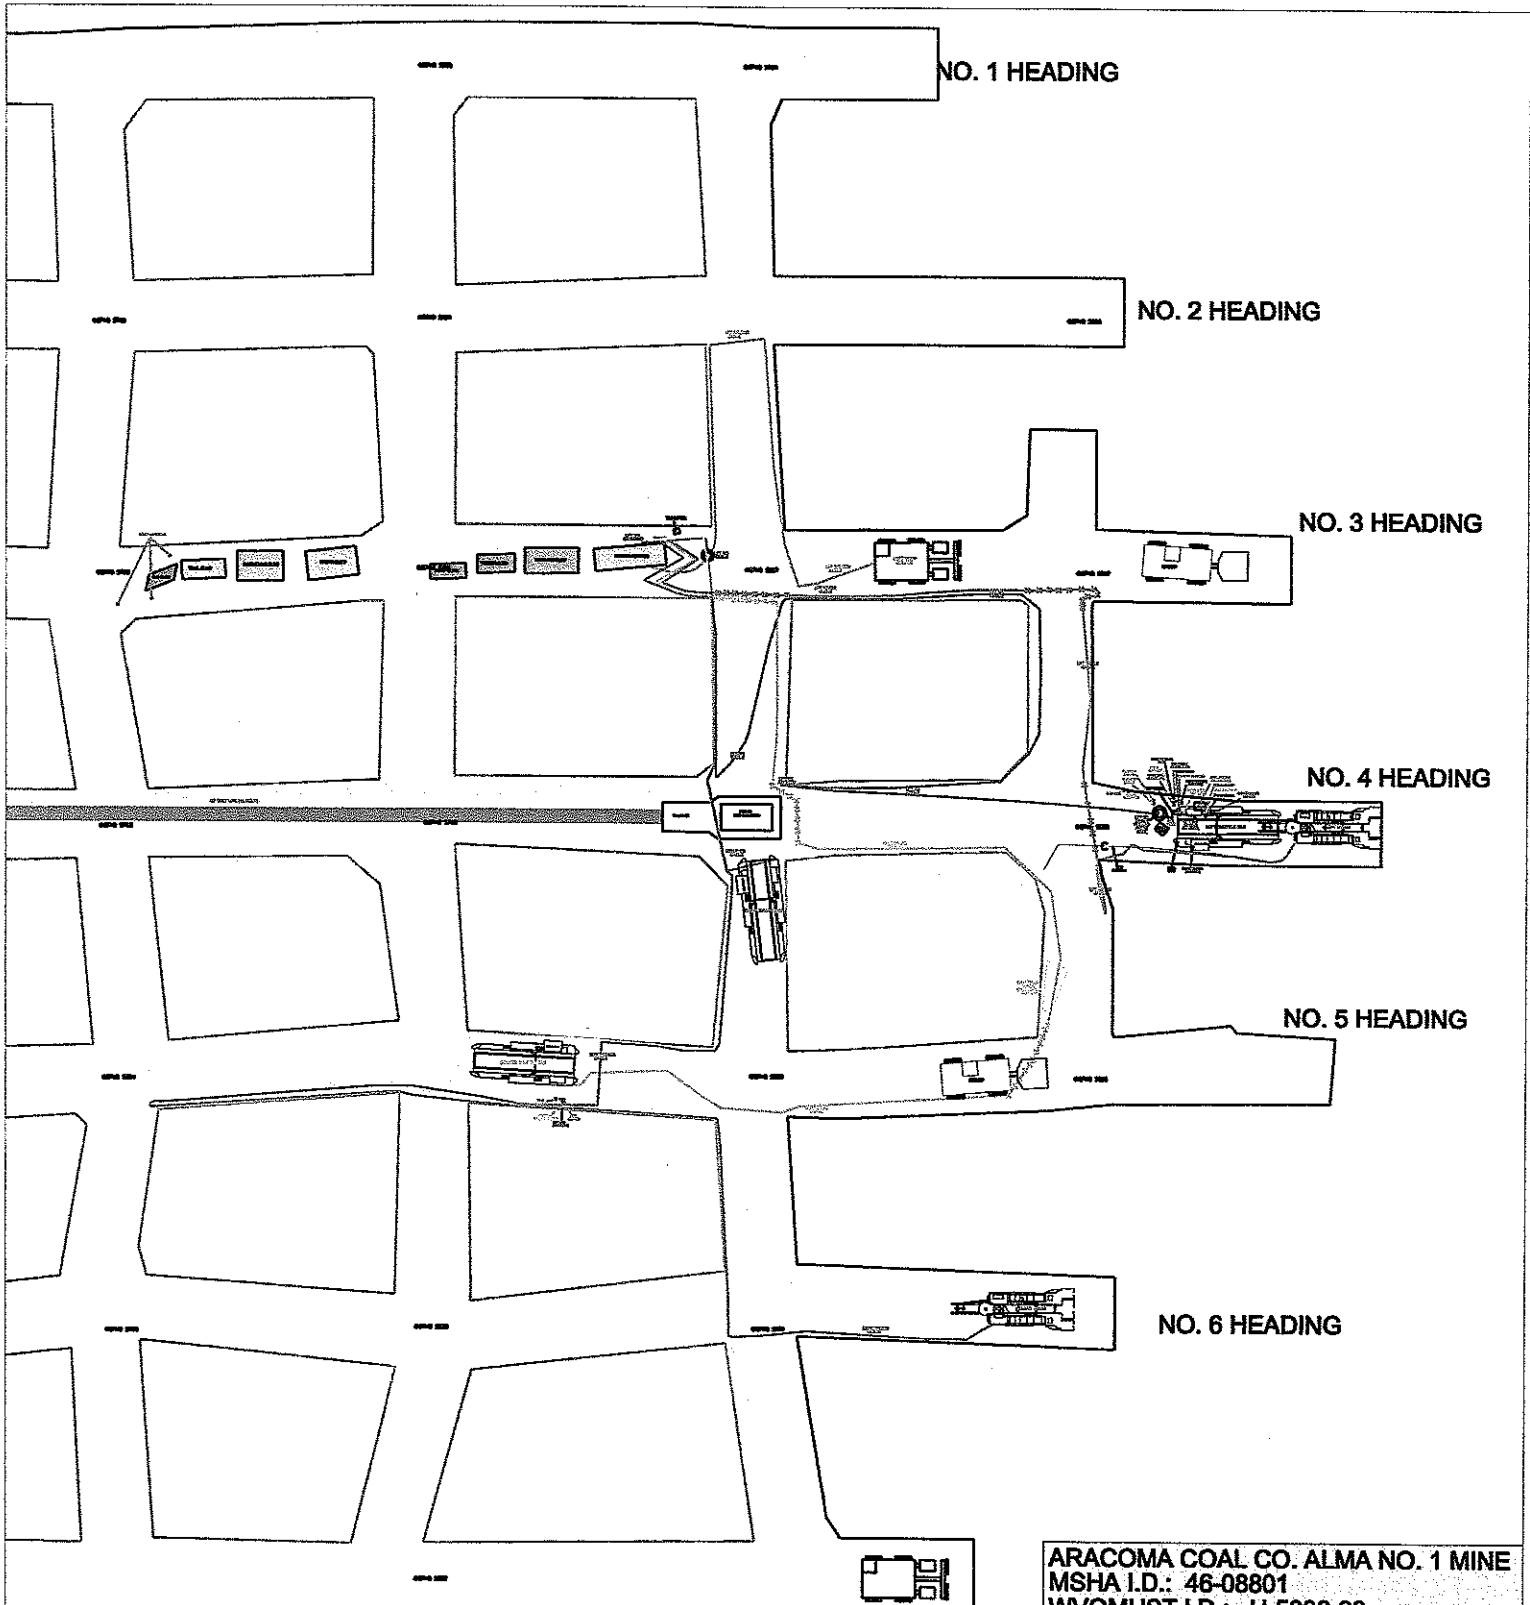
ARACOMA COAL CO. ALMA NO. 1 MINE  
MSHA I.D.: 46-08801  
WVOMHST I.D.: U-5006-99  
05-16-08 ACCIDENT LOCATION MAP  
DATE: 05-19-08  
SCALE: NTS

The accident occurred in the No. 4 entry inby the last open crosscut approximately 33 feet 10 inches inby spad no. 5866.
