West Virginia Office of Miners' Health, Safety and Training

April 10, 2002

Fatal Roof Fall Investigation Report
Rockspring Development, Inc.
Camp Creek No. 1 Mine
Permit No. U-25-84

Region Three - Danville Office
425 Lick Creek Road
Danville, West Virginia 25053
Harry Linville, Inspector-at-Large

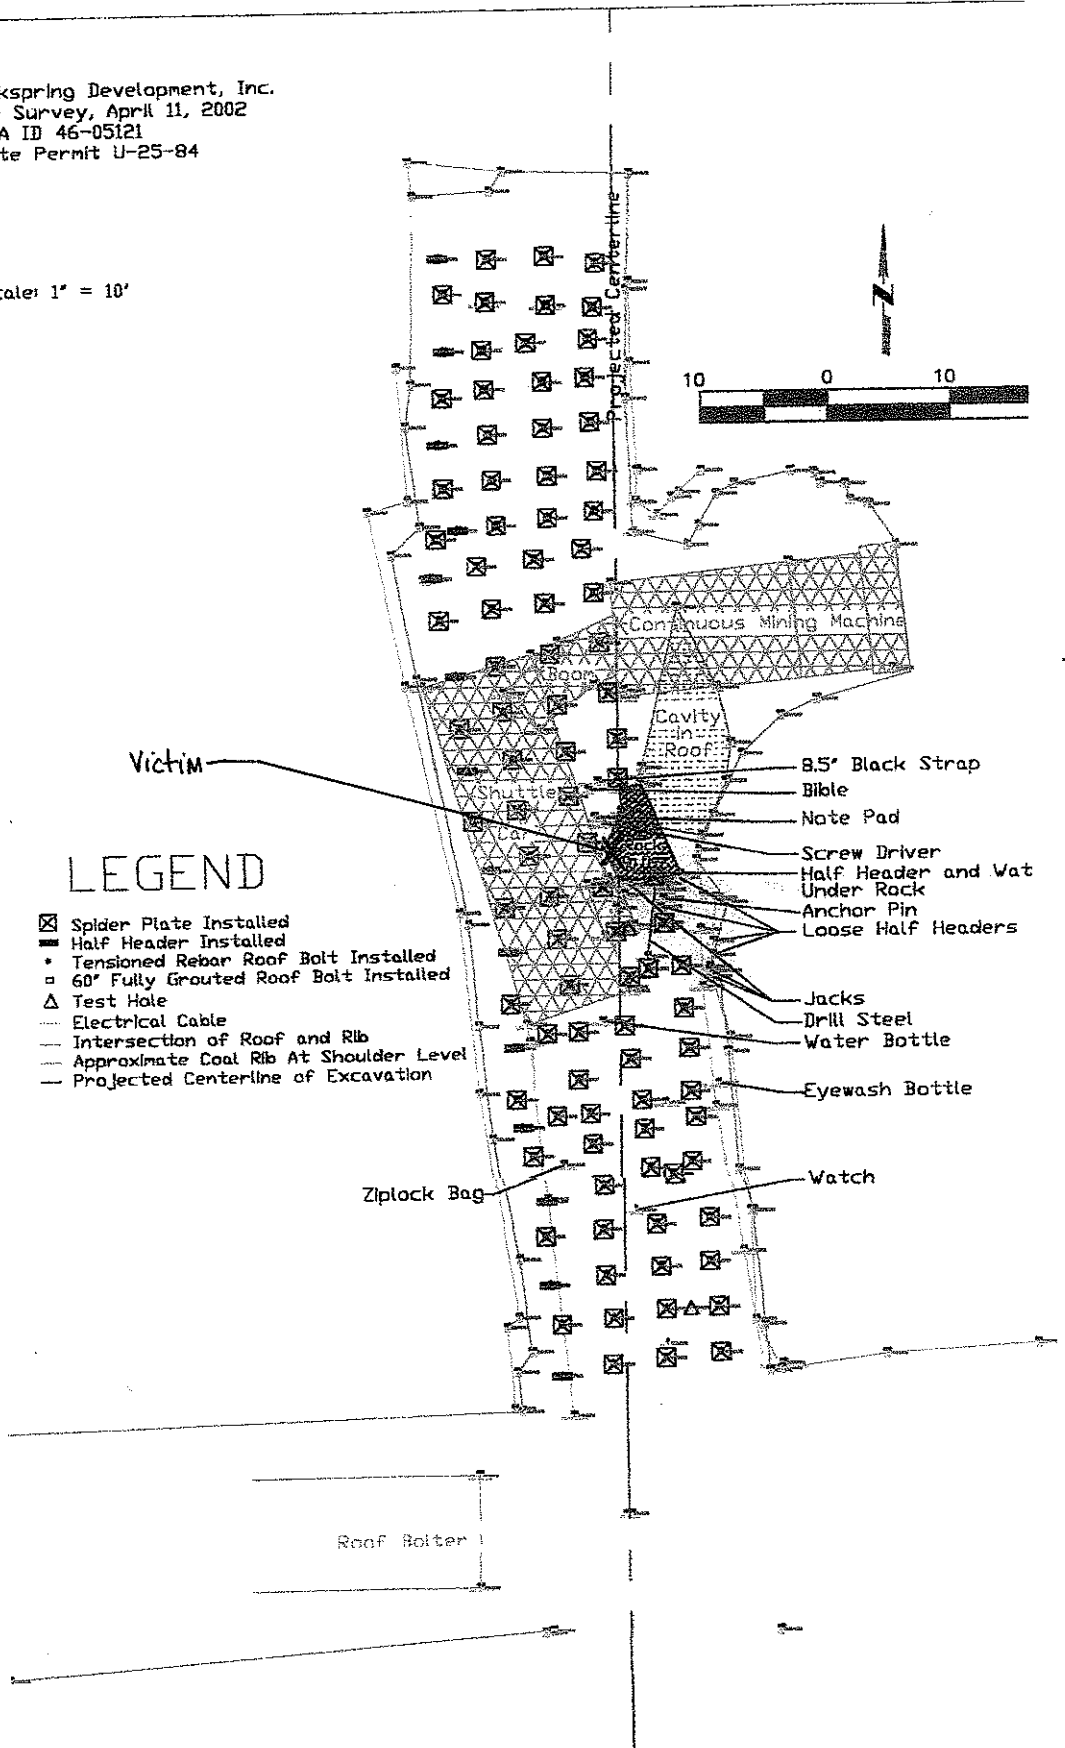
Rockspring Development, Inc.
 Site Survey, April 11, 2002
 MSHA ID 46-05121
 State Permit U-25-84

3. The roof fall separated from the roof on the inby side of the last row of permanent roof supports.
4. Reflectors required by the approved roof control plan to mark the next to last row of permanent supports were not found at the accident site.

5. The crosscut turn in width measured twenty-eight (28) feet, six (6) inches. The approved roof control plan specifies a maximum turn in width of twenty-six (26) feet.

6. The crosscut measured twenty-five (25) feet, ten (10) inches in depth at its deepest point.
7. The mining height at the accident was approximately ten (10) feet.

The victim was struck from behind by a section of falling roof material and was pinned against a shuttle car as he was standing in by the next to last row of permanent roof supports. The roof material separated from the roof on the in by side of the last row of permanent roof supports.

1. All employees were retrained in the provisions of the approved roof control with special emphasis given to requirements pertaining to reflectors, crosscut width and the designated area where mining machine operators shall be positioned.
2. The first cut mined from any crosscut that must be "turned" will be limited to a maximum
