WEST VIRGINIA OFFICE of MINERS' HEALTH, SAFETY and TRAINING

Fatal Roof/Highwall Fall Accident Investigation Report
Arjay Mining, Inc.
Adkins Branch Mine No. 1A
Permit No. U-4012-00A

Region Two – Welch Office
891 Stewart Street
Welch, WV 24801
Fred B. Stinson, Inspector-at-Large

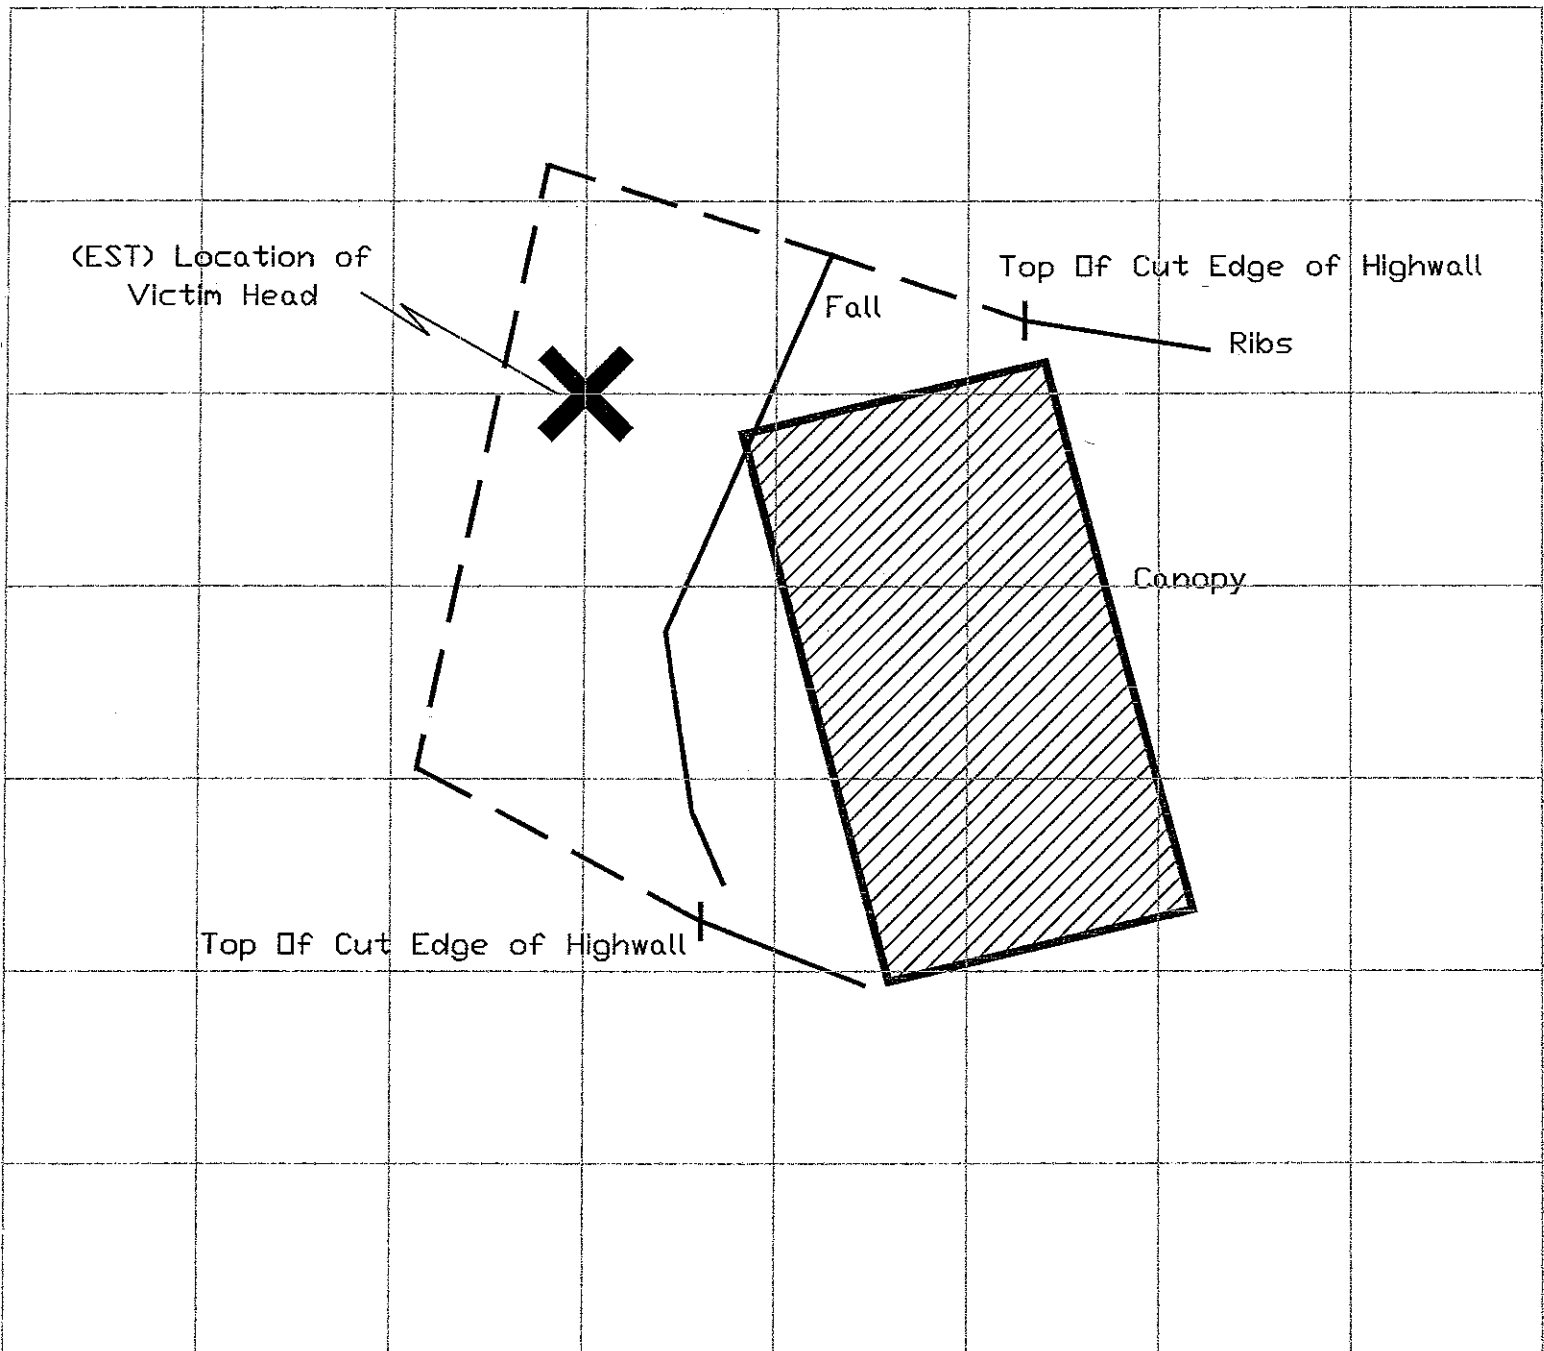
Arjay Mining, Inc.
 Adkins Branch Mine No. 1A
 MSHA Id: 46-09106
 State Id: U-4012-00
 Scale 1"=5'

Mine Fatality
 12-15-05
 Surveying Done By P&A Engineering
 on 12-16-05
 — — Estimated

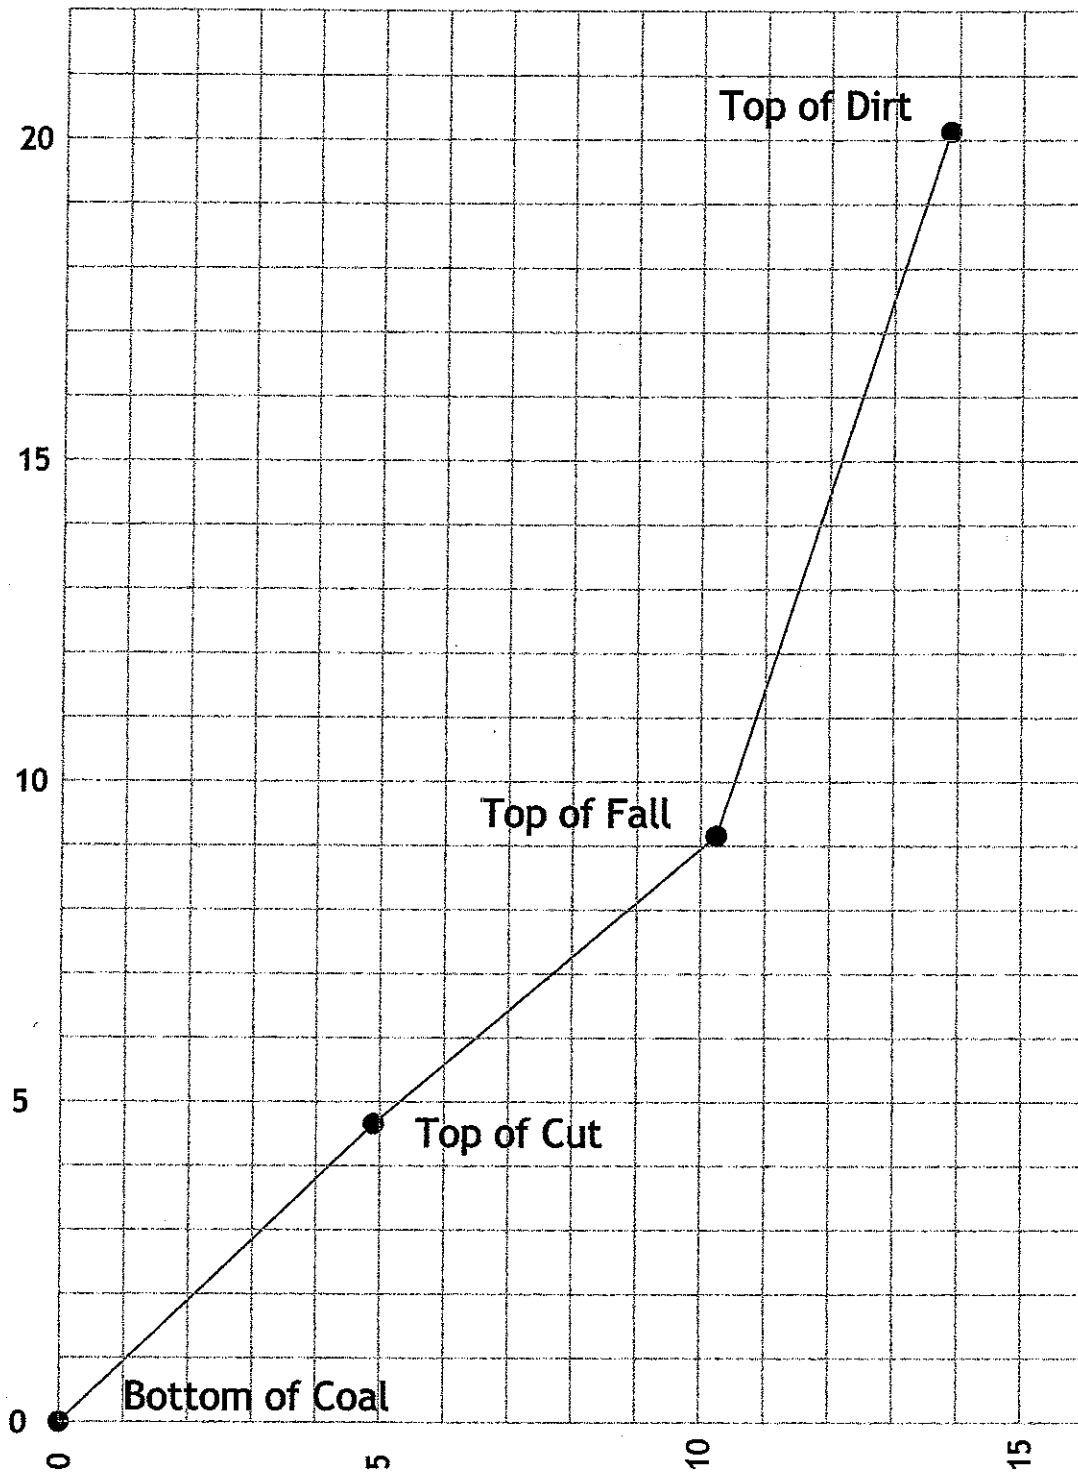
Arjay Mining, Inc.
 Adkins Branch Mine No. 1A
 MSHA Id: 46-09106
 State Id: U-4012-00
 Scale 1"=3'

Mine Fatality
 12-15-05
 Surveying Done By P&A Engineering
 on 12-16-05
