West Virginia Office of Miners' Health, Safety and Training

June 27, 2011

Report of Investigation  
Underground Coal Mine Fatality  
(Roof and Rib Fall)

Rhino Eastern, LLC  
Eagle #1 Mine  
Permit Number U00400591B

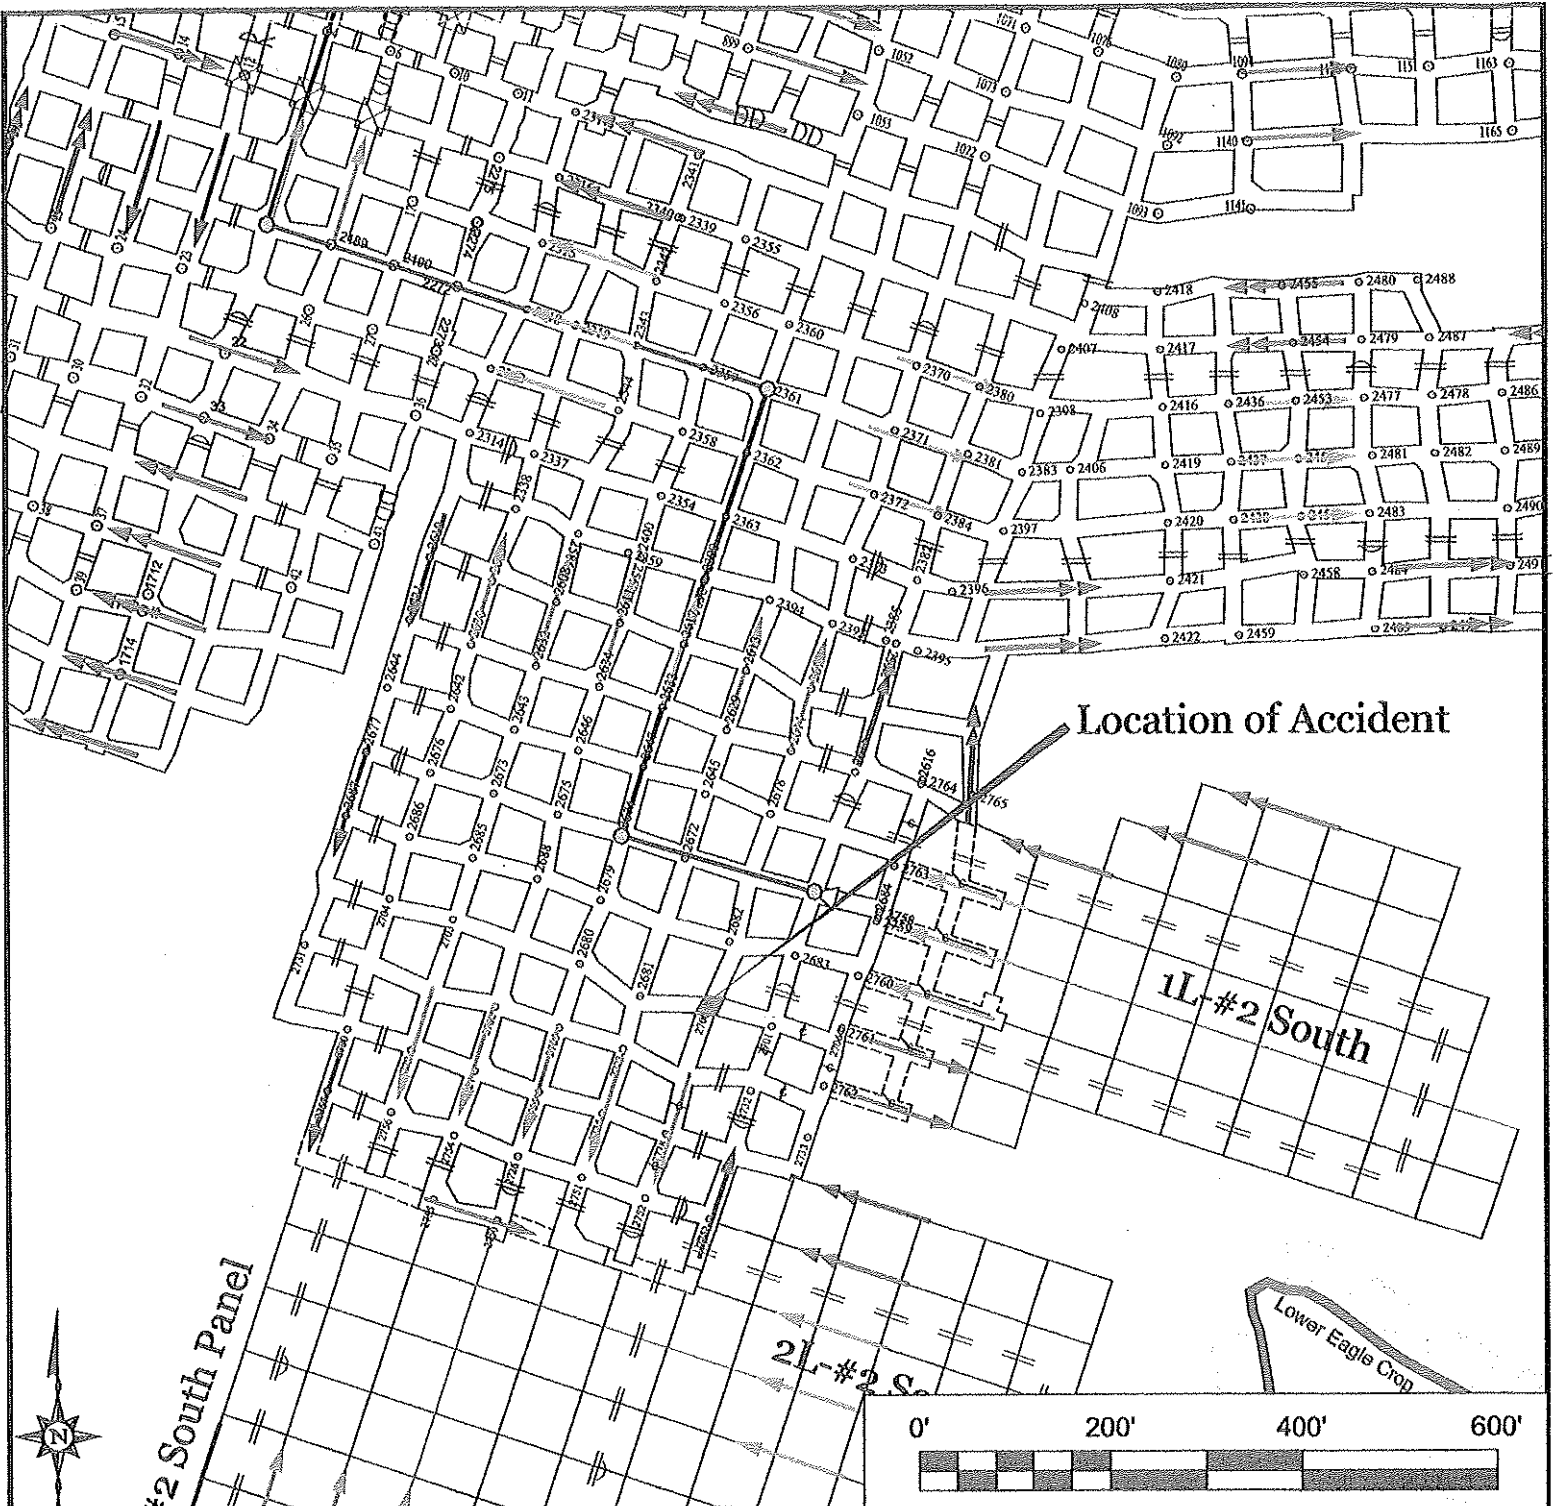
## Rib Roll Fatality Location Eagle #1 Mine Lower Eagle Seam

Location of Accident

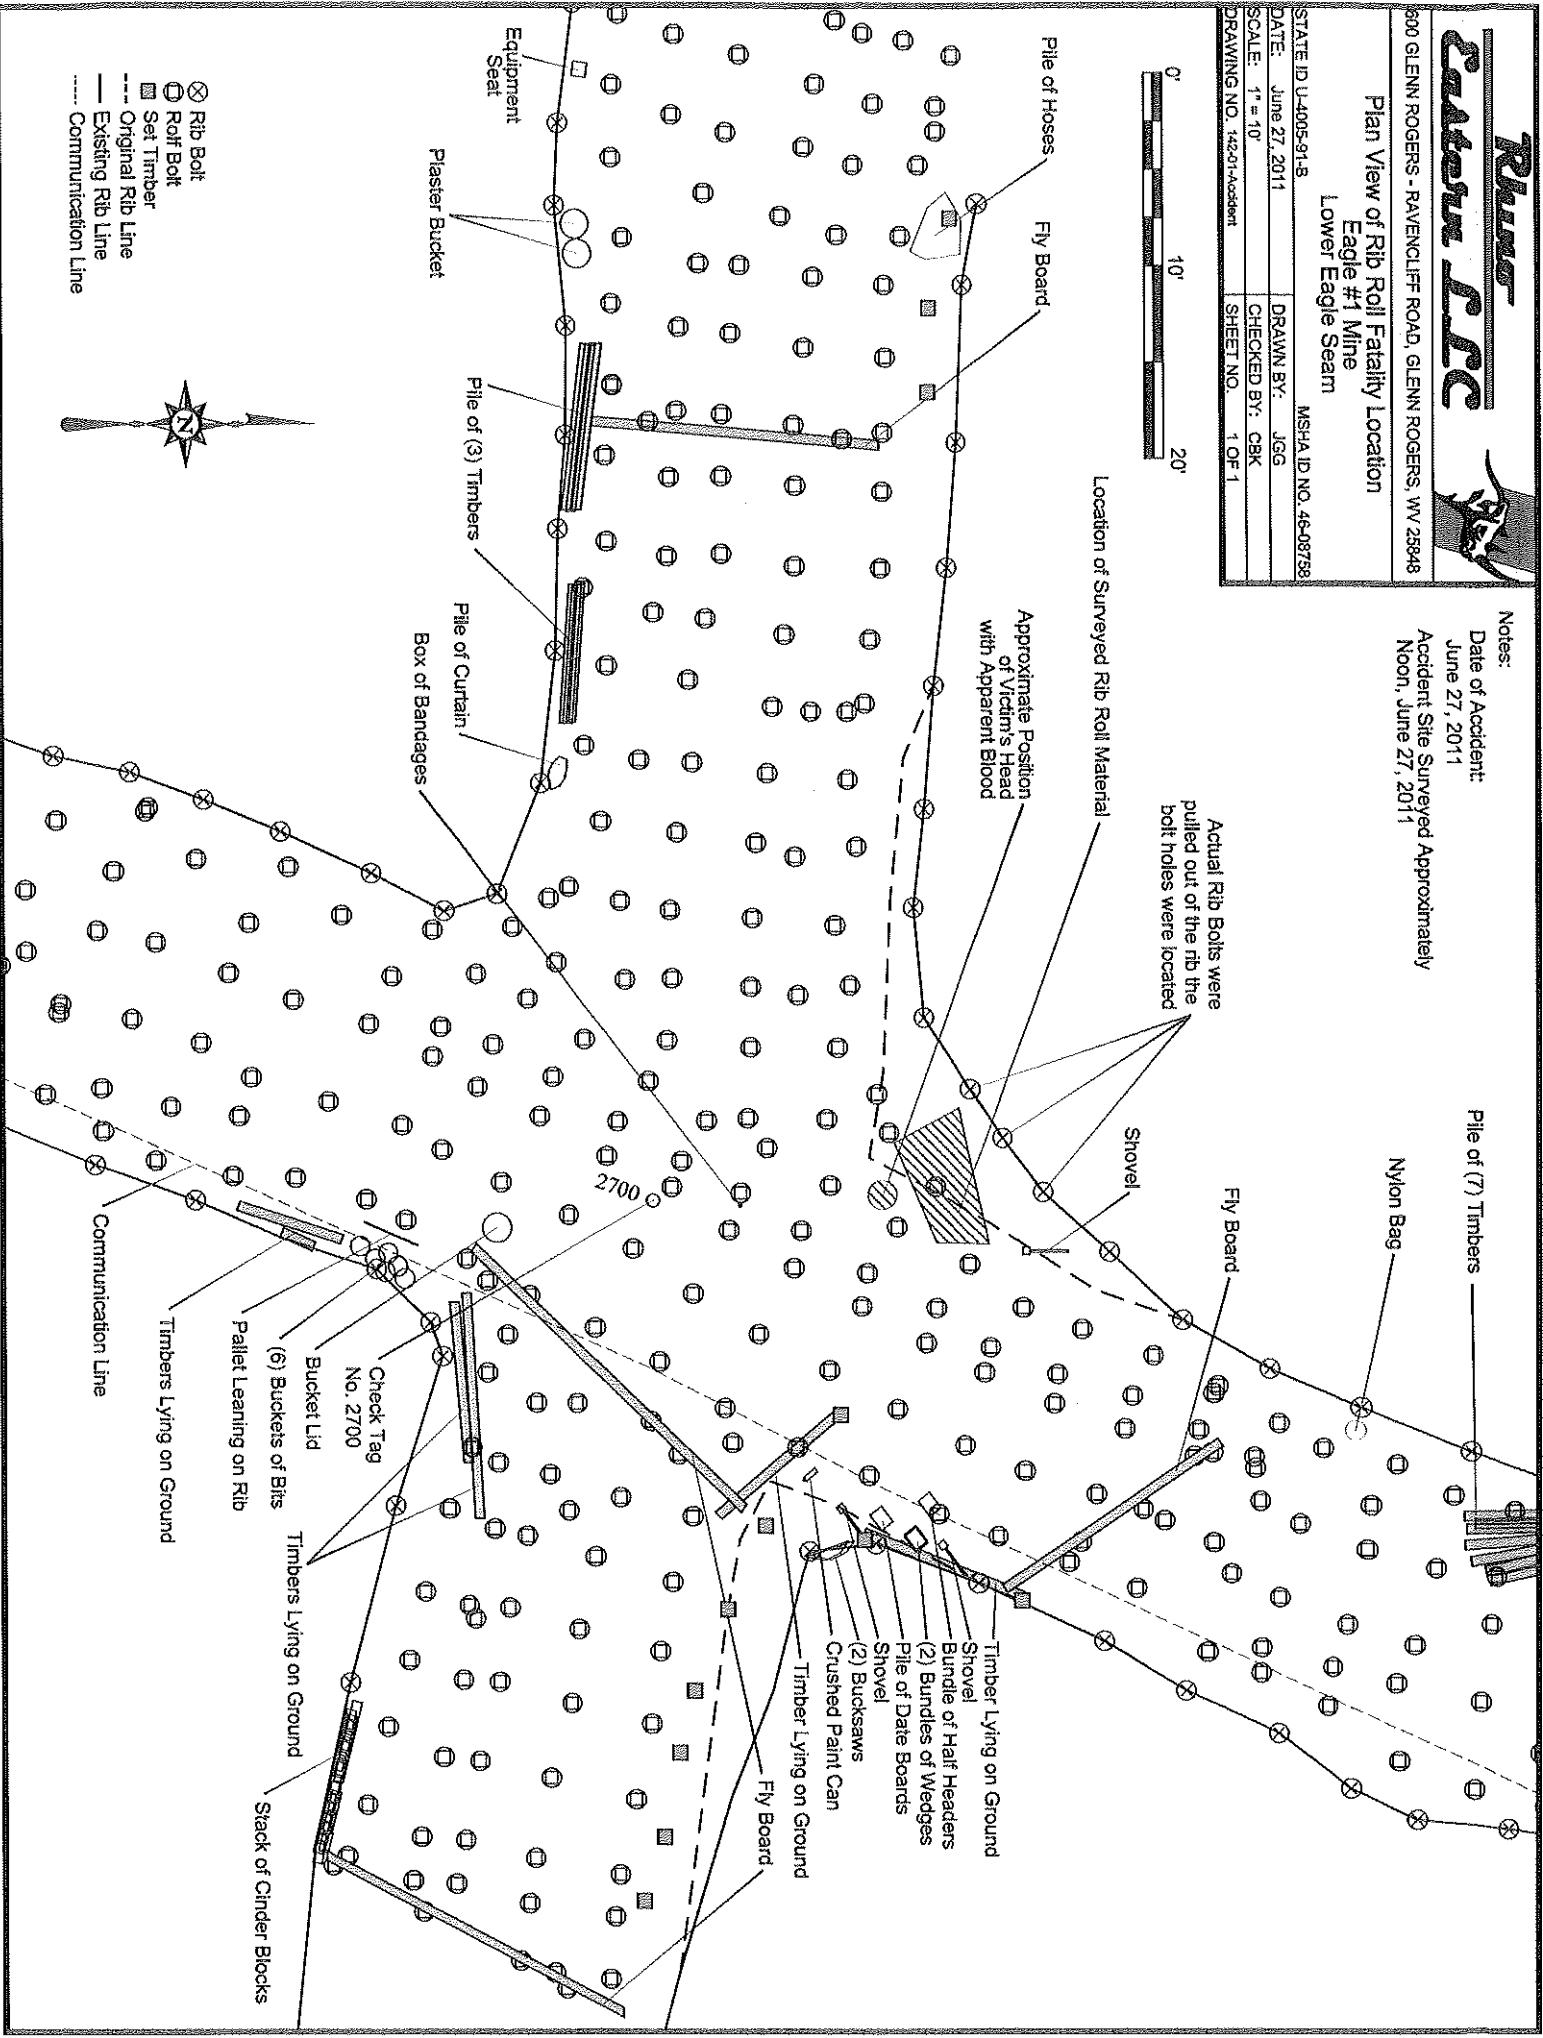
**Plan View of Rib Roll Fatality Location**  
 Eagle #1 Mine  
 Lower Eagle Seam

Actual Rib Bolts were pulled out of the rib the bolt holes were located

Approximate Position of Victim's Head with Apparent Blood

Location of Surveyed Rib Roll Material
