West Virginia Office of Miners' Health, Safety and Training

December 4, 2010

Report of Investigation
Surface Coal Mine Fatality
(Haulage Accident)

Medford Trucking, LLC, Contractor ID Number C-6067
Contractor for
Elk Run Coal Company, Inc. dba Republic Energy
Republic Energy Surface, Permit Number S-3021-95

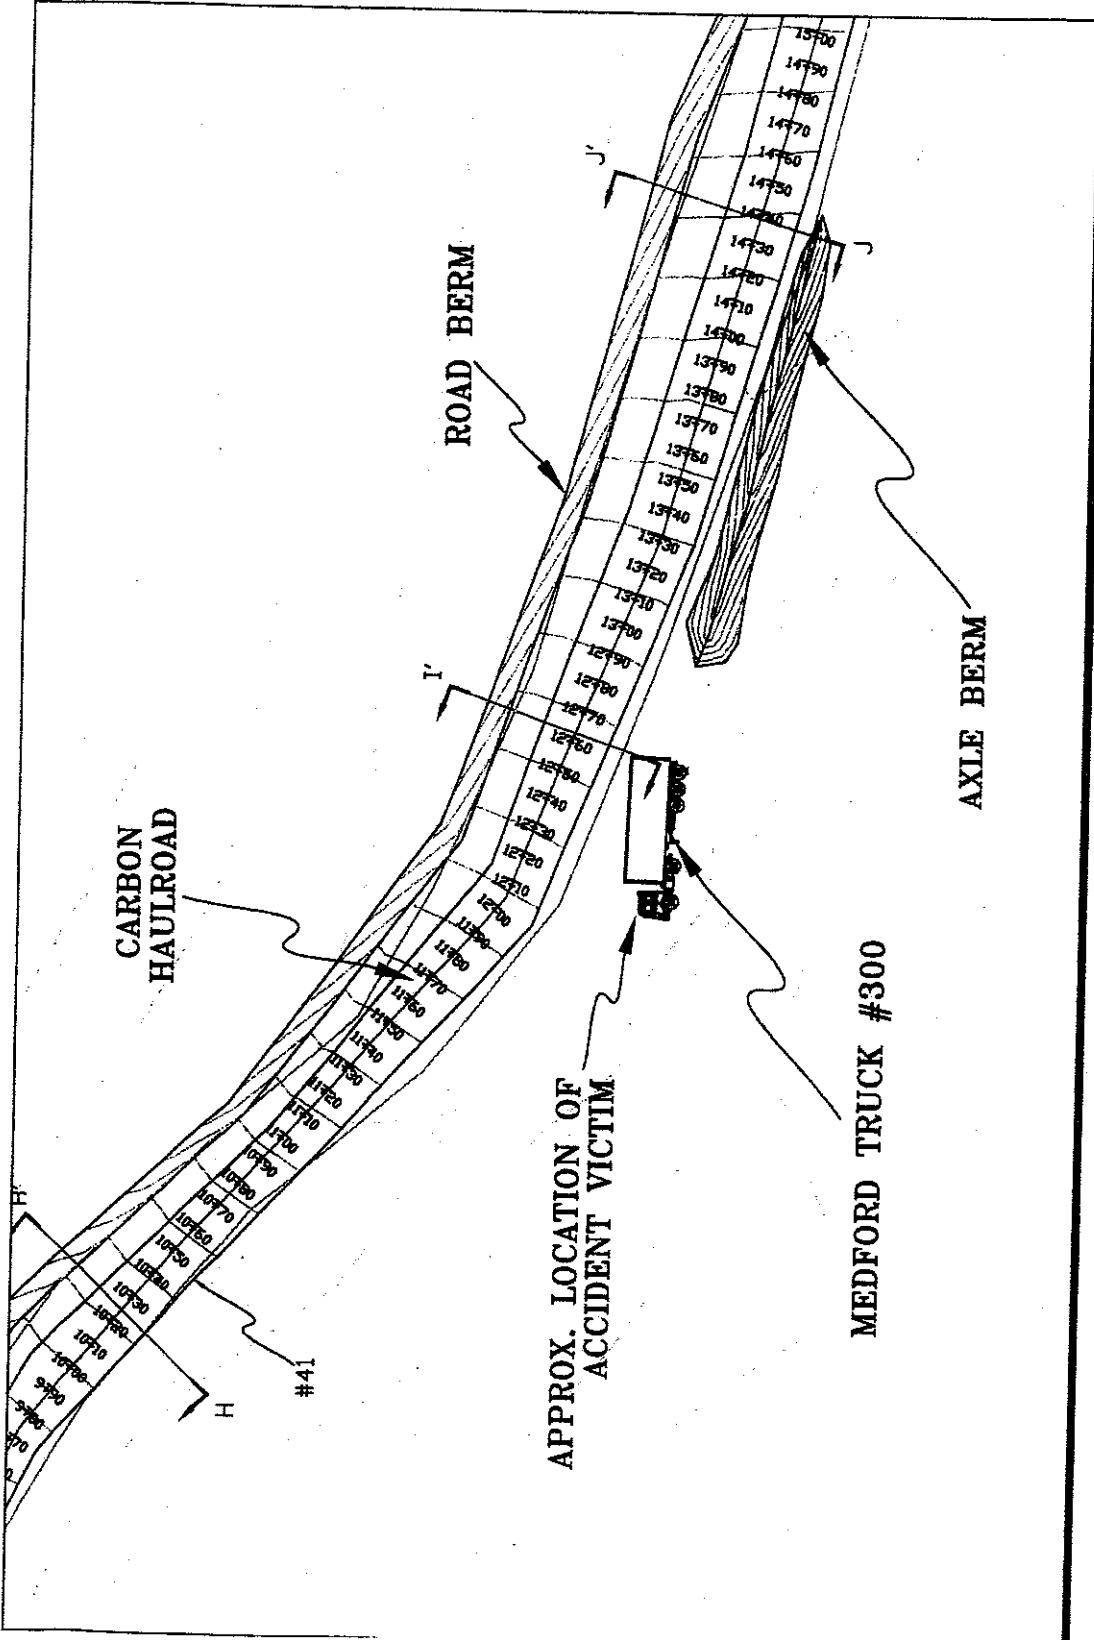
**MEDFORD TRUCKING
FATALITY ACCIDENT**

At the No. 44 road marker sign Mr. Qualls called to Henry Ferrell, the driver directly in front of him, and said, "I'm coming around you - I'm out of control - I can't slow down - I'm sorry". At this point Mr. Qualls passed Mr. Ferrell, who had just moved to the left side of the road in order to allow Mr. Qualls to pass him on the right side of the road. Mr. Ferrell stated that it appeared Mr. Qualls attempted to drive onto the straddle berm at the No. 41 road marker sign but did not strike it squarely, and ran the left truck tires up onto the side of the berm which resulted in the overturning of the truck.

The No. 300 tractor-trailer coal truck came to rest on its right side at the lower end of the straddle berm. Upon seeing Mr. Qualls' truck overturned, Mr. Tate stopped and exited the cab. He ran to the overturned truck and proceeded to remove the windshield and shut down the engine. Mr. Tate tried to free Mr. Qualls whose body was partially pinned beneath the passenger side of the truck cab. Mr. Qualls was unresponsive. Mr. Ferrell, who had also stopped at the accident scene, called 911 to report the accident. At 5:30 p.m. Kanawha County EMS arrived on the scene and removed the victim from the overturned truck. Mr. Qualls was pronounced dead by Paramedic Allen Wees at 5:49 p.m. At 7:16 p.m. Mr. Qualls was transported to the Medical Examiner's office.
