West Virginia Office of Miners' Health, Safety & Training

December 27, 2002

Fatal Roof Fall Investigation Report
Mystic Energy, Inc.
Candice No. 2 Mine
Permit No. U-5007-93

Region Three – Danville Office
425 Lick Creek Road
Danville, WV 25053
Harry Linville, Inspector-at-Large

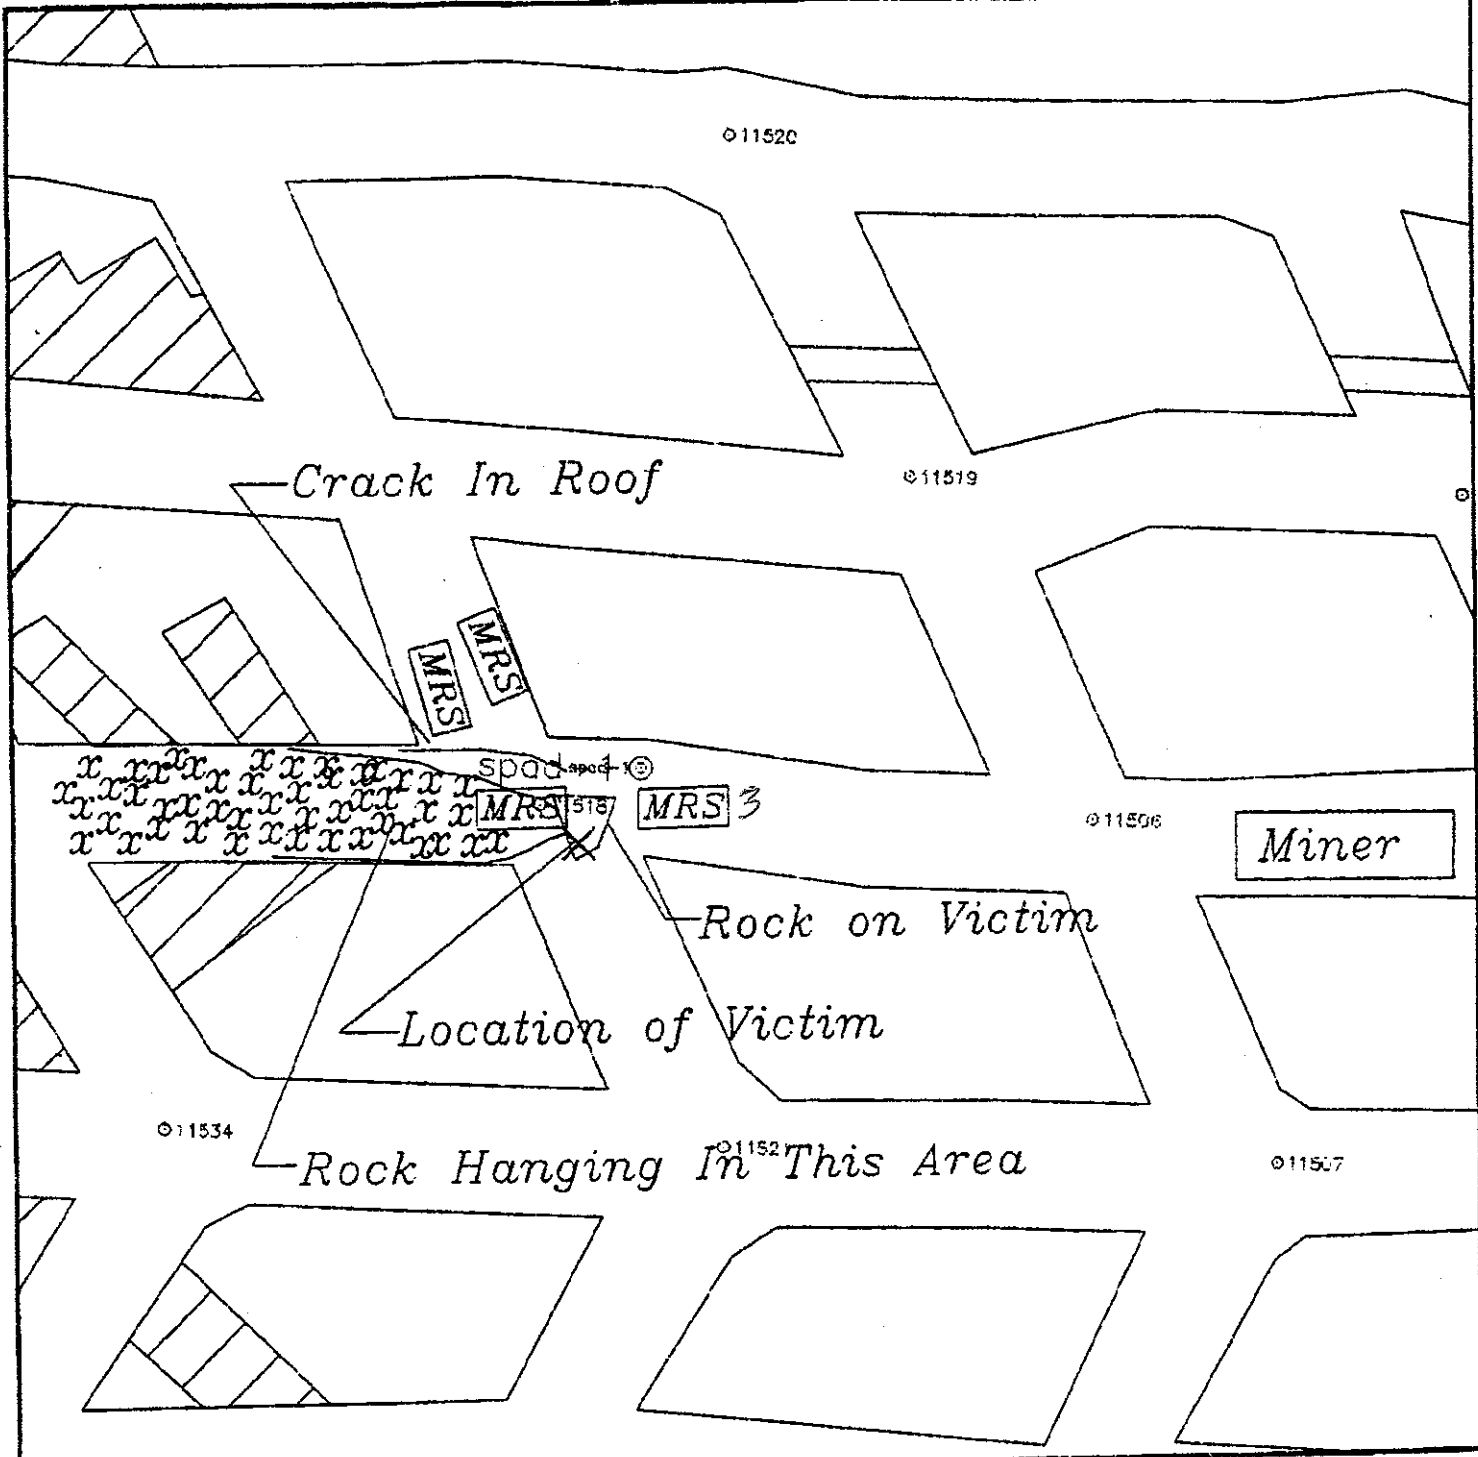
DRAWING OF FATALITY
ON 4 LT - 3 NORTH SECTION
 Date: 12-27-02
 Time: 6:30 PM

8. The victim was located between the no. 1 and the no. 3 mobile roof support at the time of the accident.
9. Those involved in the recovery indicated that the victim was completely covered by the fallen material with the exception of one forearm.

The evidence at the accident scene clearly indicated that the victim was located between the no. 1 and no. 3 mobile roof supports while the supports were being trammed from the pillar workings. Only the no. 4 mobile roof support was pressurized against the mine roof at the time the fall occurred.

Mystic Energy, Inc. will retrain all Candice No. 2 Mine employees on the mine's roof control plan, specifically, all aspects of retreat mining with special emphasis on utilization of the mobile roof supports.

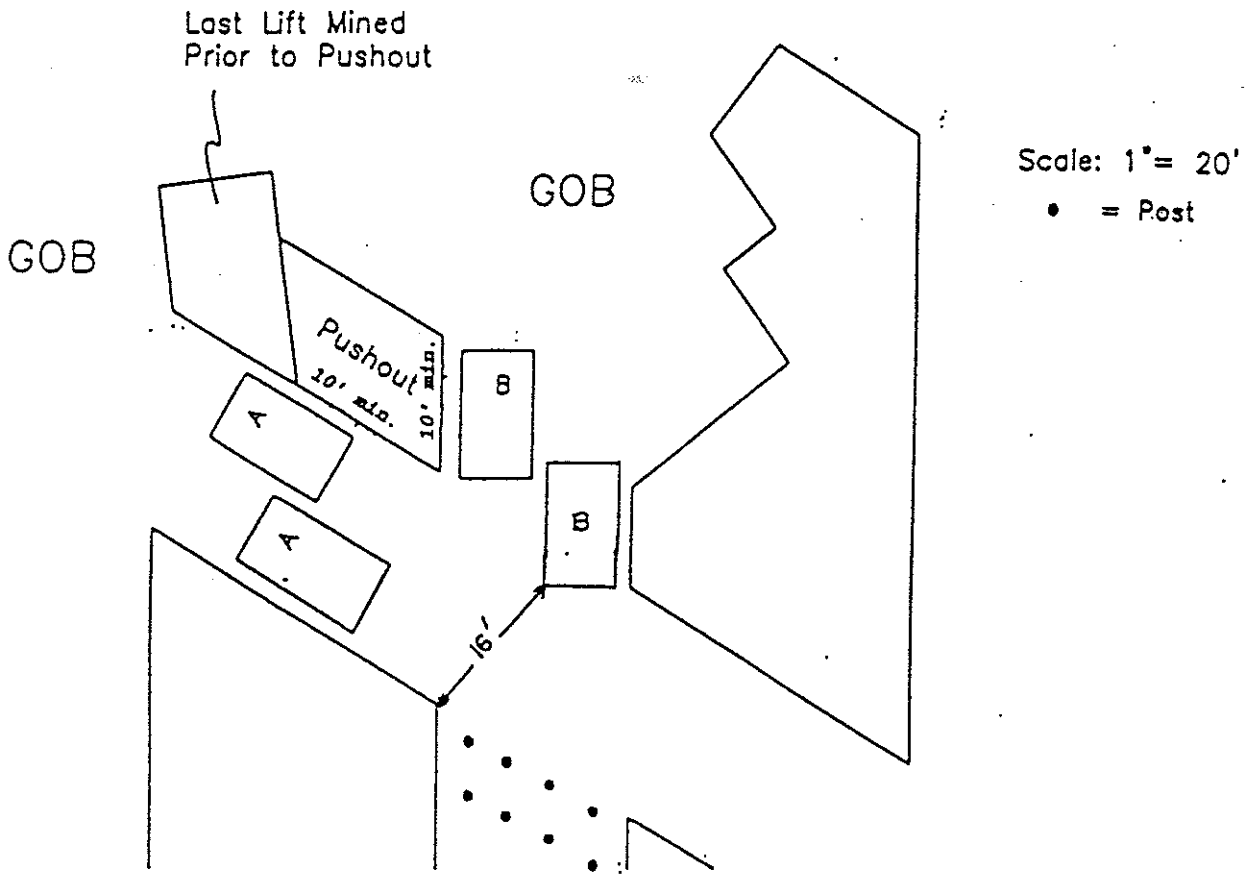
DRAWING NO. 10

According to mobile roof support operators, Jerry Bonds and Bert Gravely, the mobile roof support units had been located and set as required by the roof control plan for push-out mining (see mirror image of drawing no. 10, page 23, approved roof control plan). Mobile roof support unit no. 1 was set on the left side and mobile roof support unit no. 3 was set on the right side of the no. 5 entry, inby the last open crosscut. Mobile roof support unit no. 2 was set on the inby side of the crosscut and mobile roof support unit no. 4 was set on the outby side of the crosscut to the right off the no. 5 entry.

6. The mobile roof supports were not being moved in accordance with the approved roof control plan.
7. At least three individuals were in the active pillar workings while tramming the mobile roof supports from a final pushout.
