West Virginia Office of Miners' Health, Safety and Training

April 3, 2004

Report of a Machinery Fatality
(Underground Coal Mine)

Brooks Run Mining Company, LLC
Upper Mercer Mine
Permit No. U-2004-01A

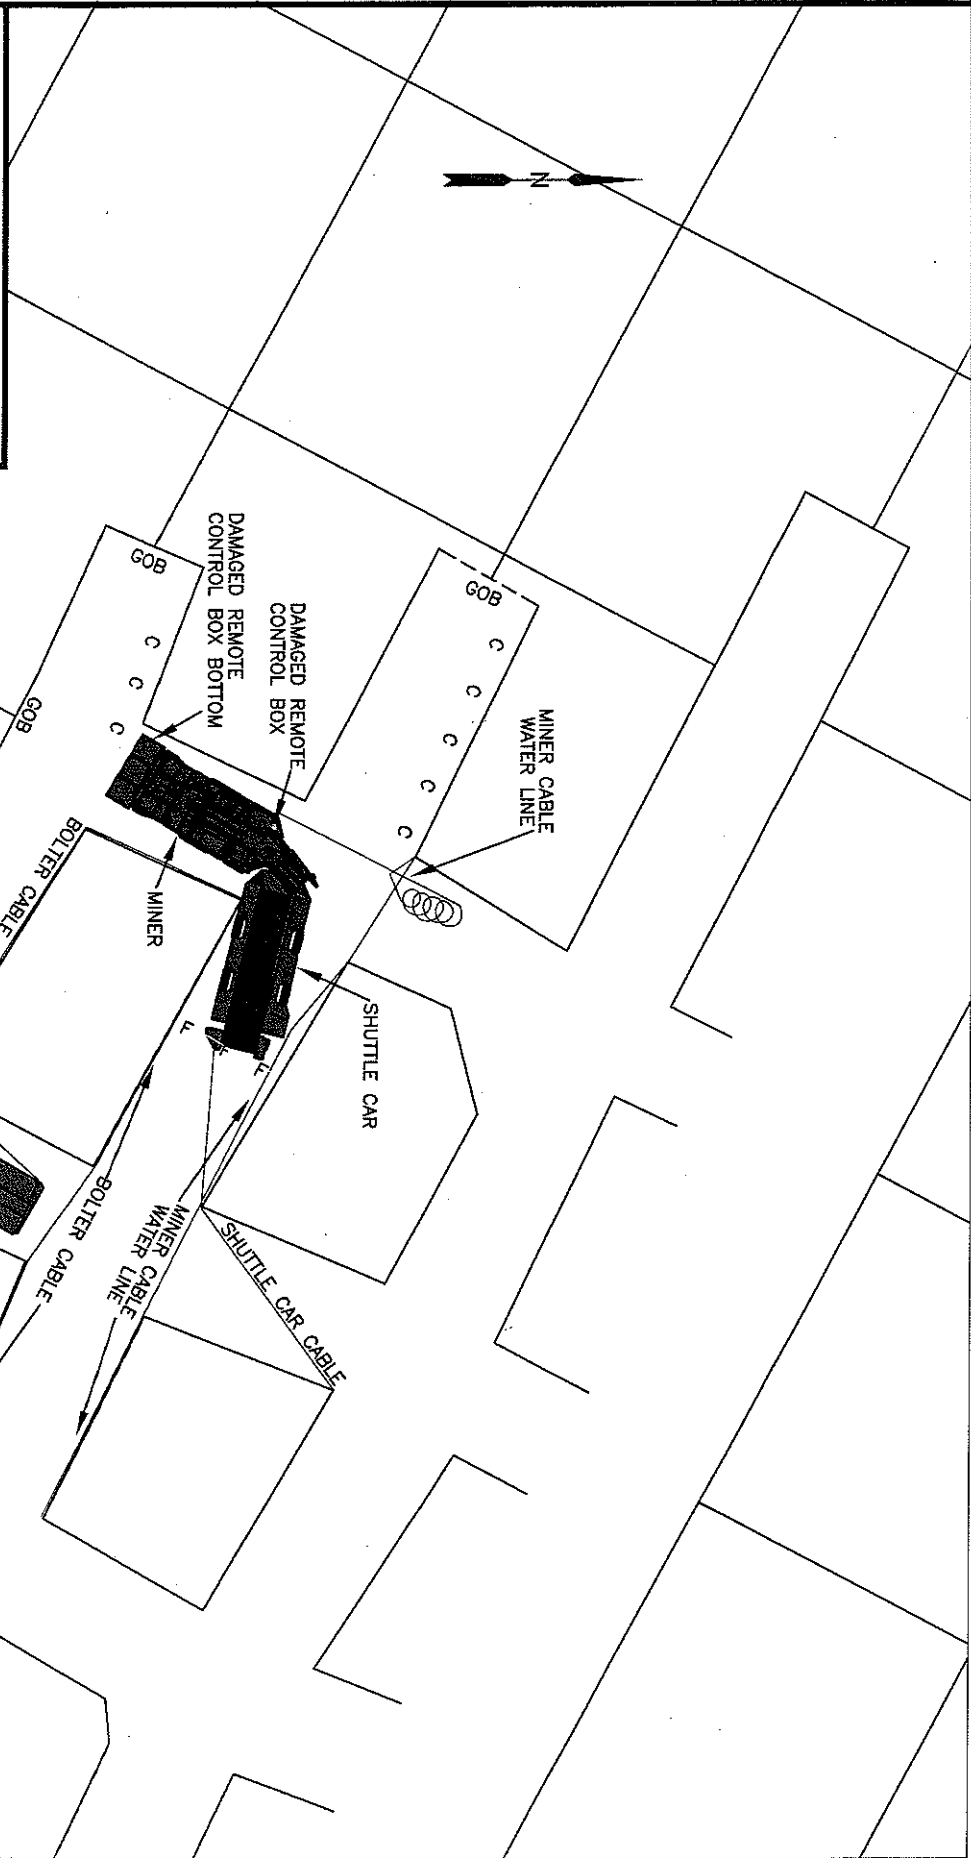
APPROX. LOCATION
BOLTER OPERATOR

REMOTE CONTROL BOX
APPROX. LOCATION
OF VICTIM

*EQUIPMENT, PERSONNEL AND VICTIM LOCATIONS APPROXIMATED
USING WITNESS ACCOUNTS.
