October 17, 2011

Report of a Fatal Power Haulage
(Underground Mine)

Consolidation Coal Company
Shoemaker Mine
Permit No. D-4791

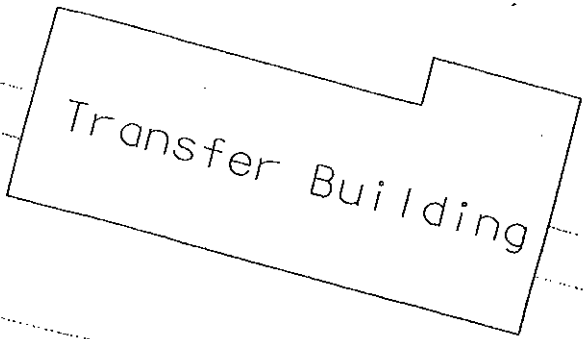
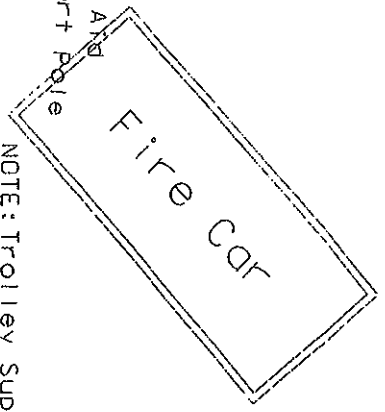
Wire Inby Exposed End

First Impact

Wire Outby Exposed End

Drag Mark Stop

Ear muffs
Trolley Support Pole
Cap Light Head Piece

NOTE: Trolley Support Pipe 57" From Ditch Digger
Trolley Support Bar 98" Above Ground
