West Virginia Office of Miners' Health, Safety and Training

June 10, 2004

Fatal Coal Truck Haulage Investigation Report  
Tug Valley Coal Processing  
Preparation Plant No. 1  
Aldrich Branch Impoundment Haulage Road  
Permit No. L-232

Region Three – Danville Office  
137 Peach Court, Suite 2  
Danville, West Virginia 25053  
Harry Linville, Inspector-at-Large

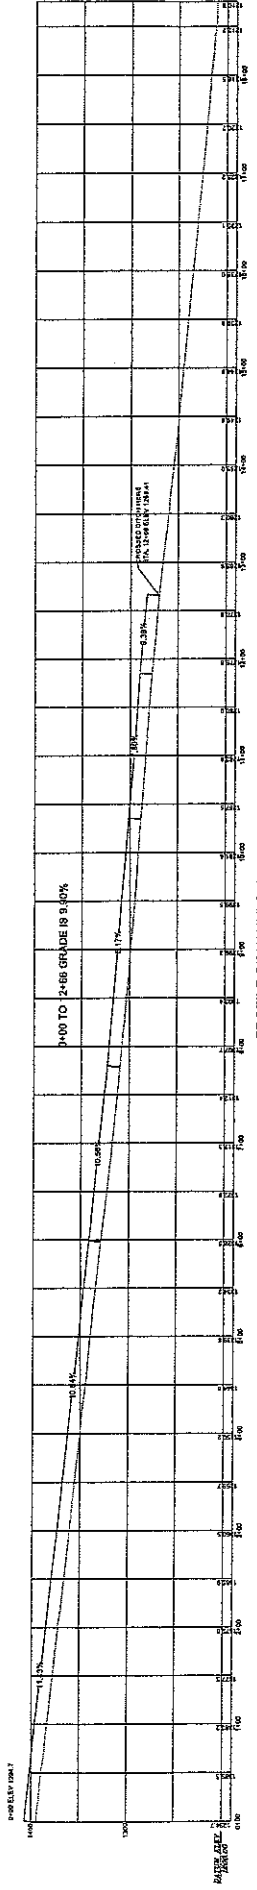
PROFILE OF HAULROAD  
SCALE 1"=200' H&V

NOTE: Overall Grade of Road From Crest (Sta 0+00)  
To Sta. 12+66 is 9.90%.

7. The haulage road grade was measured over a range of 11.43% to 9.39%. (See profile on page 3.) The accident occurred at a location approximately 1,275 ft. down from the haulage road's crest at the top of the Aldrich Branch Impoundment.

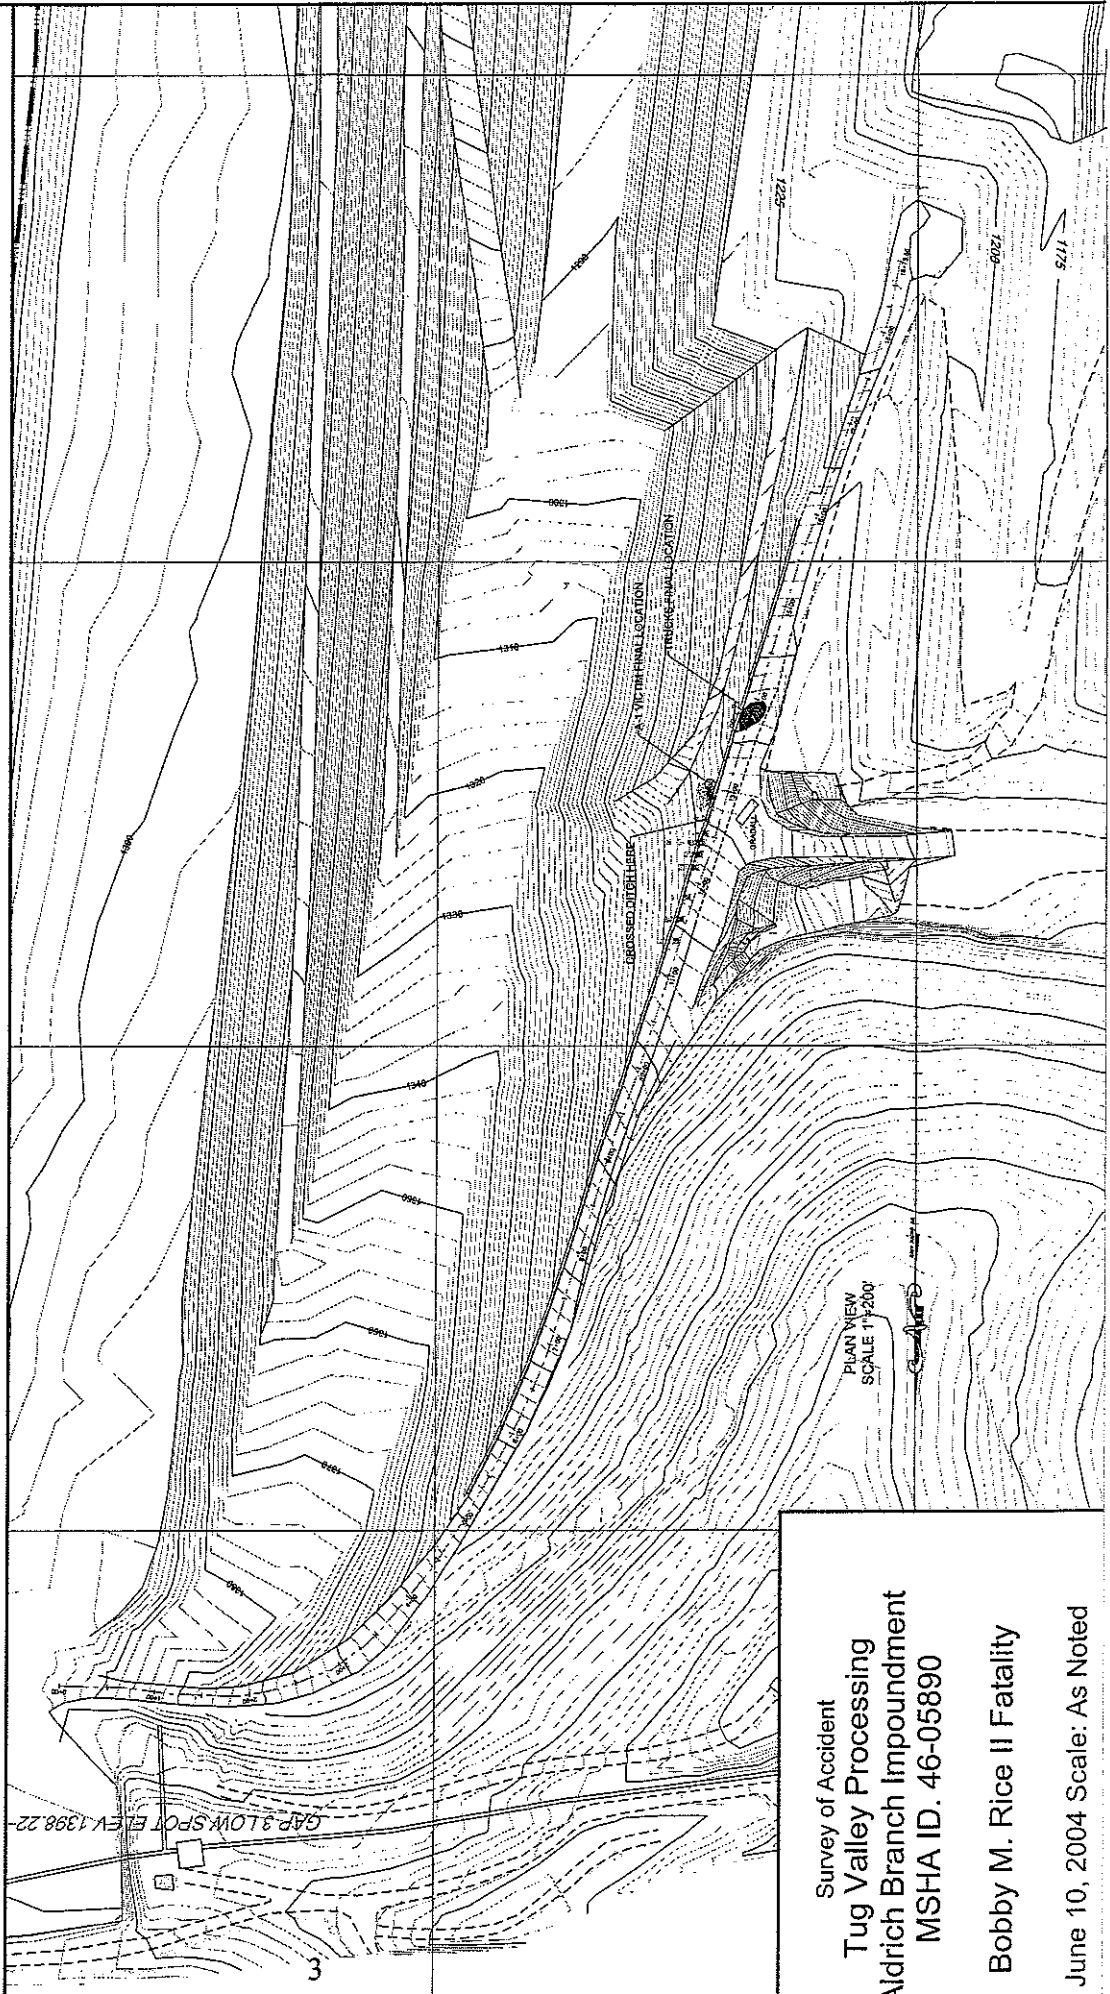
PLAN VIEW  
SCALE 1"=200'

- A1- Victim final location, bodily fluids detected
- A-2 Body parts in track, bodily fluids detected
- A-3 edge of track near ditch, outer left tandem across ditch
- B-1 bodily fluid location
- B-2 bodily fluid location
- B-3 broken glasses
- A-4 outer left tandem, across ditch
- A-5 inner left tandem, roadside
- A-6 outer left tandem, edge of ditch roadside
- A-7 inner left tandem, roadside
- A-8 inner left tandem
- A-9 outer left tandem
- A-10 inner left tandem
- A-11 outer left tandem
- A-12 inner left tandem
- A-13 outer left tandem
- A-14 inner left tandem
- A-15 inner left tandem
- A-16 outer left tandem
- A-17 inner left tandem
- Edge of Graded Road
