Fatal 7-2007

West Virginia Office of Miners' Health, Safety & Training

October 20, 2007

Report of a Fatal Power Haulage
(Underground Coal Mine)

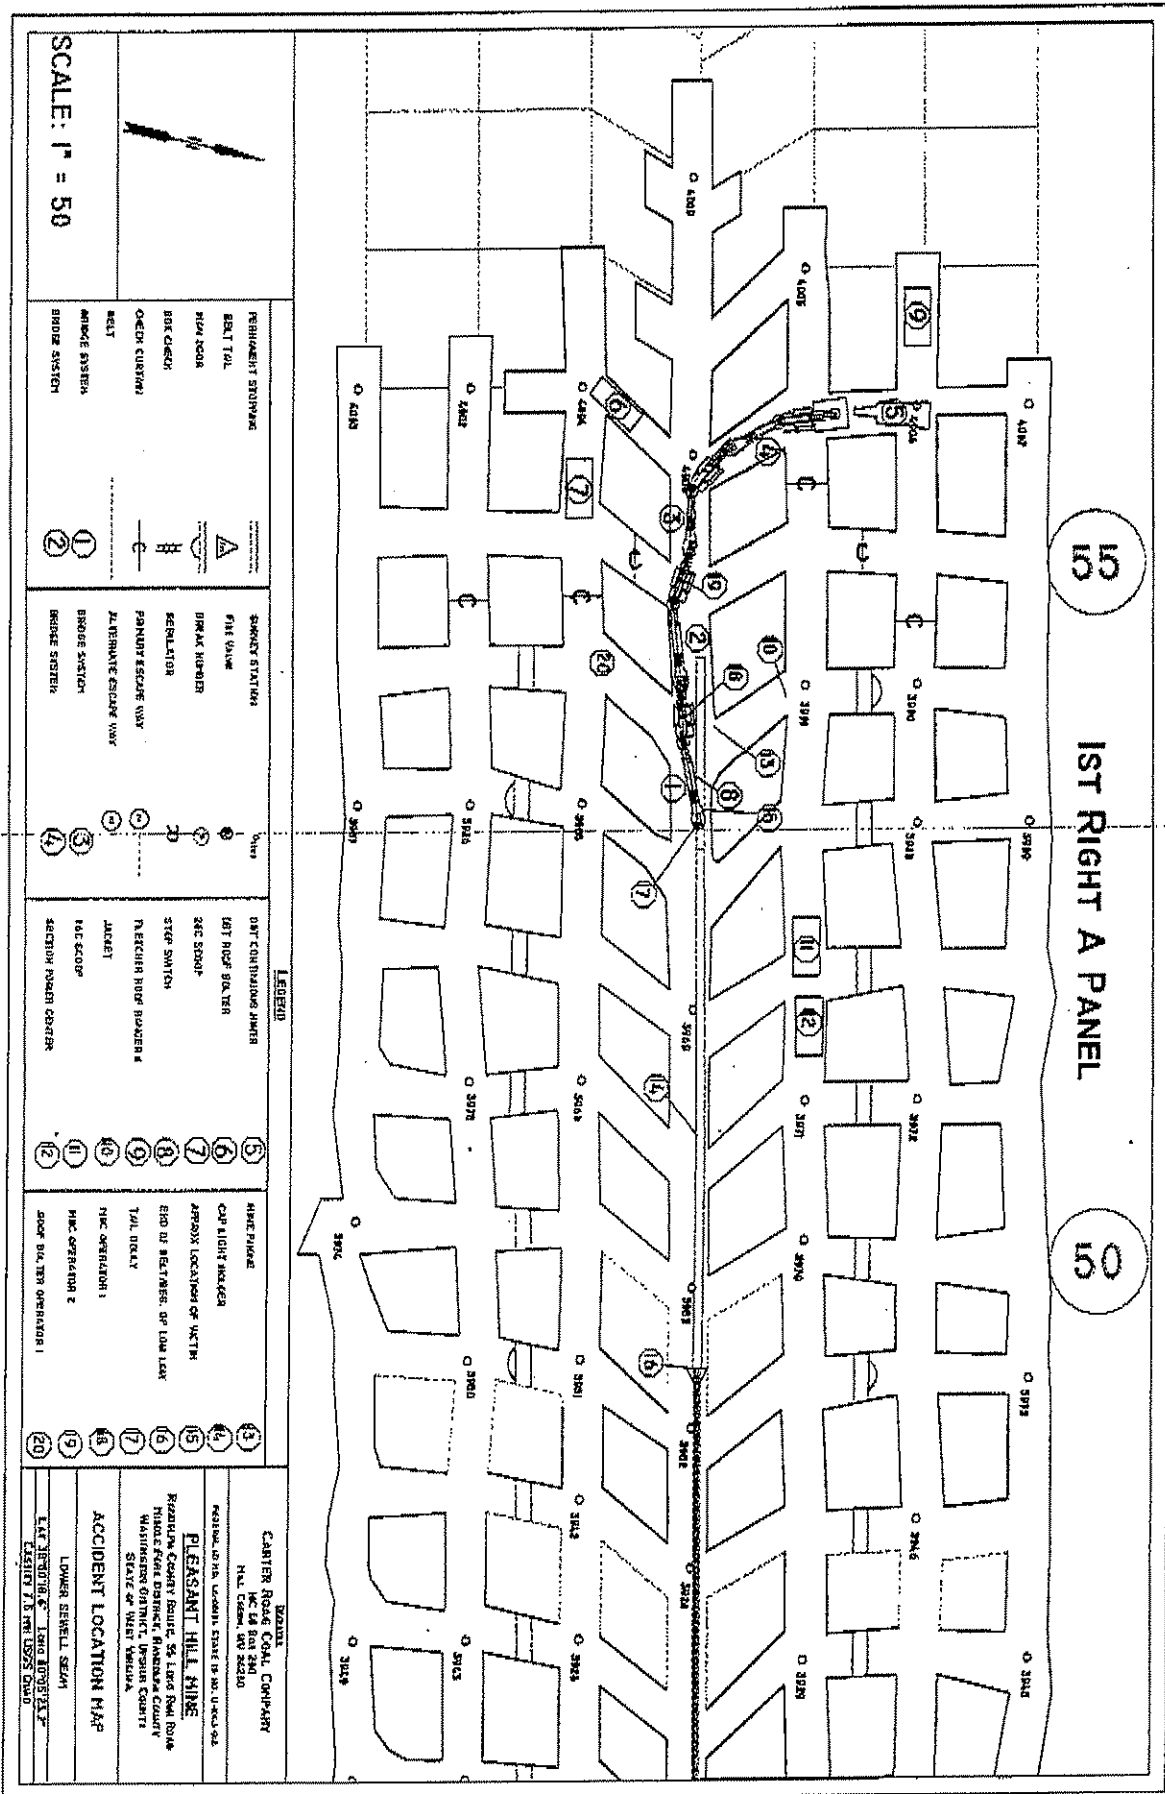
Mr. Howard T. Harris was fatally injured when he somehow became caught between the mobile bridge conveyor dolly and the LoLo belt. He was in the process of retrieving his electrical tester to trouble shoot the continuous miner.
