West Virginia Office of Miners' Health, Safety and Training

October 24, 2003

**Report of a Roof Fall Fatality
(Underground Coal Mine)**

**Roblee Coal Company
Hackers Creek No. 1 Mine
Permit No. U-2001-00**

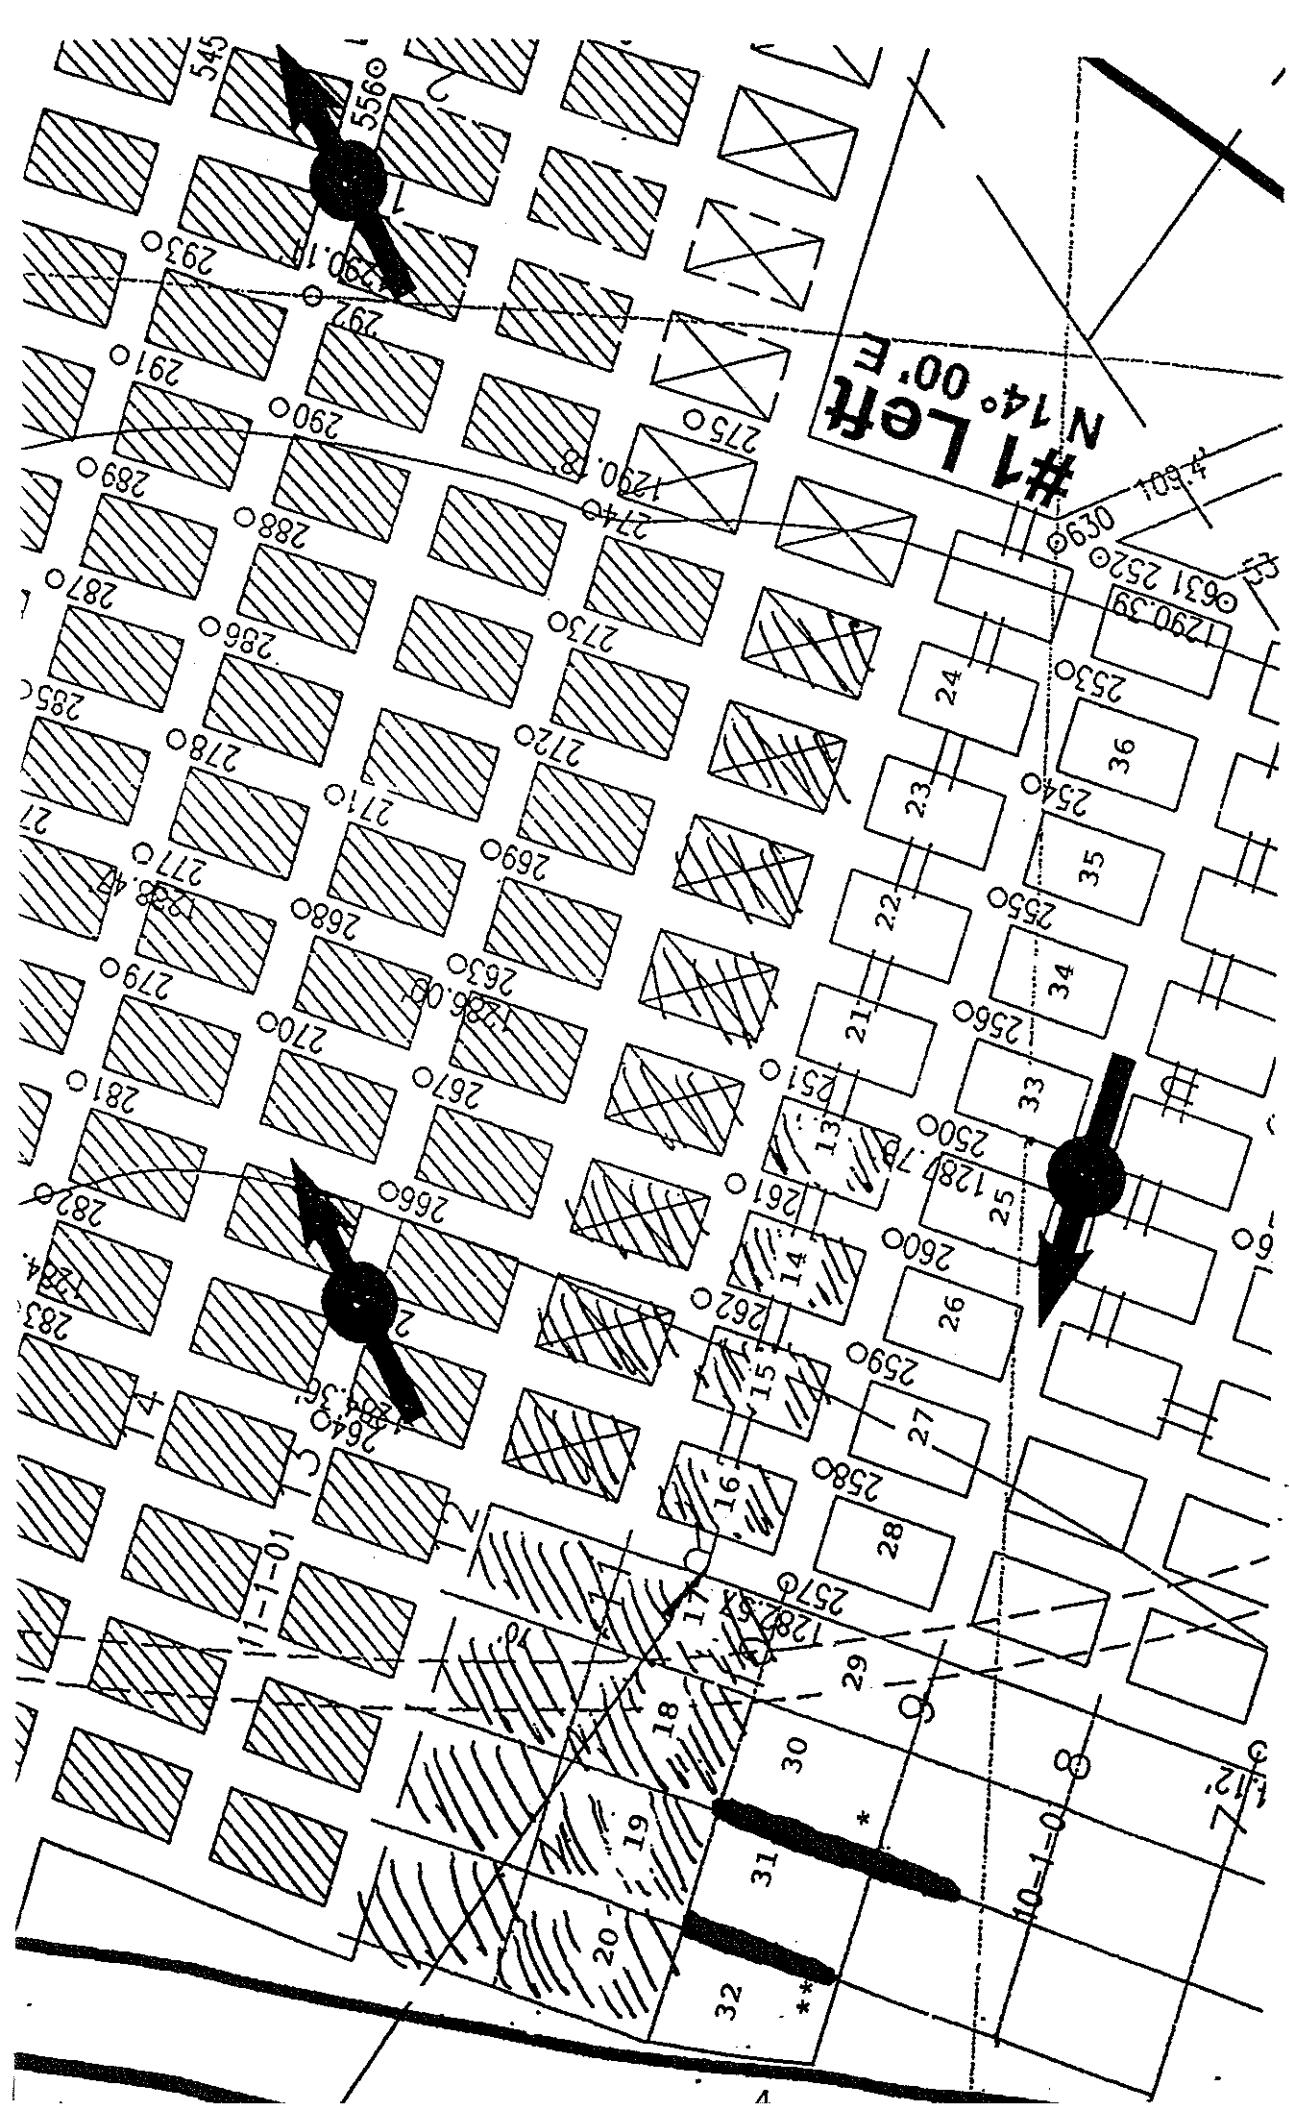
1-LEFT SECTION

* #3 ENTRY ROOF FALL OCCURRED 10/24/2003
 ** #2 ENTRY ROOF FALL DISCOVERED 10/27/2003

- The roof fall occurred in the No. 3 entry approximately 150 feet from the outcrop. The depth of cover at this location was approximately 137 feet. The fall started inby the breaker posts and extended outby and through the last open intersection for a distance of approximately 96 feet.

- A roof fall was discovered in the No. 2 entry during the on-site investigation on 10/27/03. The fall is similar in characteristics to the roof fall involved in the fatal accident. The approximate measurements of the fall in the No. 2 entry are 50 foot long, 17 feet wide and 62 inches thick. There was also a surface crack observed in the No. 2 entry.

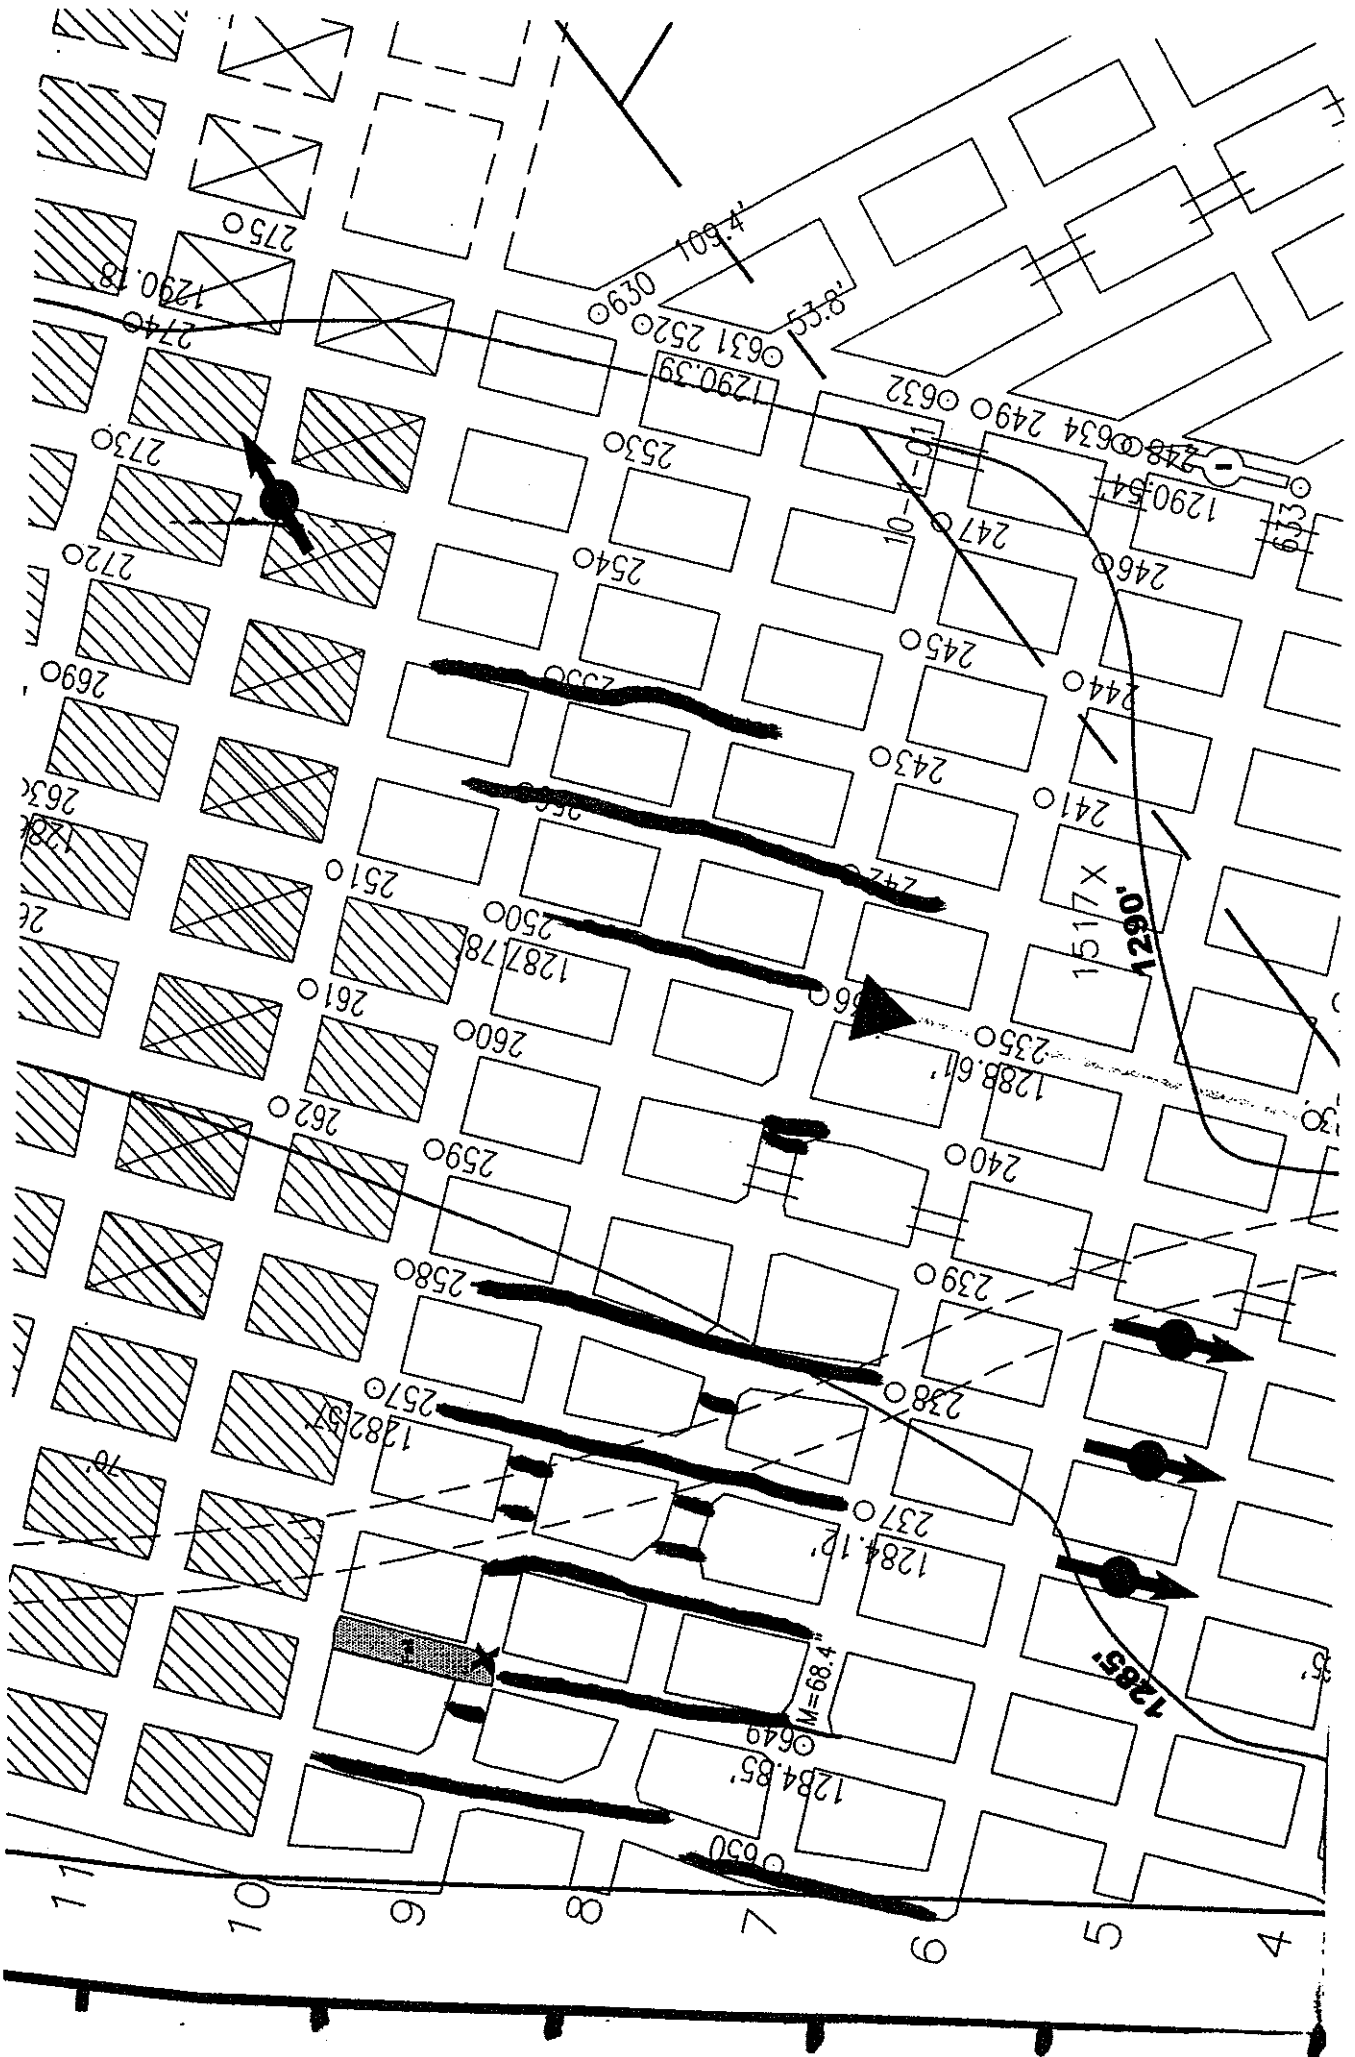
SKETCH SHOWING SURFACE CRACKS

- A surface crack was present in the mine roof along the left rib extending from the pillared area in the No. 3 entry for approximately 70 feet outby the last open intersection where the crack turns to the middle of the entry and extends another 140 feet where it ends in the corner of the right coal block. The investigation revealed approximately 3 metal straps had been installed in the No. 3 entry intersection. The approved roof control plan specified that additional supports would be installed when two or more parallel surface cracks are encountered in a working place.

- Surface cracks were present in several of the 14 entries. (See sketch on page 5).
- The victim's body was eventually found and recovered in the last open intersection of the No. 3 entry.

The roof control plan shall be revised to address current mining conditions. Management shall train all employees on the revisions of the roof control plan.
