West Virginia Office Miners' Health, Safety and Training

August 17, 2004

**Report of a Rib Fall Fatality
(Underground Coal Mine)**

**McElroy Coal Company
McElroy Mine
Permit No. U-33-83**

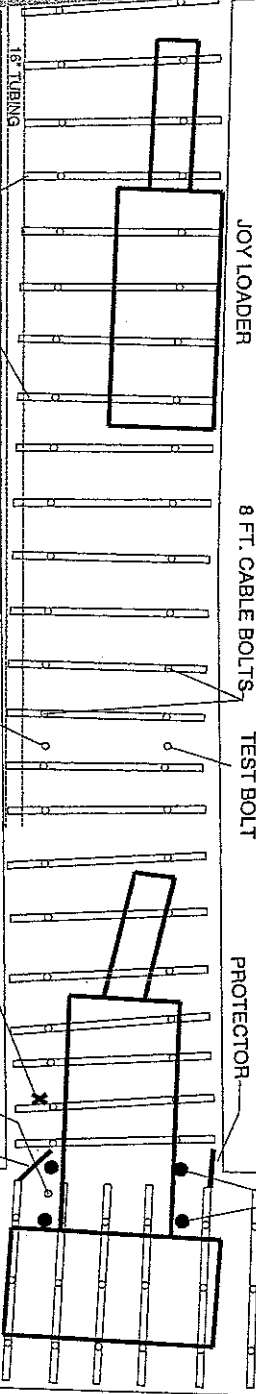
ENTRY #5

Face Wedged
Area Bolled
Not Surveyed

ENTRY #6

Face Squared
Area Bolled
Not Surveyed

8 FT. CABLE BOLTS
RIB PROTECTOR
VICTIM
DRILL UNIT
RIB PROTECTOR

JOY MINNER #5374

A fatal rib fall accident occurred at approximately 4:15 a.m. on August 17, 2004 at the McElroy Coal Company, McElroy Mine. The accident occurred on the 5 North Mains Right Side Section. Mr. Joseph Sabo, age 57, was fatally injured when struck by the coal and rock rib along the right side of the Joy continuous miner.
