West Virginia Office of Miners' Health, Safety and Training

September 16, 2007

Fall Fatality  
Coalfield Services, Inc.  
Permit Number C-1125  
Independent Contractor at  
Mingo Logan Coal Company  
Mountaineer II Mine  
Permit Number U-5031-97

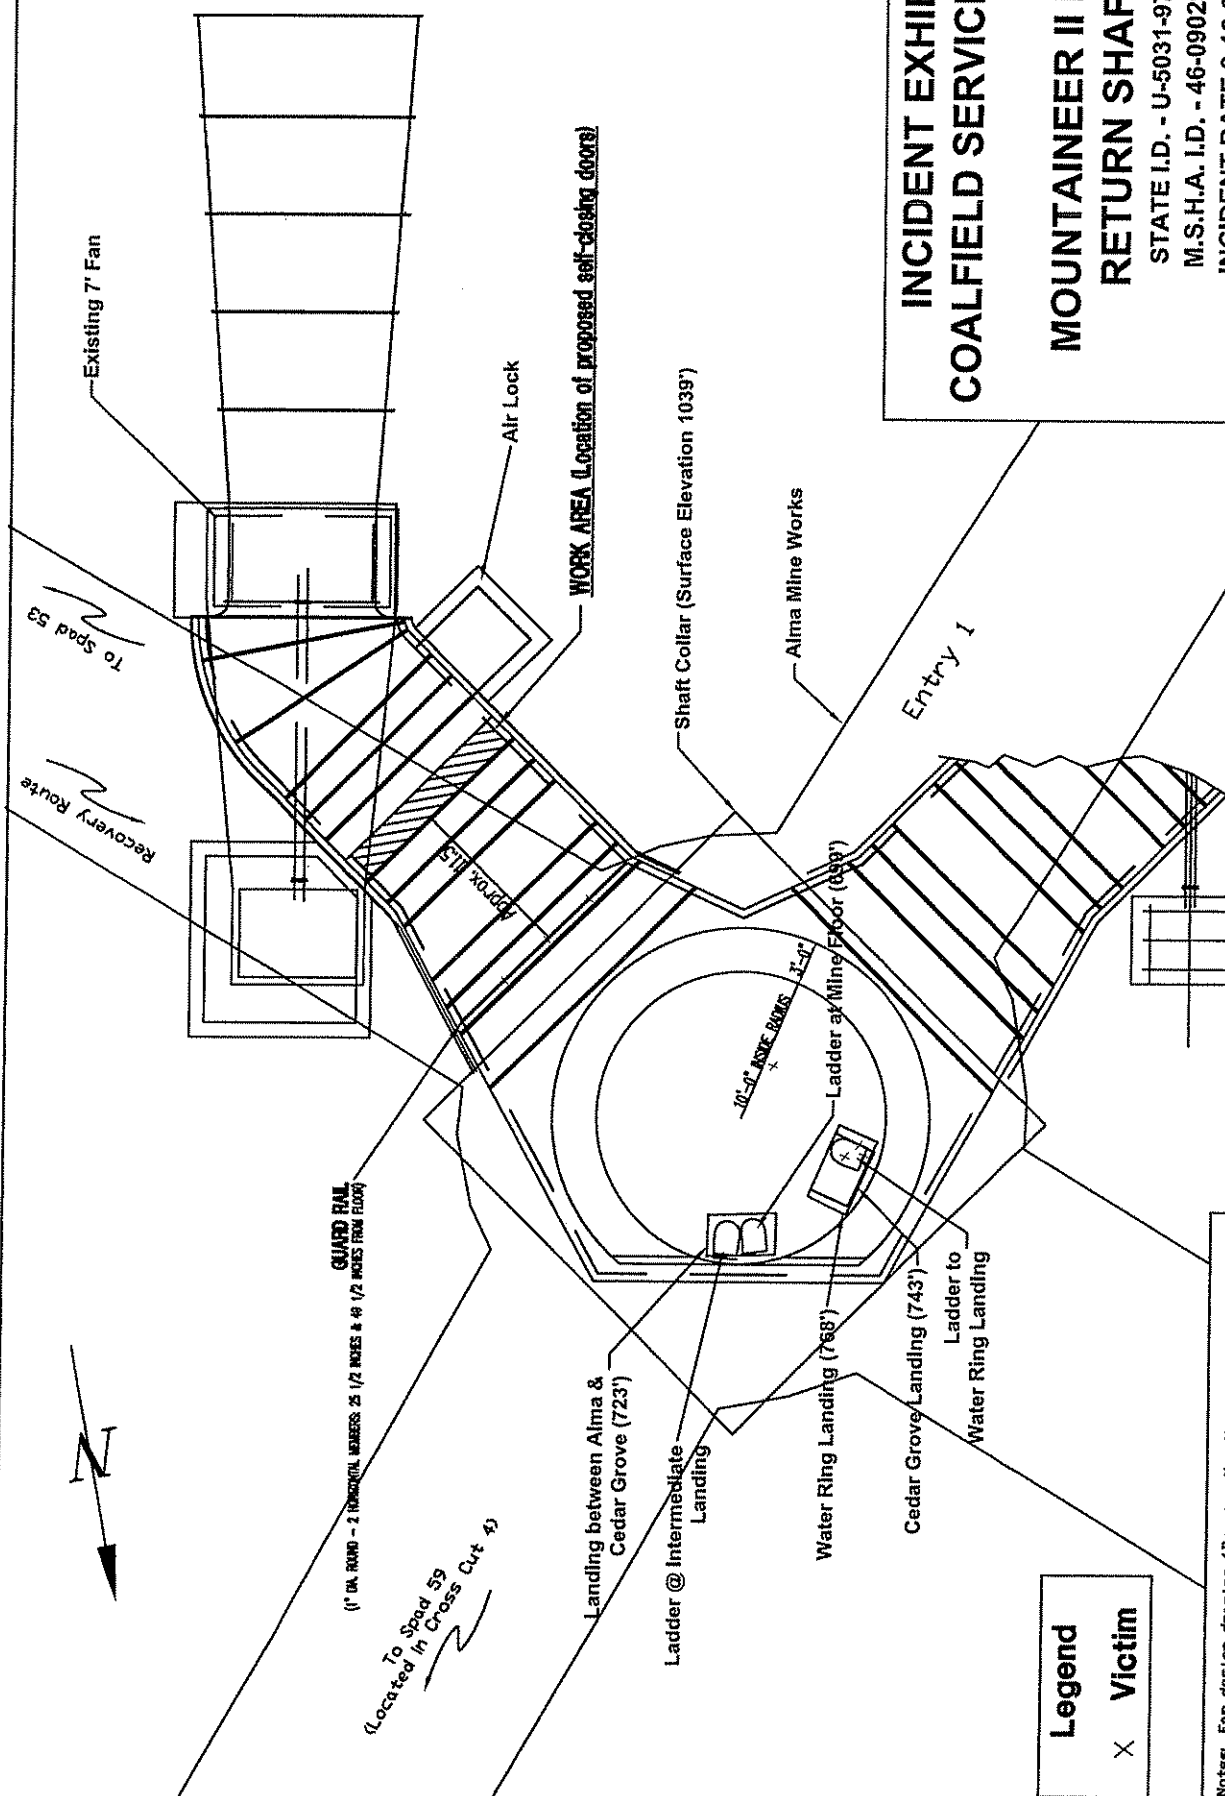
**INCIDENT EXHIBIT**  
**COALFIELD SERVICES, INC.**

Notes: Fan design drawing (Drawing No. Mountaineer-LI-4) provided by Coalfield Services, Inc., and has been modified to show clarity.  
 Elevations shown in red are approximate.

6. The return airshaft is 20 feet in diameter and tapered approximately 3 feet at the edge. The shaft depth is 336 feet. The shaft is concrete lined
7. A physical barrier / guardrail had been installed at a point 6.5 feet from the shaft opening at the closest point. The barrier extended from wall to wall. The barrier was constructed with two one inch steel horizontal rails extending from wall to wall. Three vertical steel posts connected the horizontal rails. The bottom horizontal rail measured 25.5 inches from the floor. The distance between the top and bottom rails measured 24 inches.

Information gathered by OMHST investigators indicates that the victim for undetermined reasons traveled beyond a physical safety barricade installed to deter access to an open mine airshaft. The victim's body was discovered at the bottom of the mine's return airshaft.

Retrain all employees and any contractors working around air shafts at the Mountain Laurel Complex to obey all barricading provisions and never cross over barricades into areas around shafts unless:
