WEST VIRGINIA OFFICE OF MINERS' HEALTH, SAFETY & TRAINING

December 29, 2008

Fatal Drowning Related Report Investigation
McElroy Coal Company
Ireland Loadout
Permit No. 675

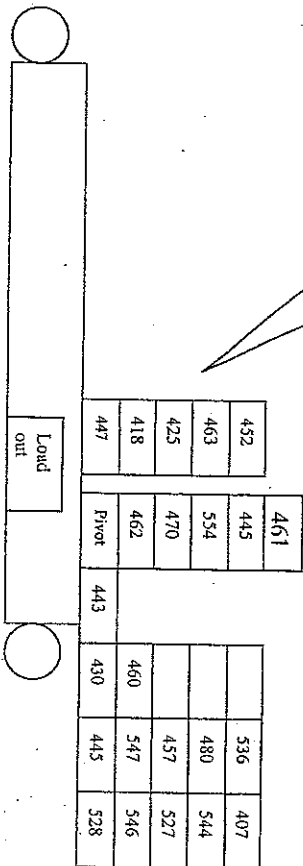
Location of barges at start of shift (best recollection per the employee's who were there that night)

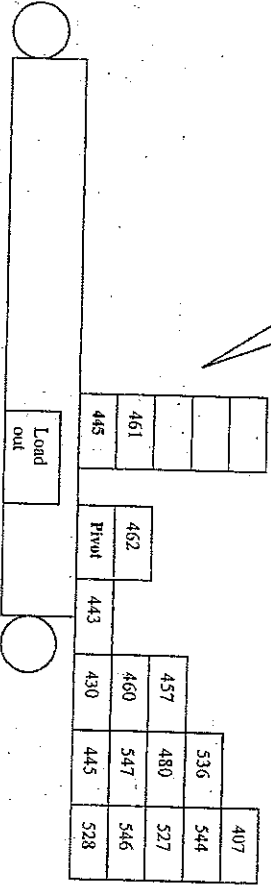
Location of barges at time of accident (best recollection per the employee's who were there that night)

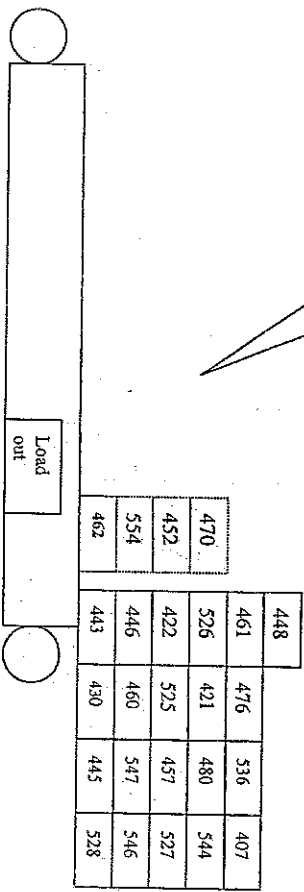
The Quarto moved the 554 barge up stream. Then the Champion moved the 452 barge upstream. Then as the Kimberly drifted 470 barge out, the victim was located and seen by the Quarto boat positioned just down stream of the Kimberly.

Location of barges after locating victim
