West Virginia Office of Miners' Health, Safety and Training

Report of Rib Fall Fatality
Underground Coal Mine

Kingwood Mining Company, LLC
Whitetail Kittanning Mine
Permit No. U-1007-98A

Fatal Rib Fall Accident Investigation Report
Kingwood Mining Company, LLC
Whitetail Kittanning Mine
Permit No. U-1007-98A

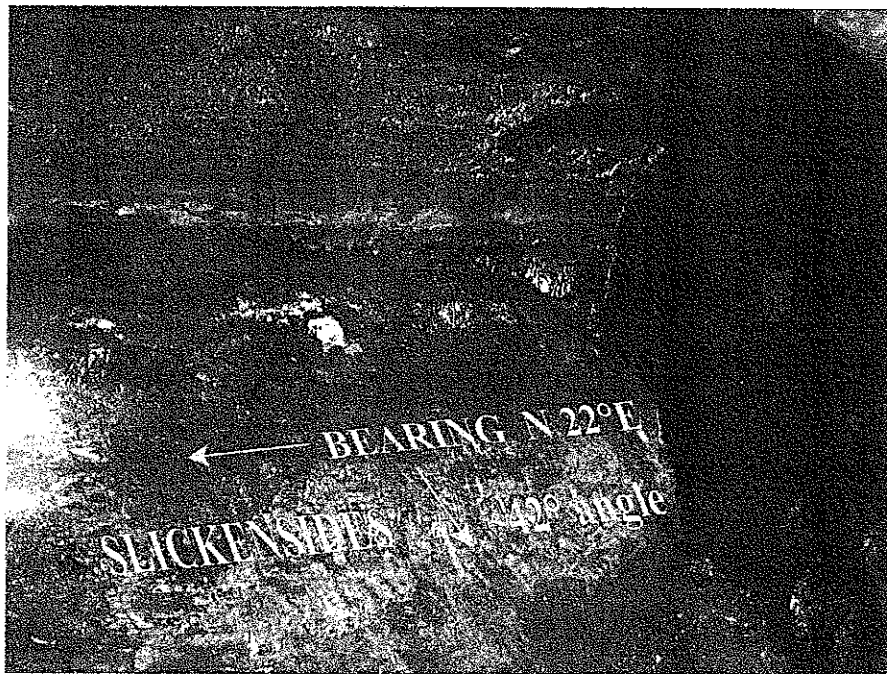
Photo 3: Looking at the bottom slip plane in rib from vantage point of where shuttle car was stationed.

Photo 3 is a front-facing view of the corner rib that failed. The bearing of the lower slickensided failure plane trends N 22°E and its slickensided surface dips toward the open cross-cut in a northwesterly direction. **Photo 4** is looking at 90° to the view shown in Photo 3 and is also the vantage for the illustrations of dimensions and angles shown in **Figures 2 and 3**.

The steep and highly slickensided surface of the lower failure plane is the primary reason for the sudden and unexpected failure of the rib slab. A slip plane angled at 42° poses a high degree of risk from horizontal forces trying to kick out a stationary rock mass due to its own weight. In conjunction the slickensided upper failure plane vertically intersects and is horizontally parallel to it, which allowed the rib block to break free.

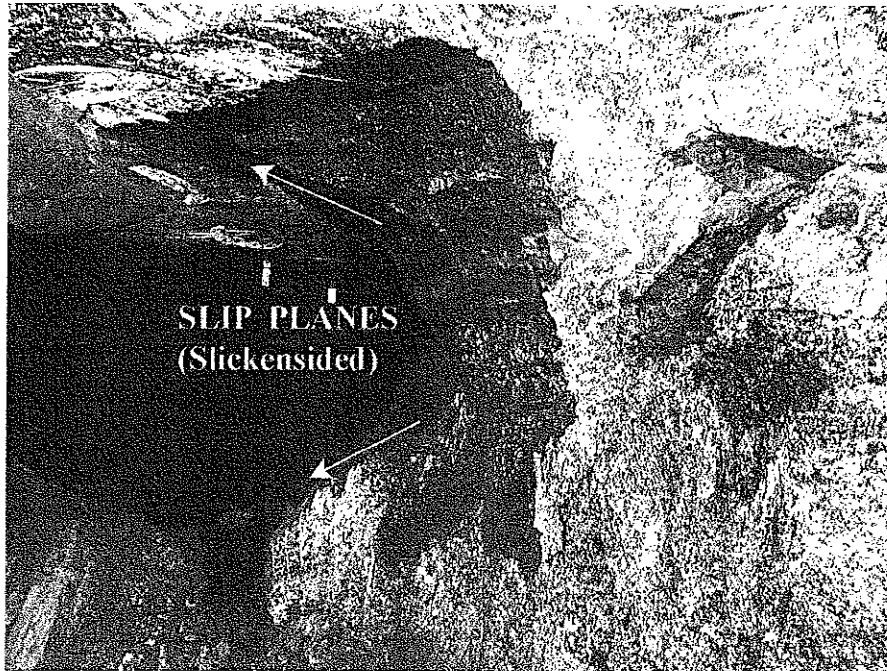
Photo 4: View of corner rib slips. Photo taken from the intersection of #5 Entry at #40 Cross-cut.. Fallen rib slab in lower left corner. Upper and lower slip planes bounded the rib slab that fell out.

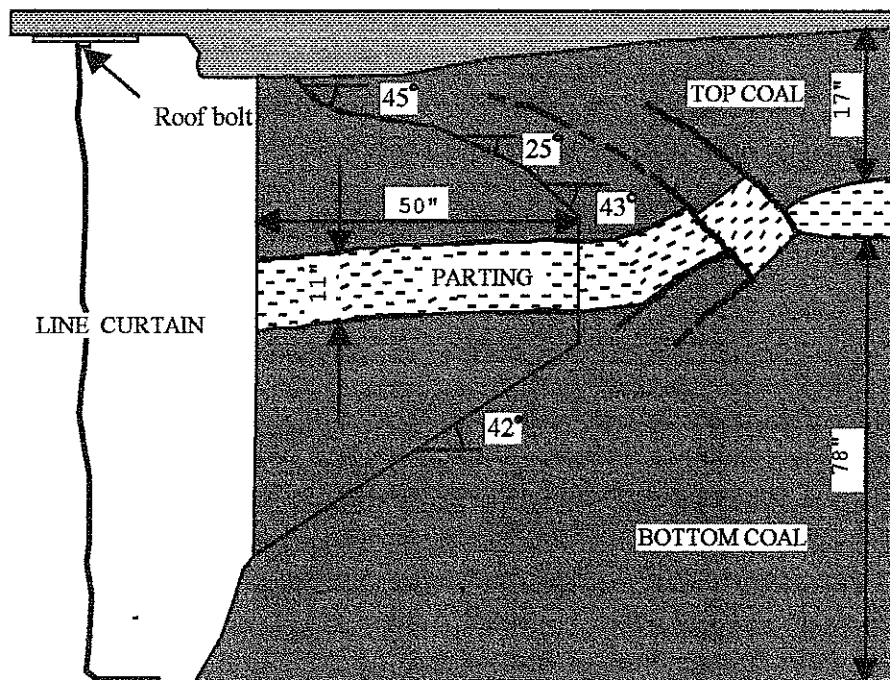
After the intersecting slip planes were mined-through in both the entry and in the turned cross-cut the resisting forces holding the rib slab in place were reduced to only three things: 1) the tensile strength of the carbonaceous shale Parting (see **Figure 2**), 2) the cohesion forces of the top failure plane, 3) and the shear-resisting frictional forces along the lower slickensided failure plane. These forces were not sufficient to resist the free-body forces acting horizontally on the slab, which are estimated at 1/3 to 1/2 of the 5-ton estimated weight of the rib slab.

Figure 2: This is a schematic view (from the vantage point of Photo 4) that shows the dimensions and bounded by intersecting slip planes as it likely looked prior to failure.

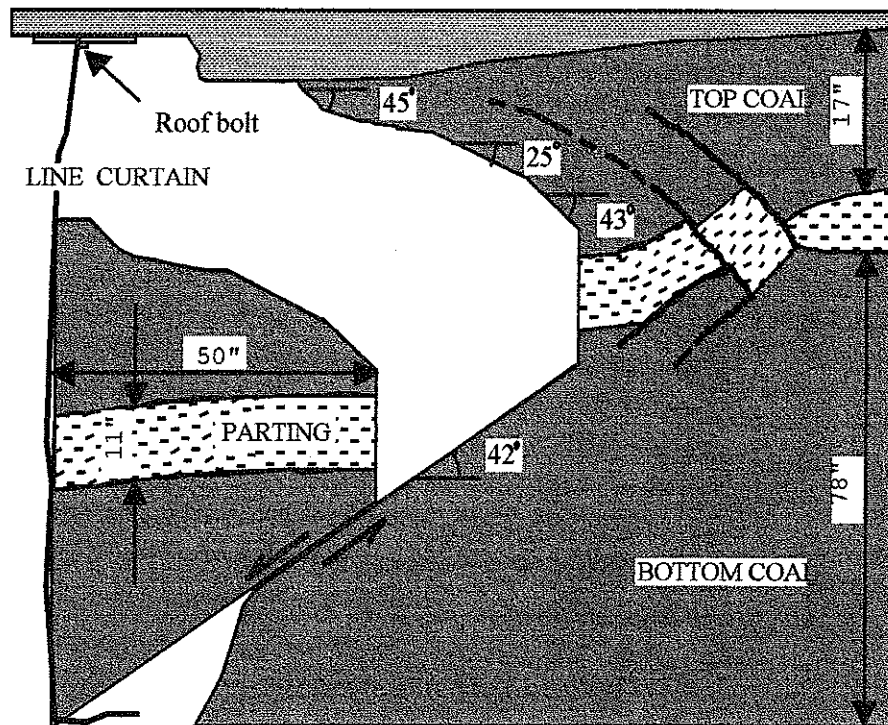
Due to the steepness of the lower slip plane the slab failure probably gave little if any advance warning of what it was about to do. The direction of movement would have been essentially perpendicular to the strike of the lower slip plane surface—approximately in the direction of N 68°W, although one side may have given way slightly before the other. Based on the evidence, it appears the outby end probably gave way first, rotating slightly about a pivot point near the inby end. Although the single rib slab is approximately 8-ft. in length, the total rib failure involved a length of about 17-ft., comprised of material that is now broken into 5-7 moderate-sized rectangular pieces and additional smaller pieces.

Figure 3: This is a schematic drawing showing the believed mode of failure of the rib slab. This view is standing in the intersection of #5 entry with # 40 cross-cut looking down #40 cross-cut in the direction of #6 entry (see Figure 2 for “before picture”).
