West Virginia Office of Miners' Health, Safety and Training

February 1, 2006

Fatal Rib Fall Investigation Report
Long Branch Energy
Mine No. 18
Permit No. U-143-82

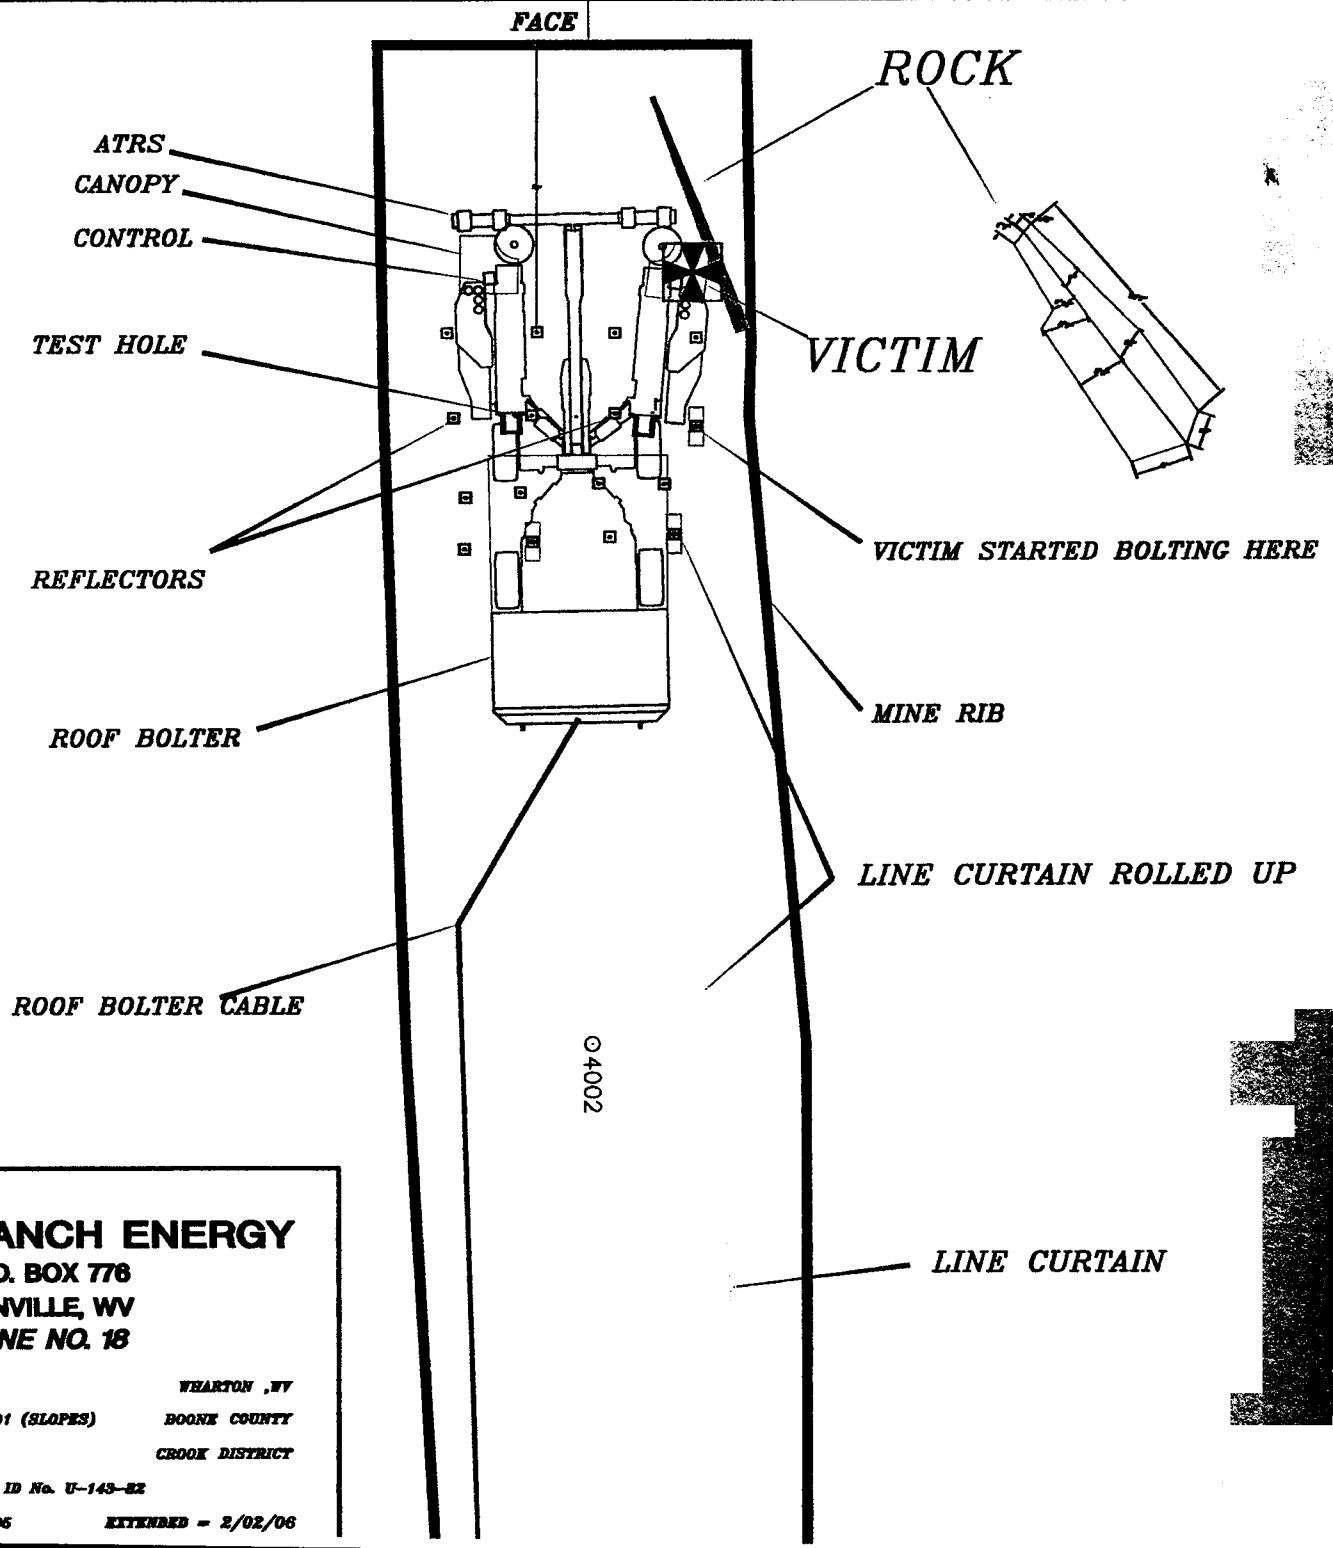
1. The section of rib that fell striking Mr. Vance measured 13 feet, 7 inches long by 1.5 to 3 feet wide and varied in thickness from 3.5 to 13 inches. The rib fall occurred as Edmund Vance and Timothy Vance were installing the third row of bolts in the no. 5 entry face and pinned Edmund Vance against the right side of the machine near the operating controls.

The physical evidence at the accident site indicated that loose ribs were present in the active working area of the no. 5 entry. Sloughing was present on both the left and right ribs.
