<u>Slide 1</u> (Introduction). Begin 1st presenter: <u>Barry Fletcher</u>; Roof Control Specialist; Investigator

**Slide 2** We would like to begin the presentation with an overview of our investigation. This overview will be followed by a detailed account of our findings concerning the explosion which occurred on April 5, 2010 by Mr. Monte Hieb our Chief Engineer. We want to again thank you for your patience as we finalized our investigation and report.

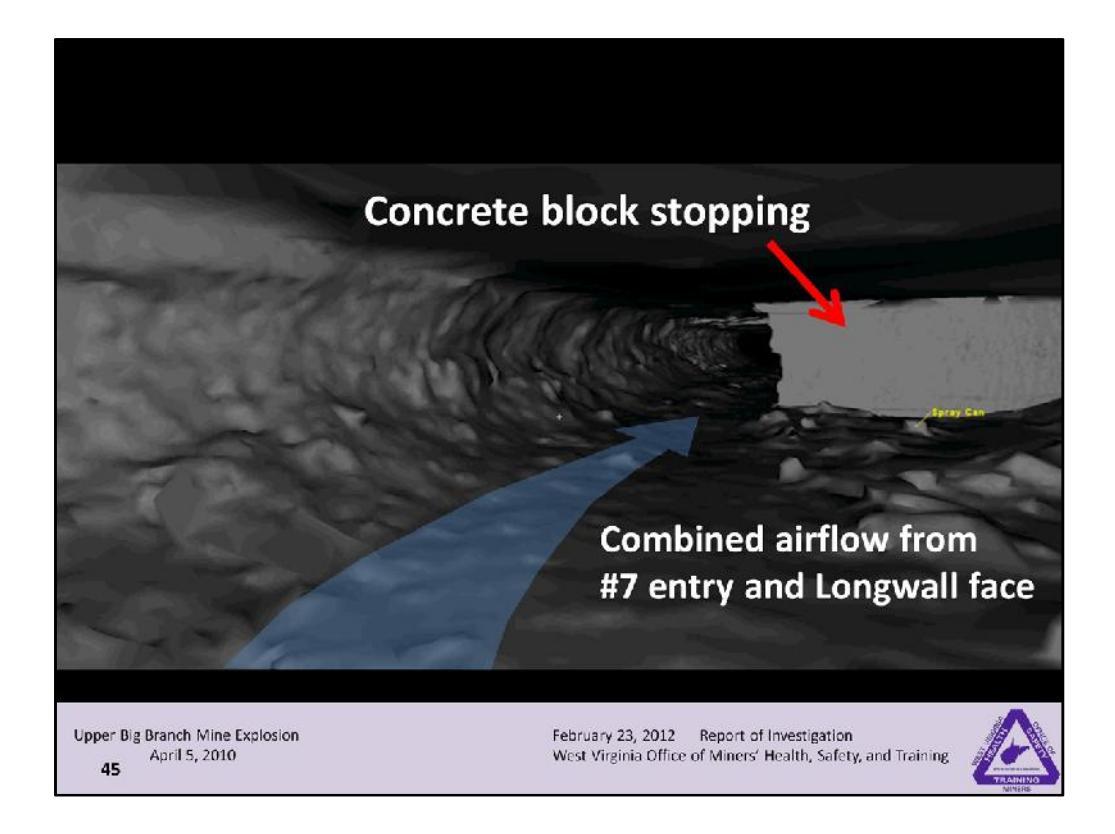
**Slide 45** As this air travels south it passes through an opening that had been knocked out in the concrete block ventilation stopping. This is the alternate route for air to travel, should the #7 entry become blocked. These stoppings are typically constructed of solid 6" concrete block.

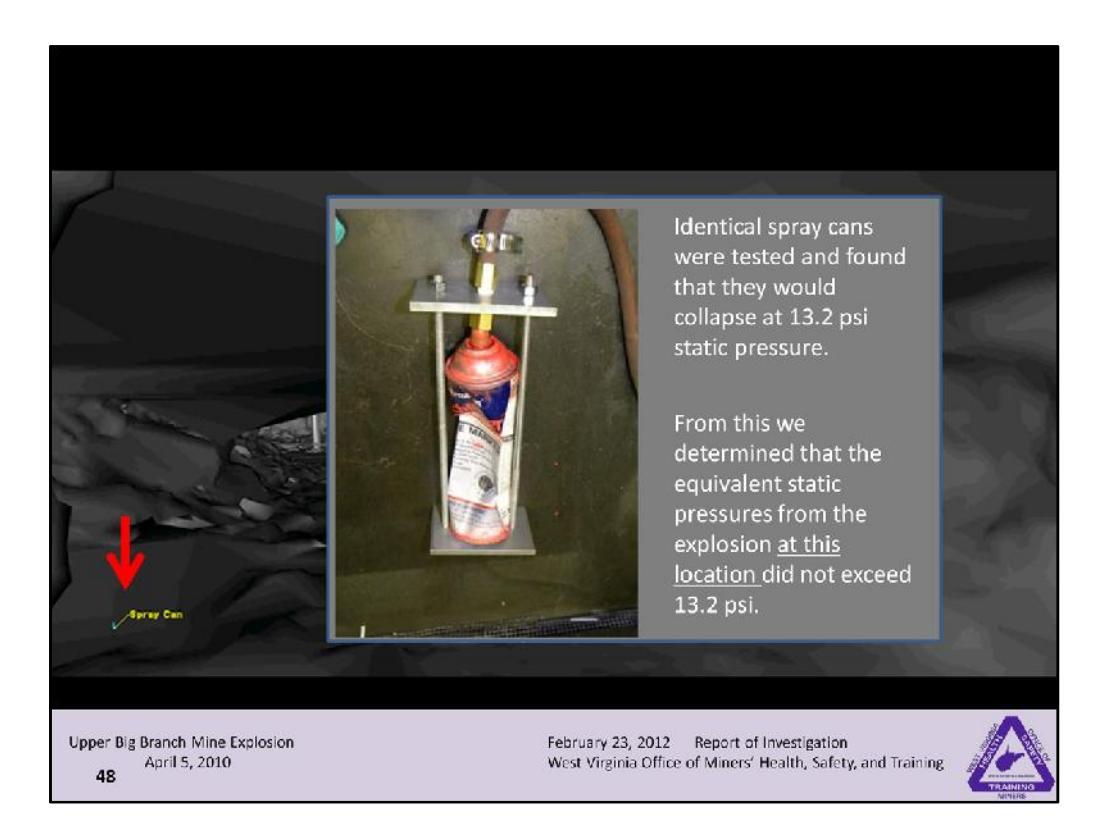
<u>Slide 48</u> Returning north through the same stopping, and just on the other side, is an example of how certain mine debris items were used to determine details about the explosion.

(click) An empty spray can found here provides clues about the maximum pressure of the explosion at this location. The top of this spray can as found had a melted plastic cap and with the exposed part of the paper label burned away.

(click) But the bottom was basically intact, and was not burned or melted, which indicates that it probably was not transported during the explosion. This makes it a useful pressure indicator for this location. The can showed no sign of collapse.

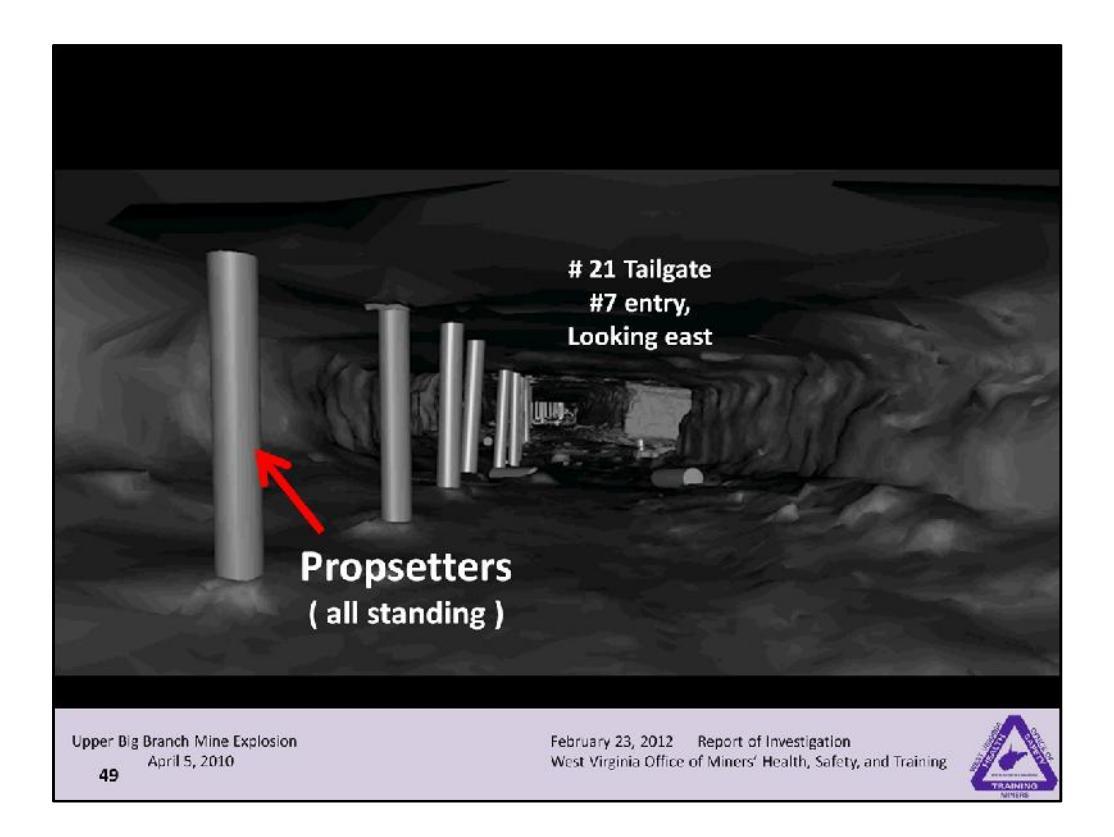
Slide 49 Continuing north we return to the #7 entry. Here at crosscut #48 all the timbers that were set in preparation for longwall mining remain standing. These timbers are machined round and are commonly referred to as *propsetters*. At this location, the explosion forces were not strong enough to knock down any of these timbers.

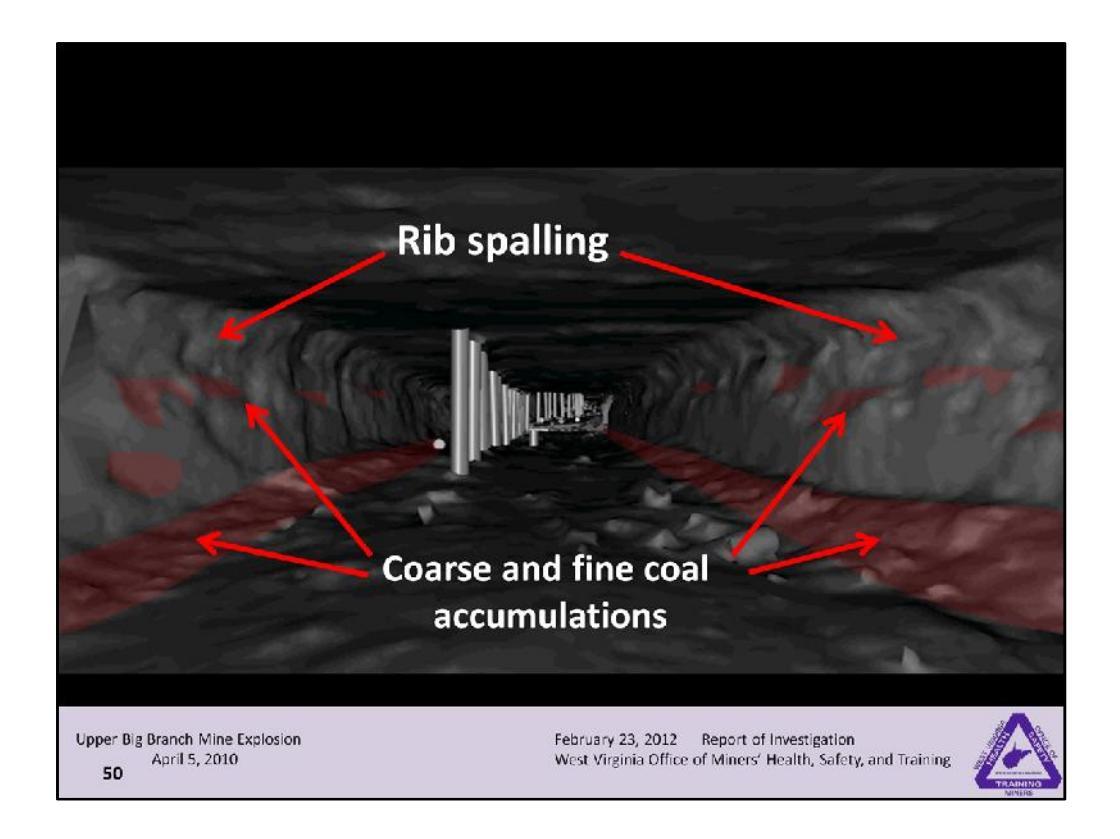
**Slide 50** There were several items from the tailgate region of the longwall that were found at this location, including parts of the Comtrol phone system and circuit boards. Here we see scattered concrete block and a standing remnant of a ventilation stopping that was breached to the north. This stopping survived the initial explosion, but was knocked down by return forces from the south. The top of the Eagle coal seam is soft and friable, and exhibits significant rib spalling.

(**click**) The spalled material ended up on elevated ledges and as a talus windrow along the base of the coal rib. These accumulations contain both fine and coarse coal.

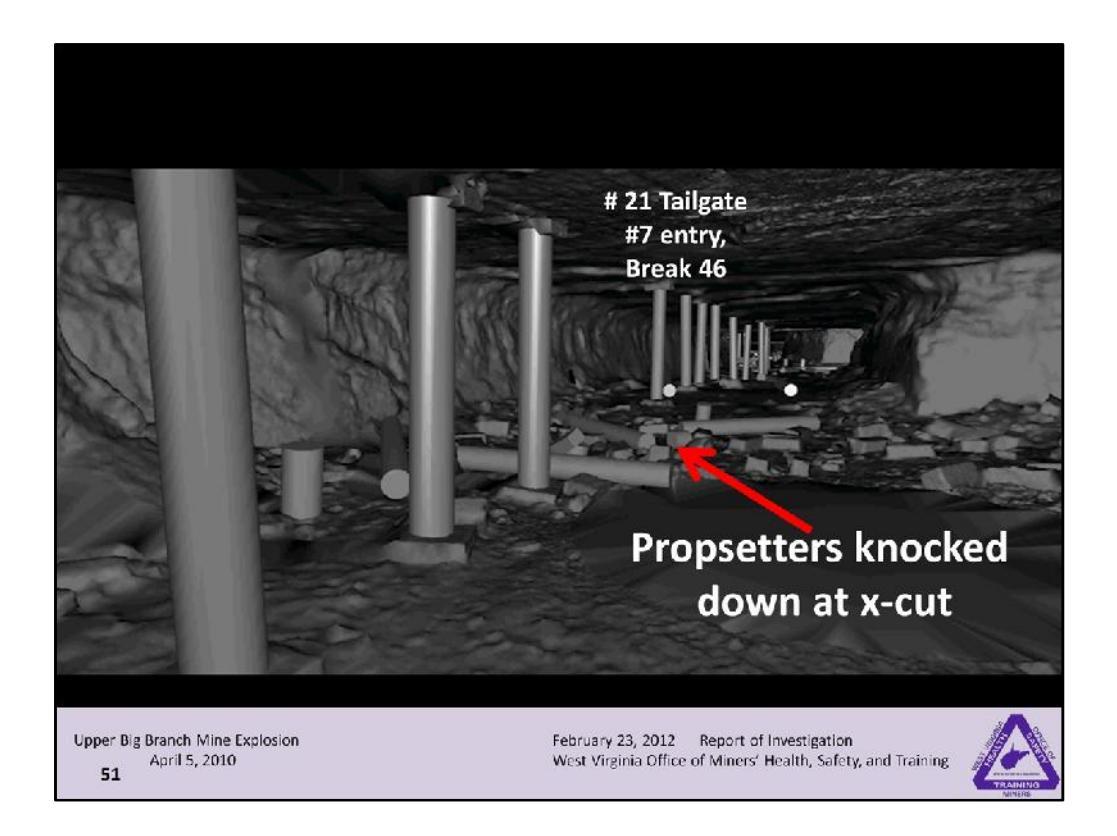
**Slide 51** As we continue east we see the propsetters are standing until we get to cross-cut #46. Here we find the propsetters have been knocked down by explosion forces and block debris traveling north through the crosscut.

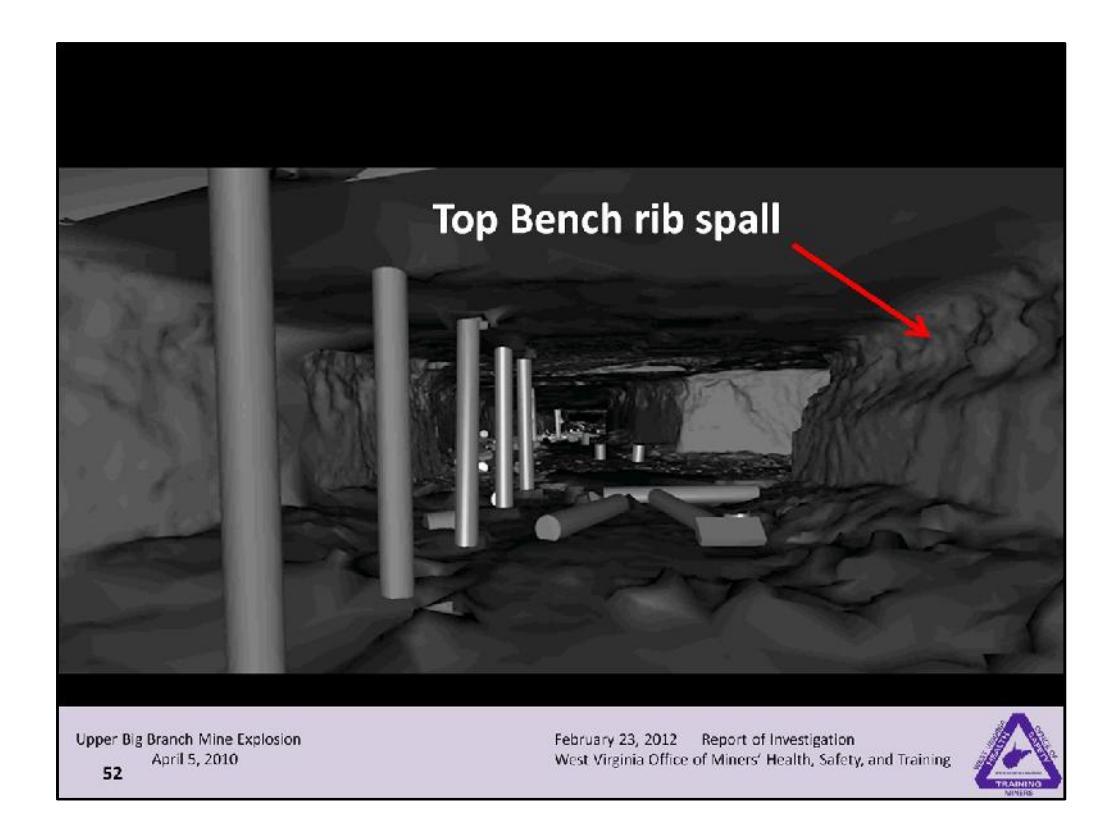
**Slide 52** This next stopping is believed to have been partially breached to serve as a regulator, then repaired back just prior to April 5th. It survived the early explosion forces in #7 entry, but not the later forces from the south.

Here between Break 46 and Break 45 is another example of how the Top Coal bench spalls out onto the floor at the base of the coal rib, and also results in elevated ledges that can collect additional dust. This occurs because the mine roof, Bottom Coal bench, and mine floor are hard, compared to the Top Coal bench.

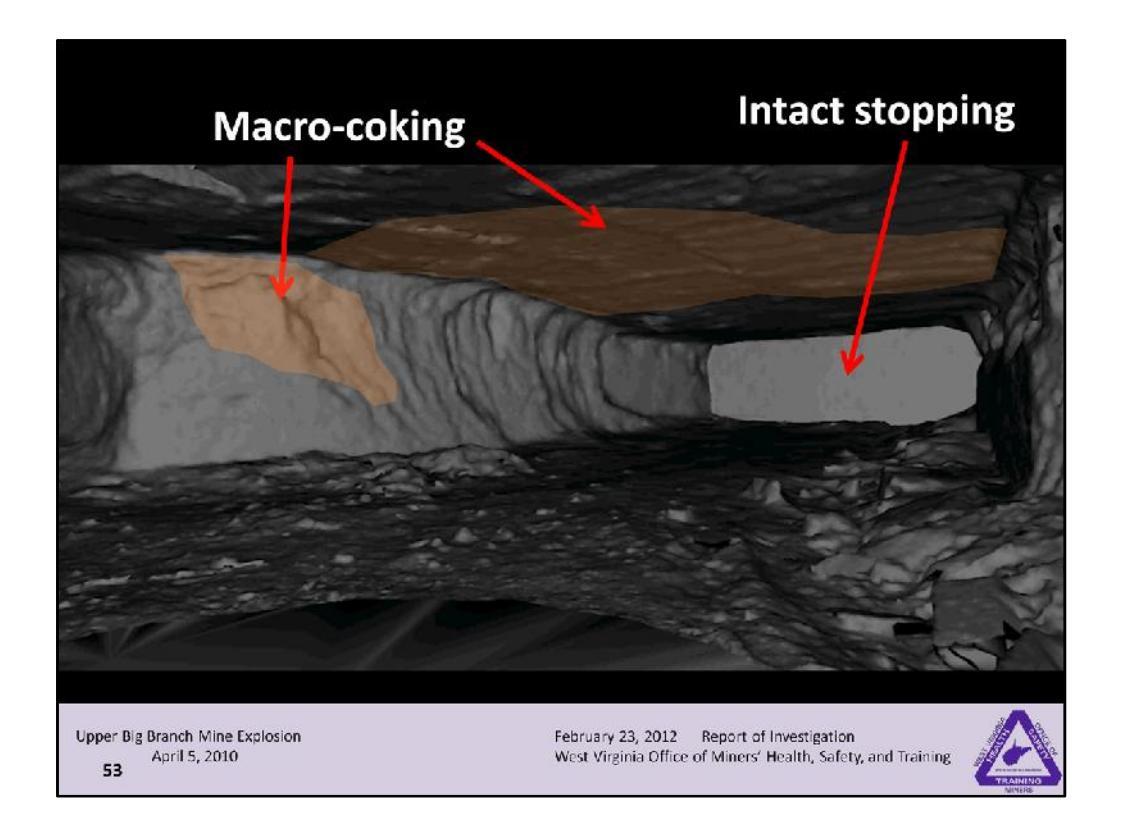
**Slide 53** The next cross-cut is Break 45. Here, the stopping in this cross-cut managed to survive the explosion. This location is marked as a regulator on the mine map, but it is fully intact-- although the previous stopping likely served that purpose before it was built back.

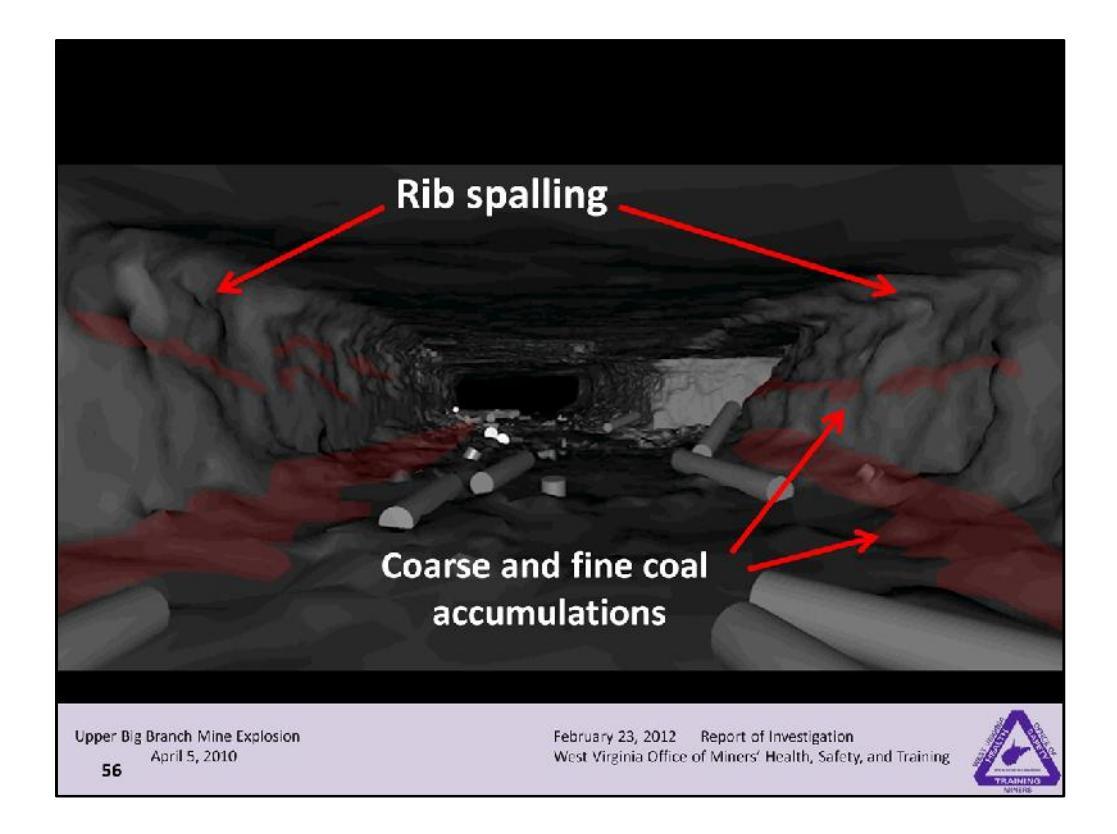
<u>Slide 56</u> The stopping in the crosscut of Break 44 appears also to have survived the initial forces through #7 entry. From Break 48 to this location we observed no pan bending resulting from the initial explosion forces, but from here forward the explosion speed and forces began to increase.

(click) Rib spalling of the Top Coal bench continues to be apparent from the hourglass profile. Although the amounts of spalled material do not <u>appear</u> excessive the concentrations necessary to sustain an explosion can be surprisingly small. Accumulations of coarse and fine coal particles are perched on ledges and on the talus slopes along the toe of the rib, where the fine dusts dislodged by a propagating explosion front can become suspended and burned explosively.

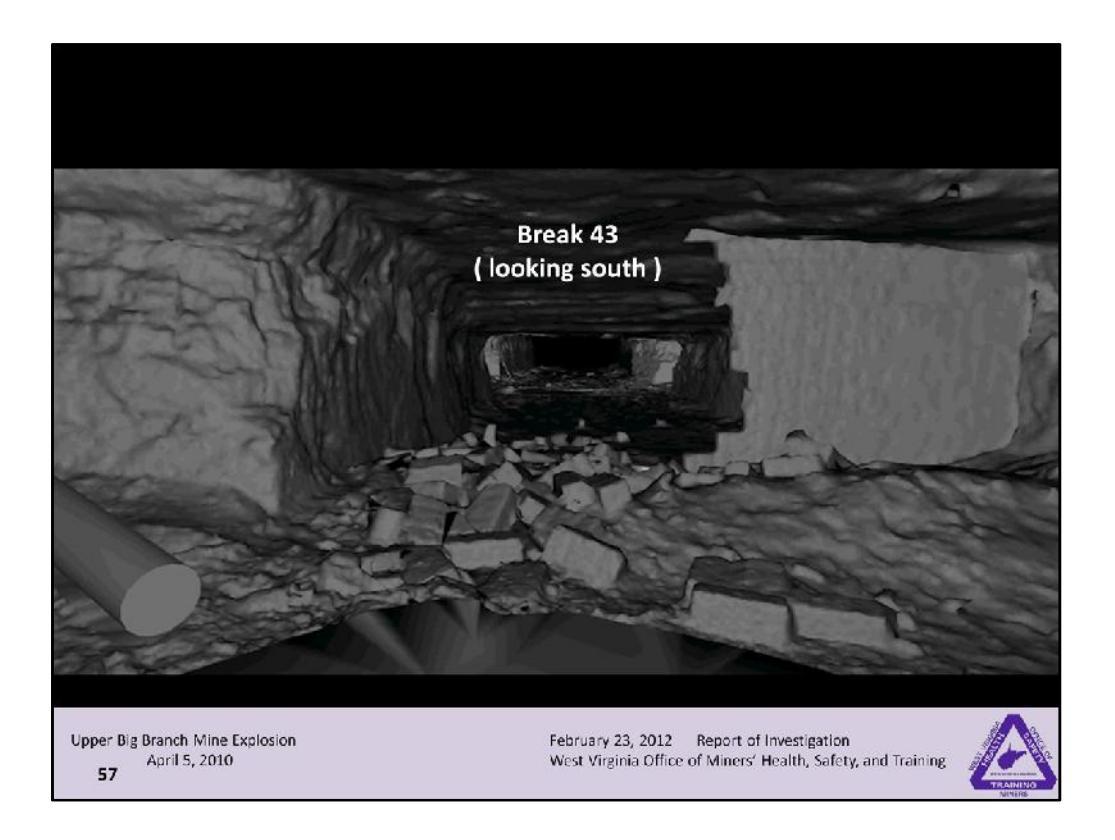
**Slide 57** Approaching Break 43 we find the stopping was knocked down by forces from the south. However, were we to travel one more break east down this entry we would find that the explosion forces in #7 entry reached a threshold that began blowing out stoppings south and bending pans to the east.

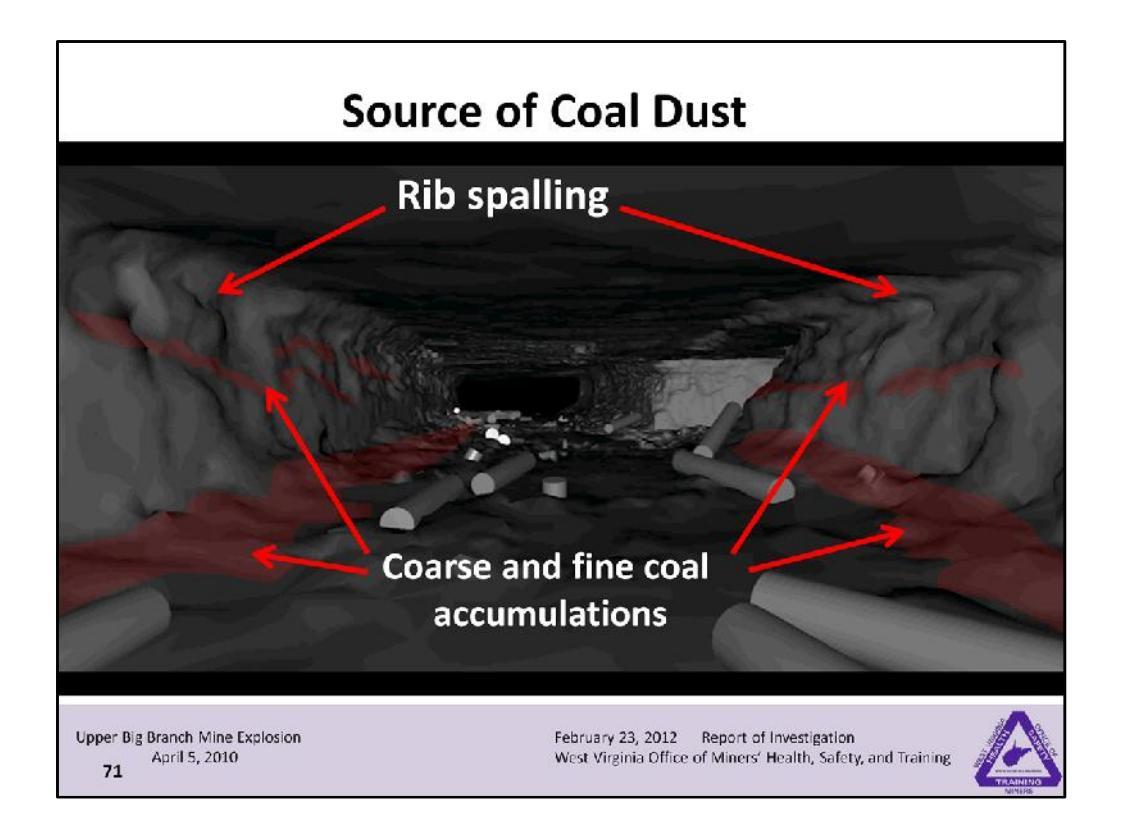
<u>Slide 71</u> In the #21 Tailgate entry the cavities in the Top Coal represent spalling that occurred since the area was first mined and rock dusted. It is believed that this area was never re-rock dusted, and accumulating fine dust would not have had incombustible material mixed with it to arrest an explosion.

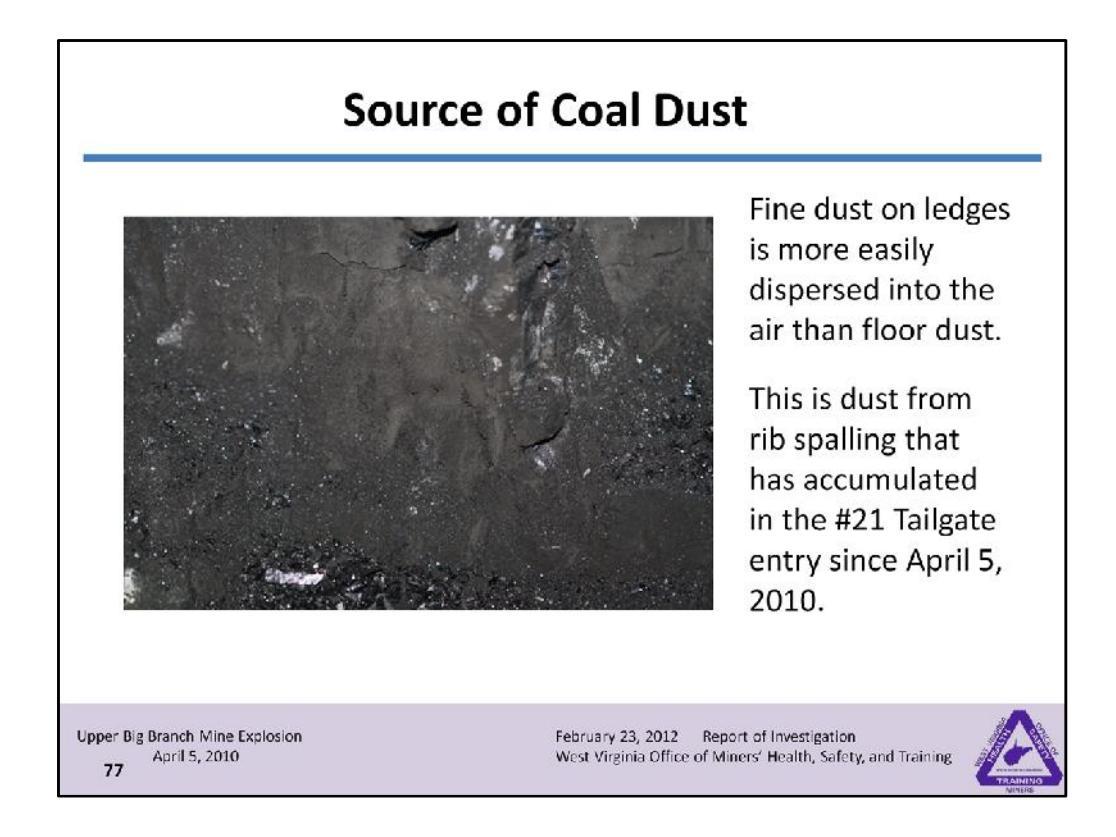
**Slide 77** However upon weathering they produce a surprising amount of fines. In fact they produce more fines than is reasonable to expect by their appearance in the coal seam. This condition may not be unique, but neither is it considered typical. Coals that have high vitrinite contents, such as the Top Coal at UBB, are typically softer--fusain partings or not.

Because the spalled fines appear to have played a role in the availability of explosive dusts that fueled the UBB explosion, it is prudent to do additional research to better understand them.
