Report of Fatality
Highwall Miner Accident
Surface Coal Mine
March 7, 2019

South Fork Coal Co., LLC
Blue Knob Surface Mine
Permit Number S00300511

**REPORT OF FATALITY
HIGHWALL MINER ACCIDENT INVESTIGATION
SOUTH FORK COAL CO., LLC
BLUE KNOB SURFACE MINE
WV PERMIT NUMBER S00300511**

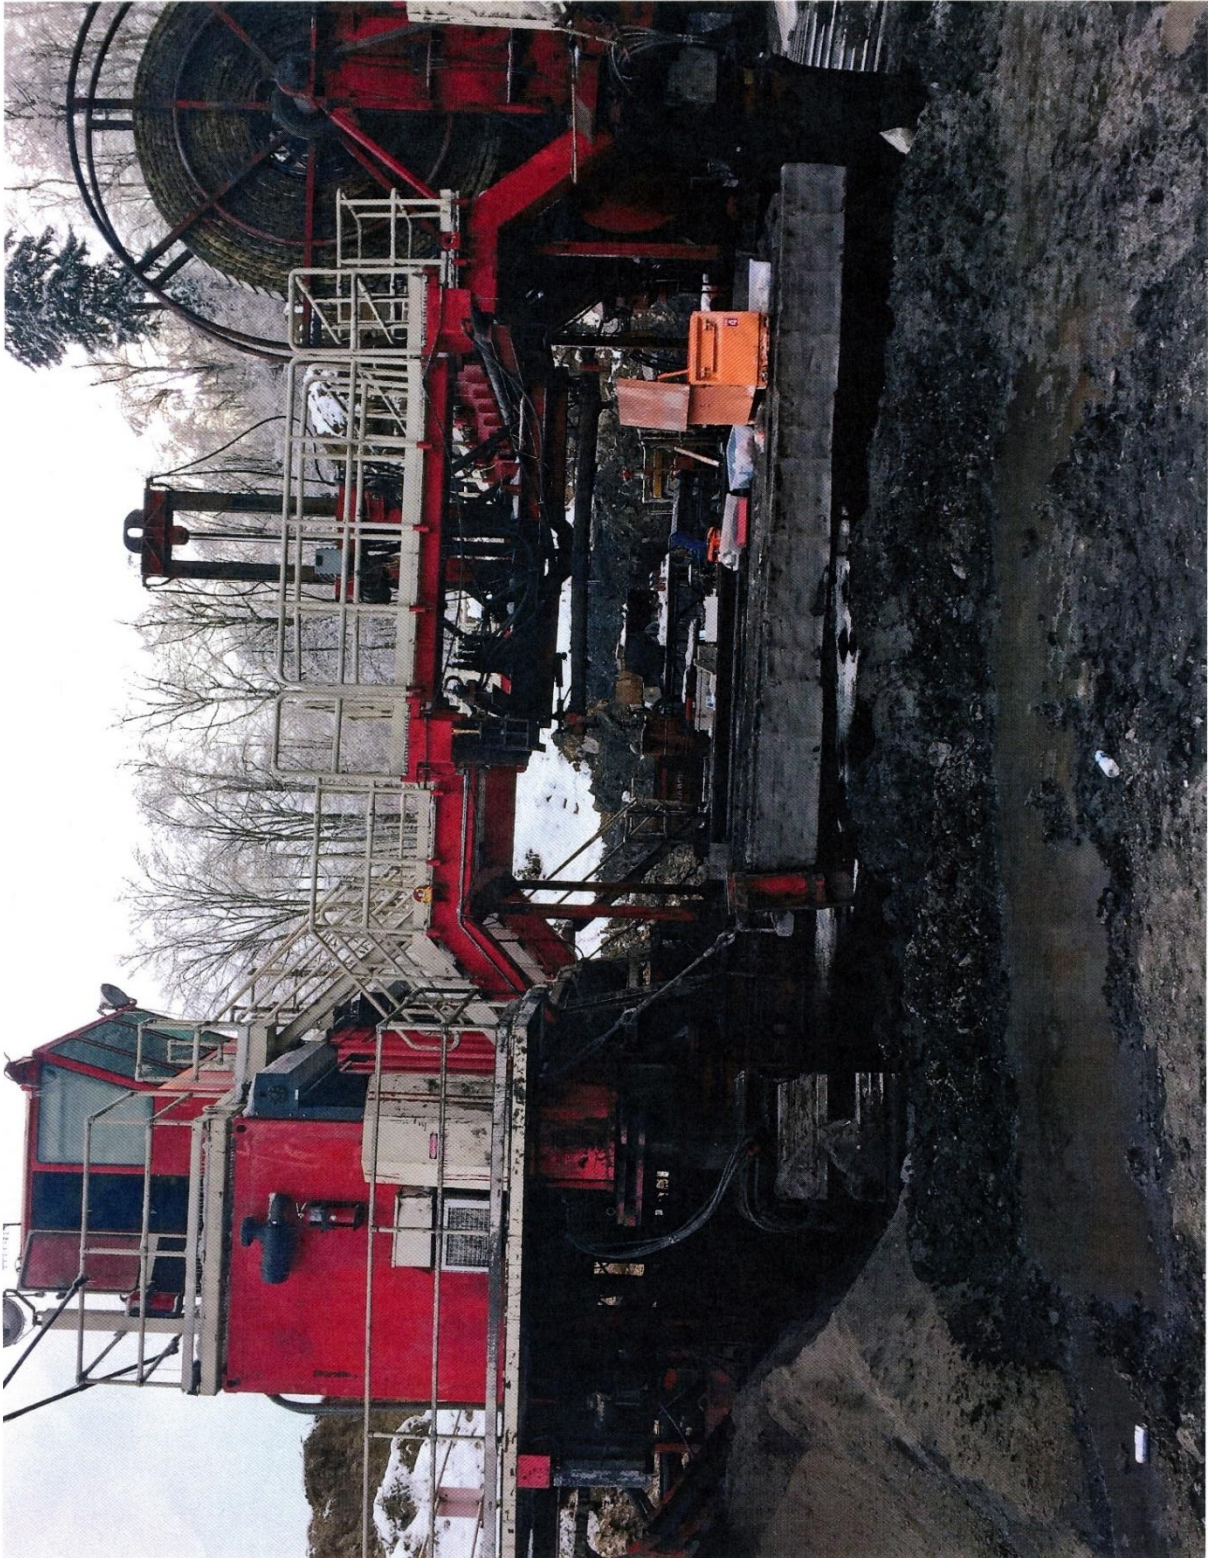
Side View Superior Highwall Miner

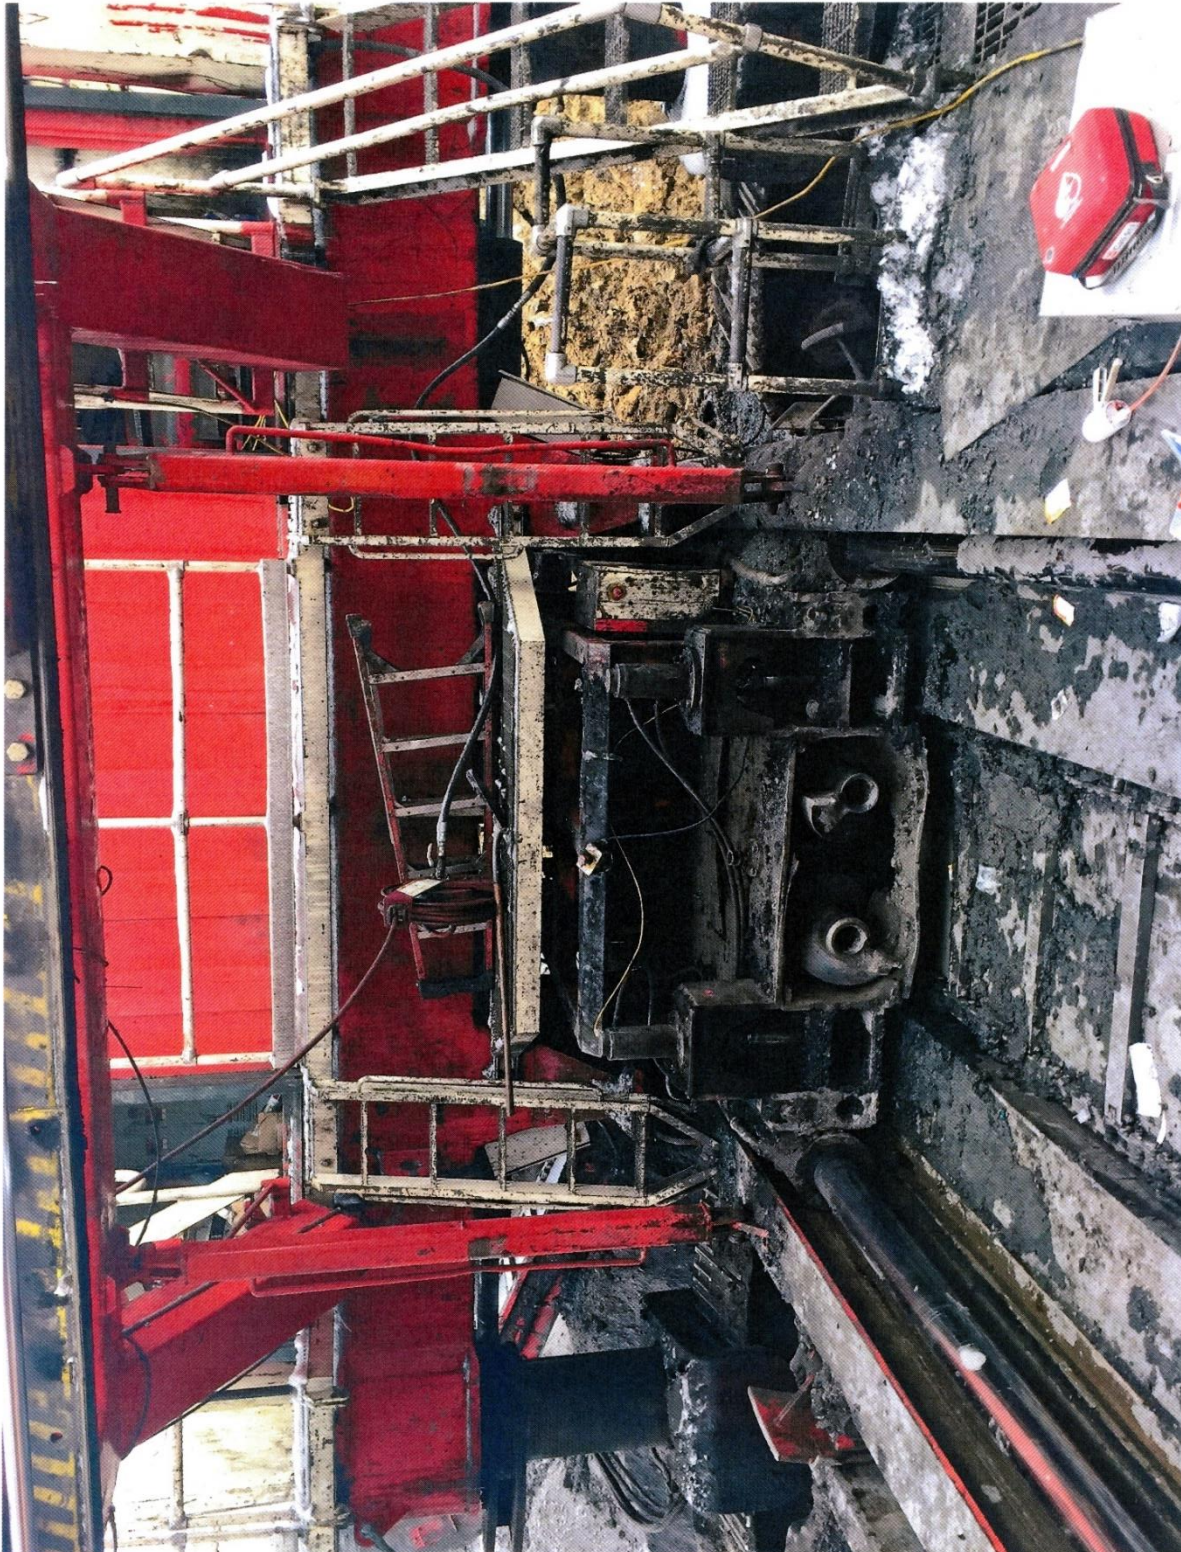
Superior Highwall Miner Powerhead

Mr. James W. Nichols, miner operator / foreman, located in the upper control room witnessed Mr. Adam DeBoard walk up the highwall miner launch and stand between the steps and the upright steel support beam located at the powerhead on the right side of the highwall miner with a shovel in his left hand. As Mr. James W. Nichols, highwall miner operator / foreman, was watching the highwall miner push beam come up from the belly pan, he saw the shovel that Mr. Adam DeBoard was holding in his left-hand fall towards the conveyor chain (belly pan) as the highwall miner push beam was being extracted. Mr. James W. Nichols raised partly up from out of his operators' seat. He saw that Mr. Adam DeBoard's leg had gone into the conveyor chain (belly pan) in front of the powerhead. Mr. Adam DeBoard grabbed the upright steel support beam while the highwall miner push beam was being extracted. Mr. Adam DeBoard's head was caught between the upright steel support beam and the highwall miner push beam.

Mr. Adam DeBoard received fatal injuries when he was caught between the upright steel support beam located at the right rear side of the highwall miner near the powerhead and the highwall miner push beam being extracted.

1. The upright steel support beams located at the front and rear of the highwall miner shall be declared red zones. These areas shall be painted brightly and warning placards installed. Eliminate the back-access steps on the magazine side preventing access from the ground. Chains shall be installed across the second level access to the red zone and

across the upright steel support beams front and rear of the highwall miner magazine side preventing access to the red zone.
