West Virginia Office of Miners' Health, Safety and Training

Report of Fatality

Mobile Equipment

LSM Excavating LLC

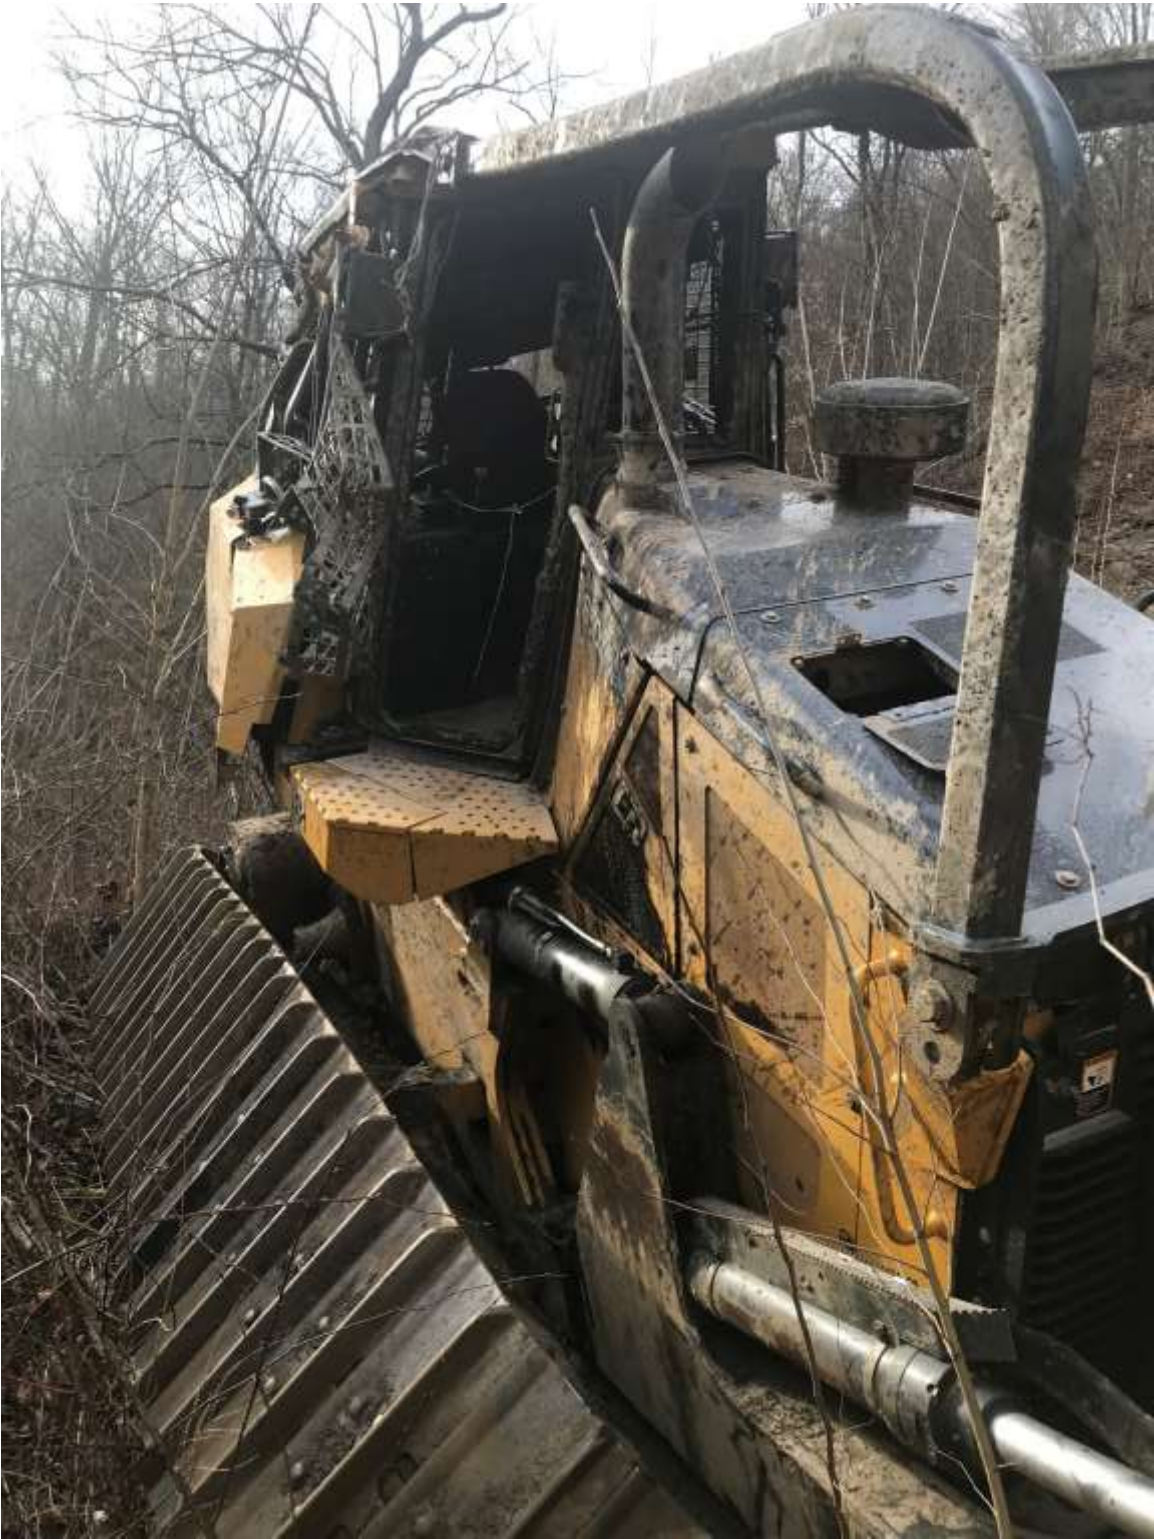
Photo of John Deere 850K dozer after accident

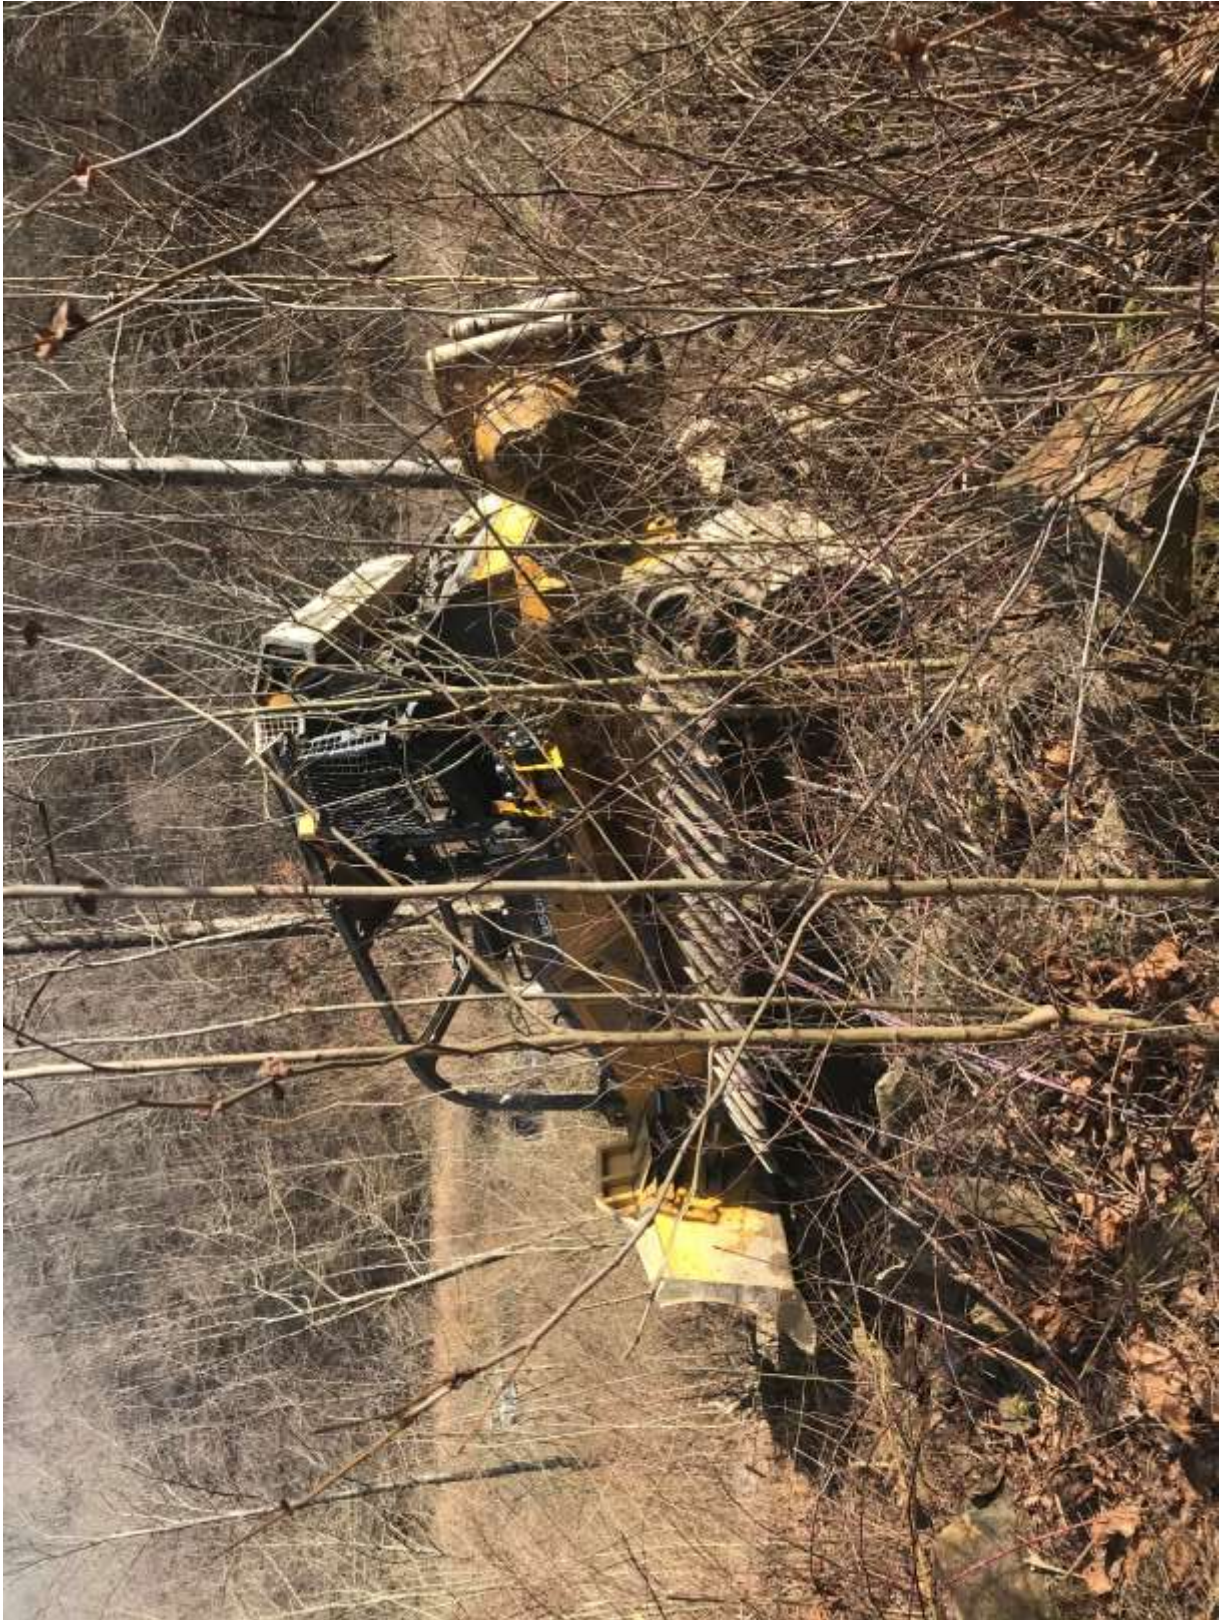
Photo of John Deere 850K dozer after accident
