Report of Fatality
Fall of Roof and Rib
Underground

February 28, 2025

Marfork Coal Company, LLC.
Black Eagle Mine
Permit Number U00300118
Wright Concrete and Construction, Inc.
Permit Number C00007262
Near Pettus in Raleigh County

Region IV Office
337 Industrial Drive
Oak Hill, WV 25901
Christopher M. Dawson, Inspector-at-Large

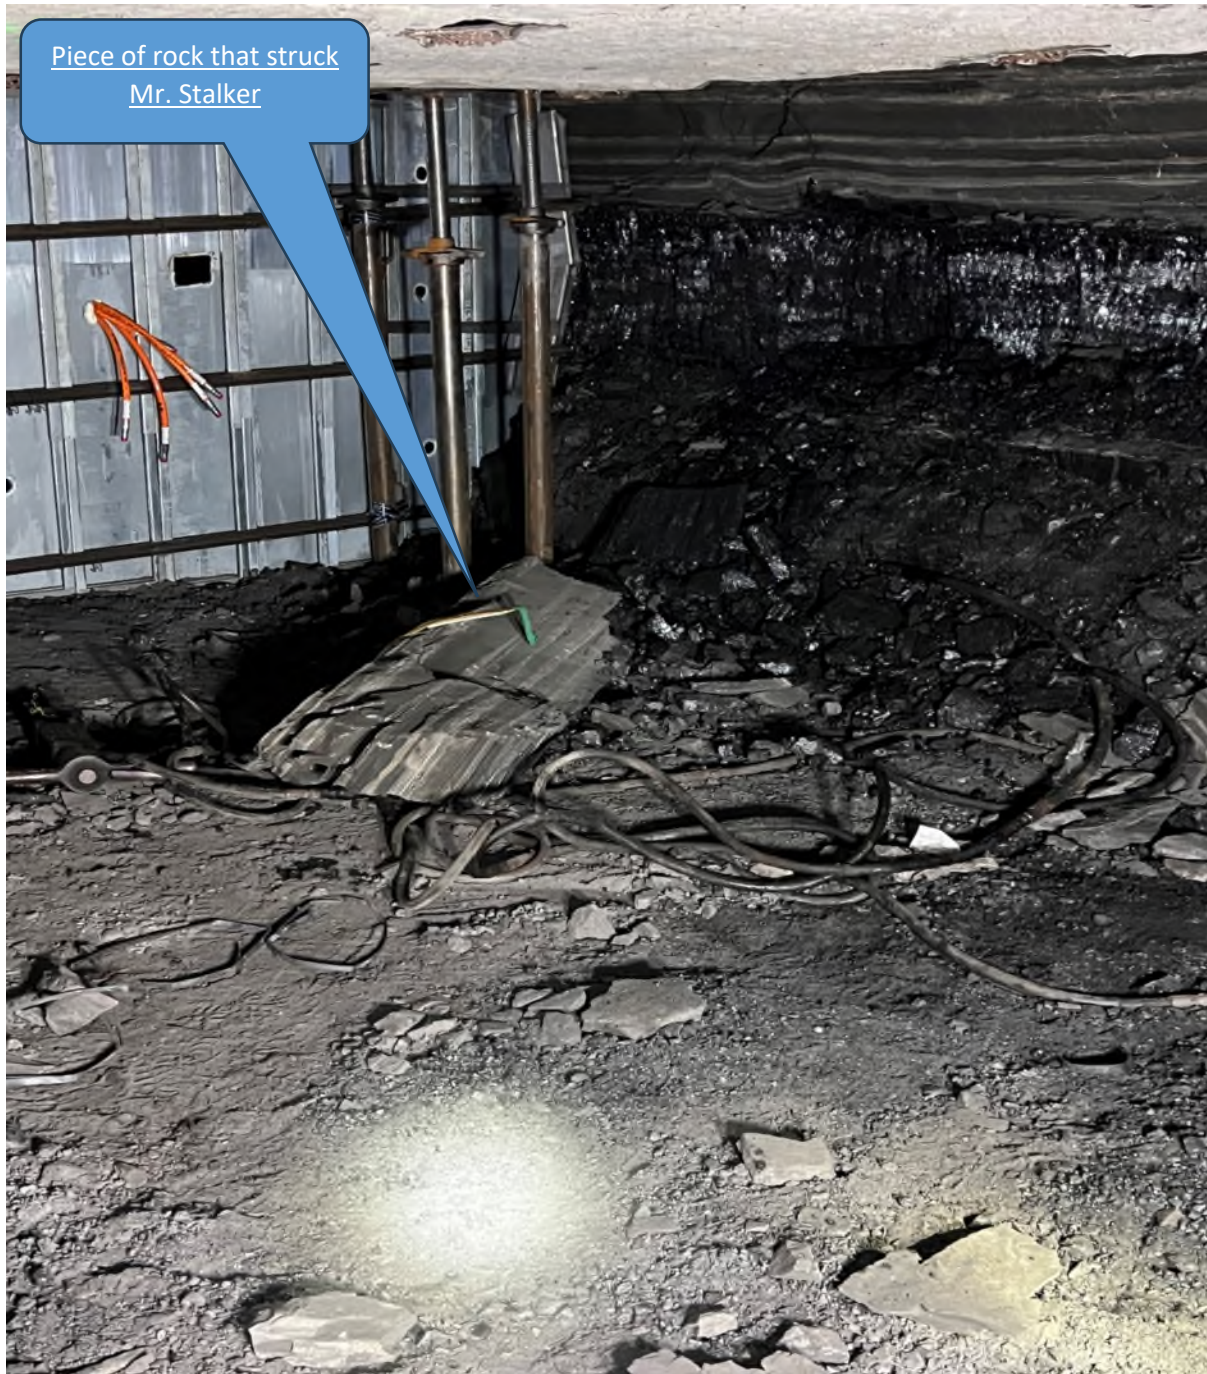
The accident site.

Mr. Stalker went to the right rib looking in by towards the #8 Seal and leaned against it to take a break. At approximately 2:30 p.m., a piece of the rib rolled out and landed on Mr. Stalker's torso. No one witnessed the rock fall onto Mr. Stalker, but just after it happened, the rock was observed laying across his torso. Immediately, Mr. Stiltner tried to get the rock off of Mr. Stalker but couldn't. Mr. Wills arrived at the scene to check on the Seal Construction Crew and assisted

Mr. Stiltner and Mr. Bailey in getting the rock off of Mr. Stalker. The rock measured approximately 68 inches wide, 23 inches long and was 8 inches thick.

Mr. Stalker was struck in the torso by a piece of rock that fell from the rib, near the face of the #8 Seal of the 1A Seal Site.

Mr. Stalker was last observed sitting near a rib, in the work area at the #8 seal of the 1A Seal site. Mr. Stalker had been using a jack hammer to dig for the water trap that goes in the seal. A portion of the rib became loose and fell onto the torso of Mr. Stalker, resulting in a severe crushing injury, causing difficulty in breathing. This accident resulted in the death of this individual.

All underground construction sites will be examined every day that work is scheduled and every 2 hours after the pre-shift has been conducted. All examinations will be documented in the construction record book.

Daily safety talks on roof and rib conditions in and around work areas will be conducted before shifts begin with all Wright Concrete & Construction, Inc. employees on each underground project in a West Virginia coal mine with written records of each.

Periodic roof and rib condition checks will be conducted throughout the shift by the lead supervisor.

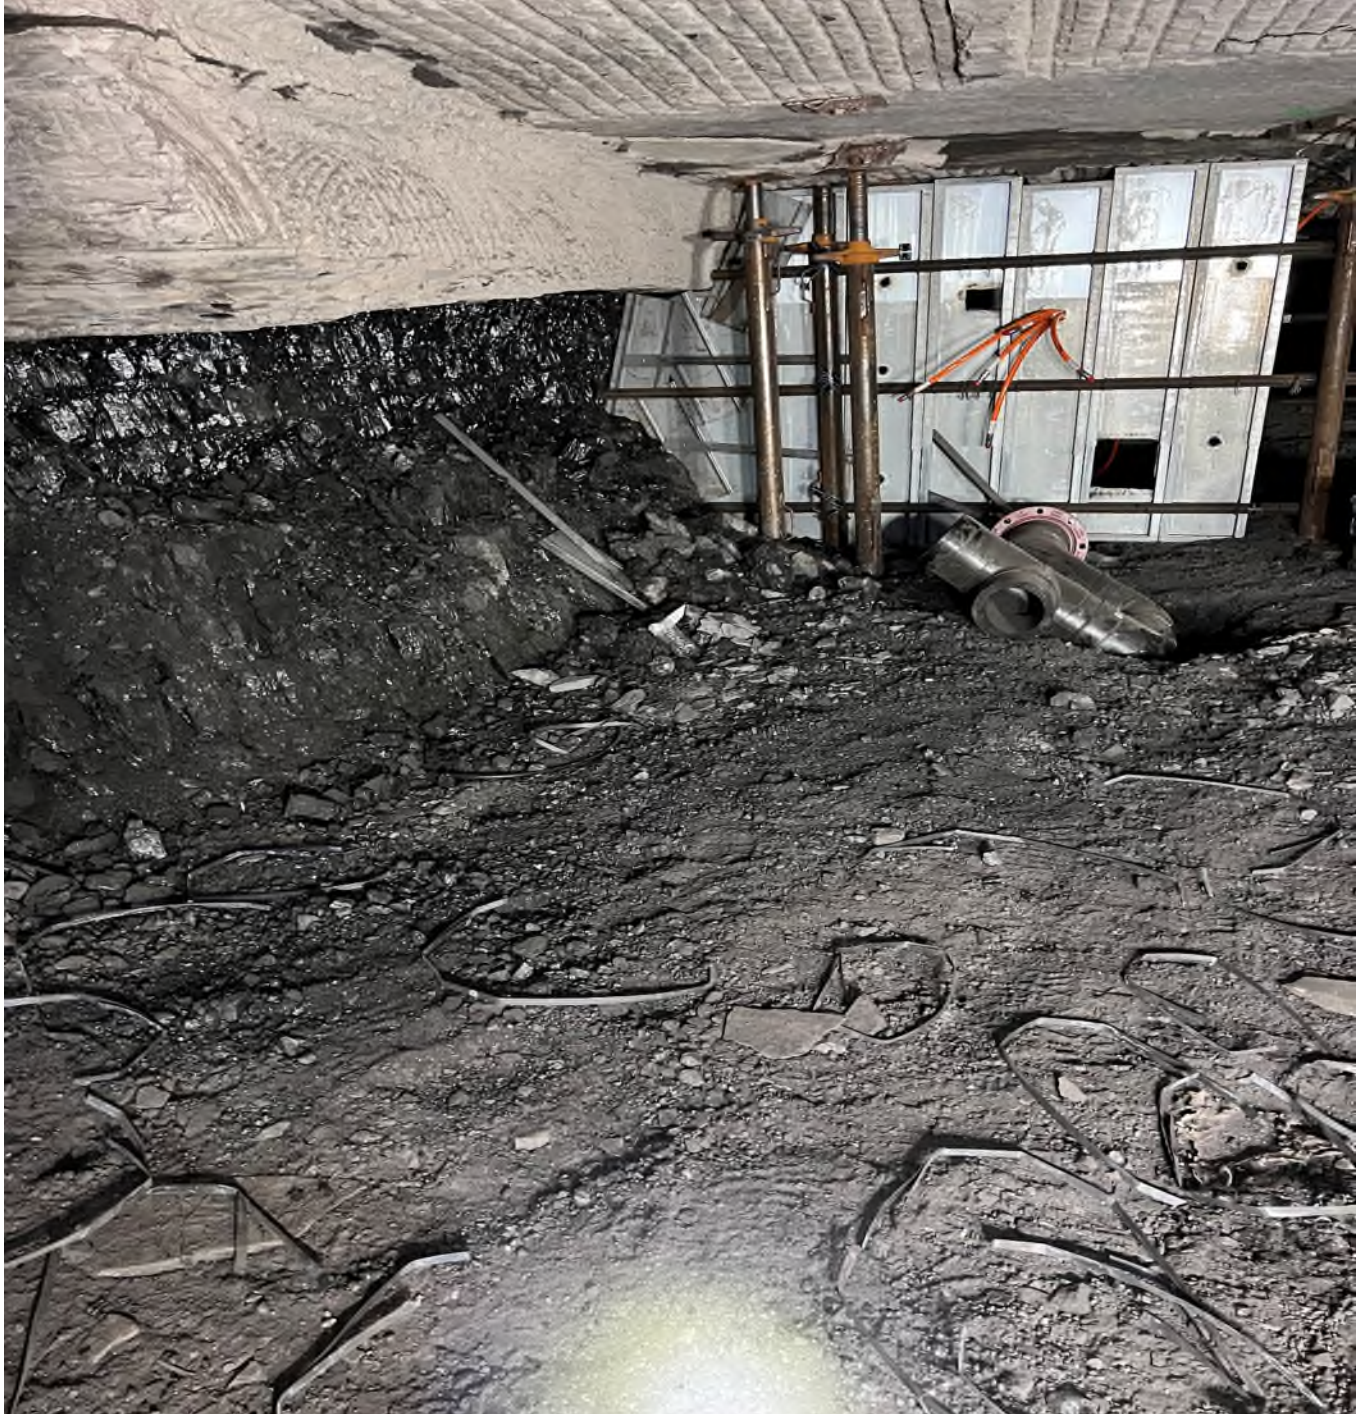
The water trap that was being worked on just prior to the accident. Mr. Stalker was sitting on the other side of this mine entry when the accident occurred.

At approximately 1:00 p.m., according to written statements, the Seal Construction Crew began jack hammering the mine floor, at the #8 Seal, to allow for sufficient clearance for installation of the water trap. At the same time, Mr. Stiltner was using the oxygen/acetylene torches to cut holes into the Kennedy Panels used to frame up the #8 Seal, to allow the water line for the water trap to pass through both walls of the seal. Mr. Stalker and Mr. Bailey were using the jack hammer to dig for the water trap.
