Report of Fatality  
Longwall Setup Face Haulage Equipment  
April 3, 2026

Ohio County Coal Resources  
Ohio County Mine  
Permit Number D00004791B  
Near Dallas in Ohio County, WV

Region I Office  
14 Commerce Drive Ste 1  
Westover, WV 26501  
Edward Peddicord, Inspector-at-Large

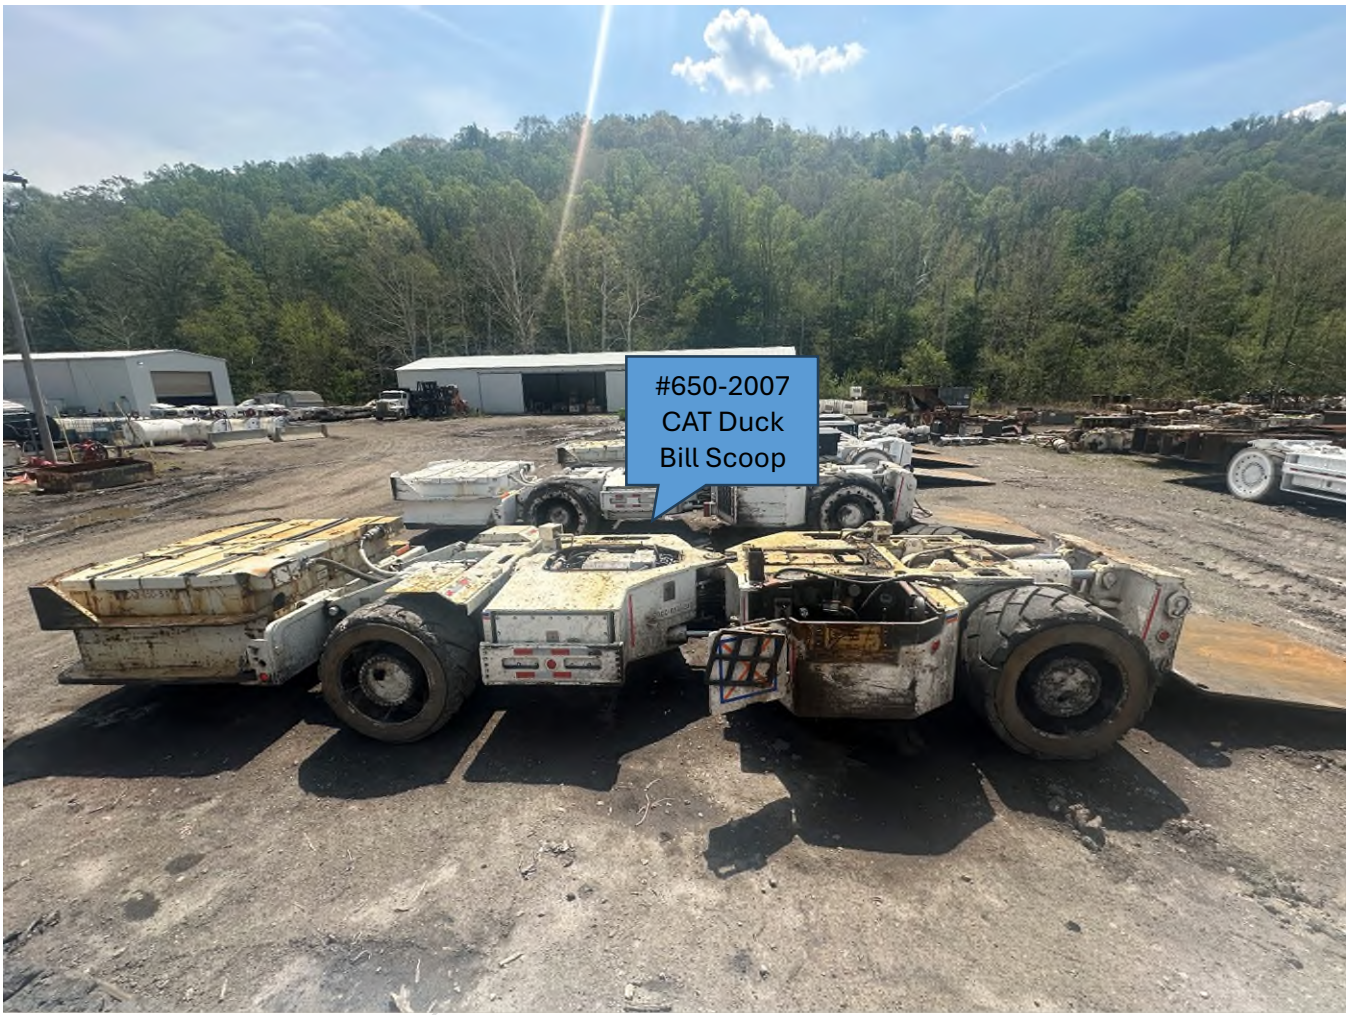
Photo of the #650-2007 CAT Duck Bill Scoop that was involved in the accident. (The canopy and glancer bar were removed from the machine prior to this photo.)

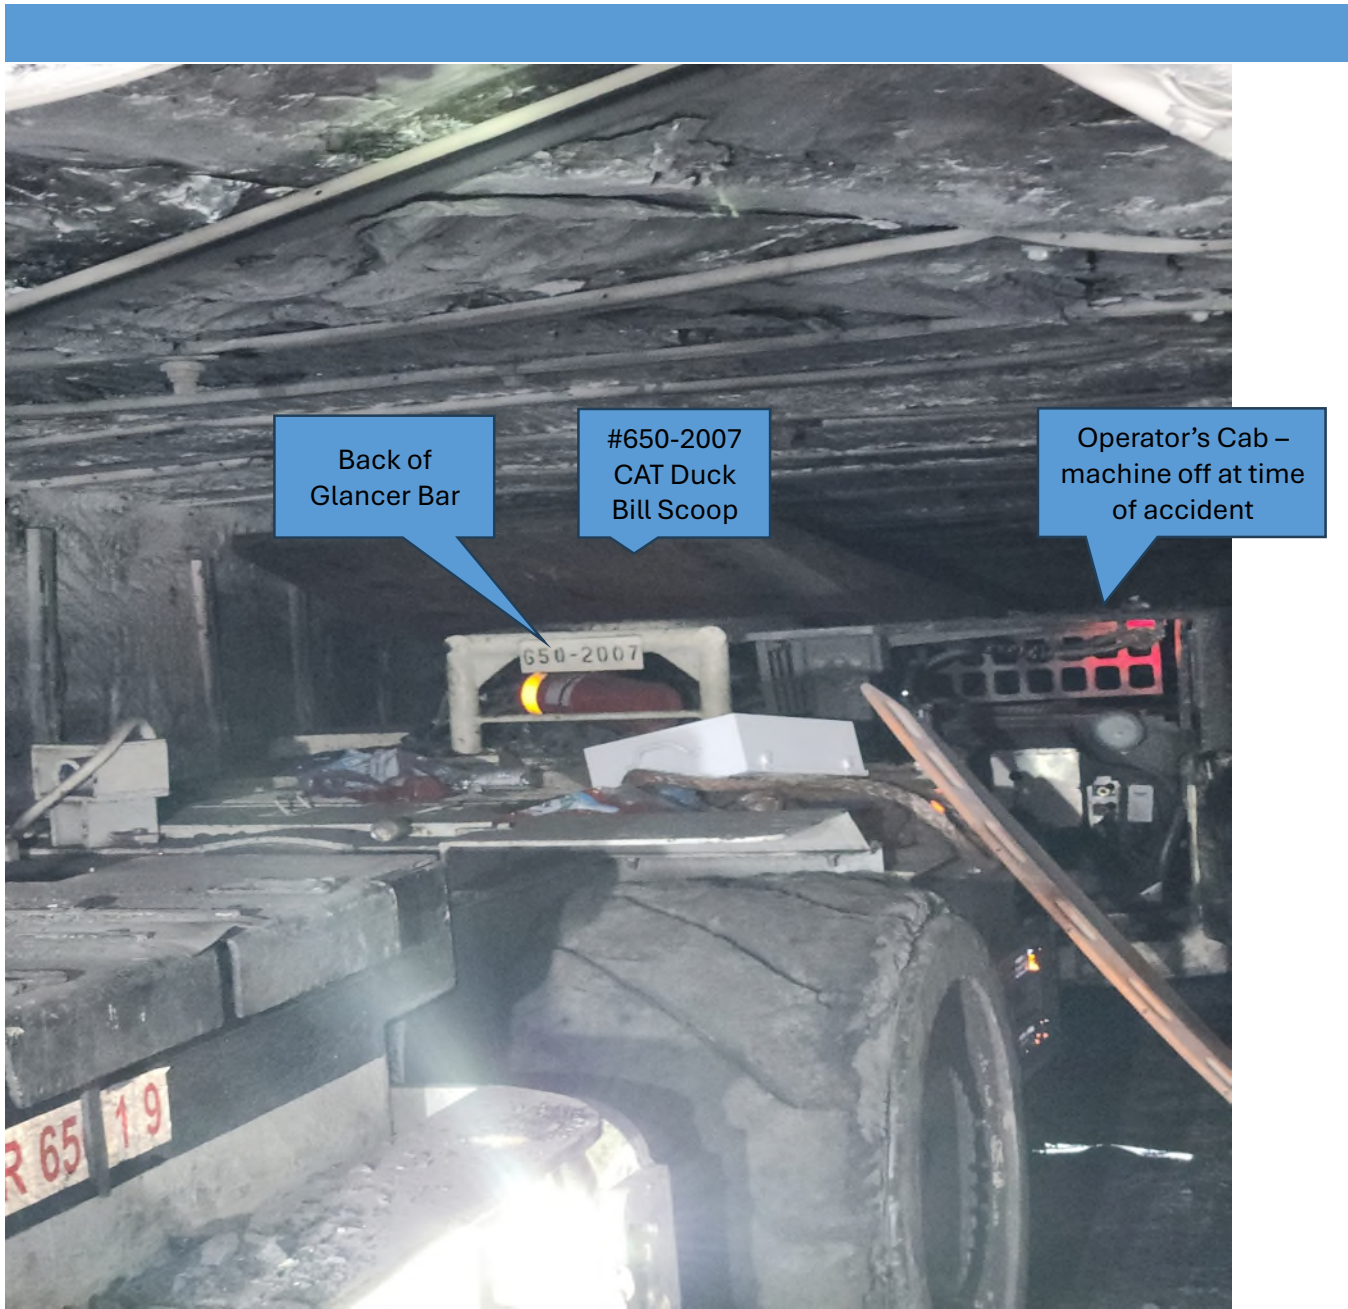
Photo of the accident scene at the #3 Left Longwall Setup Section.

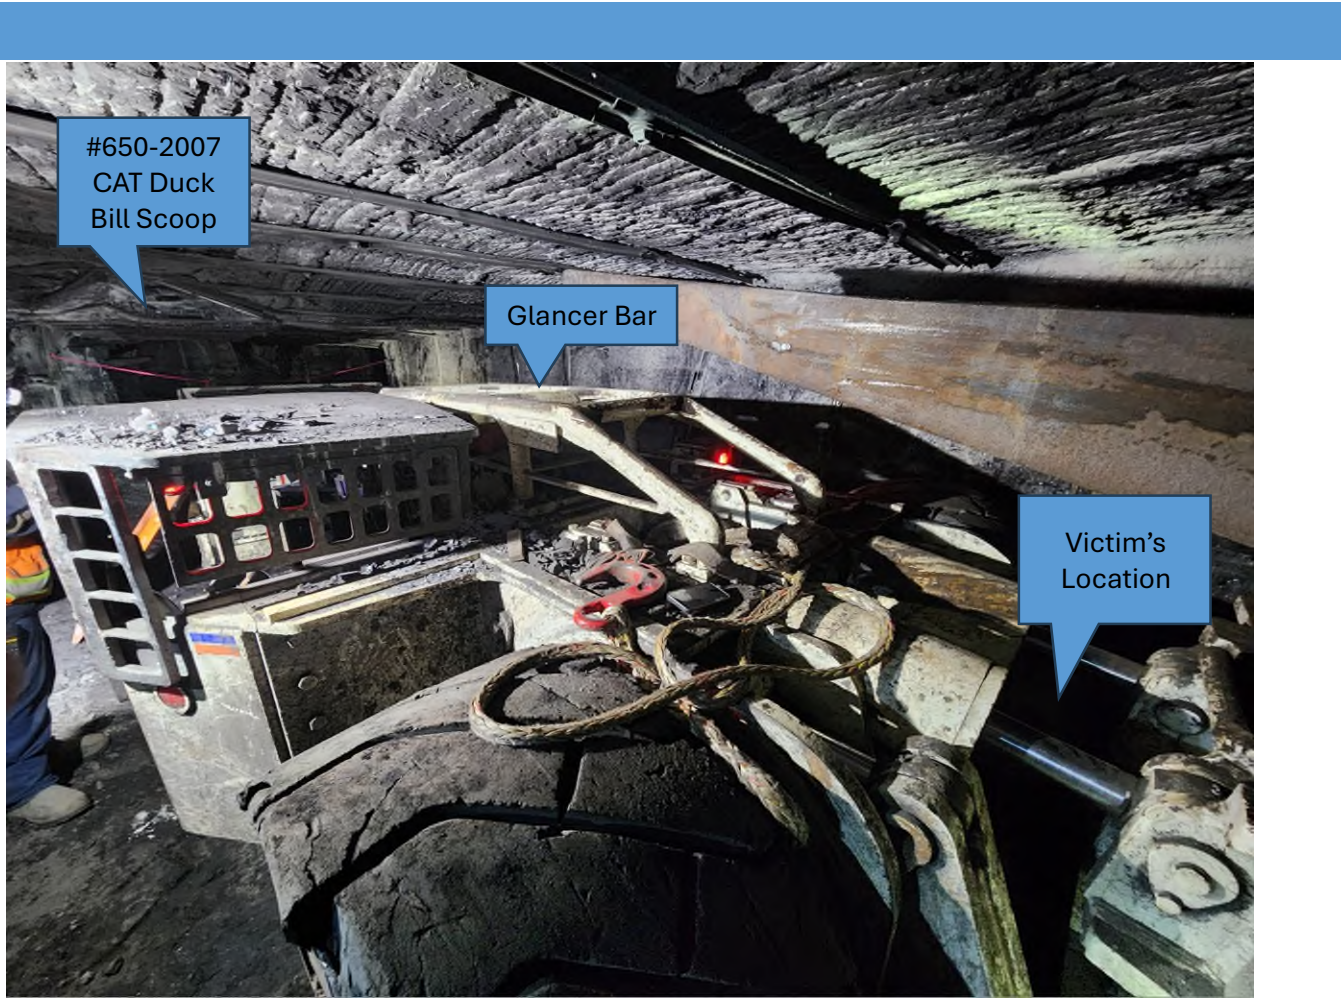
#650-2007  
CAT Duck  
Bill Scoop

Glycer Bar

Victim's  
Location

Photo of the accident scene at the #3 Left Longwall Setup Section.

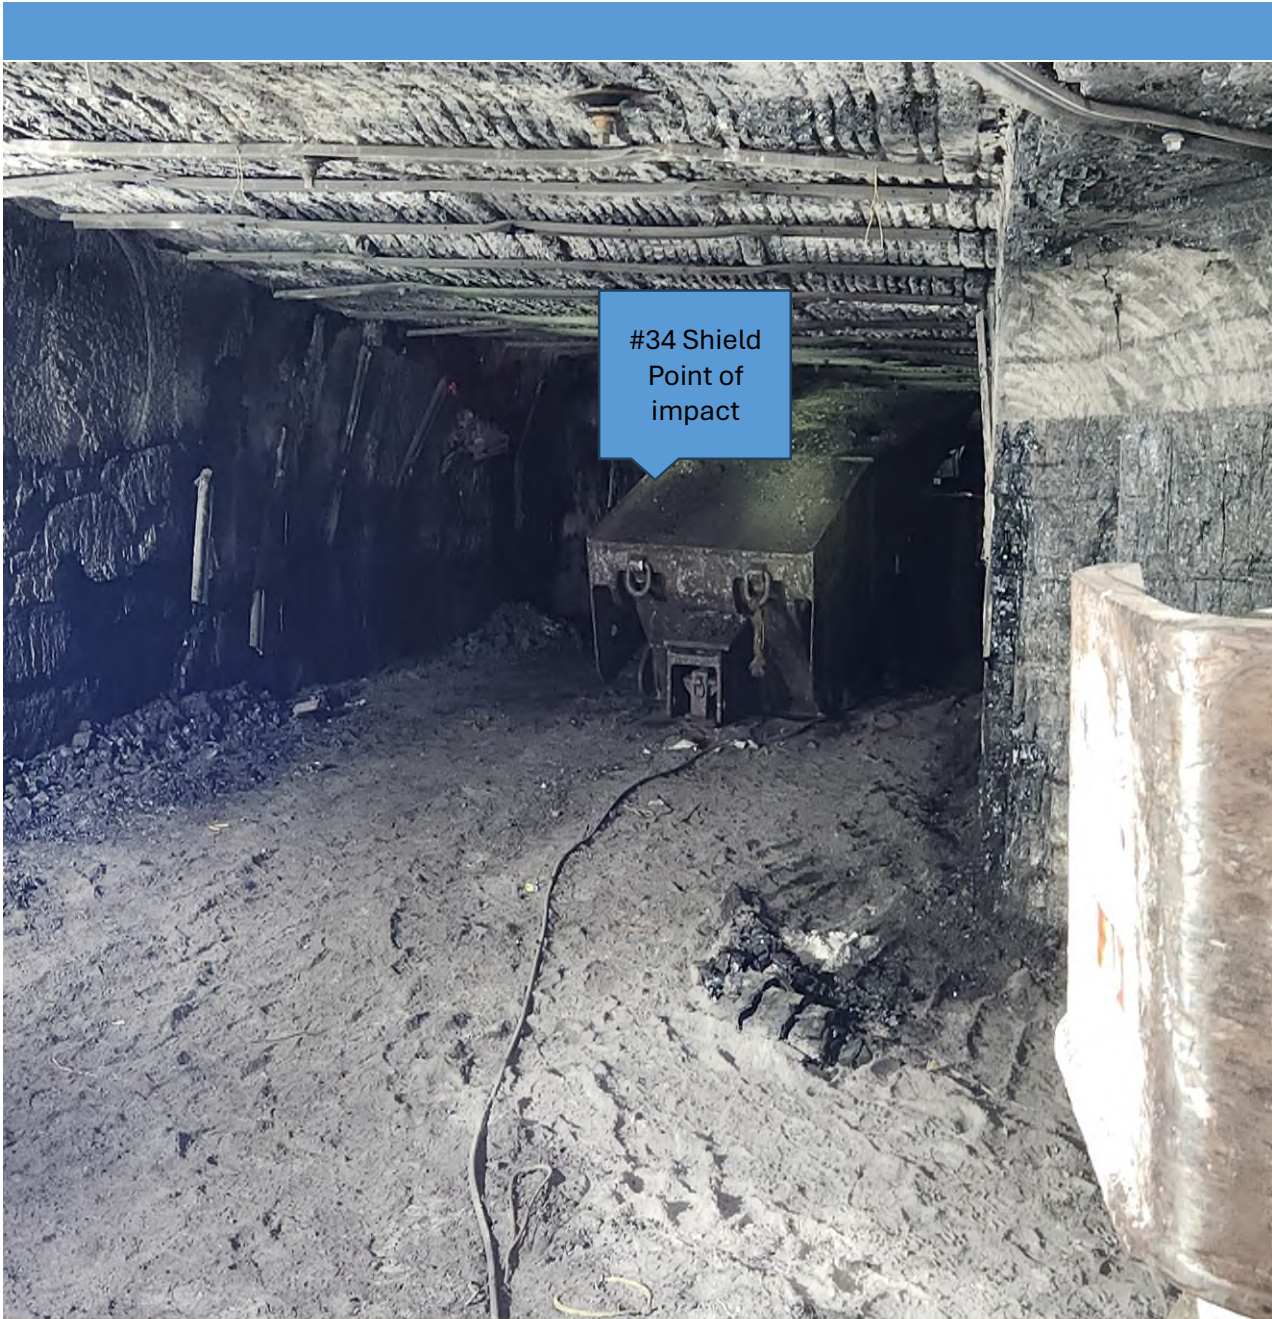
Photo of the accident scene at the #3 Left Longwall Setup Section.

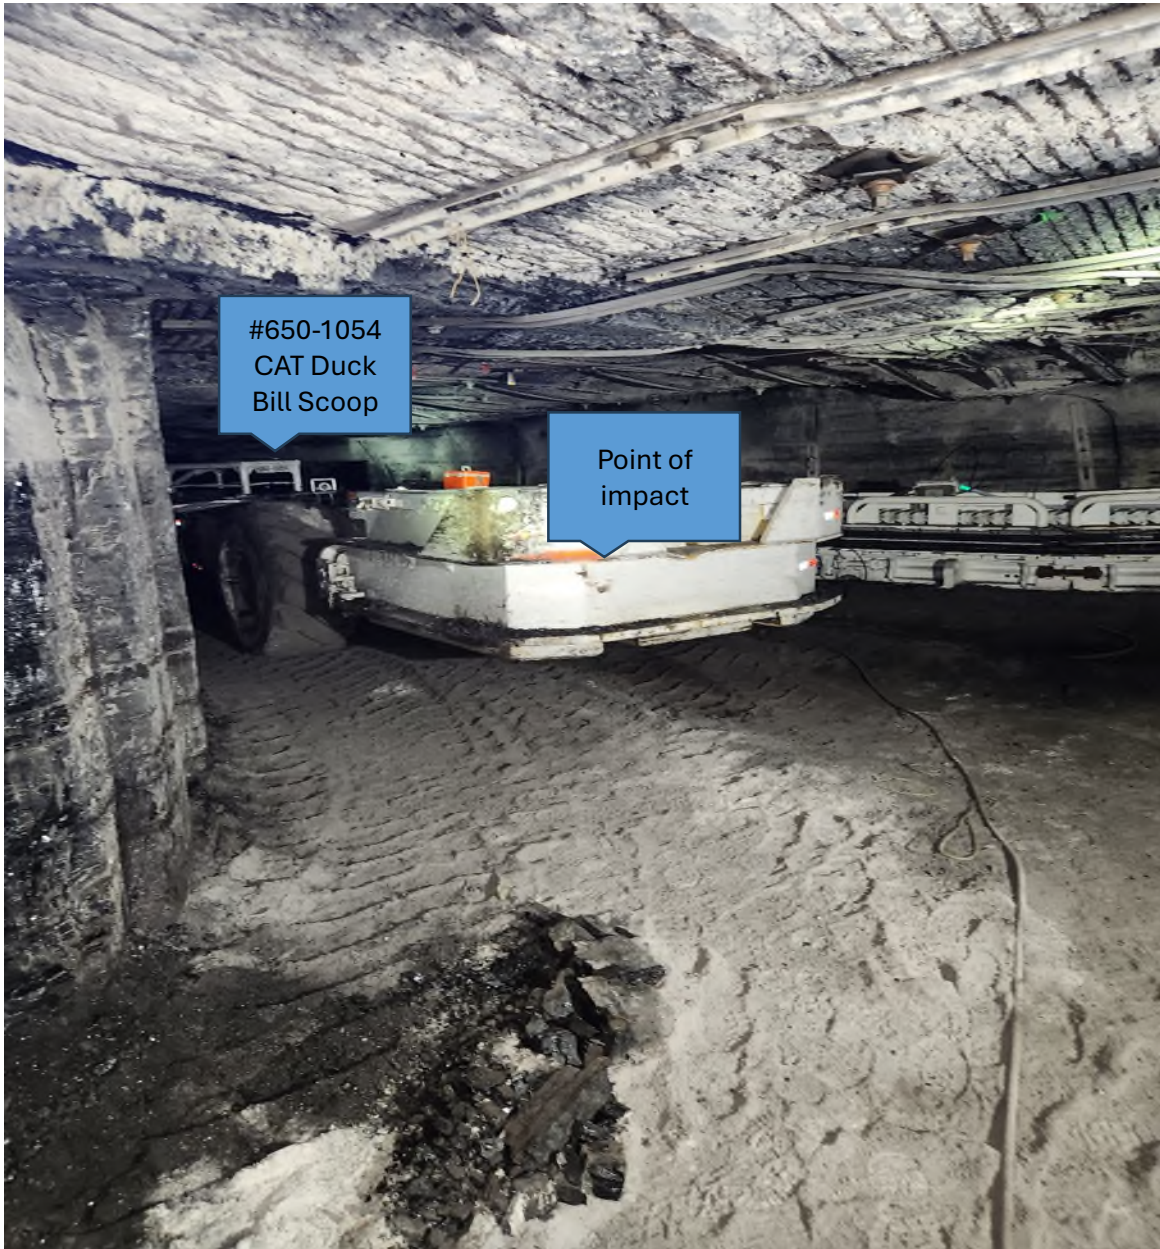
Photo of the accident scene at the #3 Left Longwall Setup Section.

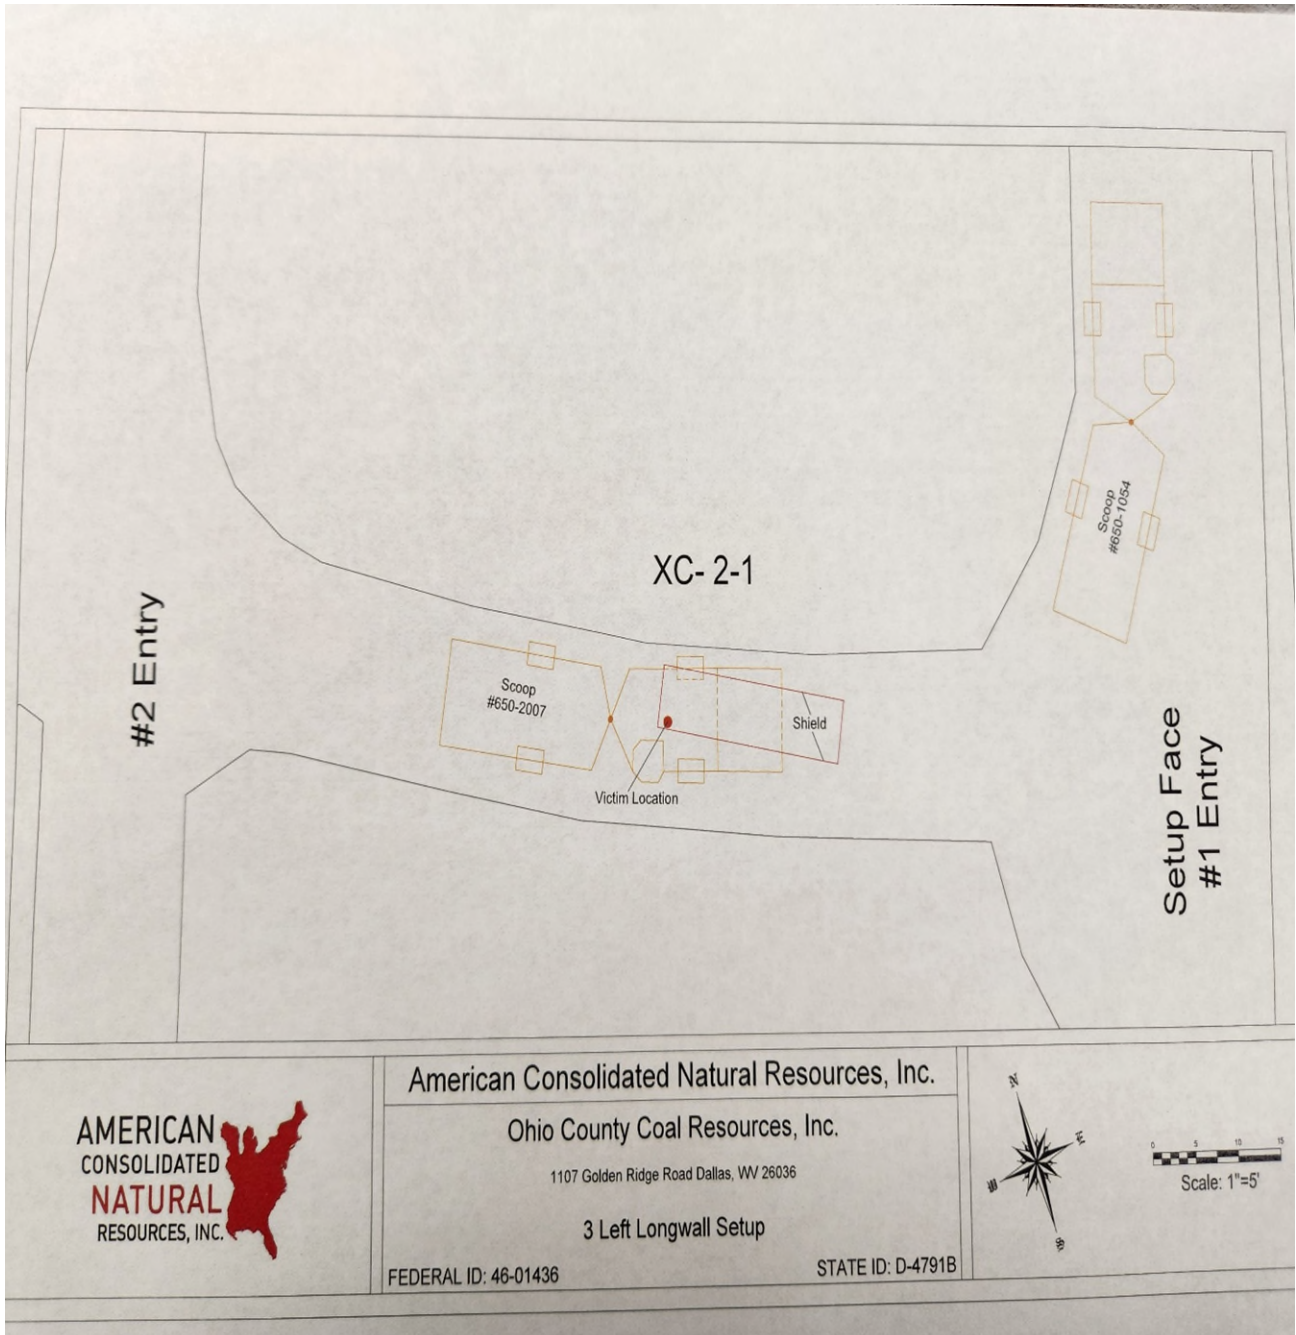
CAD drawing from Ohio County Mine of the accident scene at the #3 Left Longwall Setup Section.
