Subject: Additional Approvals of ChemoBio Shelter™ under WV Legislative Rule Title 56, Series 4  
Emergency Rules Governing Protective Clothing and Equipment

Re: Request for Modification

The purpose of this letter is to seek approval from WVOMHST regarding the use of brass bodied air and oxygen regulators in our ChemBio Shelter models for the WV-MSHA refuge alternative refit program.

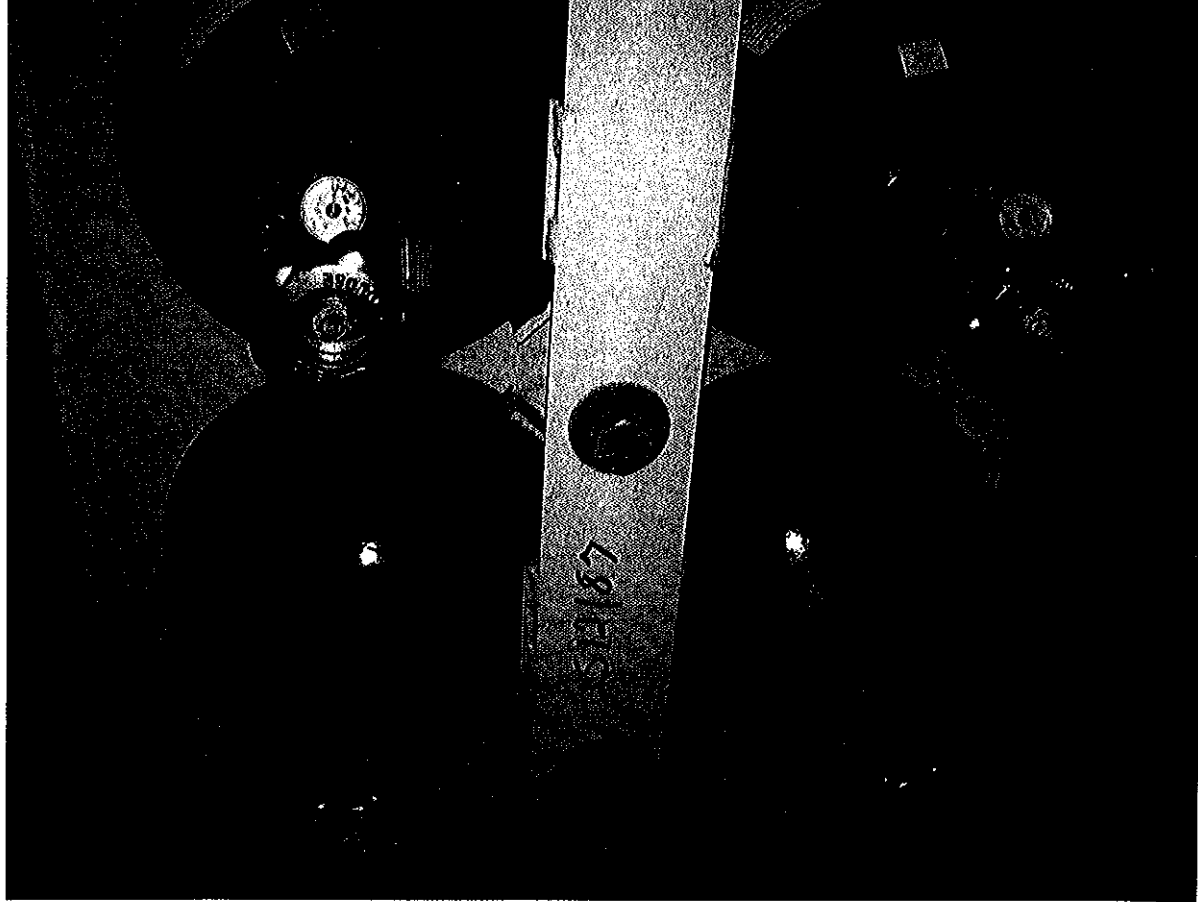
The attached Site Visit Photo 1 shows corrosion on the un-protected steel cylinder cap threads and the cadmium plated cylinder retainer bolts exposed to the mine atmosphere. Attached Site Visit Photo 2 is a close-up of a Cavagna CGA-701 oxygen cylinder valve showing obvious de-zincification residue, although there is no visual evidence of stress-corrosion cracking at this point. Attached Site Visit Photo 3 shows the current-style (no cover) high pressure regulator box removed from this unit. It is noted that the brass-bodied high pressure oxygen (left and center) and the high-pressure air regulators (right) are bright & shiny and exhibit no surface patina or evidence of de-zincification. This regulator box was mounted within the sealed "safe area" of the LifeShelter and connected by tubing through the bulkhead plate shown in attached Site Visit Photo 4 and 5.

View of cylinder rack with  
green being oxygen and  
yellow air

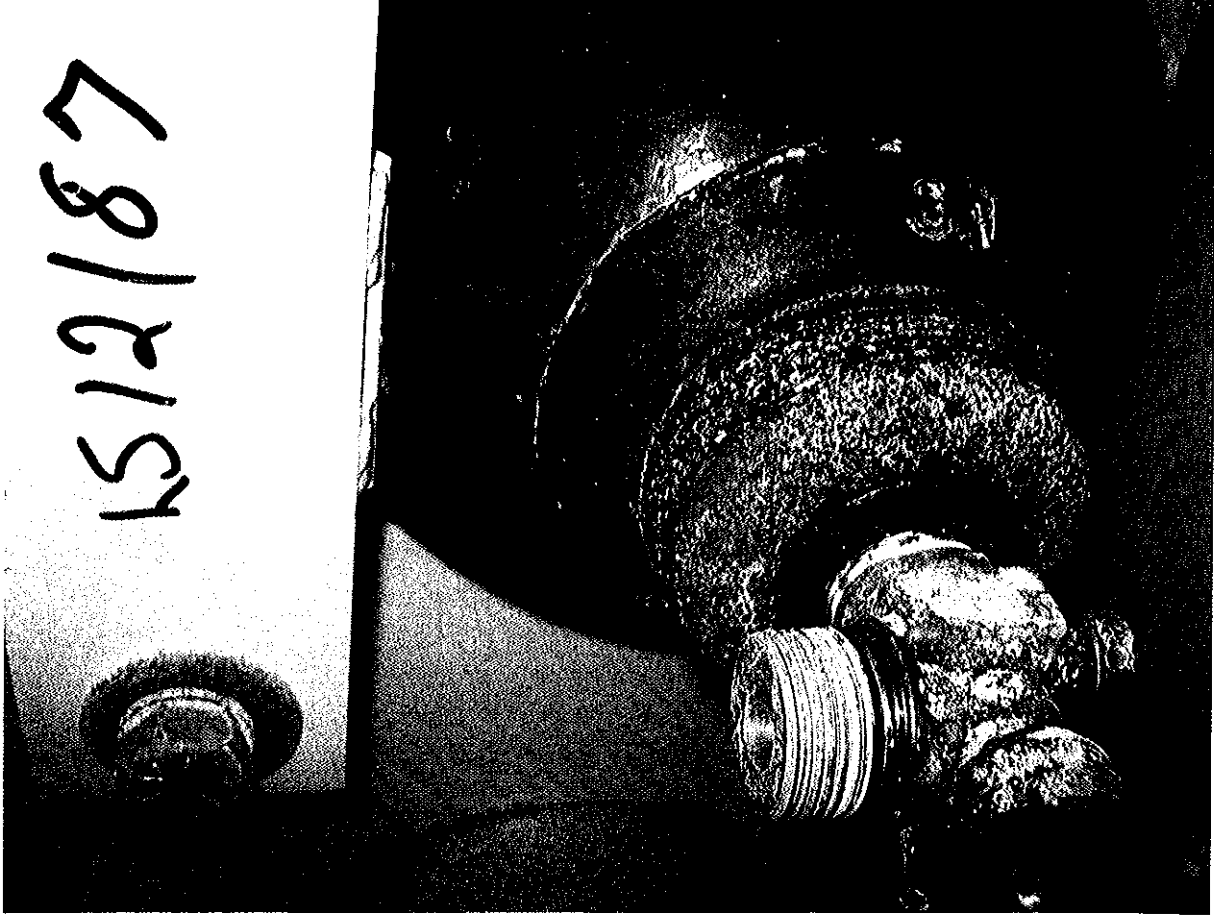
Site Visit Photo 2

Close up of one of the oxygen cylinders with the white residue typical of dezincification.

No visible signs of stress corrosion cracking were yet evident.
