CONTENT:
APPENDIX 5.3-1 to 5.5

REPORT of INVESTIGATION
SAGO MINE EXPLOSION

JANUARY 2, 2006

WEST VIRGINIA OFFICE of MINERS' HEALTH
SAFETY AND TRAINING
DECEMBER 11, 2006
RON WOOTEN, DIRECTOR

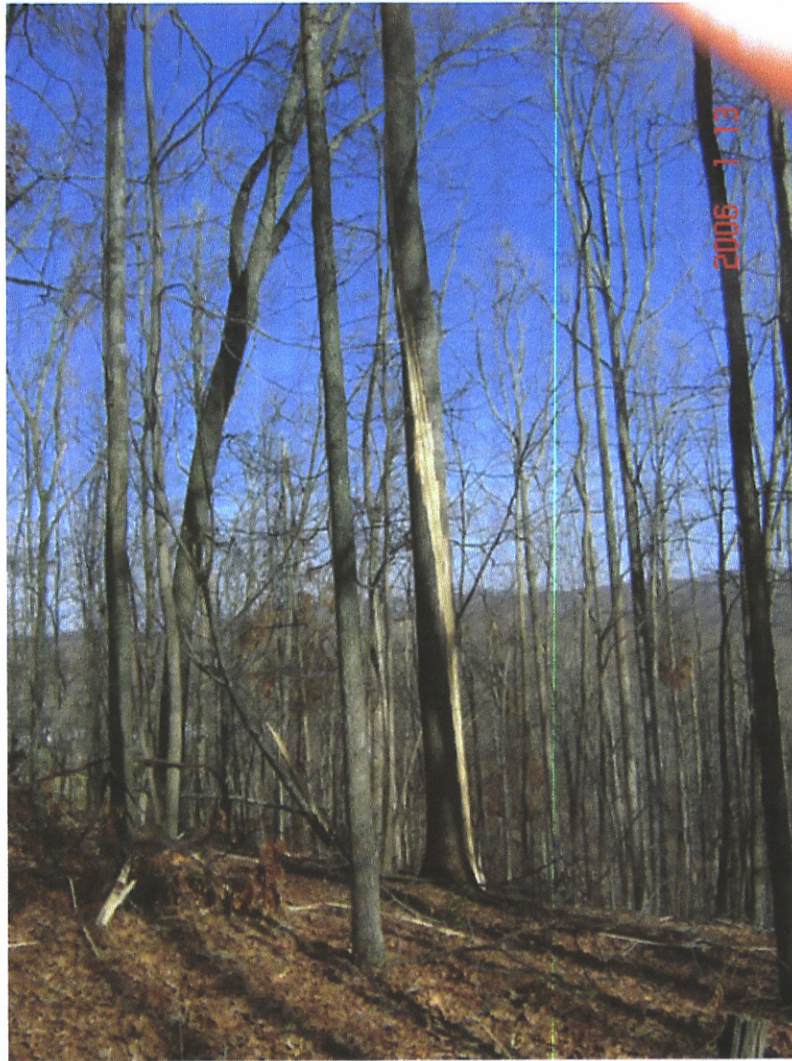
Photo 1: Damage To Lightning Struck Tree

This corresponds precisely with the timing of two nearly simultaneous **lightning strikes** approx. 2 miles apart, located on the attached map. The strongest of these, recorded by Vaisala (StrikeNet), was reported to be a +101.0 kA hit at LAT 38.926, LONG -80.233 at **06:26:35.680 am** on January 2, 2006. This is the location where Sago engineer Kermit Melvin and myself found the lightning-struck tree last Friday (see Photo 1).

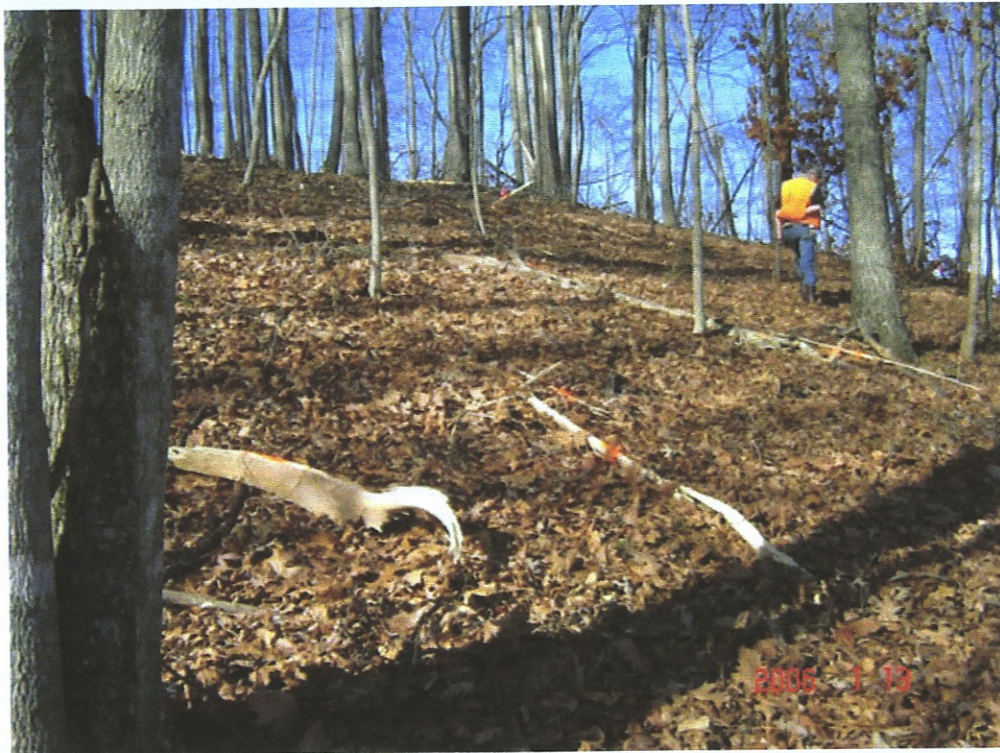
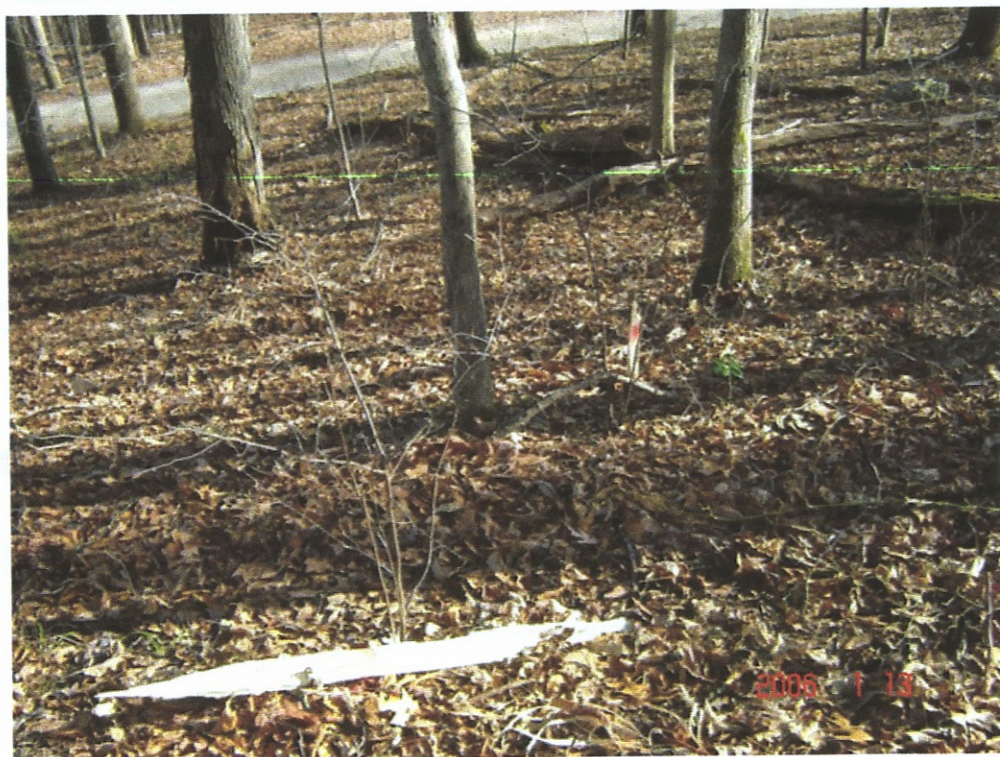
Photo 2 and 3: Survey of Fragments From Lightning Struck Tree

You will notice that, per your instruction, we located all of the trees, with the exception of small saplings, within the 50' radius, and trees over 12" in diameter outside of the radius. Also, although the map depicts shards and splinters of uniform length and width, we depict the width throughout the shard as its width at the widest point. Most of the shards were tapered at each end, and many, perhaps 10% or so, were broken.

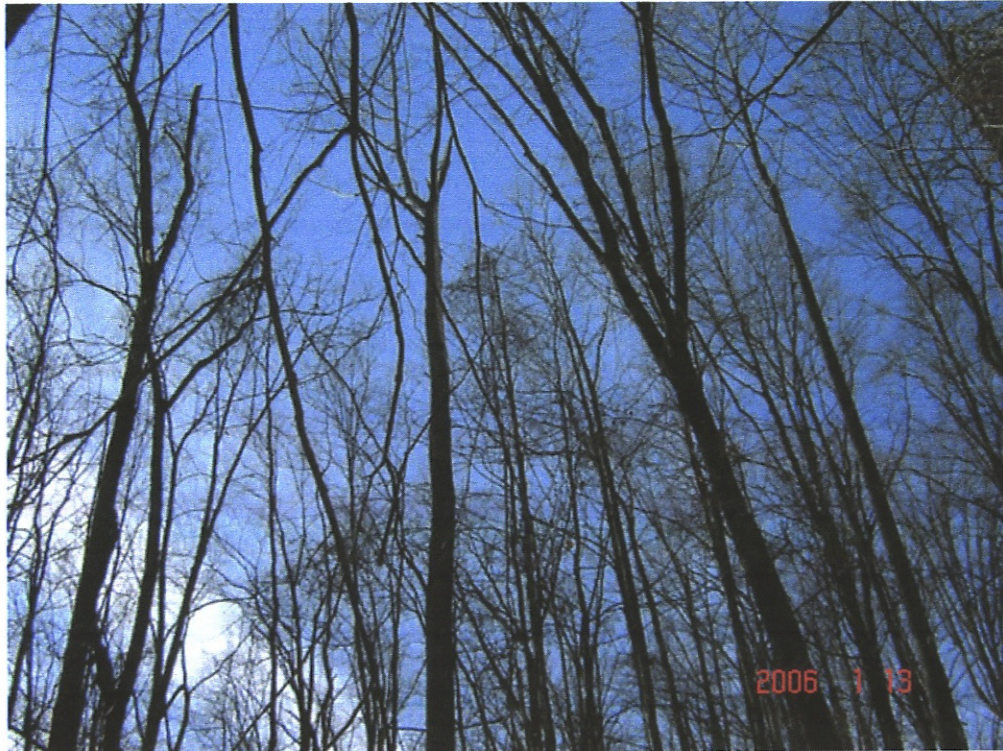
Photo 4: Broken Tree Top of Lightning Struck Tree

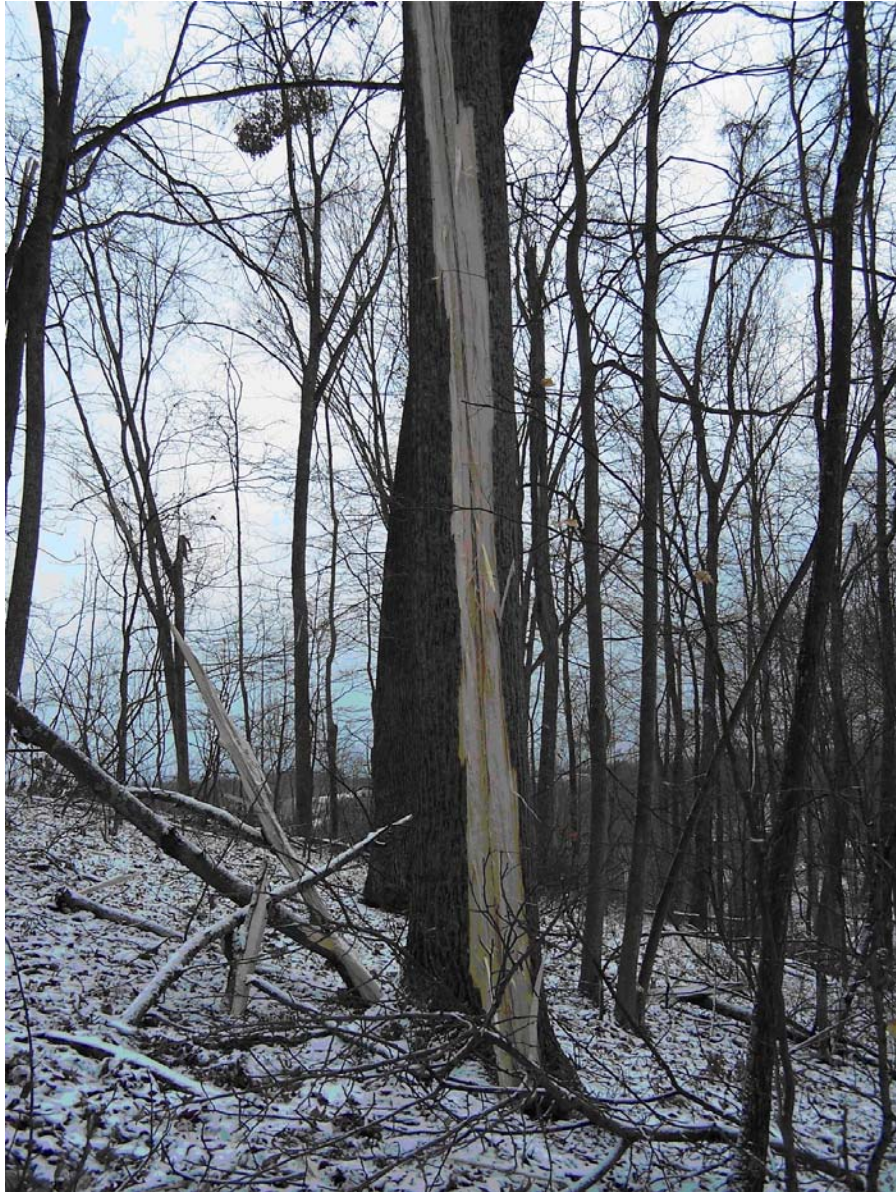
Photo 1. Poplar tree very recently hit by lightning and in close proximity to +110 kA hit recorded by

Vaisala (StrikeNet) at LAT 38.926, LONG -80.233
at **06:26:35.680 am** on January 2, 2006, Photo by
Kermit Melvin, January 6, 2006.

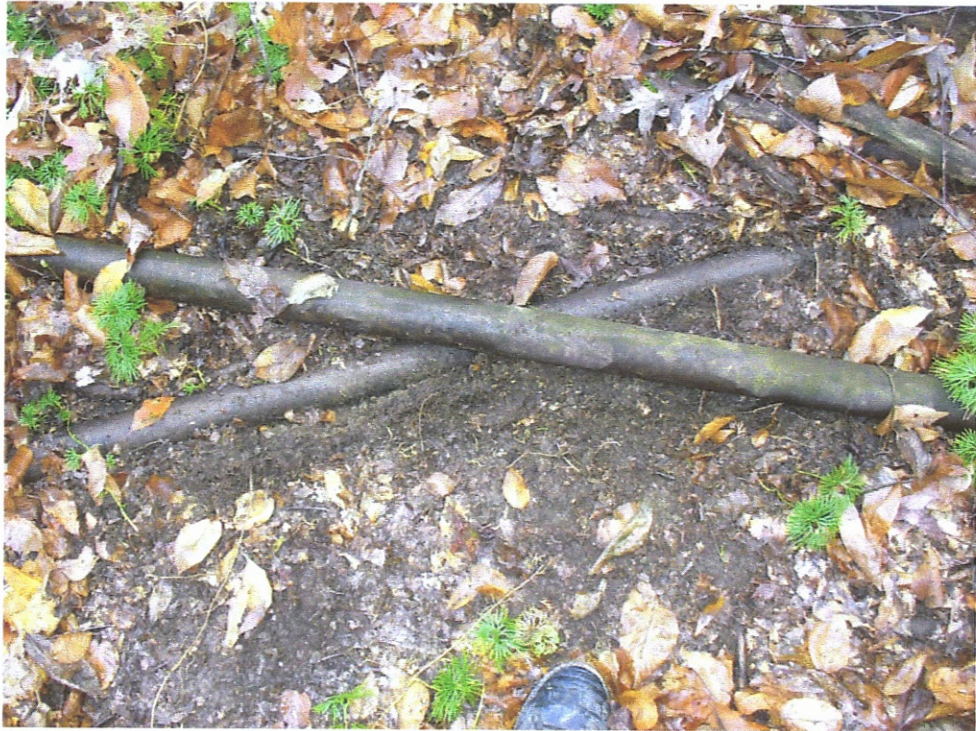
Photo 1:
Location Where Trubie Run Gas Line
Crosses Another Company's Gas Line

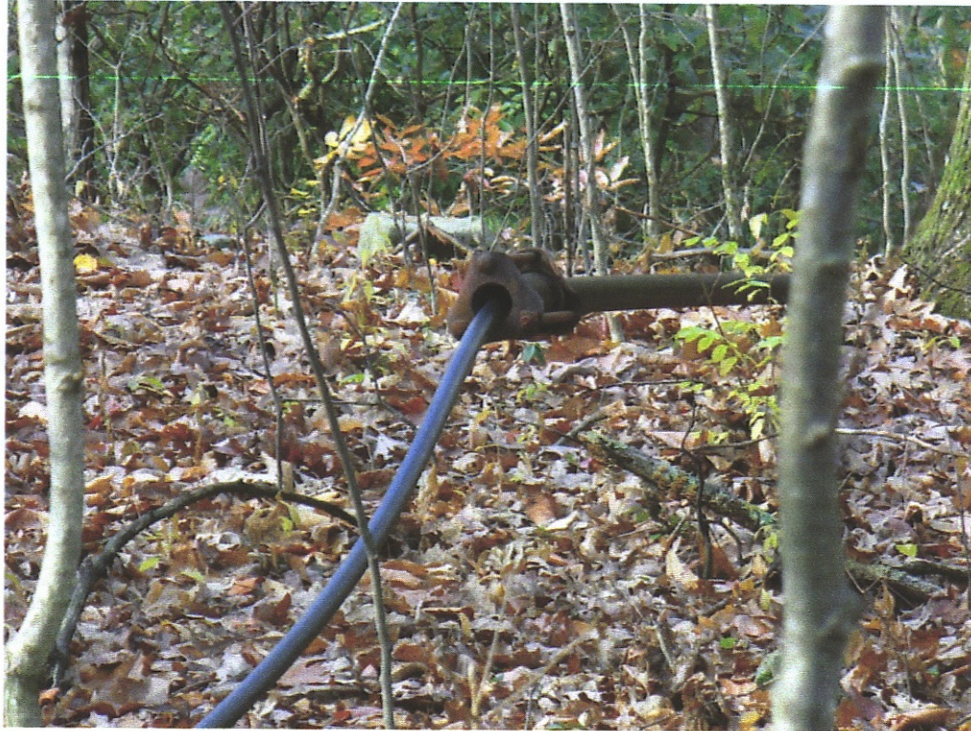
Photo 2:
A Twenty Five Foot Break In Trubie Run Steel Gas Line
And Spliced Together With Plastic Gas Line

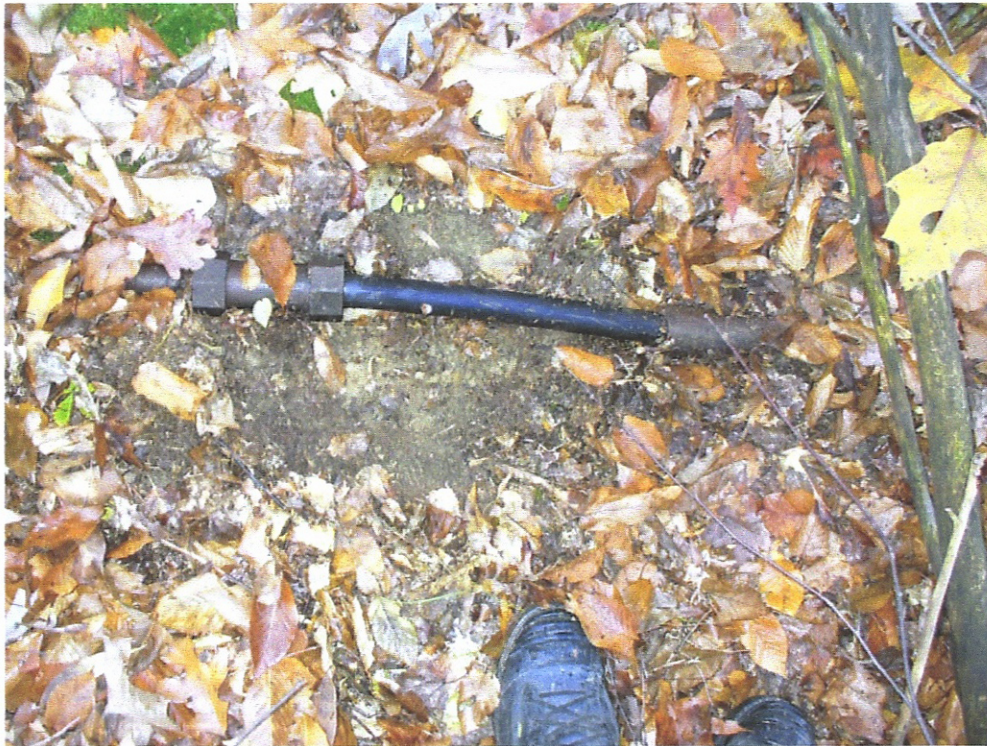
Photo 3:
A Two Foot Break In Trubie Run Gas Line
And Spliced With Plastic Gas Line

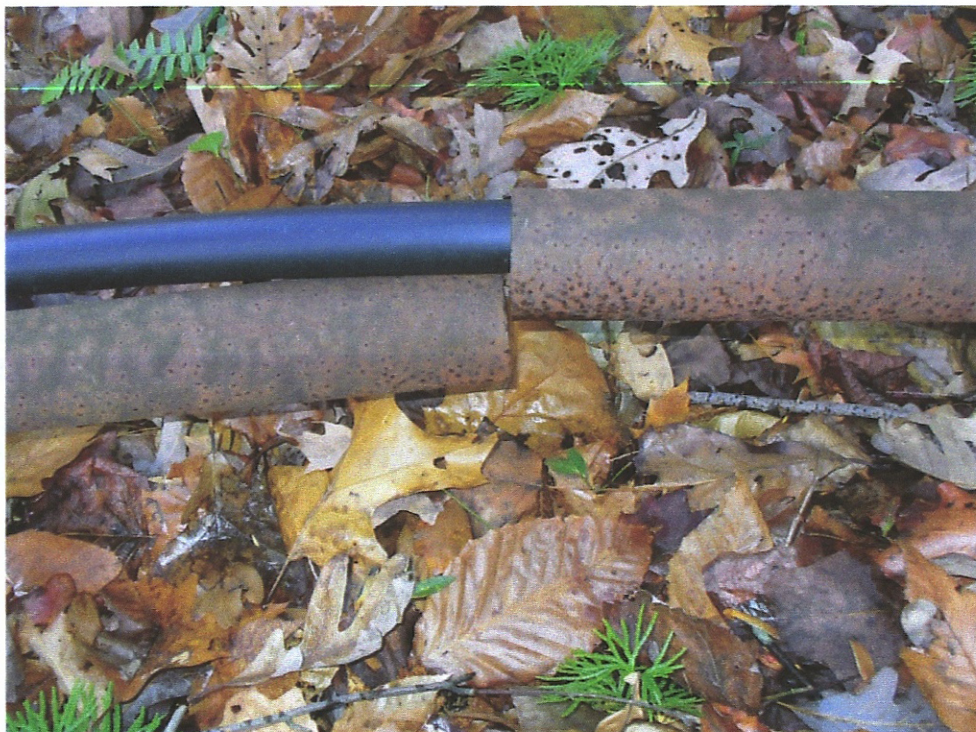
Photo 4:
Break In Trubie Run Gas Line
And Spliced With Plastic Gas Line
