**WEST VIRGINIA OFFICE OF MINERS' HEALTH, SAFETY AND  
TRAINING**

**REPORT OF FATALITY**

**Fall-Elevated Work Place**

**Ohio County Mine Preparation Plant**

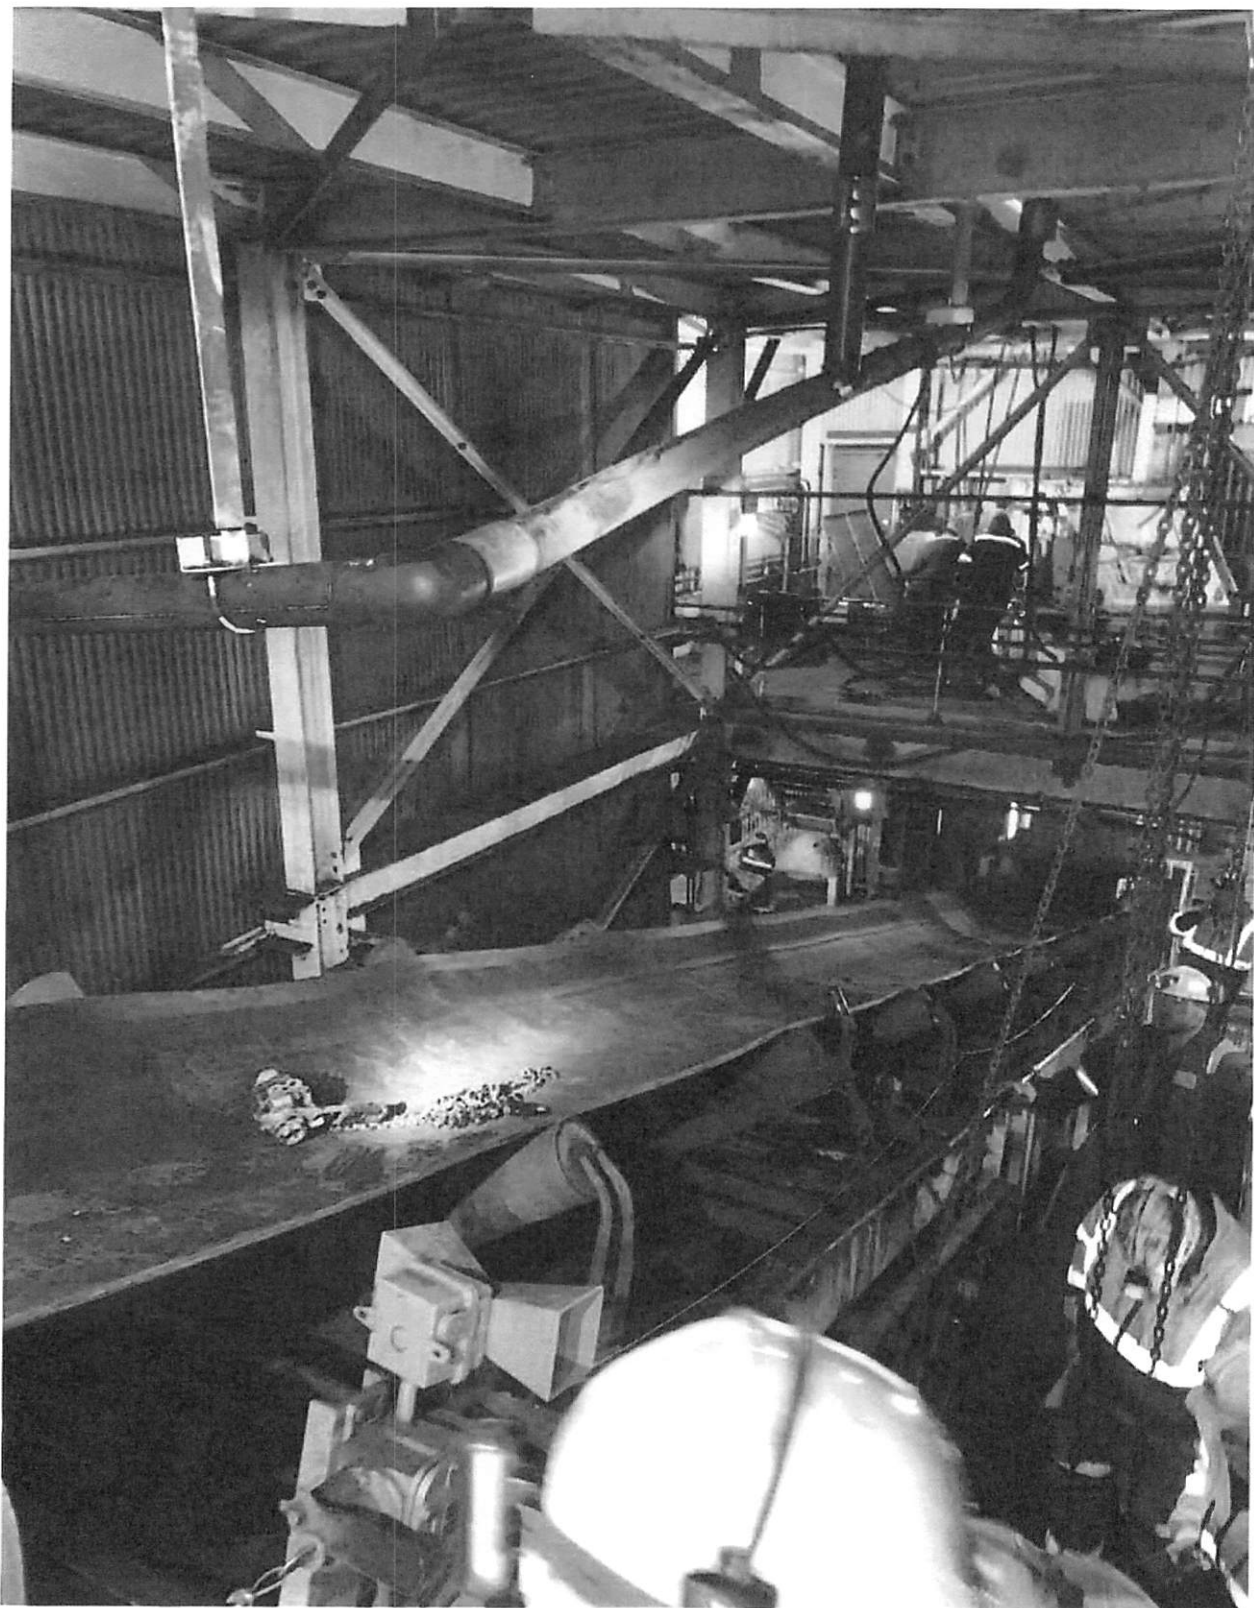
Photo of the working location on 400 belt

19. At least two (2) distinct sets of boot prints were observed on top of the 400 belt at the accident scene.
20. A chain hoist with grease/oil on the chain was laying on the belt in the approximate location of the fall. Boot and chain skid marks on the belt were observed at this location.

Mr. Phillips received fatal injuries when he fell from the 400 belt at the Ohio County Mine Preparation Plant. Mr. Phillips was observed standing on top of the belt and was not wearing fall protection. Mr. Phillips fell approximately twenty-eight (28) feet landing on the concrete of the fourth floor.
