REPORT of INVESTIGATION into the MINE EXPLOSION at the UPPER BIG BRANCH MINE

APRIL 5, 2010

BOONE / RALEIGH CO., WEST VIRGINIA

**WEST VIRGINIA OFFICE of MINERS' HEALTH,
SAFETY & TRAINING**

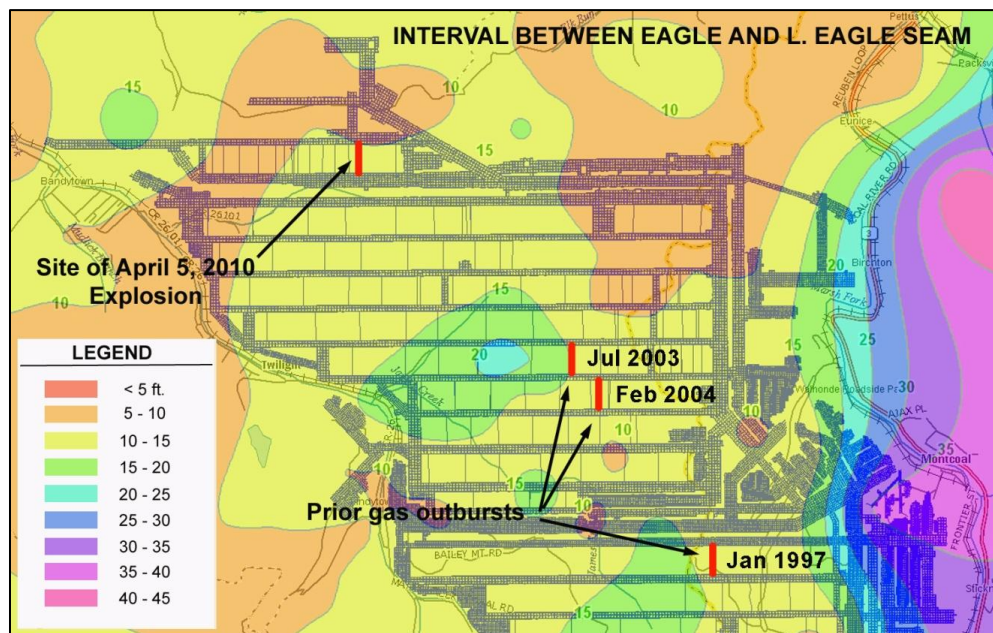
Map 2. *Interburden Isopach Map* showing the thickness (feet) of rock between the Little Eagle seam and overlying Eagle seam. Approximately 10 to 15 feet of interburden separates the Eagle and Little Eagle seams where gas events have occurred.

The thickness in the rock interburden between the Eagle seam and the Little Eagle seam is shown in **Map 2**. The location of the active longwall on April 5, 2010 and during the three prior gas

events were where intervals between the Eagle seam and the underlying Little Eagle seam were approximately 10 to 15 feet. This is in the mid-range of interburden thickness, with the low range being 5 to 10 feet and the high range being 15 to 25 feet. All things being equal it would be logical for the thinner interburdens to be more easily ruptured by abutment stresses, allowing gas from below to enter the mine. However, there was little longwall mining where the interburden is less than 10 feet thick. Also, the spacing of core holes may exceed the frequency of variations in the interburden thickness, and predicting such small changes may not be of practical benefit.

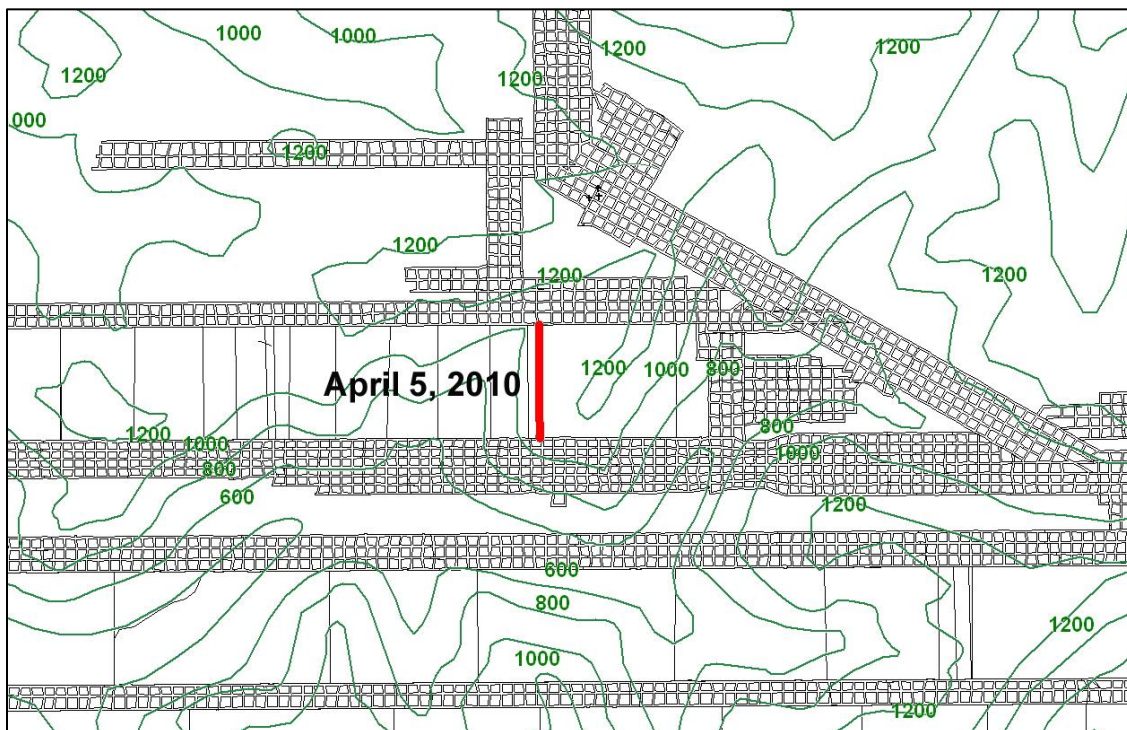
The depth of cover on April 5, 2010 was approximately 1,000 to 1,050 feet. The three (3) documented gas events at UBB, (1997, 2003, and 2004) were associated with longwall mining where the depth of cover exceeded 800 feet. The gas excursion that occurred in 2004 occurred at a cover depth 1,000 to 1,250 feet, and this is the same range that existed at the time of the event in 2003. The shallowest cover appears to be during the 1997 event, where cover depths were approximately 800 to 900 feet. These trends are further illustrated in **Maps 3A, 3B and 3C**.

Map 3A. The depth of cover over the Longwall on April 5, 2010 was 1,000 to 1,050 feet.

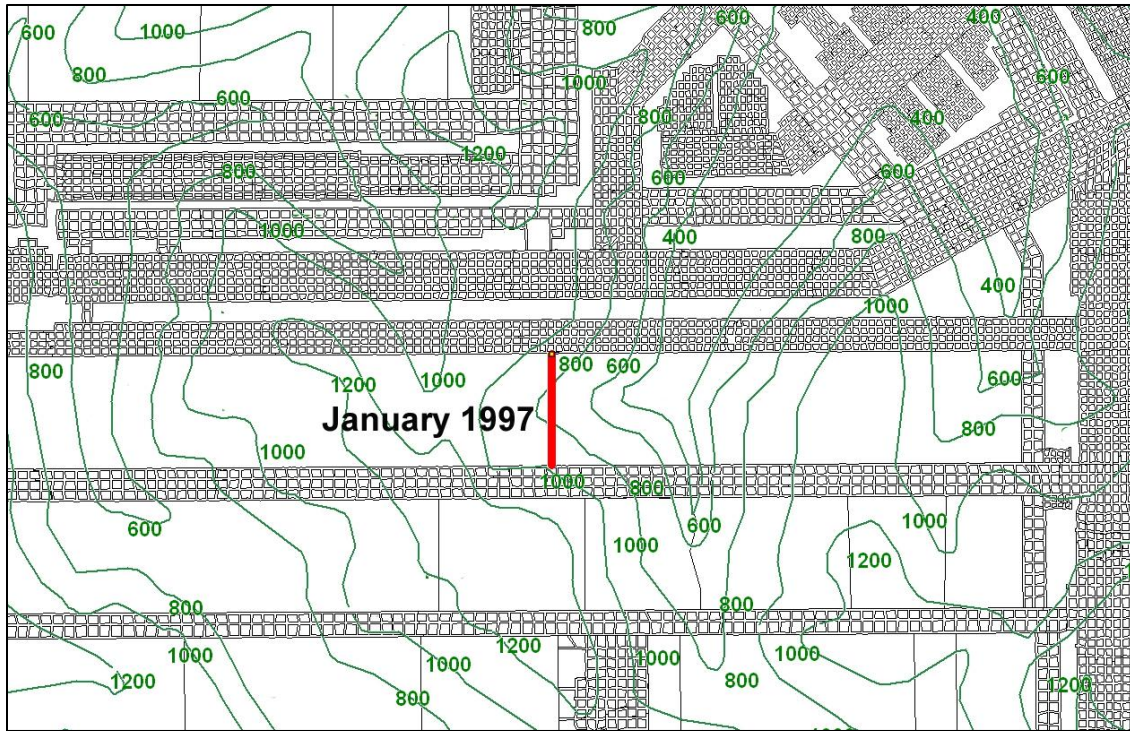
MAP 3B. The depth of cover over the Longwall on January 4, 1997 was 800 to 900 feet.

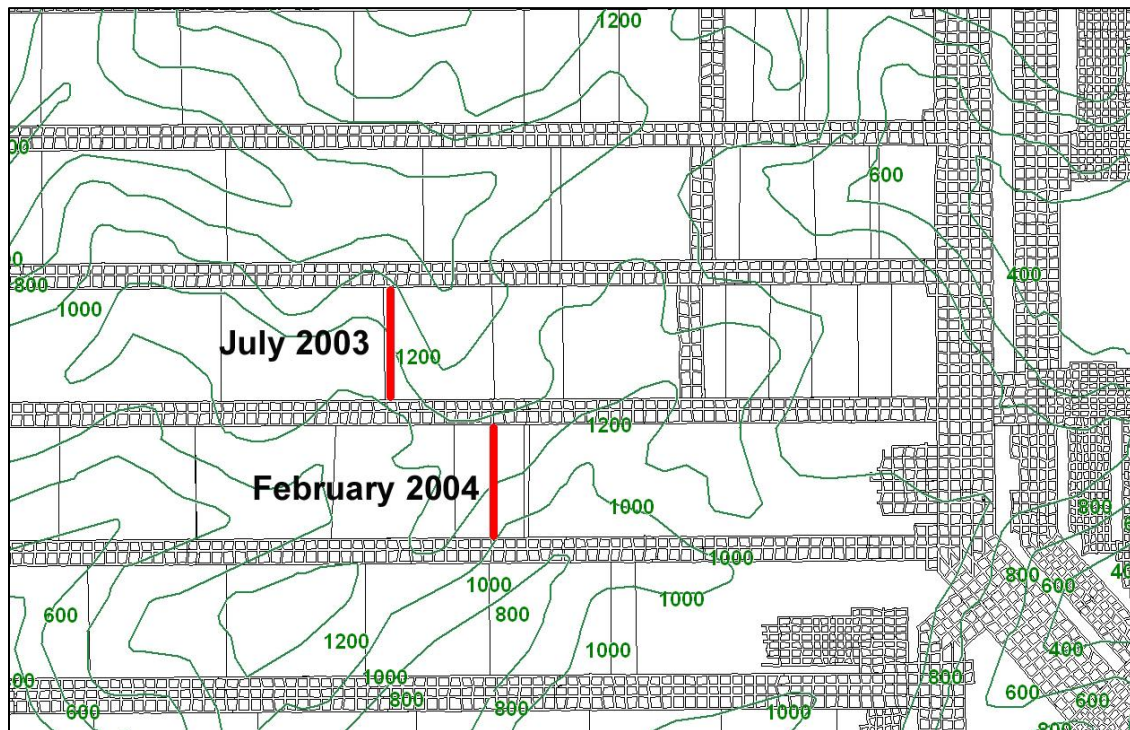
MAP 3C. The depth of cover over the Longwall on July 4, 2003 was 1,000 to 1,250 feet. The depth of cover over the Longwall on February 18, 2004 was also 1,000 to 1,250 feet.

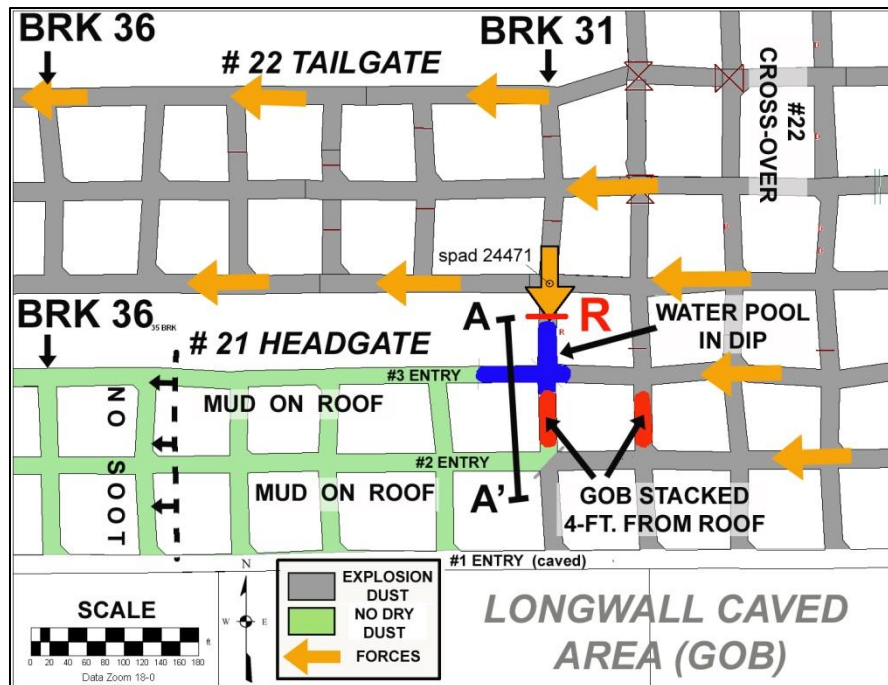
Figure 2. West of the #22 Cross-over explosion forces entered #21 Headgate from the North, via the regulator at BRK 31 (also the location of evaluation point EP-65). Upon encountering the water-filled dip in the #3 entry, water was picked up and dispersed into the #2 entry, where flame was extinguished and explosion propagation subsided to extinction.

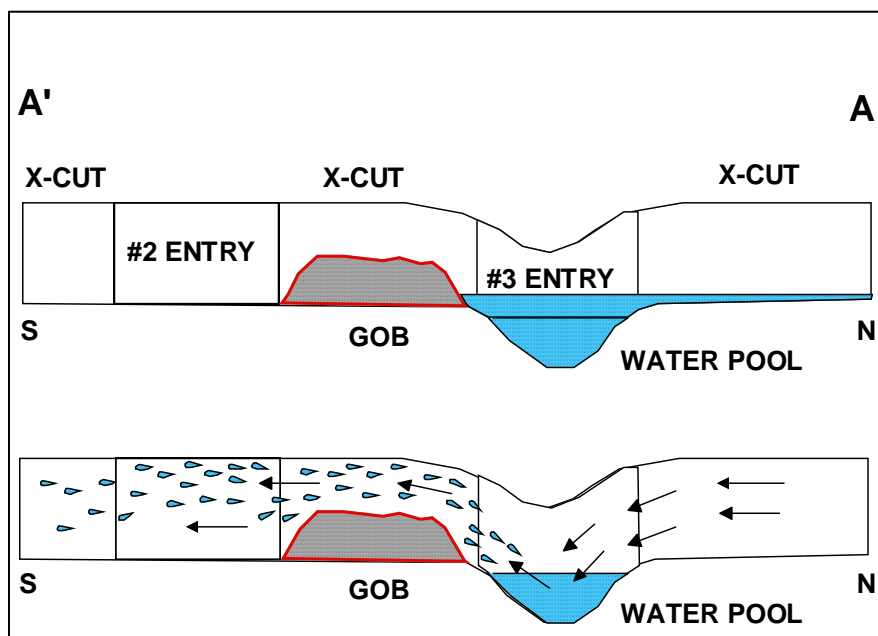
Figure 3. Profile view along A-A' (looking West) showing how the explosion forces from the north are thought to have picked up water and dispersed it across the gob in the crosscut to between #3 and #2 entries. The mine roof and roof bolts were coated in mud west of BRK 31, and explosion forces quickly subsided to extinction, in by (west toward the exhaust fan located at Bandytown).

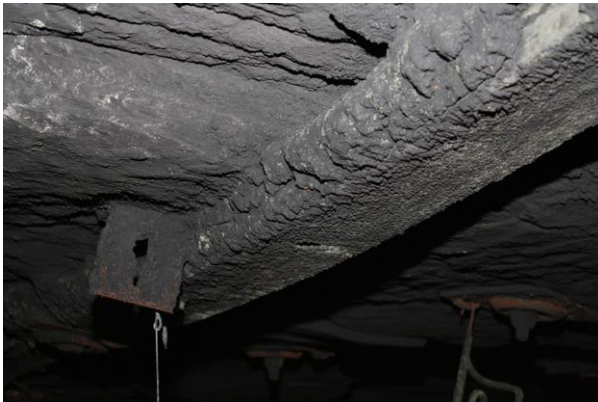
In the western half of the #21 Headgate between the #21 Cross-over and the #22 Cross-over the path of the explosion was east-to-west, with the leading edge following the north solid rib (the #5 entry). West of the #22 Cross-over the 5-entry system of #21 Headgate dropped the two entries on the right (north), and became a 3-entry system. A parallel set of 3 entries just to the north had been started a few weeks before the explosion (#22 Tailgate). Because of the northern location of the explosion's leading edge the first arrival of explosion forces west of the #22 Crossover entered #22 Tailgate first, then at BRK 31 (see **Figure 2**) entered #21 Headgate through a connecting crosscut. These forces traveled south, crossing a water-filled depression and a gob pile³, dispersing water into the crosscut to the south and into the #2 entry. An instant later, explosion forces from the east entered this same water hole through the #3 entry, and also entered the open, unobstructed #2 entry.⁴ Rather than impacted dust on roof structures, the dust was deposited as thick mud (see **Figure 4A, 4B**).

Figure 4A. (LEFT) Impacted “mud” on east side of header board across entry #2, between BRK 32 and 33, and about 70 feet inby spad 22806.

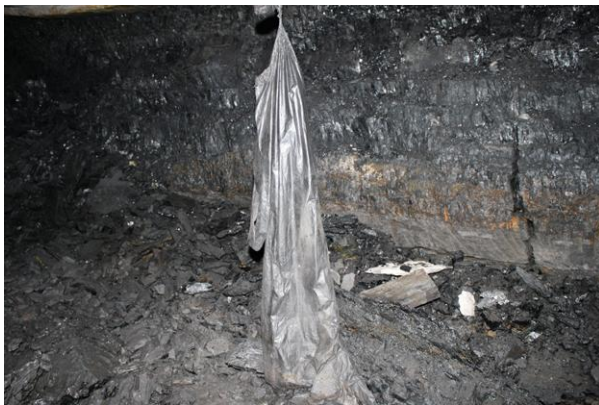
Figure 5A. (LEFT) A plastic trash bag hung from a roof bolt; crosscut between #2 and #3 entries, at BRK 35, (view looking north), being just inby spad 22806.

From this and other evidence investigators concluded that the explosion forces subsided to extinction in #21 Headgate between break 31 and break 35.

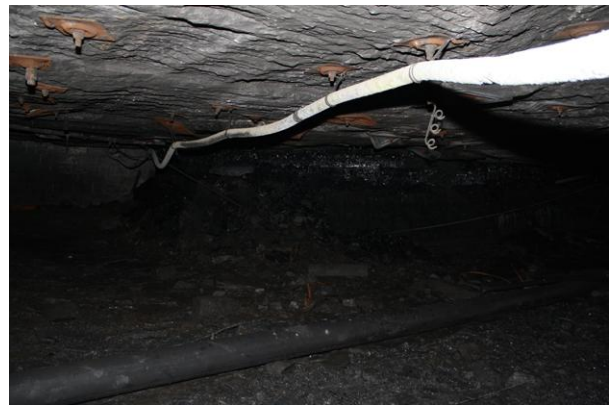
Figure 5B. (RIGHT) A 2.5 inch diameter plastic rock dusting hose stretched across entry #2; BRK 34, (view looking north), being also at the intersection of spad 22828.

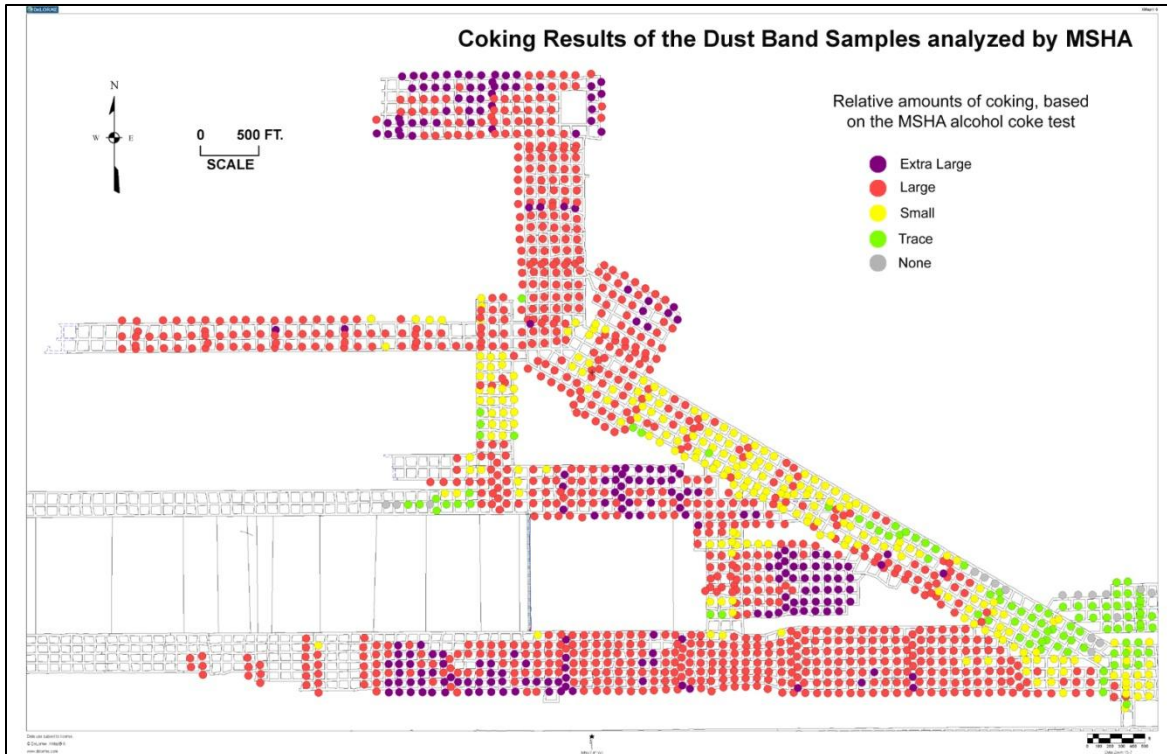
Map 1A. Results of MSHA dust band sample analyses (first round); Coke Content

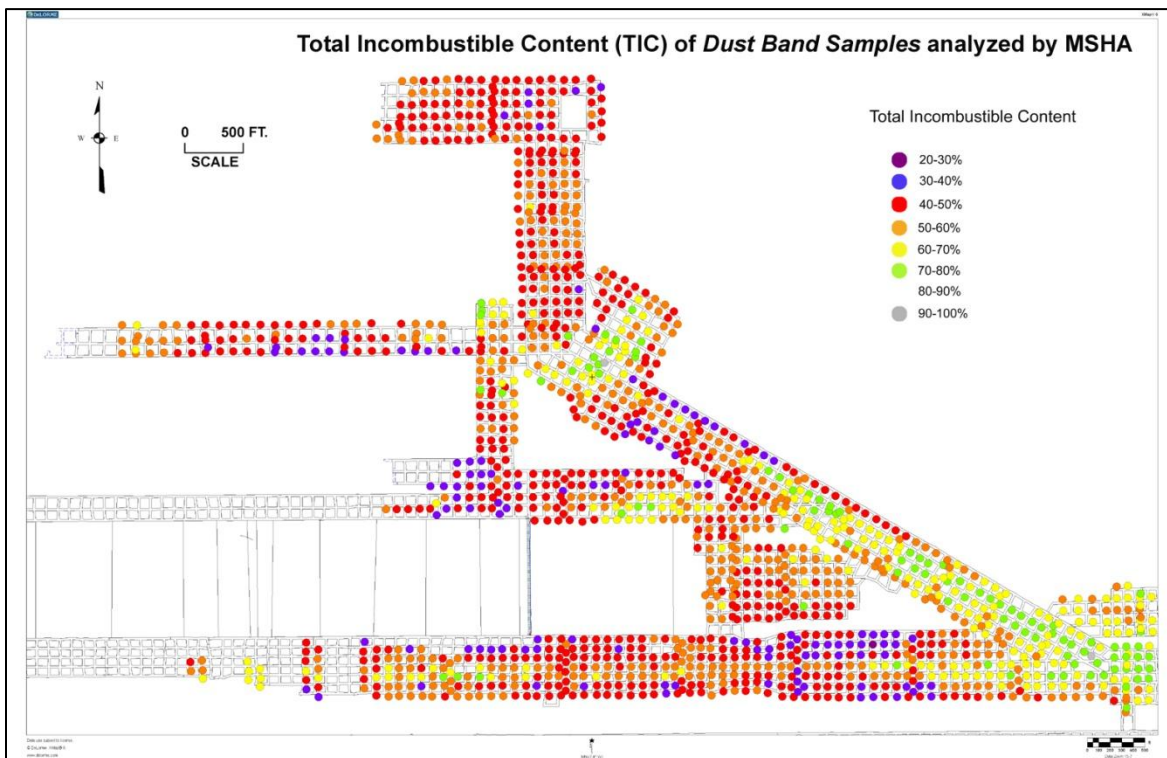
Map 1B. Results of MSHA dust band sample analyses (first round); Total Incombustible Content

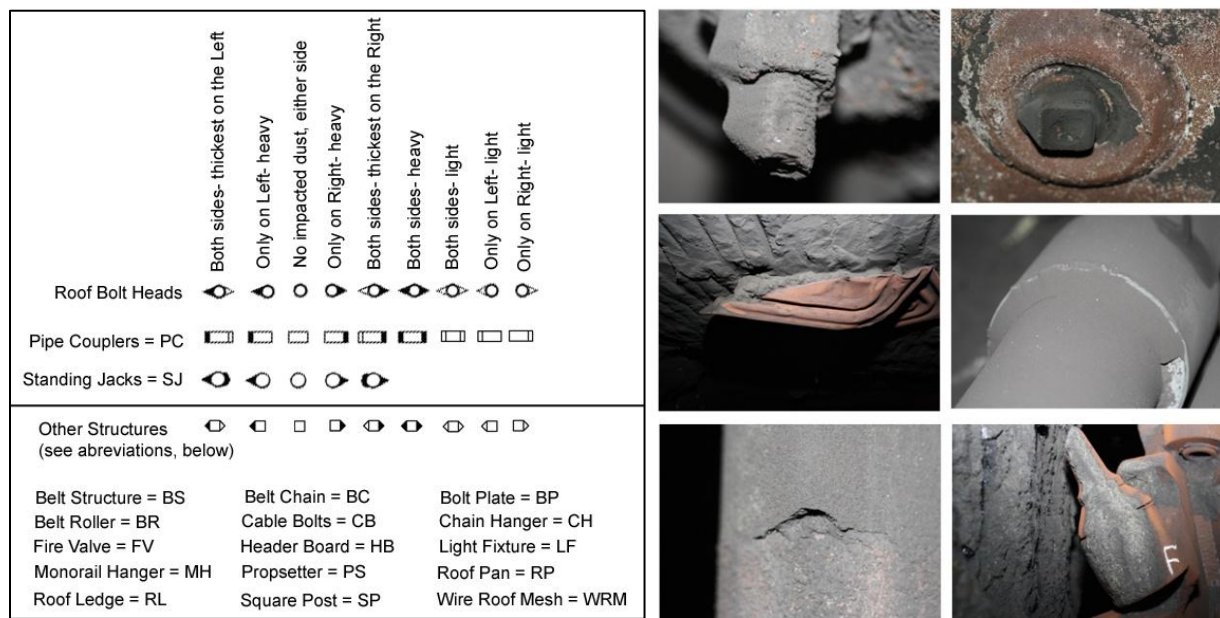
Figure 2. (LEFT): The map symbols shown were used in the *West Virginia Flames and Forces Map* to depict the orientations and size of impacted dusts deposited on protruding or standing structures by explosion air currents. (RIGHT): Some examples of impacted dust deposits on roof bolt structures, a pipeline coupler, a standing jack, and a shear bit.

Small cylinders of approximately ¾-inch diameters (such as the protruding, threaded heads of torque tension roof bolts) often had dust accumulations on two sides--one side heavy, the other light. Cylinders that were larger than about 1.5 inches (such as sand jacks) tended to have a single longitudinal wedge on one side, and a thin dusting on ½ circumference of the opposite side, with clean zones separating the wedge from the region of thin dust (see **Appendix 7.9-3**).

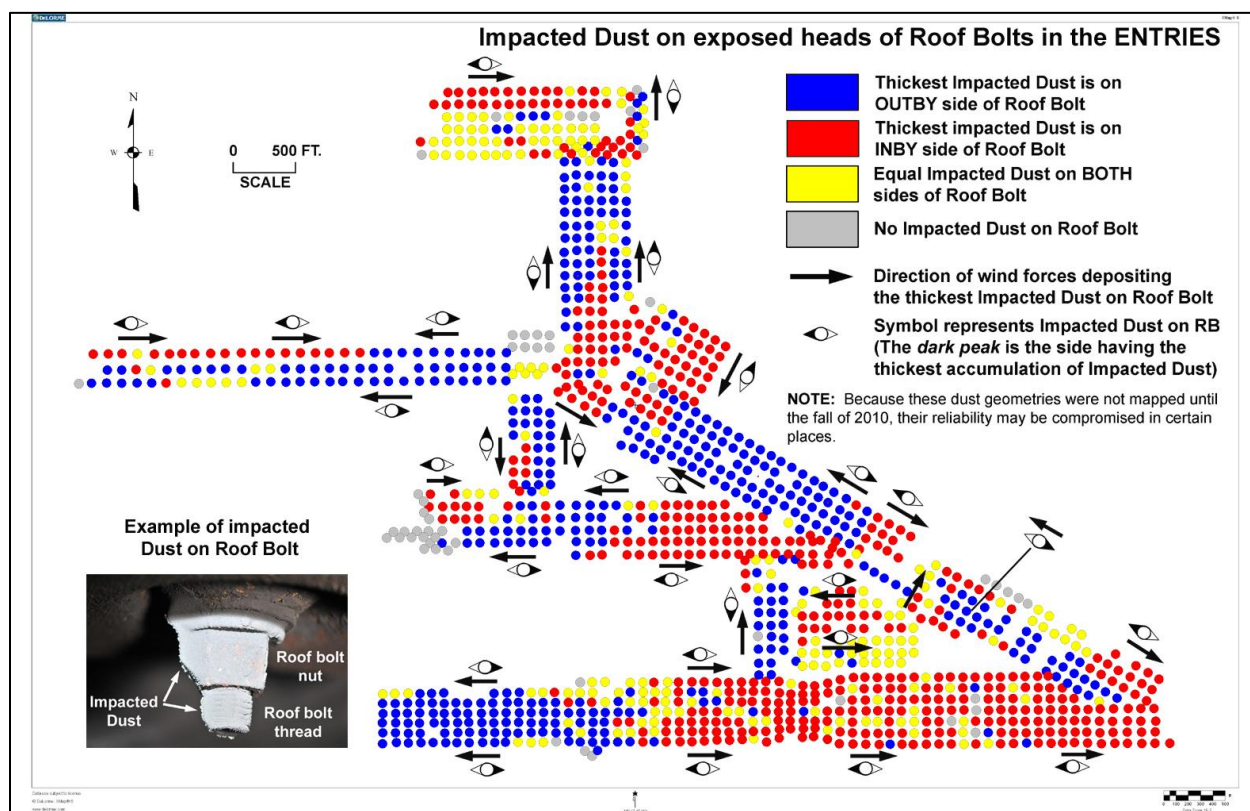
Map 2. This is a summary map of impacted dust deposits which formed on roof bolt heads. The relative thickness and geometry of the impacted dust deposits are determined and plotted to delineate deposition trends. Progressive deterioration over time somewhat compromised the effort to accurately document them.

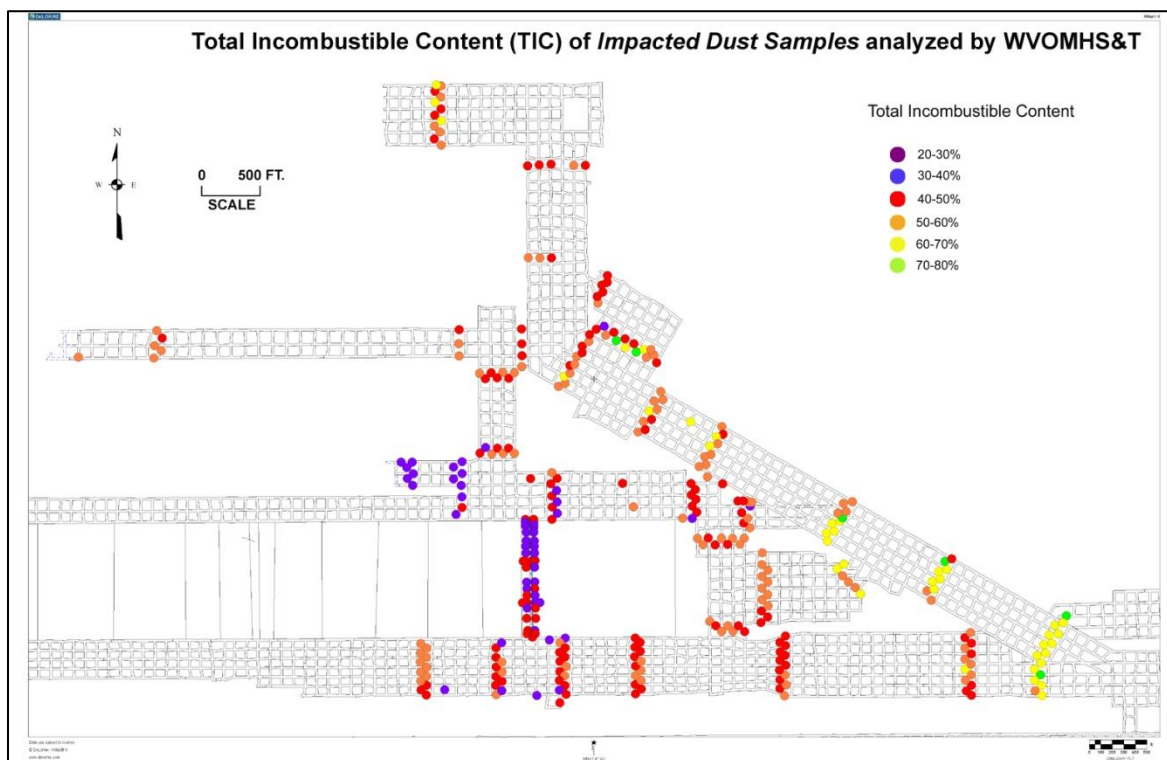
Map 3B illustrates the results of the total incombustible content (TIC) performed on post-explosion impacted dust samples, using the low-temperature ash testing procedure (LTA),¹⁰ which is fundamentally the same test procedure used by MSHA for the band sample testing. The TIC analyses of the MSHA dust band samples (see **Map 1B** and **3B**) and WVOMHS&T impacted dust samples are similar.

Map 3B. WVOMHS&T impacted dust sample results: Total Incombustible Content (TIC)

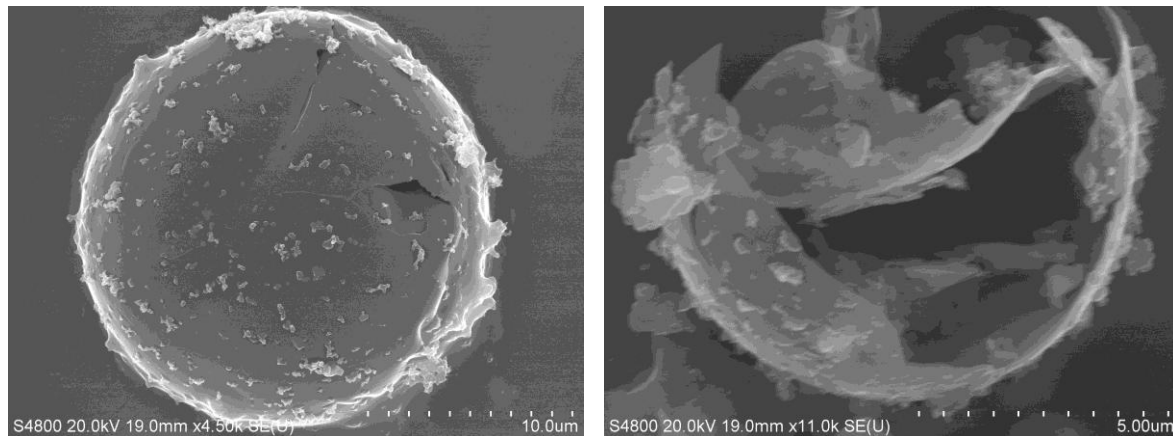
Figure 4. (LEFT) Microscopic, hollow ash rich spheres (cenospheres) are formed during high temperature coal combustion. (RIGHT) The fact that they have thin shells and are hollow is diagnostic. These samples came from the impacted dust samples collected in the explosion region. All of the samples examined contained some cenospheres.

Cenospheres were found in the impacted dust samples from shield cylinder legs and other structures on the Longwall, although their numbers were fewer than for samples collected and examined from other locations across the explosion region of UBB. Coking was generally absent on the Longwall, except between shields 41 and 72 and in the headgate and tailgate areas. Incombustible content was very low along the length of the Longwall. Together, these data suggest that relatively minor amounts of dust were brought in from outside the Longwall during the explosion. For details of the SEM examination for cenospheres by NIOSH: (see **Appendix 8.2-3** and **8.2-4**)

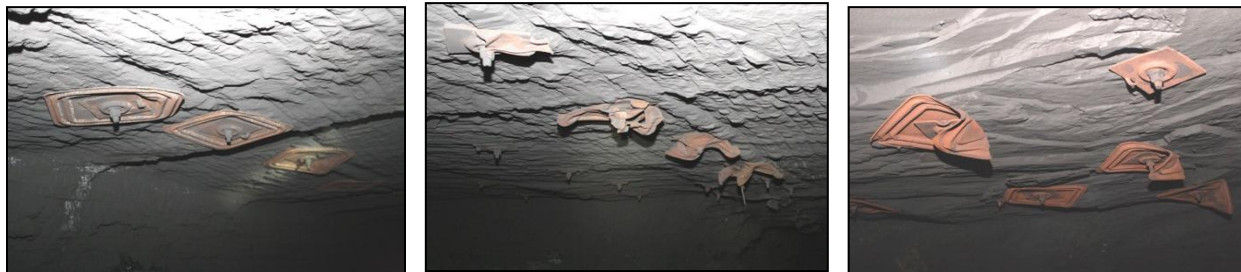
(a) **NO pan bending:** The GRAY regions shown in **Map 1** indicate where pan bending did not occur (see **Figure 5**).⁵ These are relatively quiet areas of the mine, in which comparatively less damage occurred.

Figure 5. (Left) An example of “NO PAN BENDING.” Pans bent < 90 degrees.

Figure 6. (Middle) An example of “SEVERE PAN BENDING.” Generally, 10 or more pans bent >90 degrees were in this category⁶. The mangled style was more diagnostic than the numbers.

(b) **SEVERE pan bending:** The RED regions in **Map 1** are used to indicate high numbers of bent pans and severe pan bending (**Figure 6**). Usually this involved 10 or more pans bent in one equivalent line of roof bolts, between the two adjacent intersections. Such severe pan bending was found in regions where severe damage to other structures was evident, and was where high flame speeds and/or high reflected pressures were involved. These occurred at physical obstructions, such as dead ends caused by roof falls or the farthest point of mining advancement. They also occurred at “T” intersections such as the junction of #21 Tailgate with #21 Cross-over, and also #22 Tailgate with #22 Cross-over. A third place they occurred was in the middle of #22 Headgate and #9 North, where the northern entries were playing catch-up and then overtaking

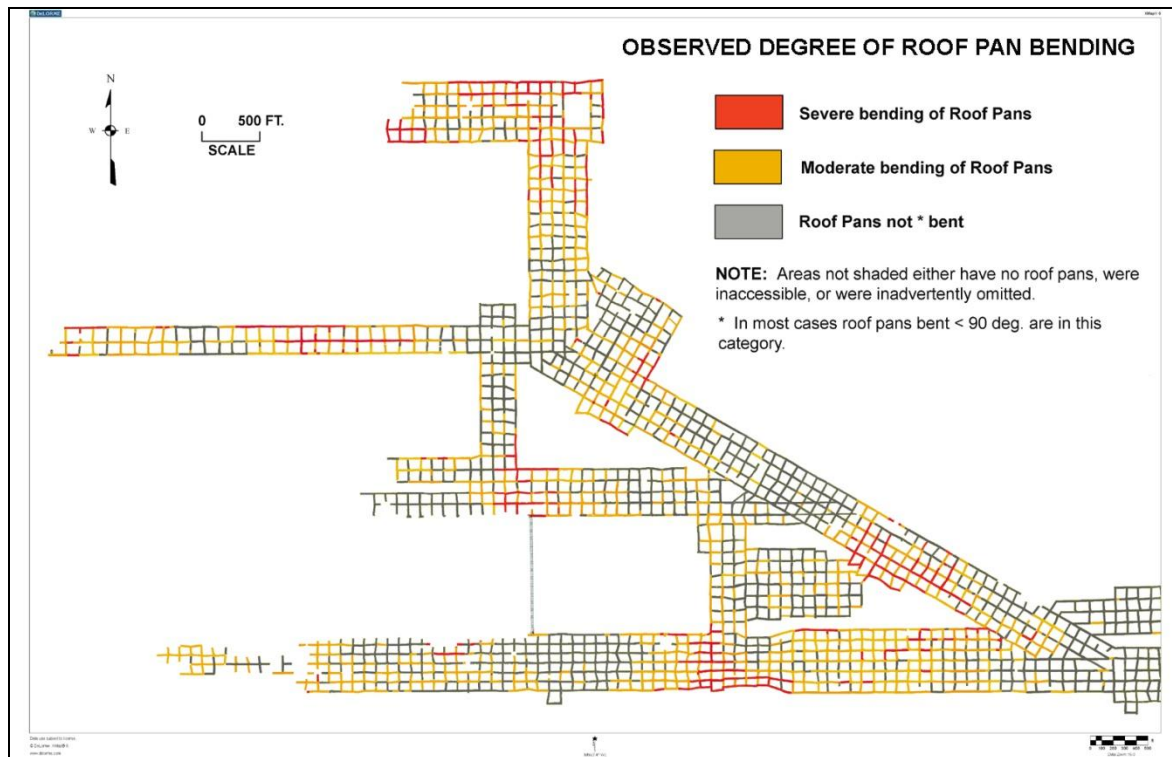
A 3-color classification was adopted for depicting the observed relative degrees of *pan bending* using a solid background fill pattern. A simplified version of the compiled map is shown in **Map 1**, and summarized as follows:

Map 1. The relative degree of “Pan Bending,” summarized from the *WV Flames and Forces Map*.

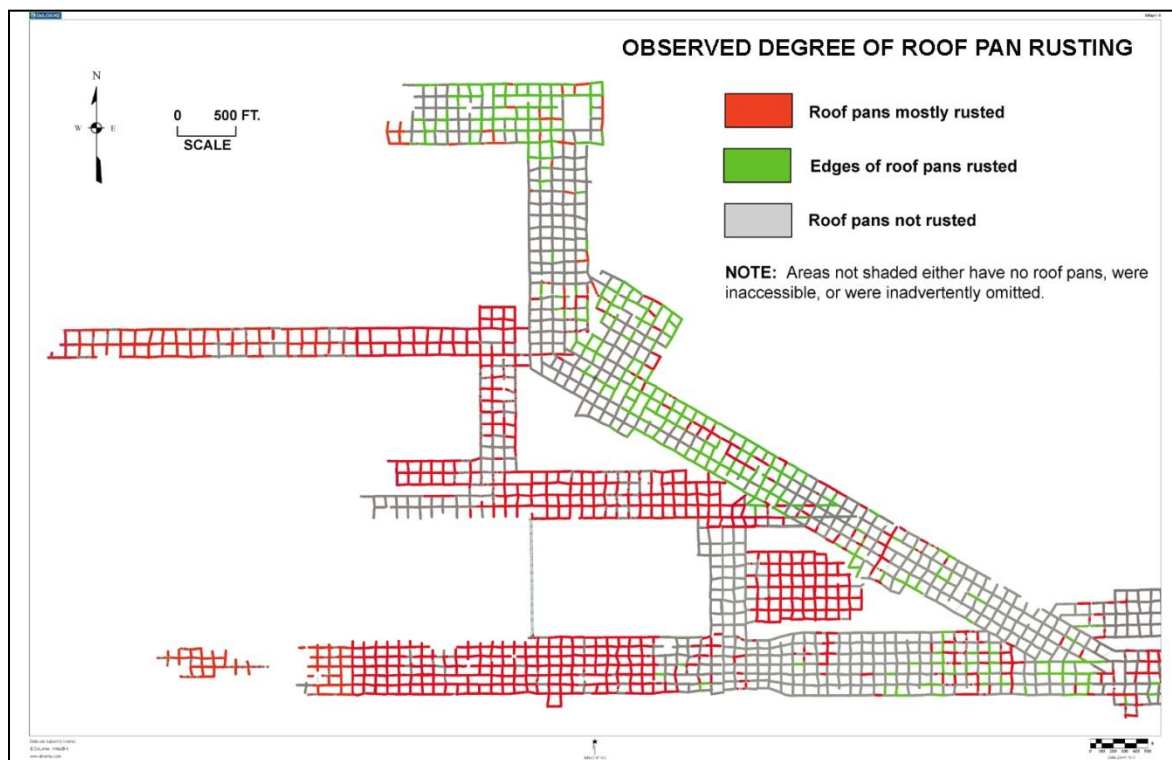
Map 2. The relative degree of “Pan Rusting,” summarized from the *WV Flames and Forces Map*.

From the start of the investigation in July, 2010, many of the moderately to severely damaged pans already developed a reddish-brown patina due to erosion of their galvanized finish. As the investigation progressed, the pans in several areas which had been mapped originally a few months earlier as “no rusting” had begun to develop rusted edges.

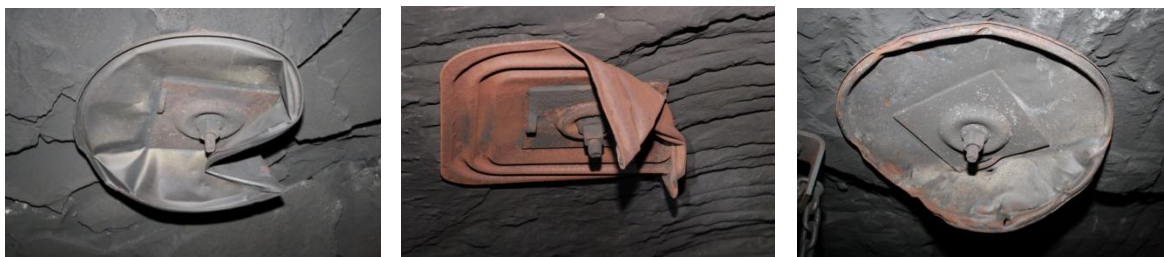
(a) **NO Rusting:** Pans which are not rusted (**Figure 8**) are indicated in GRAY. In general, pans that were not rusted were not bent or were moderately bent. There were just a few examples where severely bent pans were not rusted.

(b) **MOSTLY** or entirely **RUSTED:** The color RED is used to indicate pans that are mostly or entirely rusted (**Figure 9**). Pans that were severely bent were usually rusted, although there are a few examples where this was not the case.

(c) **EDGES** of pans, only **RUSTED:** The color GREEN is used to indicate when most of the pan itself is not rusted, just the exposed edges (**Figure 10**). Over time, some of the areas that were originally mapped as “not rusted” began showing effects of edge rusting. This category represents a transition between (a) and (b), above.

Figure 8. (Left) An example of a roof pan Not Rusted **Figure 9.** (Middle) An example a roof pan Mostly or Entirely Rusted. **Figure10.** (Right) An example of a roof pan with Edges, Only Rusted

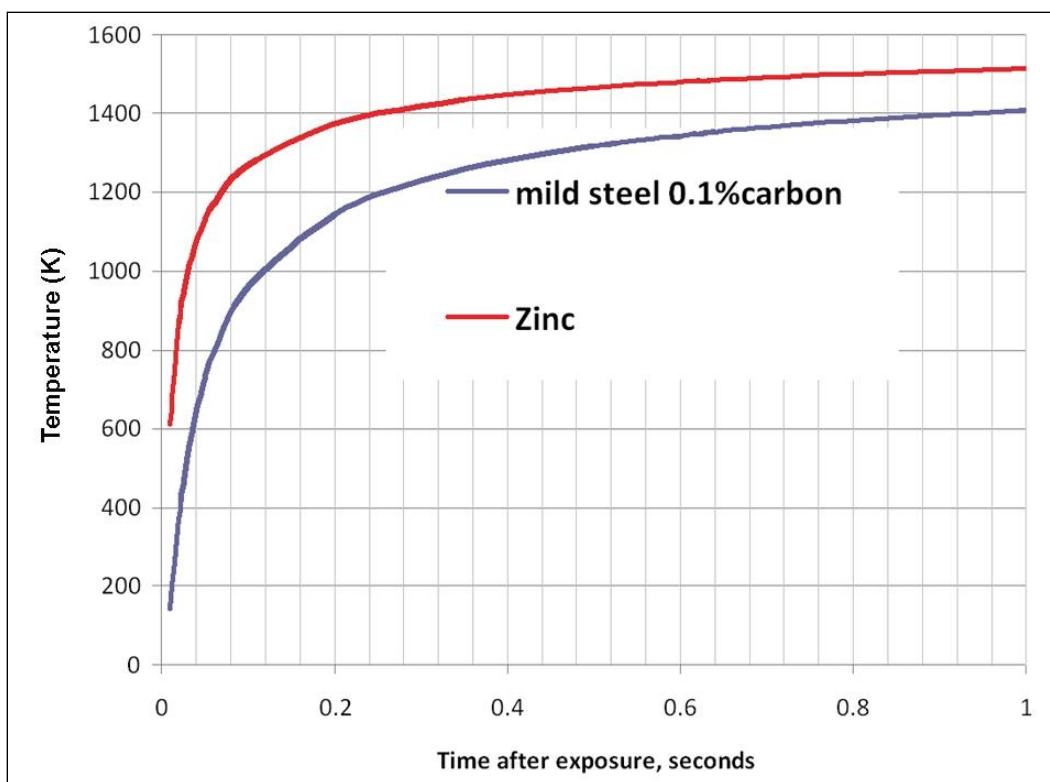
Assuming the pans were exposed to a temperature of 1,627° K, investigators estimate the time required to reach the temperature necessary to destroy the rust-preventative coating on the pan. It was determined that such reactions were possible, but additional research is needed to validate this theory.

Figure 12. Temperature rise in a 0.08 cm thick plate with time. Plate is assumed heated by a constant temperature of 1627 K, and the curve represents temperature rise with time for zinc and steel.

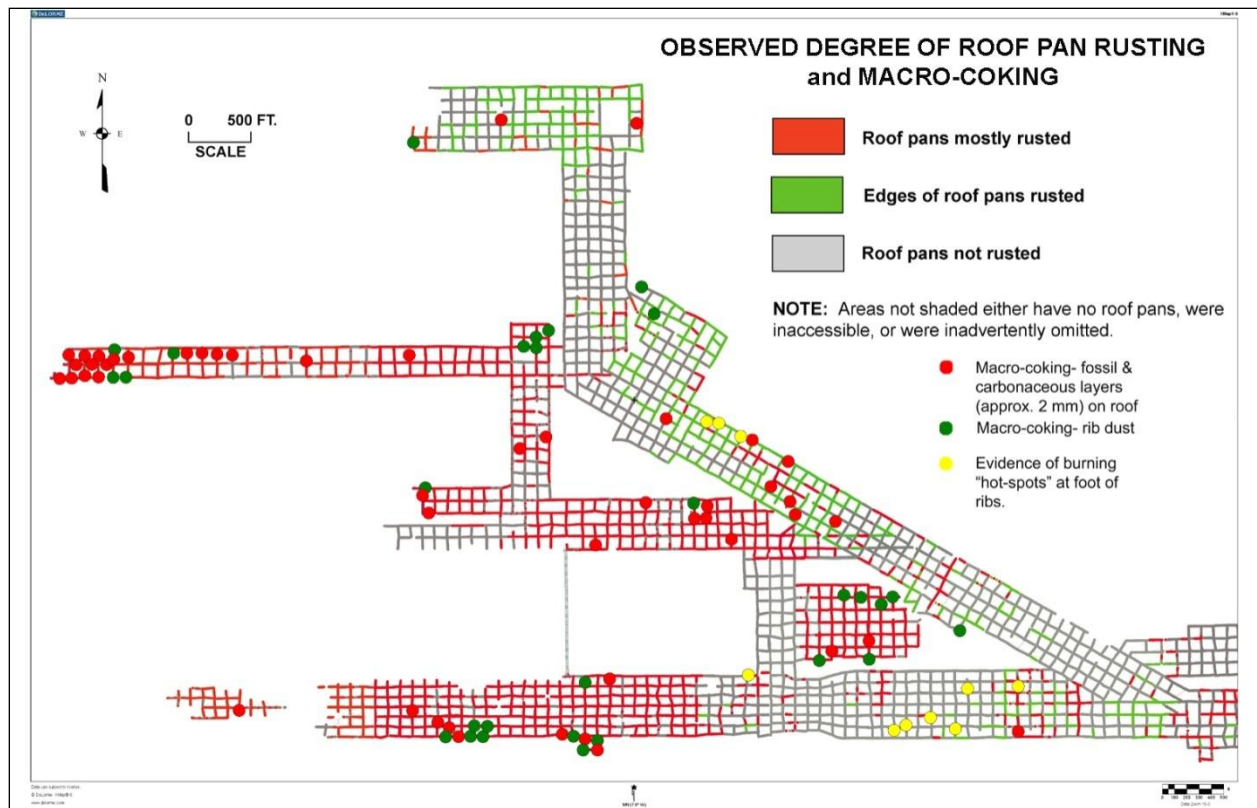
There is a possible correlation between macro-coking and pan rusting (see **Map 3**). Macro-coking is defined here as coked coal textures that are visible to the naked eye, occurring when particles and/or thin carbonaceous layers on the mine roof, ribs, or floor are exposed to flame of extended duration. Virtually all of the locations where macro-coking of the roof and ribs was observed the pans were either rusted or had edges rusted. Similarly, where the pans were not rusted, macro-coking evidence was not found (see **Map 3**). This could be indicative of either a stronger flame, slower flame, flame in proximity to the perimeter surfaces rather than down the middle of the mine opening, or a combination of the above.

Map 3. Where macro-coking of roof and/or ribs was observed, pans were either rusted or had their edges only rusted. Areas where the pans were not rusted did not have macro-coking.

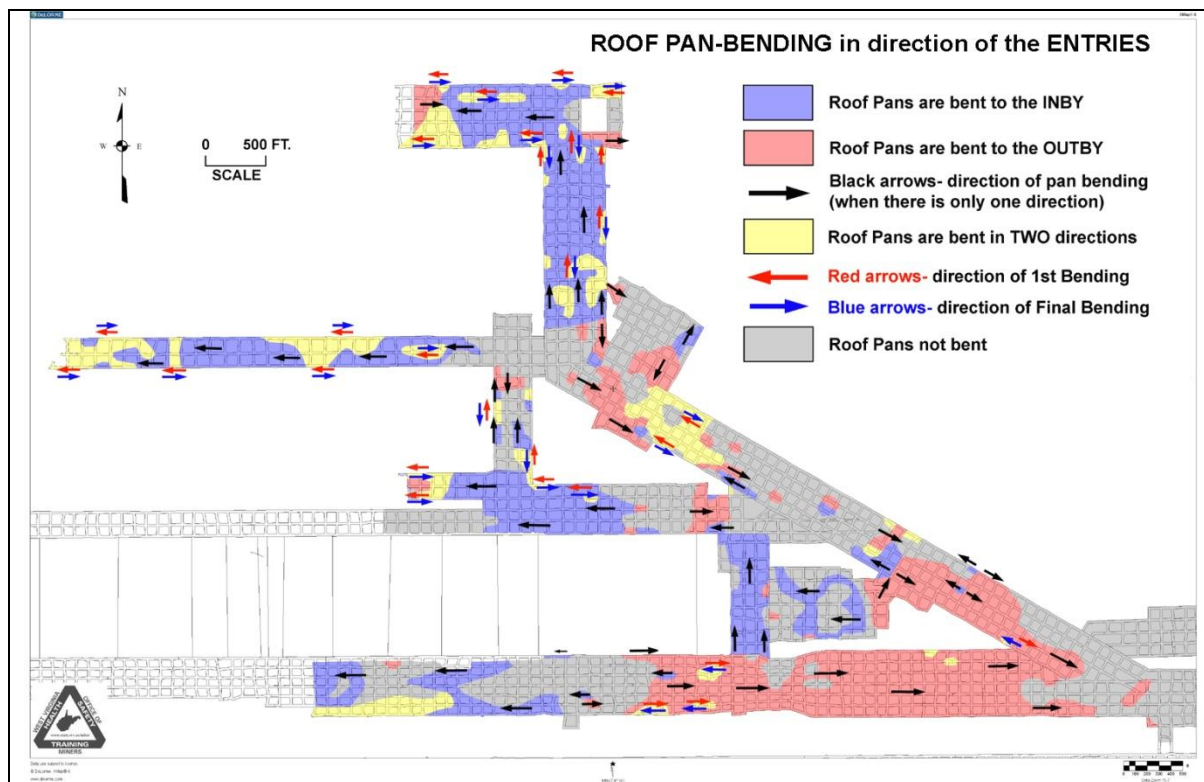
Areas shaded in blue and red in **Map 4A** and **4B** indicate where unidirectional bending occurred in the inby and outby directions, respectively. The black arrows are added to help clarify the indicated bending trends. The areas shaded in gray are regions where pans were not bent. The yellow shaded regions indicate where roof pans were observed to be bent in two directions—some one way, some the other way, some both ways.

Map 4A. "Pan Bending" in the "ENTRIES"; summarized data from the *WV Flames and Forces Map*

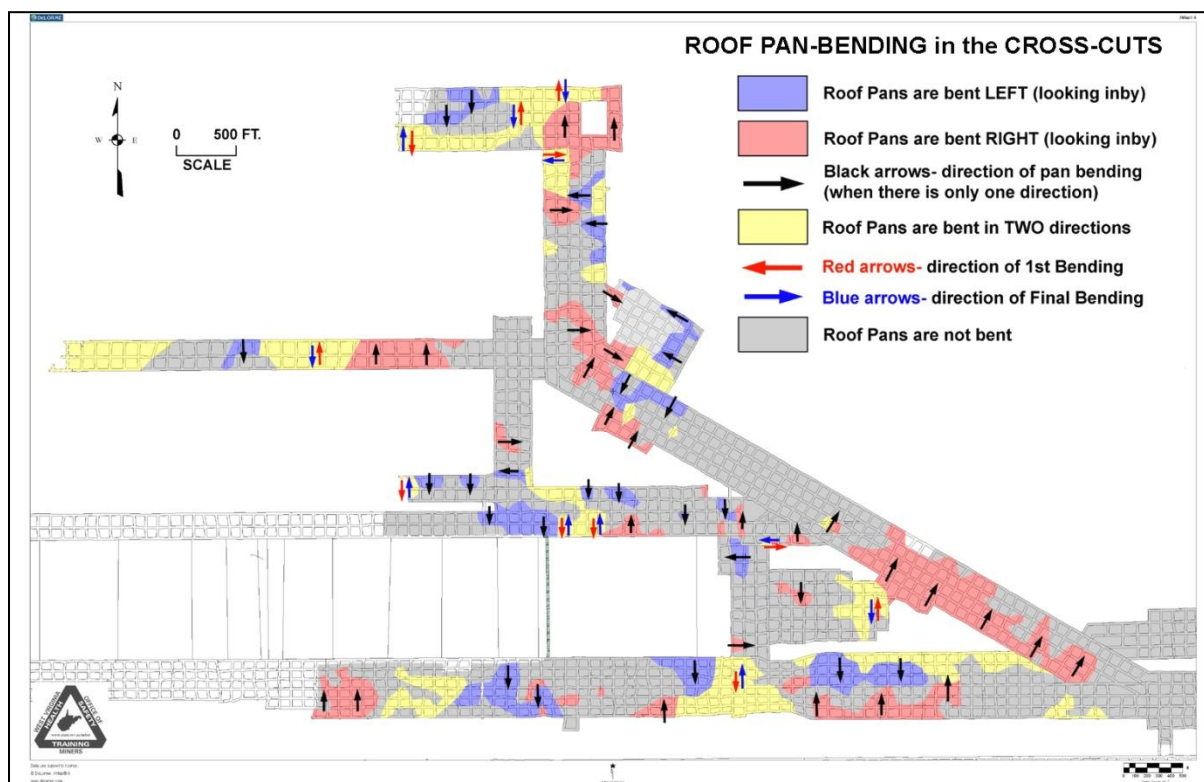
Map 4B. "Pan Bending" in the "CROSSCUTS"; summarized data from the *WV Flames and Forces Map*

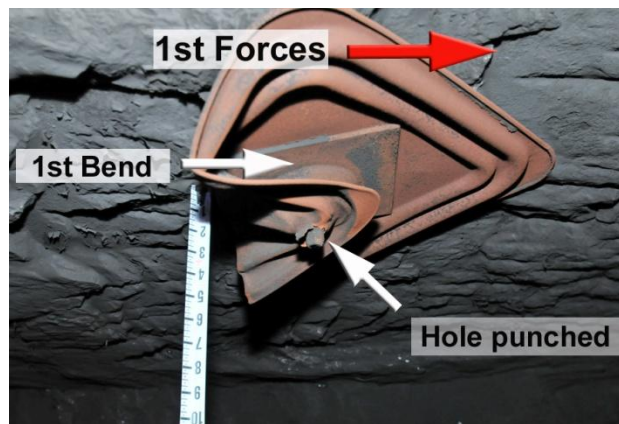
Figure 13. An example of pan bending from 1st Forces. Where threaded bolt heads protrude more than 1” below the bolt plate, a hole is often punched through pan on impact.

Examples are shown in **Figure 13** and **Figure 14**, where a hole is first punched through a square pan as it was bent initially over the end of a *torque tension roof bolt*. If subsequent wind forces were sufficient to remove the “hole-punch” from its impaled position, it might dislodge the “hole-punch” and return the roof pan always in regions where other pans were similarly bent, or alternately bent just one way or the other (the yellow regions in **Map 3A** and **3B**).

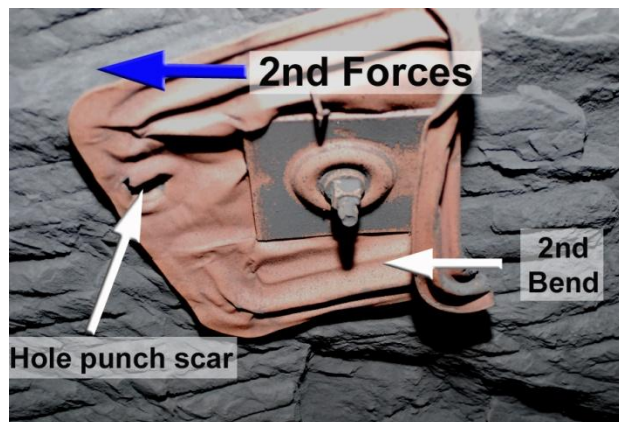
Figure 14. An example of pan bending by 2nd Forces. Hole-punched pan is straightened back.

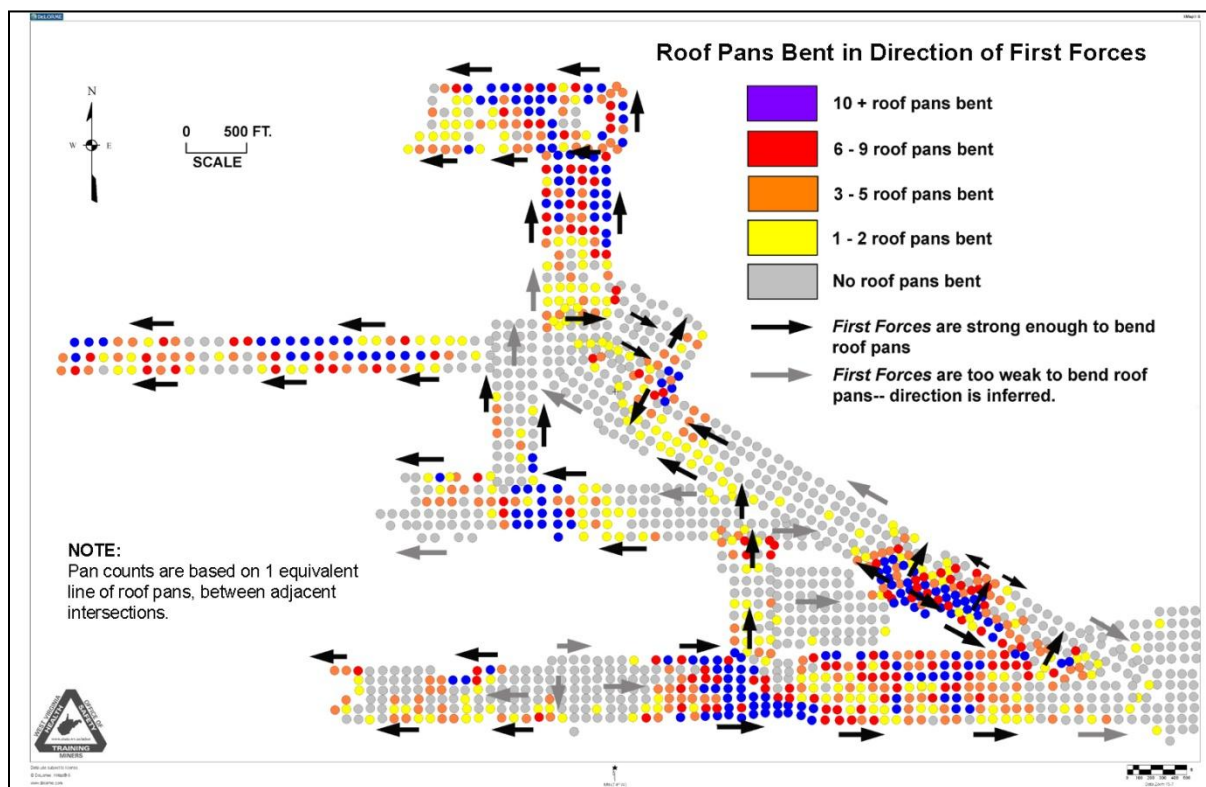
Map 5A. Pan Bending by First Forces; summarized data from the *WV Flames and Forces Map*

The regions indicated in gray represent areas where roof pans were not bent. The colors yellow, orange, red, and violet are used to indicate where pans are bent and their frequency (pan counts), which gives a relative indication of explosion pressures across the mine.

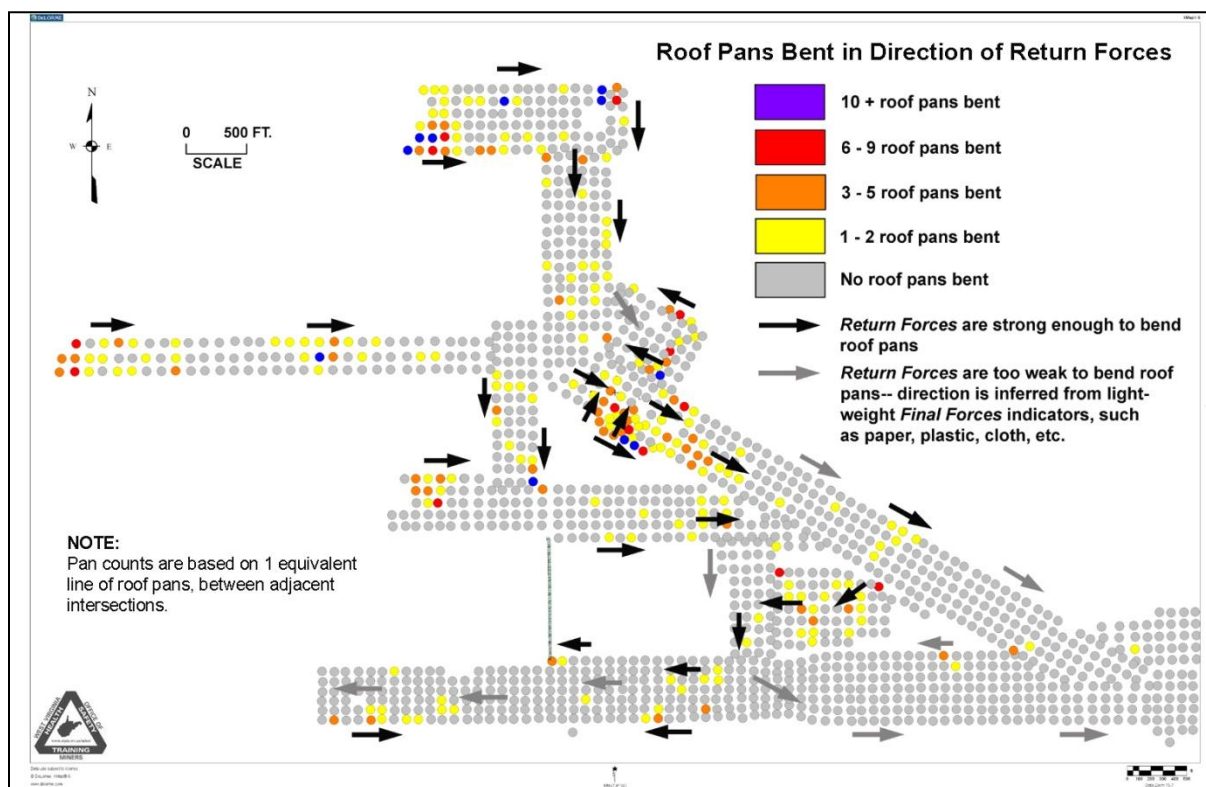
Map 5B. Bending by Return Forces; summarized data from the *WV Flames and Forces Map*
