REPORT of INVESTIGATION into the MINE EXPLOSION at the UPPER BIG BRANCH MINE

APRIL 5, 2010

BOONE / RALEIGH CO., WEST VIRGINIA

**WEST VIRGINIA OFFICE of MINERS' HEALTH,
SAFETY & TRAINING**

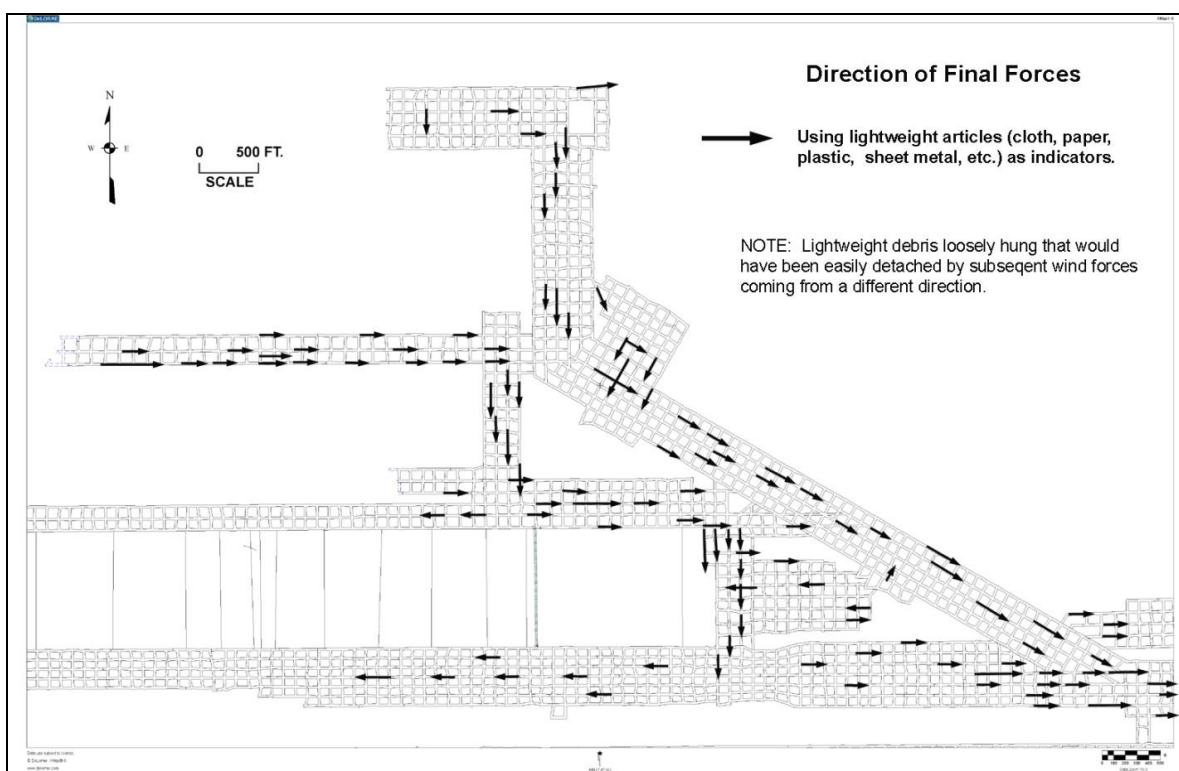
Map 1. This map of “Final Forces” across the explosion region of the Upper Big Branch Mine was based mostly on the lightweight items caught loosely on a stationary structure, where subsequent wind from a different direction would have likely dislodged them. See **Map 3A, 3B** for details of the longwall.

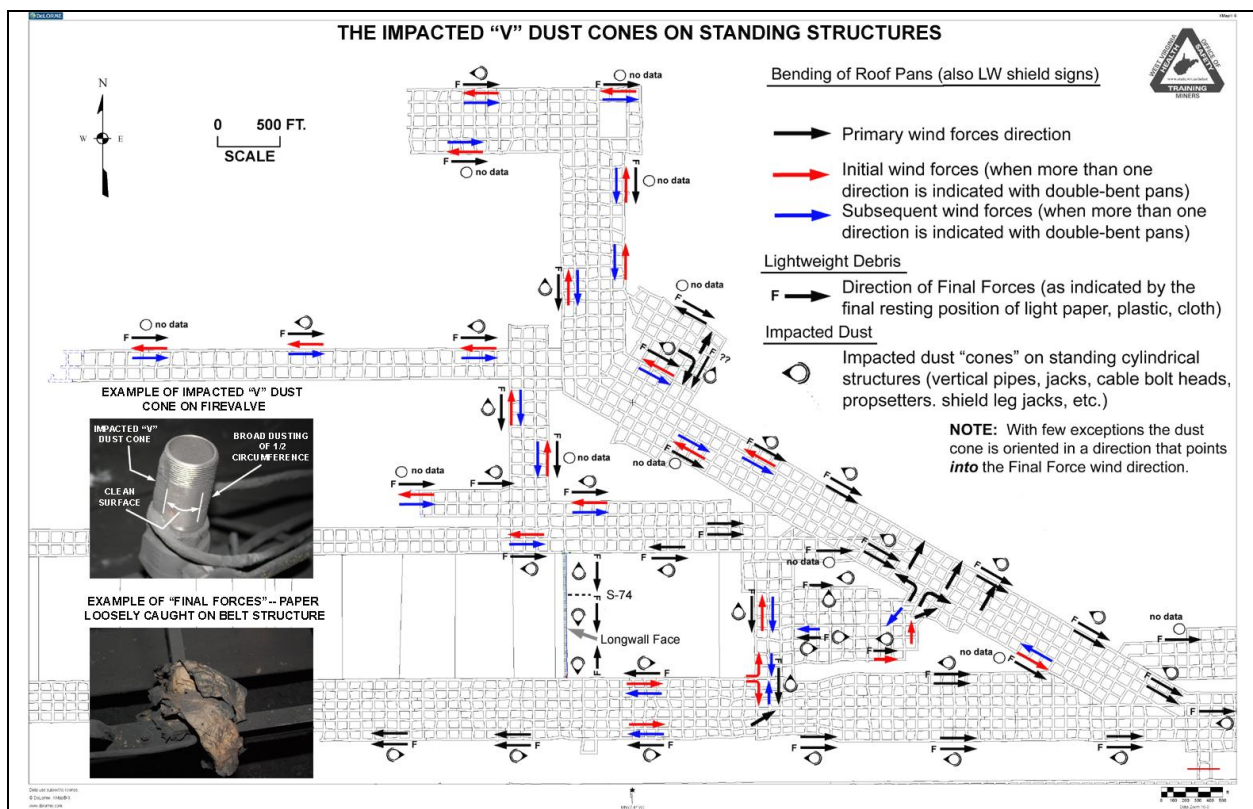
Map 2. The Impacted "V" Dust Cones observed on various cylindrical structures across the explosion region all point in the windward direction of the Final Forces. They are dust deposits that appear to have been placed during the last wind event carrying dust.

Although it is not certain, it appears that any dust placements on cylindrical surfaces from earlier wind events are scoured off by the Final Forces event, culminating with Impacted "V" Dust Cones being preserved only on the windward side of that final wind cycle.

As shown in **Map 2**, the regions such as the eastern ½ of #21 Tailgate, dust cones point in the direction of initial forces because the Initial Forces and Final Forces were in the same direction.

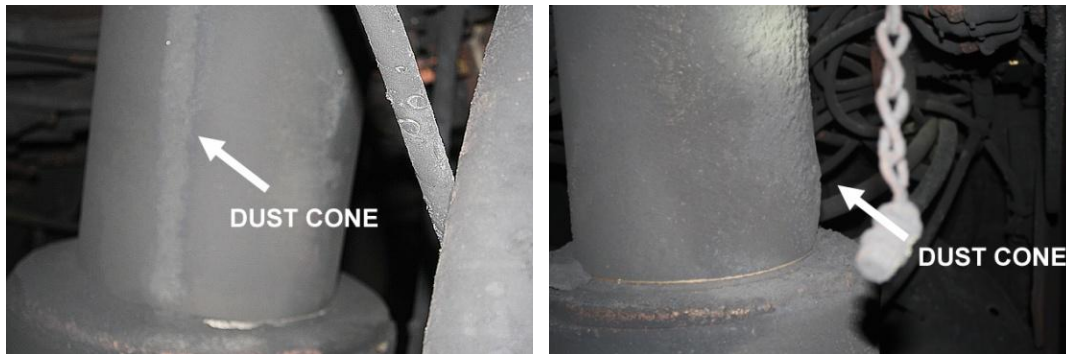
Figure 10. (LEFT) Cylinder leg on Longwall; South side of south jack, Shield 166. View looking NW. These are deposits are Final Forces features, originating from the Tailgate side of the longwall.

Figure 11. (RIGHT) Cylinder leg on Longwall; North side of north jack, Shield 10. View looking W. These are deposits are Final Forces features, originating from the Headgate side of the longwall.

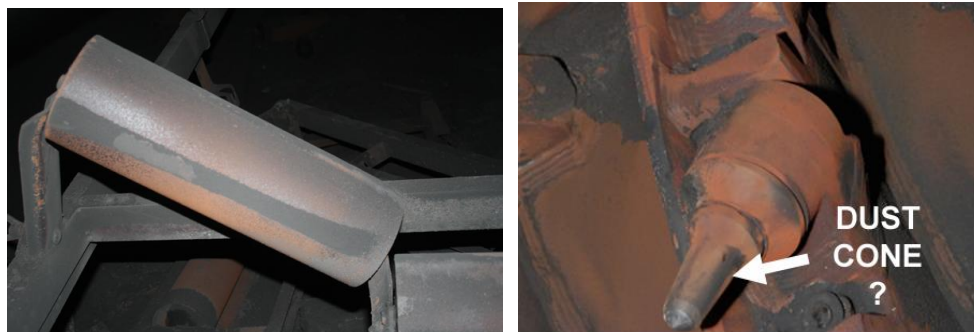
Figure 14. (LEFT) Roller on belt structure with impacted dust cone; #21 Cross-over, approximately 30 feet south of spad 23813, looking south. Final Forces were from the NORTH.

Figure 15. (RIGHT) Poorly-developed dust cone on bit of longwall shearer. In the #7 entry of #21 Tailgate, near spad 22544, looking W-NW. Final Forces were traveling to the WEST. *This photograph courtesy of Performance Coal Co.*

Other cylindrical structures, such as belt rollers (**Figure 14**), developed prominent dust cones--again, always on the windward side relative to the Final Forces direction, as indicated by the lightweight debris.

fallen off, and it was difficult to discern (**Figure 15**). These apparent cone shadows point east, which is the direction Final Forces were traveling from in this area.

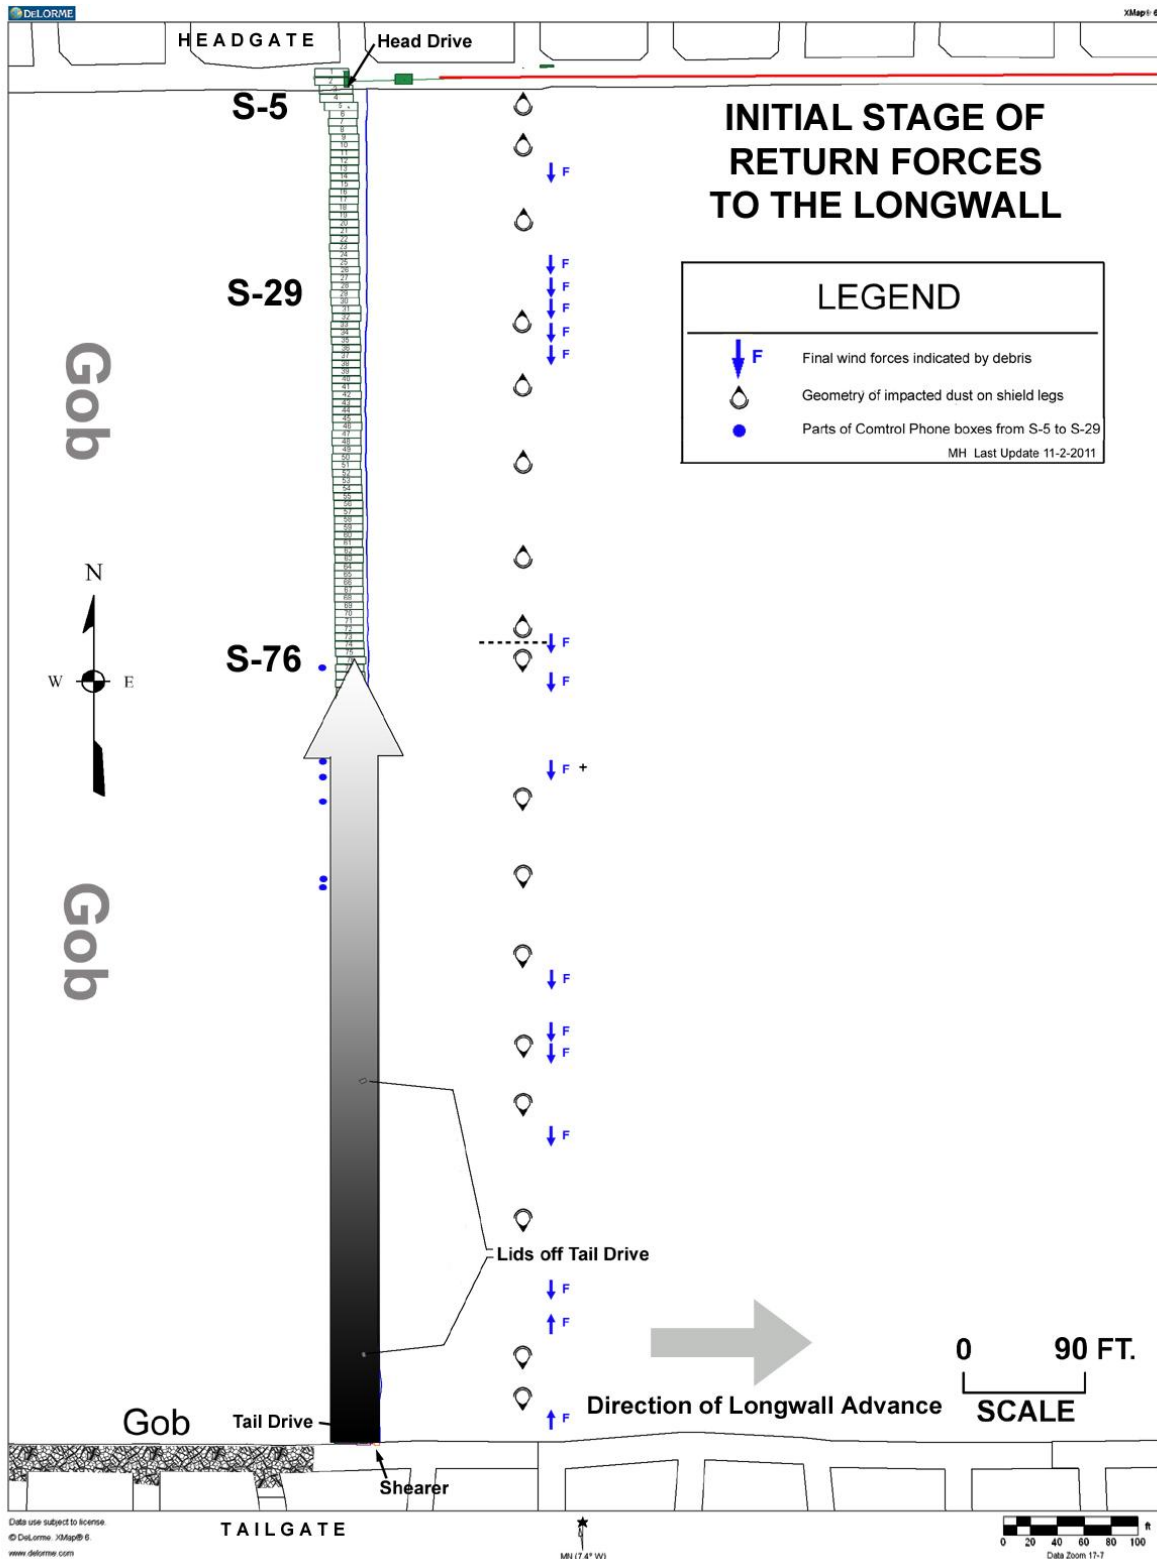
As illustrated in **Map 3A**, we know that dust-carrying final wind forces from the Tailgate deposited dust on the southern exposure of cylinder legs as far north as Shield 76, and lightweight debris should have traveled that far, or farther (both indicted in *blue*). However, if winds came subsequently from the north this debris would have been rearranged, and we might never know it.

Map 3A. Final Forces entered the longwall first from the *Tailgate region*, with enough energy to deposit Impacted “V” Dust Cones on the cylinder legs, at least as far as Shield 76.

The middle area of the longwall (Shield 76-158) where there is apparently conflict between the Impacted “V” Dust Cone placement and the lightweight articles placement is believed to be due to the fact that the items between Shield 76 and Shield 158 were rearranged by winds coming last from the Headgate. Further, perhaps due to a combination of large cylinder leg diameters and because numerous obstructions from hydraulic hoses and electrical cables around the cylinder legs, there were found to be a few south-facing dust cones that had been placed south of Shield 75 survived re-deposition, but any that may have been deposited farther north were erased by the subsequent Headgate forces (as they normally are) and overprinted with dust cones which point the other way, as we found them.

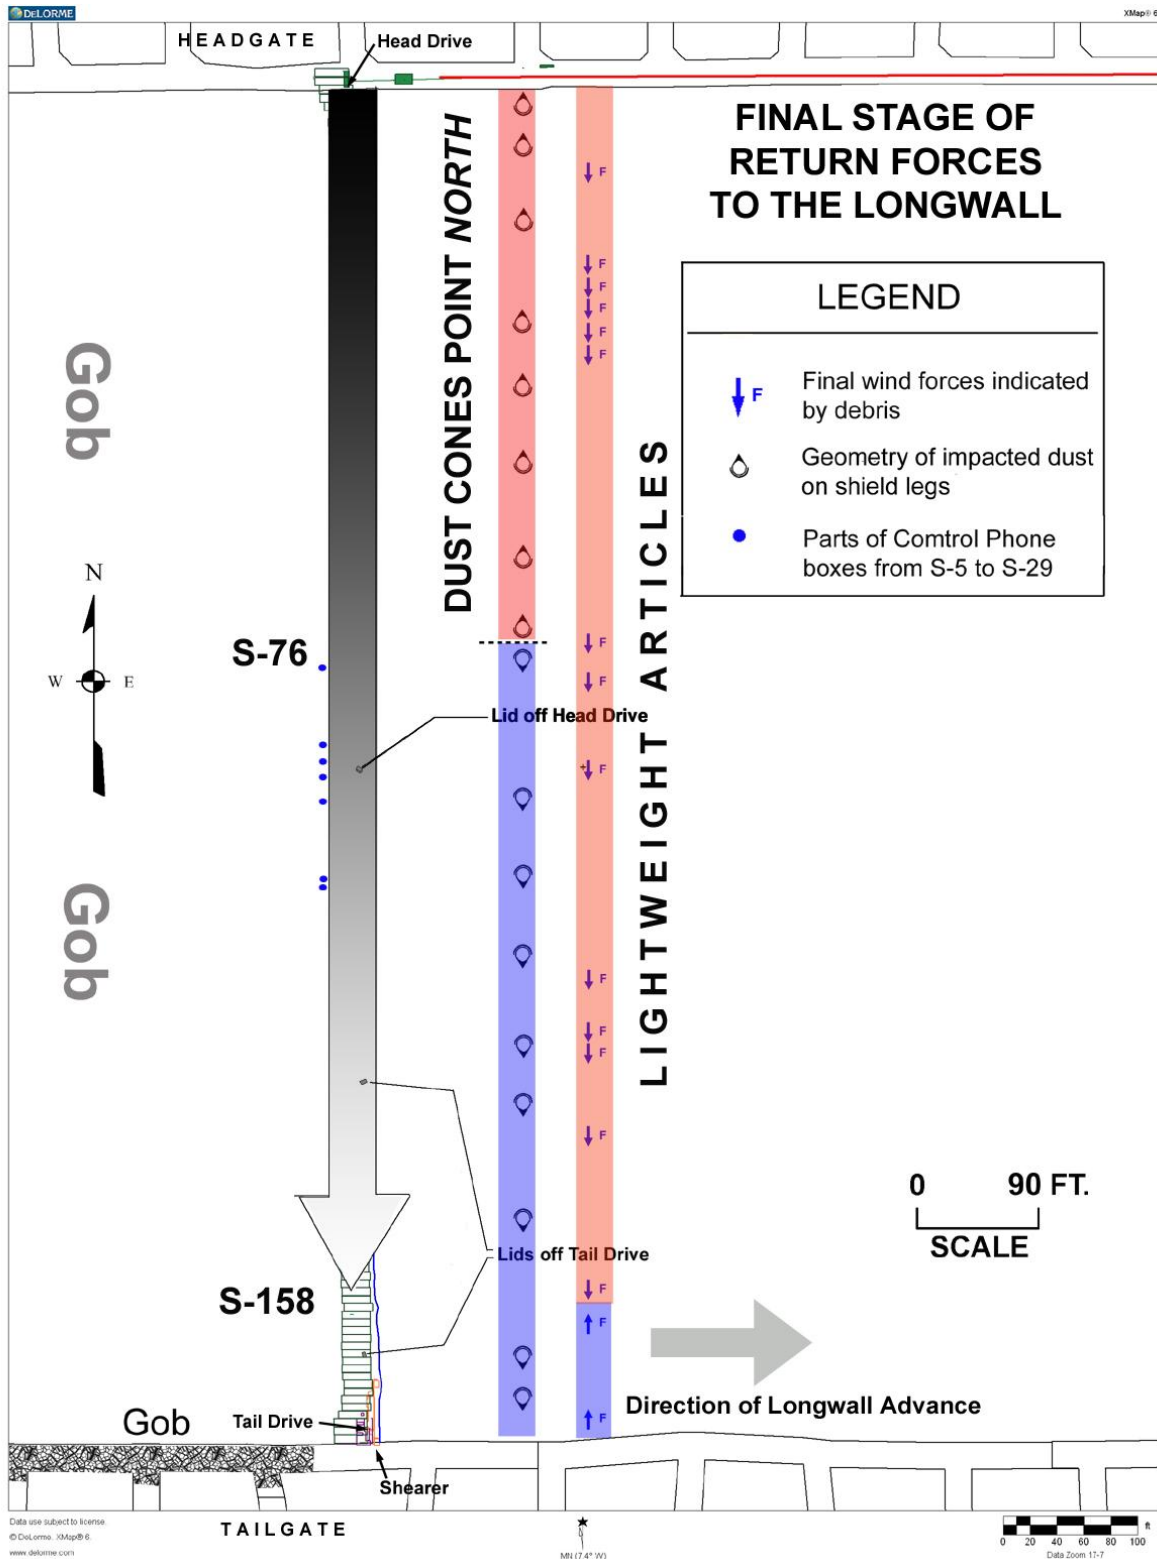
As illustrated in **Map 3B** we find from the south-directed final wind forces, indicated between the Headgate and Shield 72, are consistent with the lightweight debris articles we observed. They came to rest in a manner consistent with these south-directed wind forces, at least as far south as Shield 159, where south of this point some of the former placement north-driven placement of lightweight articles survived.

Map 3B. Final Forces entered the longwall second from the Headgate region, with enough energy to deposit Impacted "V" Dust Cones on the north side of cylinder legs, at least as far as Shield 72, but rearranged lightweight structures as far south as Shield 158.

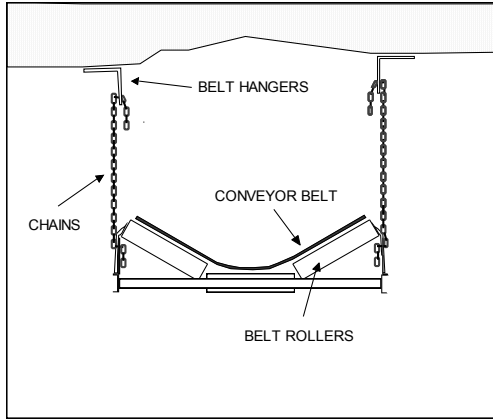
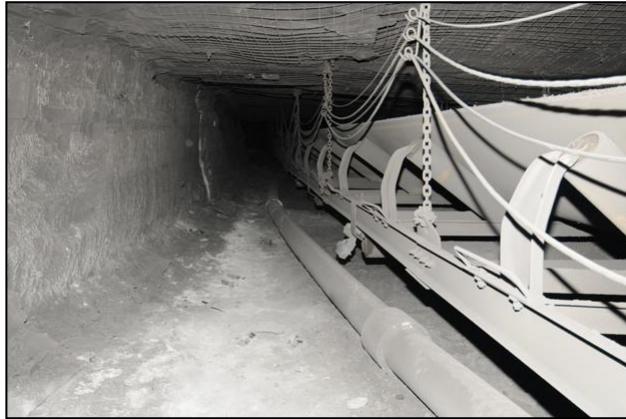
Figure 1A. Between crosscuts the belt structures are relatively intact. This is an example view of a suspended belt structure near spad 19819, North Glory Mains (NGM), looking inby.

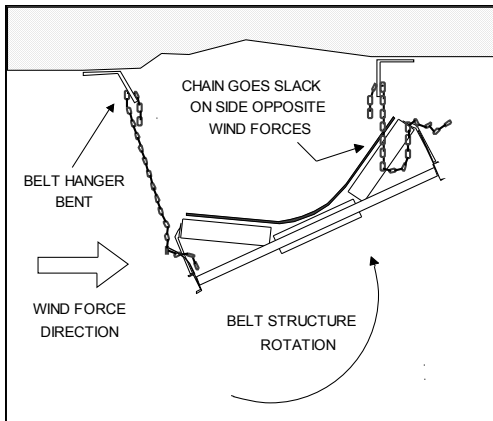
Figure 1B. In crosscuts, explosion forces entering perpendicular to the belt and from the SW side cause a CCW rotation of the belt structure, which would be from the LEFT side, looking inby (left lateral). This example view is near spad 19835 in NGM, looking to the SW from the edge of the crosscut.

The *counter-clockwise* rotation produced when left-lateral explosion forces intercept the suspended belt structure is illustrated in **Figures 1A, 1B and 1C**. In this example the chains on the windward side are subjected to tensional stresses, often bending the belt hangers and ultimately pulling the chains apart. The chains on the leeward side of the wind forces, while not typically pulled apart, had frequently been popped out of their keyhole attachments as the belt structure rotation caused slack in the chains. The direction of belt structure deflection of the various belt lines is shown in **Map 1**, which covers most but not all sections of belt structure.

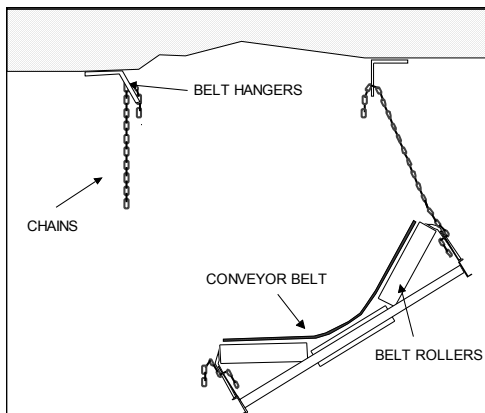
Figure 1C. After the CCW rotation the chain on the windward side may be broken, or the chain on the leeward side may become unhooked, dropping one side of the belt structure. This example view is in the North Glory Mains near spad 19852, looking inby.

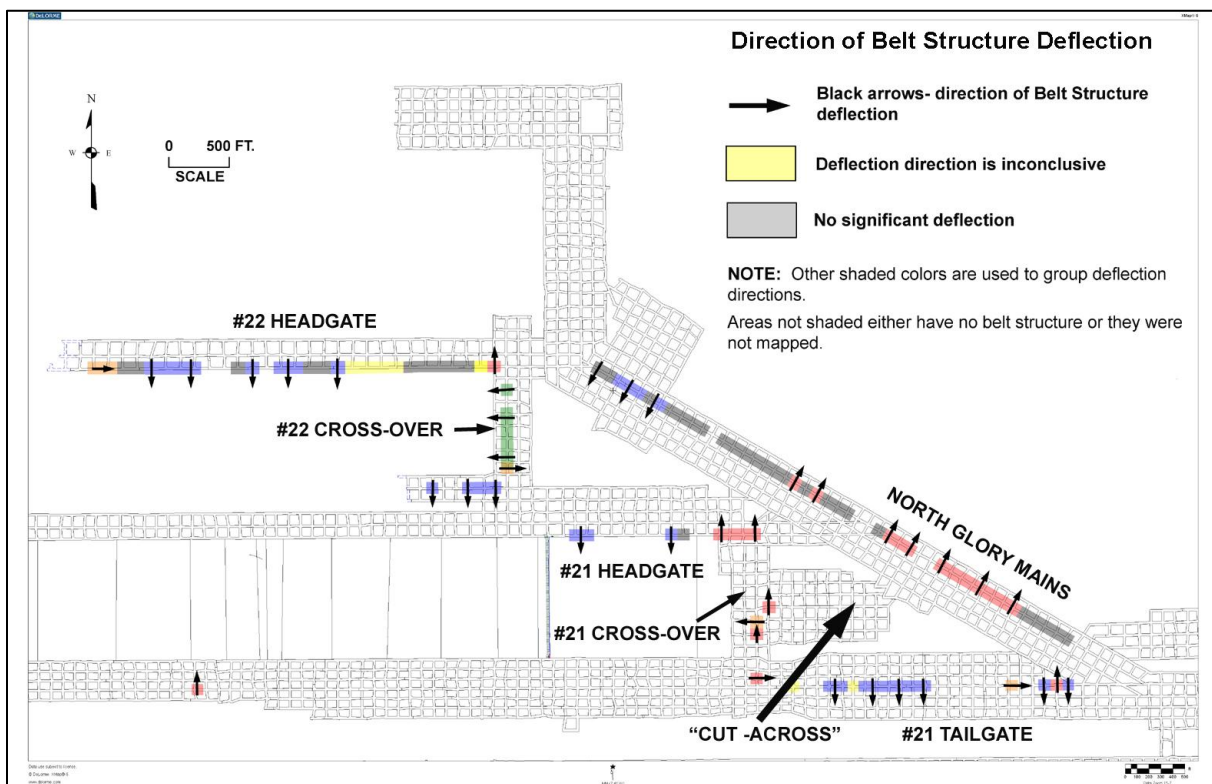
Explosion propagation directions which were parallel to the belt structure caused less damage than forces which were perpendicular, for example forces propagating from the Cut-Across and into North Glory Main crosscuts caused significant structural damage in these intersections, resulting in significant deflection or twisting of the belt structure.

Map 1. Areas where the explosion damage was noted to the Belt Structure, and the direction of forces involved.

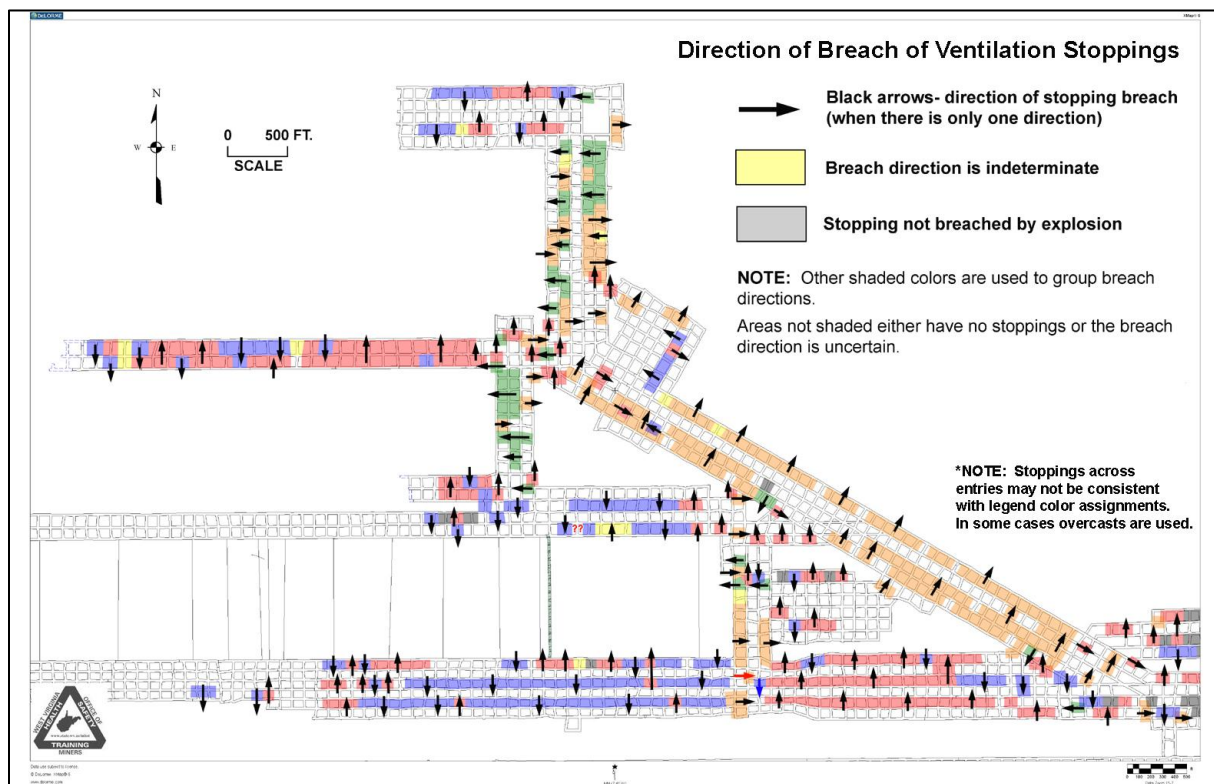
Map 2. Direction of breach of ventilation stoppings due to explosion forces.

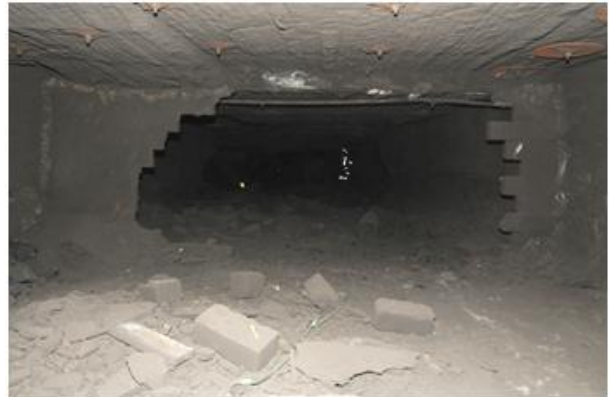
Figure 5. (RIGHT) Concrete block stopping, breached during explosion, with block debris in foreground.

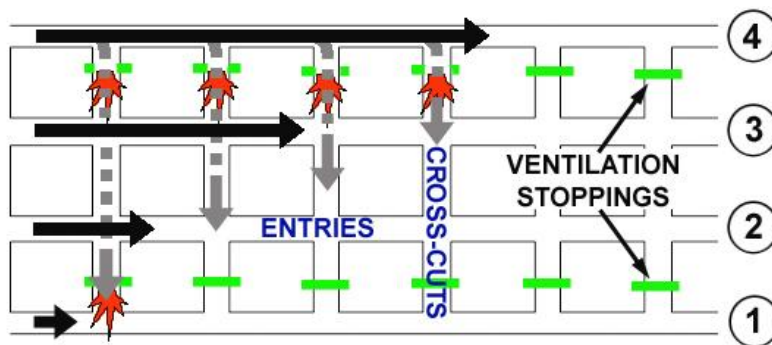
Figure 6. For a propagating explosion traveling in the direction of the entries (black arrows), the leading edge entry can be inferred by the direction in which the ventilation stoppings (green) are breached in the crosscuts (gray arrows), as determined by their debris fields (red).

An example is given in **Figure 6**, showing an explosion propagating through four parallel entries and branching into successive crosscuts as they are encountered. If the leading edge favors the outside entry (in this case, entry #4), the stoppings will tend to fail in the direction of entry #1. In making such turns wind forces are reflected off solid surfaces at intersections, resulting in confusing and potentially misleading damage patterns. This is part of the reason intersections are excluded when mapping and counting bent roof pans (see **Appendix 7.9-2**).

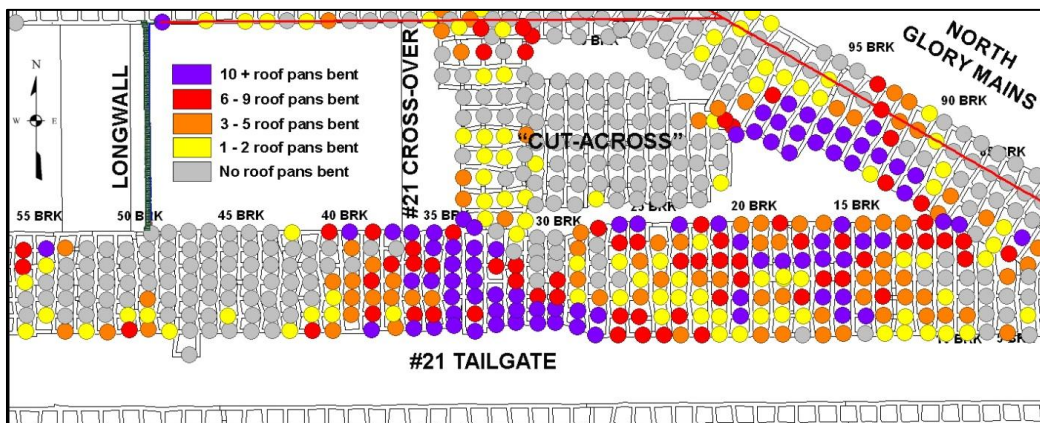
Map 3B. This map summarizes the numbers of roof pans bent in the direction of the Initial Forces.

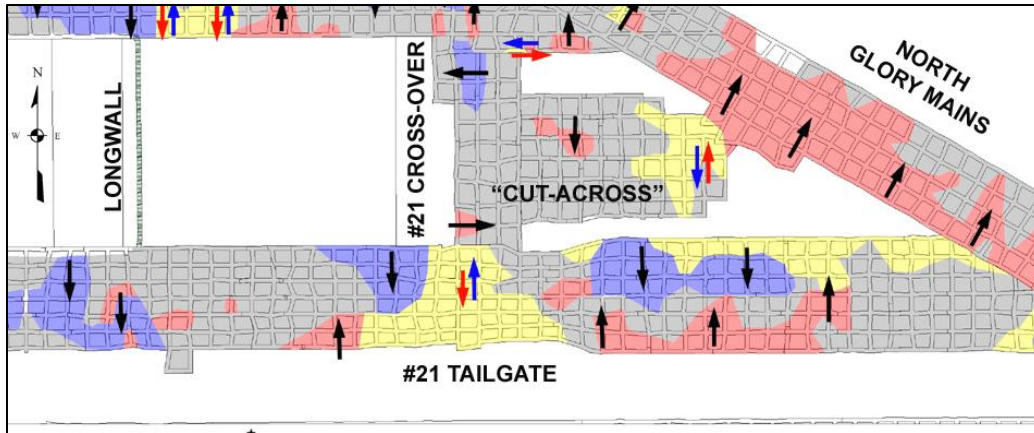
Map 3C. This map summarizes the direction of roof pan bending in the mine CROSSCUTS.

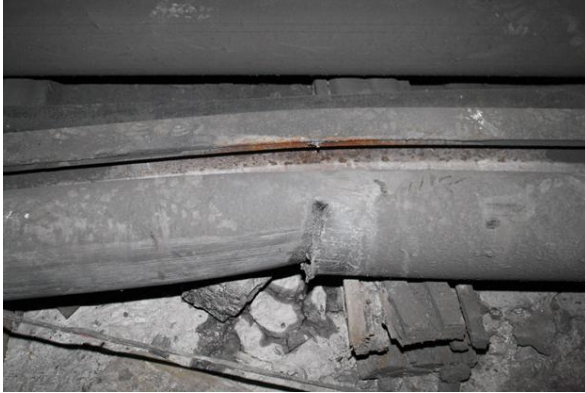
This capacitor box, which is approximately 8 feet x 4 feet x 3.5 feet high was transported to the NE from its original location at “A” to location “B” where it appears to have impacted the track and waterline (**Figure 9**), deflecting both slightly, to the north (see **Figure 10**). Dynamic wind forces moved the box.

Figure 9). (LEFT) Bent track and punctured waterline, at location “B” (see the figures below).

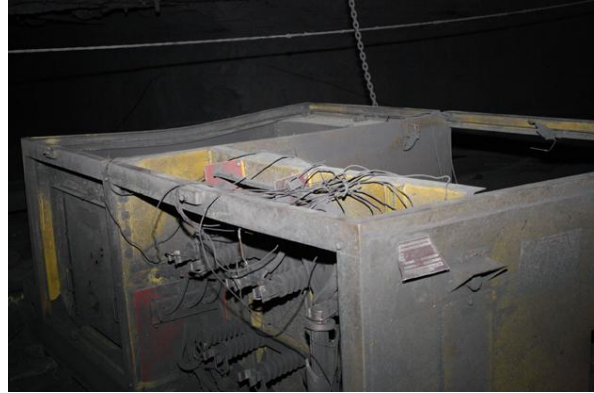
Figure 10). (RIGHT) The capacitor box in its final resting position at location “C” (see the figures below).

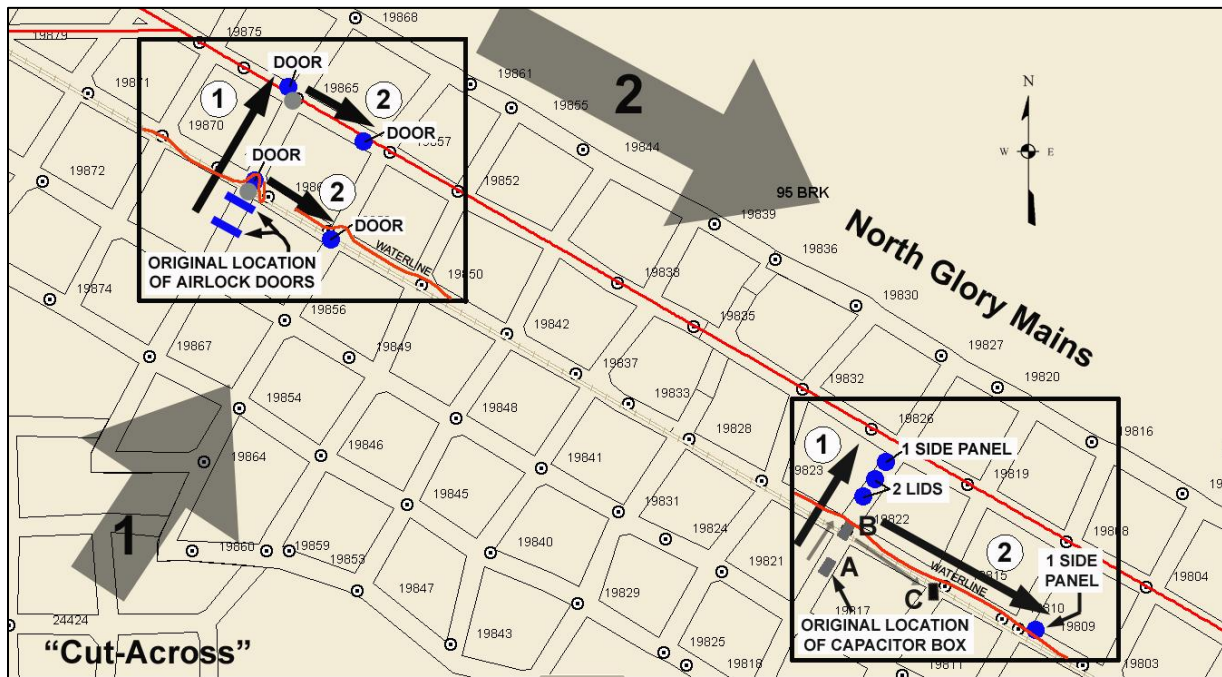
Other mine structures were also used to determine direction and sequence of explosion forces. Two examples are given below, (1) transport of airlock doors, and (2) transport of power boxes, which are in the same general vicinity of the North Glory Mains (see **Figure 11**).

Figure 11. Forces traveling NE (1) out of the Cut-Across Panel entered the North Glory Mains, followed later by return forces (from the NW) through the North Glory Mains, traveling to the SE (2).

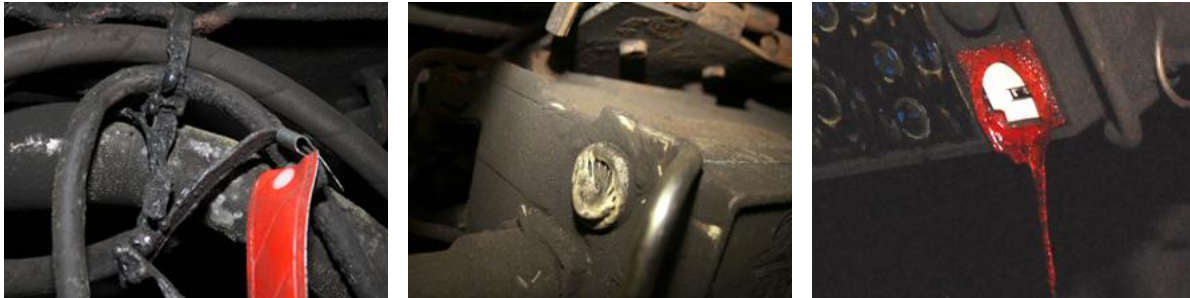
Evidence of heating exists on most of the shields north of Shield 72, but there is little evidence of heat between Shield 72 and Shield 160. Items that display evidence of heating (blistering, discoloration, melting) include zip ties (used to secure and hang cables and hoses), plastic speaker and lens covers on CIU boxes, and fluorescent light covers (see examples, **Figure 1, 2**). There is little evidence of coked dust on the Longwall, except between Shield 41 and Shield 72, (see **Appendix 7.9-1, Map 4**) where small and medium amounts of coke are present on the south side of shield cylinder legs and on surfaces which face the gob (west). Coke is evidence of flame.²

Figure 1. (LEFT): Melted zip ties; Shield 38; (MIDDLE): Melted speaker cover; Shield 39; (RIGHT): Melted plastic lens cover on Shield 62 control box (CIU). Note the clean white area behind the melted red lens.

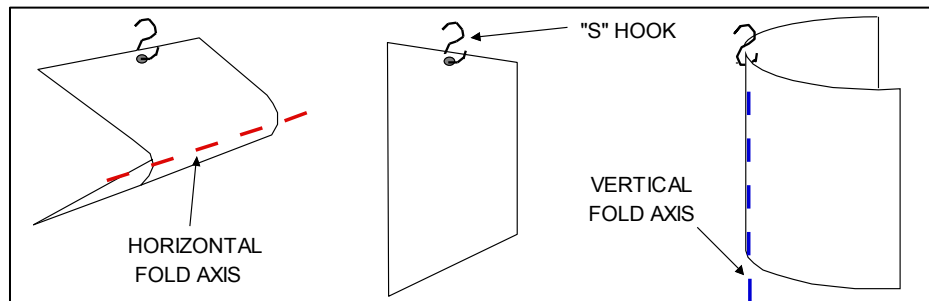
Figure 3A. (LEFT): Shield sign bent along horizontal fold axis, (MIDDLE): Shield sign unbent, (RIGHT): Shield sign bent along vertical fold axis.

It is believed that the change in bending styles is related to an obstruction in the gob, just north of the “hotspot” that terminated propagation behind the shields. Earlier in the day a delay to mining occurred while repairs were made to the B-lock on the shearer between the Headgate and approximately Shield 65. In this same region, many of the shields were not pulled up, and the delay involved at least 2.5 hours. When mining did resume, the shields south to the Tailgate were pulled up as the shearer advanced. It is unknown why the Headgate shields were not advanced, but because of the time the shields were stationary it is believed the gob would have been tight against those shields (see **Section 4.1**). In contrast, mining from Shield 65 to the Tailgate was completed in approximately 30 minutes, and those shields were moved up as the shearer advanced, creating some space behind the shields that had not caved or was in the process of caving. It is believed that the explosion began in the gob near the Tailgate, and as one branch expanded north behind the shields it traveled in this space, and expanding gas forced it’s way from the back of the shield openings into the longwall. The signs hanging along the

North of the “hotspot” between shields 64 and 56 the horizontal bending style transitions to the vertical bending style (from Shield 56 to Shield 42). The surviving signs north of Shield 42 (inclusive) are bent along their vertical axes. The CFD analysis demonstrates that signs folded along their vertical axes are caused by wind forces traveling in the direction of the axis of the longwall, not from the direction of the gob. It is believed the explosion forces behind the shield encountered gob rocks closer to shields that had not been pulled up, which denied it space and/or fuel to propagate into. These forces became funneled into the Longwall, where it appears they subsided to extinction. Just north of this jump is a region where reflected pressure appears to have been created between Shield 50 and Shield 36, causing the majority of the E-Stop buttons on the shield control boxes (CIU ‘s) to be pushed in. The minimum normally-incident pressure to do this is approximately 6-7 psi.⁵ It is speculated that the diverted forces of this pressure event reflecting off the Longwall coal face or cable trough next to the chain conveyor pushed these buttons. The CIU buttons are described below in more detail. North of Shield 47 not many signs survived, but those which remained were folded along their vertical axes, indicating that wind forces through this region were directed either north-to-south or vice versa, but not from the gob.

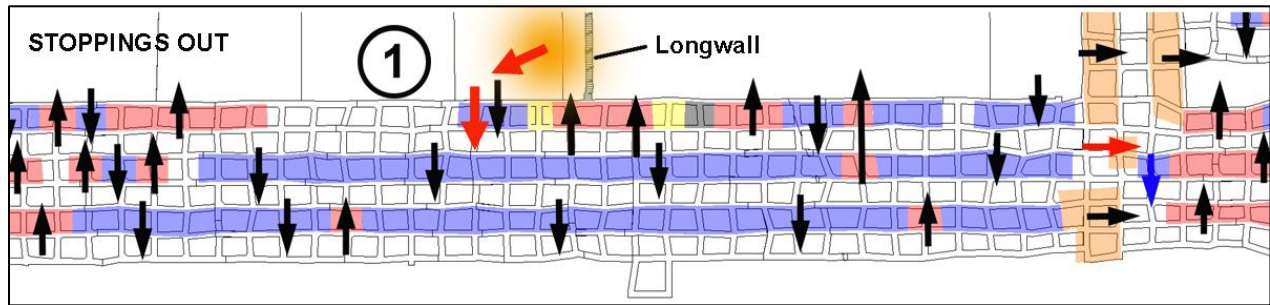
Figure 4A. #21 Tailgate: Directions which ventilation stoppings were blown by explosion forces.

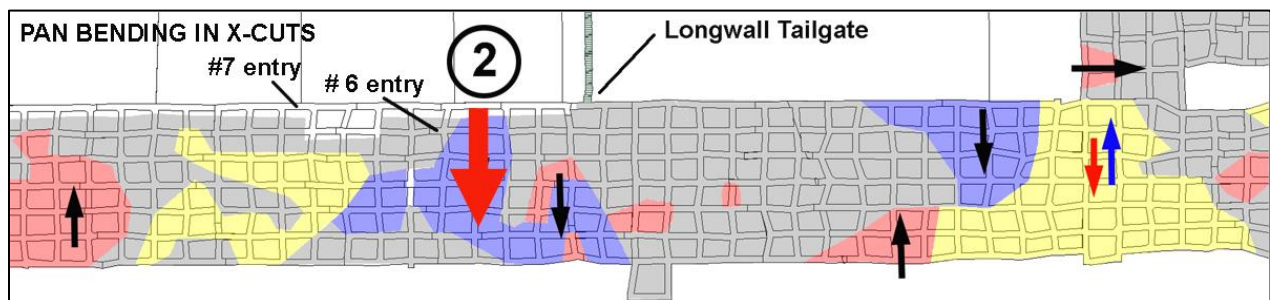
Figure 4B. #21 Tailgate: Direction roof pans in CROSS-CUTS are bent by explosion forces. YELLOW areas are where there is bending of pans both ways.

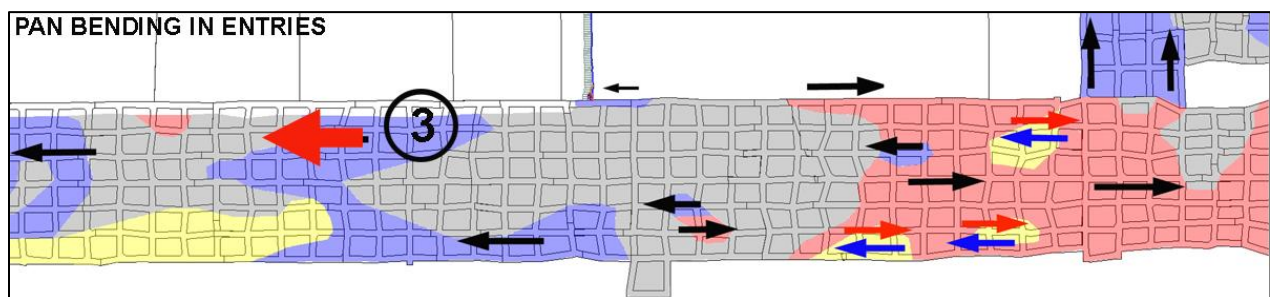
Figure 4C. #21 Tailgate: Direction roof pans in ENTRIES are bent by explosion forces. YELLOW areas are where there is bending of pans both ways

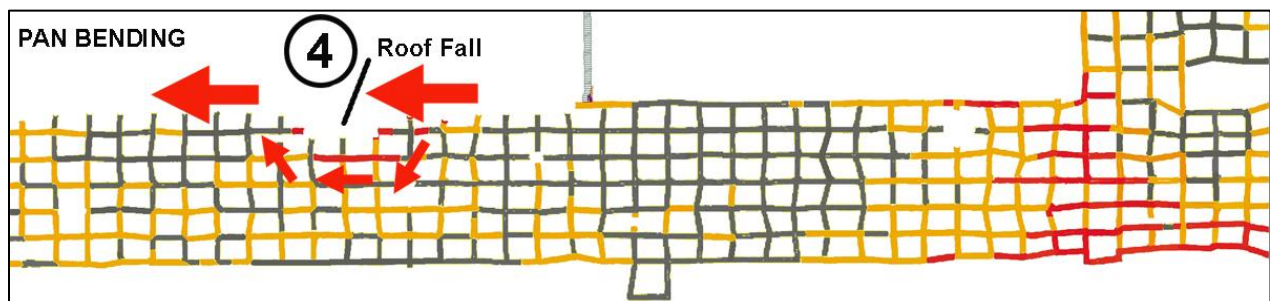
Figure 4D. #21 Tailgate: GRAY: Roof pans are unbent.. ORANGE: Roof pans bent >90 degrees. RED: Roof pans are severely bent.

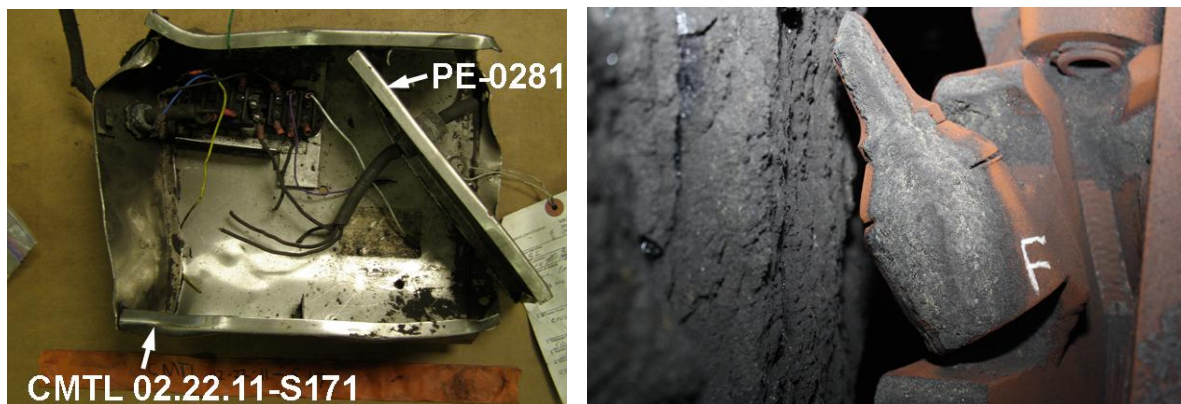
Figure 5A. (LEFT): Two pieces of the same Control box believed to have originated at Shield 173 (RIGHT): Impacted coal and dust along the north face of shearer bit, next to the solid coal face.

Impacted wet dust (mud) on the north side of the Tailgate shearer drum suggests initial explosion forces passed over the shearer and exited the Tailgate. Deposits of impacted mud were found on the tail-drive cowl,⁶ shearer bits (**Figure 5A**, right) and on the first several wood props (propsetters) standing just outby the shearer in the #7 entry of the tailgate (**Figure 5B**, left). The

Two Control phones in the southern half of the Longwall were missing from their shield mounts after the explosion. The unit at Shield 117 was missing, but its pieces appear to have traveled north as far as Shield 106. The other unit was at Shield 173, and pieces (see **Figure 5A**, left) were found as far north as Shield 166 and at least one piece was found outby, east of the shearer in the #7 entry. Examination showed that an aluminum bottom (MSHA evidence PE-0281) found near Shield 171 and an aluminum side (State evidence CMTL-02.22.11-S171) found

approximately 140 feet outby the shearer were a close match.⁷ These items and others from the Longwall found outby the shearer⁸ indicate forces exited the Tailgate during the methane explosion in the gob.

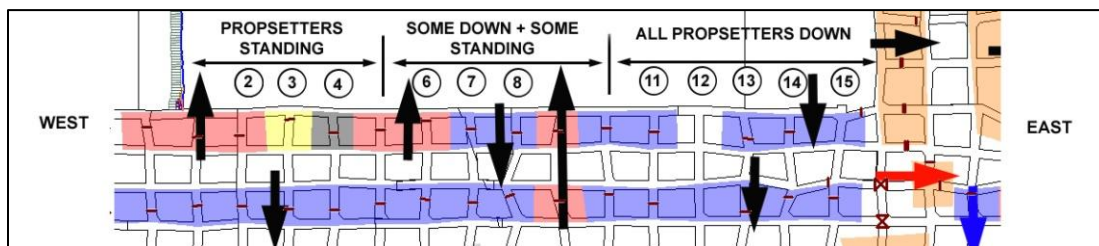
The 1st ventilation stopping (see **Figure 7A**) located east of the Longwall is approximately 20 feet wide and has an opening of approximately 8 feet. It would be normal for this stopping to have been manually breached as part of normal Longwall ventilation. The initial explosion forces from the Longwall did not cause conspicuous damage to this stopping, although some blocks were blown northward by subsequent forces. Tests performed on an empty, undamaged spray can indicate static pressure here did not exceed 13.2 psi.⁹

Figure 7A. Direction of Stopping Deflection. RED: Stopping failed to the N.; BLUE: Stopping failed to the SOUTH.; YELLOW: Stopping debris went N. and S.; GRAY: Stopping is still intact

The 2nd stopping outby failed by subsequent explosion forces directed to the north. It appears to have survived the initial pressures of the explosion in #7 entry.

The 3rd stopping failed, leaving debris both north and south. This stopping is believed to have been partially opened as a regulator¹⁰, but repaired shortly before April 5, 2010. As a result, it appears to have partially failed on the initial outby propagation in #7 entry, scattering debris to the south, then failed more completely as return forces scattered more of it later to the north.

The 5th and 6th stoppings, failed in a northward direction, and are believed to have survived the initial explosion, only to fail from subsequent forces. Propsetters (round timbers) had been erected in the #7 entry ahead of the Longwall for supplemental support. Between the Longwall and this location they remained standing. For the next 5 breaks some propsetters remained standing, some are down.

The 9th stopping survived the initial explosion (but failed later to the north). Moderate pan bending pointing east is observed in #7 entry, in response to the escalating pressure wave.

Beginning with the 10th stopping outby the shearer, explosion pressures reached a point at which no more propsetters were left standing outby and all stoppings from there outby to the #21 Cross-over had failed in breaches directed southward. Moderate pan bending (see **Figure 7C**) pointing east was observed in entries #4, 5 and 6 confirming the explosion has reached those entries.

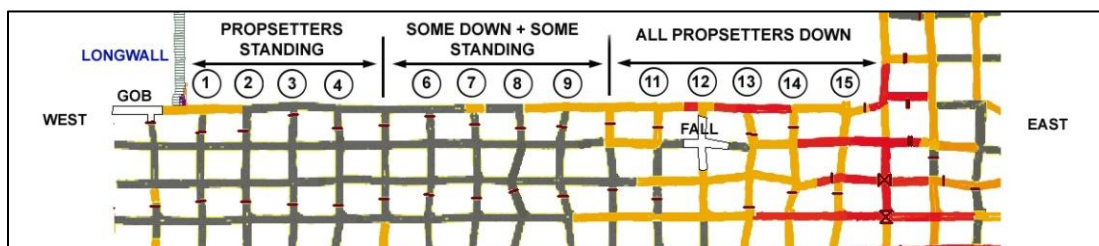
After entering the #7 entry of #21 Tailgate explosion forces traveled east toward the #21 Cross-over. As it traveled east its strength increased as fuel was consumed and pressures increased. This progression of increasing force corresponds to increasing to levels of damage to standing supports, stoppings, and roof pans (see **Figures 7A-7E**).

Figure 7B. Degree of Pan Bending. GRAY: Pans are not bent. ORANGE: Pans are moderately bent; RED: Pans are severely bent.

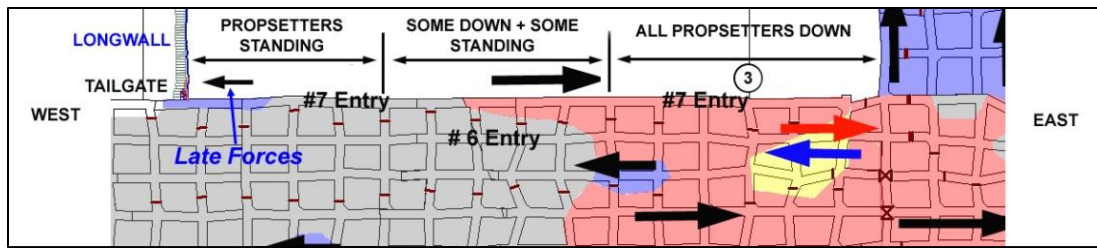
Figure 7C. Roof Pan Bending in the direction of the ENTRIES. RED: Pans are bent to the OUTBY; BLUE: Pans are bent to the INBY(left); YELLOW: Pans are bent both directions; GRAY: Pans are unbent.

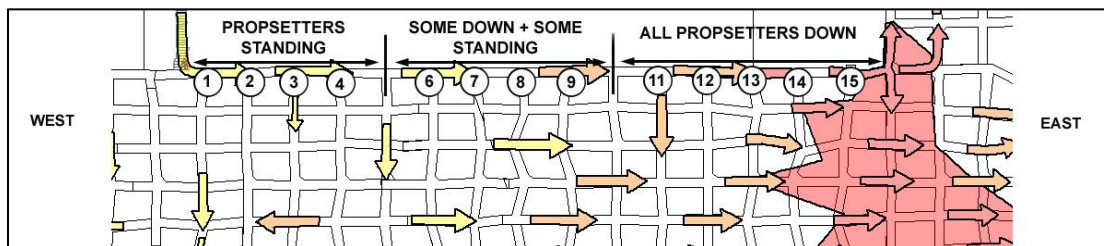
Figure 7D. Generalized Explosion Path- YELLOW ARROWS: Inferred wind direction, but pans are not bent.; ORANGE- RED ARROWS: Pans are moderately and severely bent, respectively. The red shaded region is severe pan-bending.

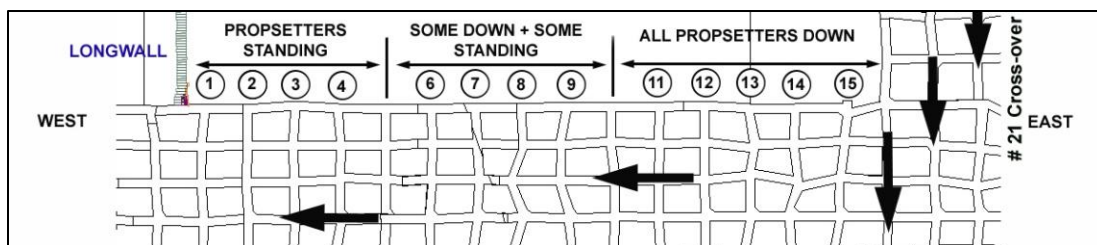
Figure 7E. Final Forces. Based on light-weight items (paper, plastic, cloth) caught loosely on stationary structures, and which would have been easily dislodged by subsequent wind forces.

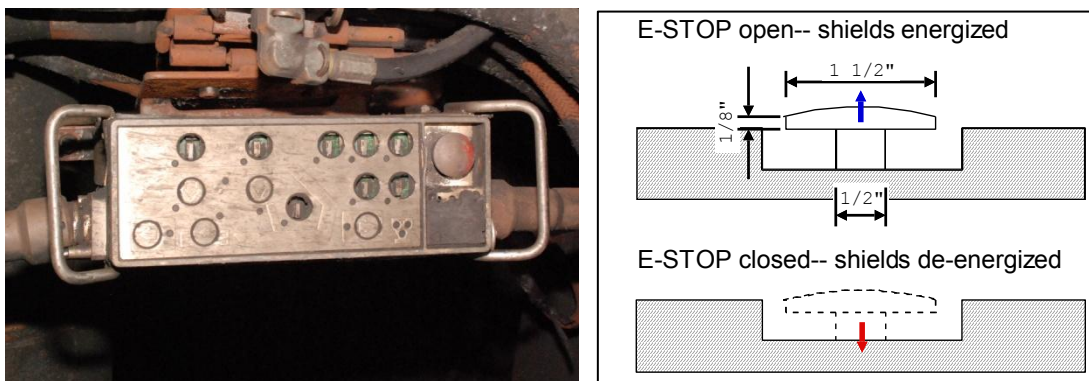
A shield control box (CIU) was mounted at each shield, approximately 12 inches below the shield canopy and facing in the direction of the solid coal face. An emergency stop (E-stop) button is mounted in the upper right corner of each box (see **Figure 11**). The E-stop button is 1.5 inches in diameter and has a slightly curved face.

Figure 11. (LEFT): Shield control box (CIU). The E-stop button is in the upper-right corner. (RIGHT): The E-stop button has a slight curvature and 1/8 inch activation distance to engage. A force of 9-10 lb applied perpendicular engages the button.

Clusters of shield control boxes had their E-stop buttons engaged.¹⁸ Red dots (see **Map 1**) signify where the E-stop buttons were noted to have been “engaged”. To deactivate all of the shields on the Longwall it is necessary to engage only one button. Because numerous buttons were found engaged, especially at the Tailgate and Headgate, where longwall pressures and damage appear greatest, it is believed the buttons were pushed in by wind pressures from the explosion, not activated by the section crew.
