REPORT of INVESTIGATION into the MINE EXPLOSION at the UPPER BIG BRANCH MINE

APRIL 5, 2010

BOONE / RALEIGH CO., WEST VIRGINIA

**WEST VIRGINIA OFFICE of MINERS' HEALTH,
SAFETY & TRAINING**

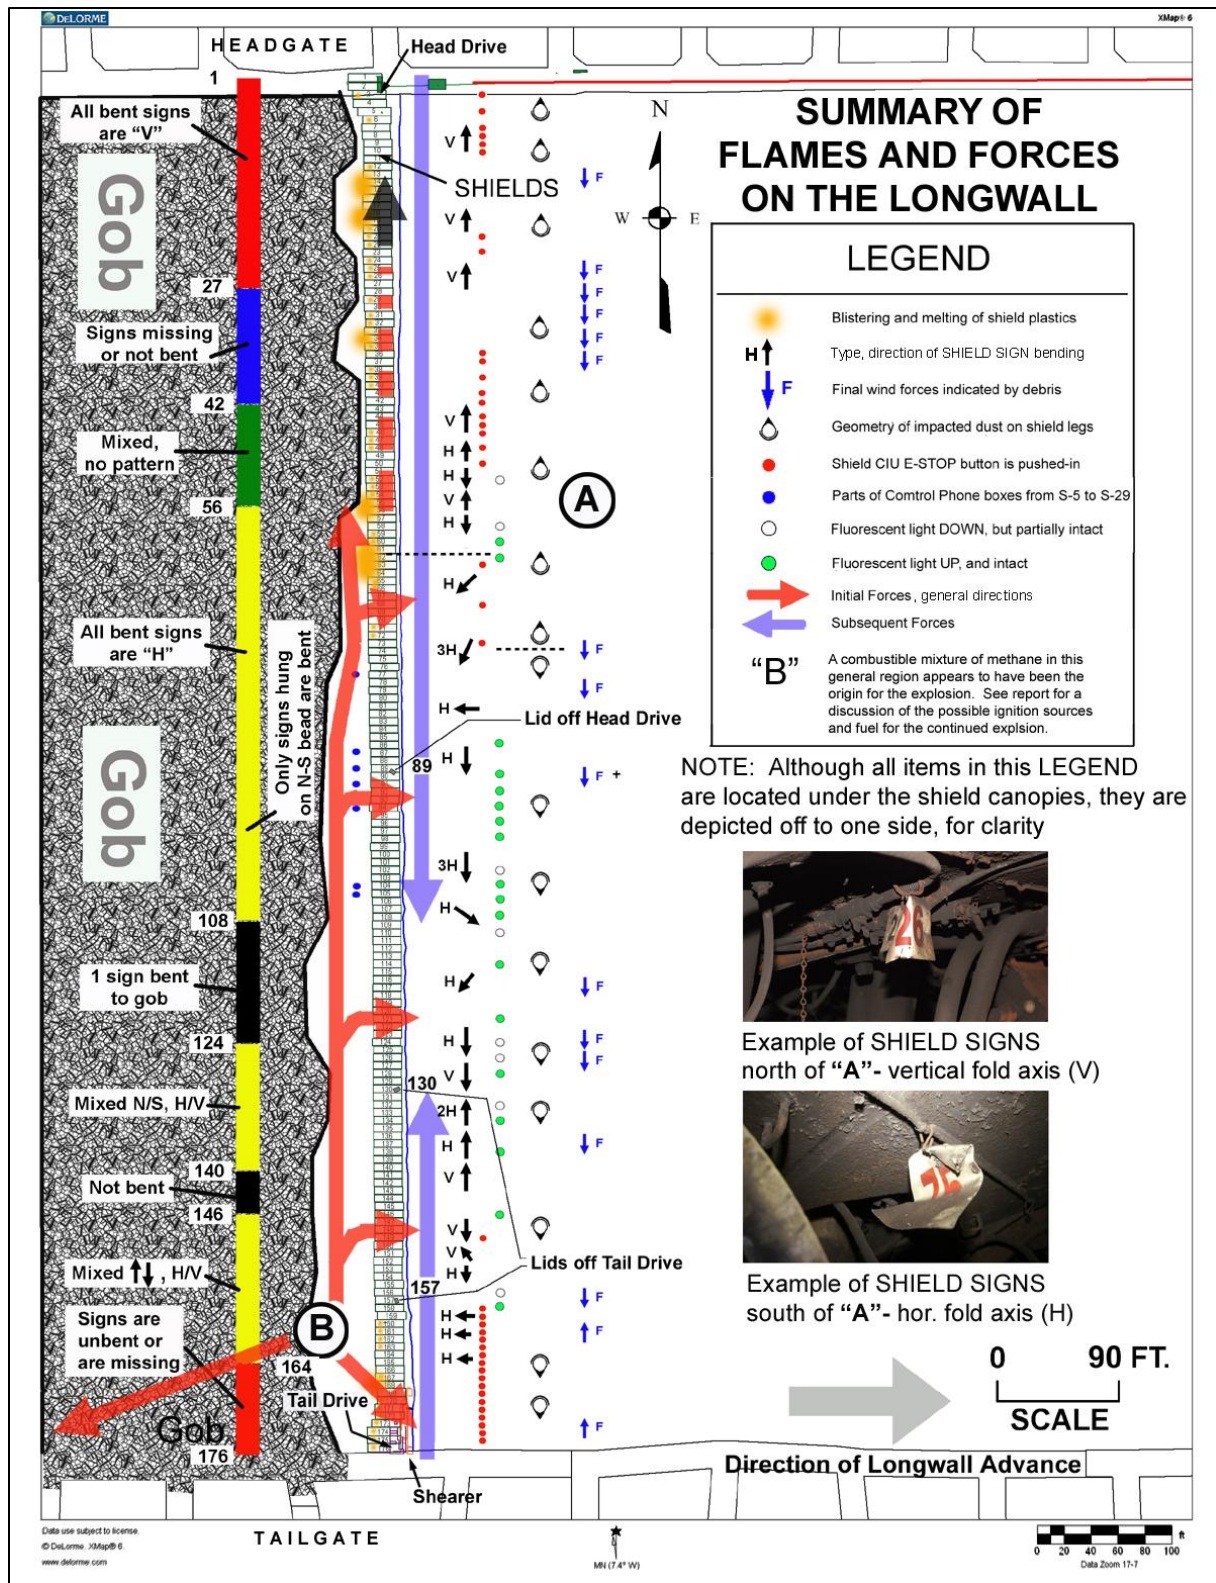
Some of the information used to determine the sequence of events, direction, relative heat and relative pressure on the Longwall is summarized in **Map 1**. The large red arrows show a generalized view of the initial explosion. Subsequent forces (large blue arrows) re-entered the Longwall, first from the south, then from the north. The symbols shown are described in the legend. Further information about the longwall region can be found in **Appendices 7.9-1, 7.9-3 and 8.2-4**.

Map 1. Initial Forces on the Longwall (red arrows) appear to have been influenced by amount of closure between the gob and back of shields. Subsequent Forces (blue arrows) entered the TG, then the HG.

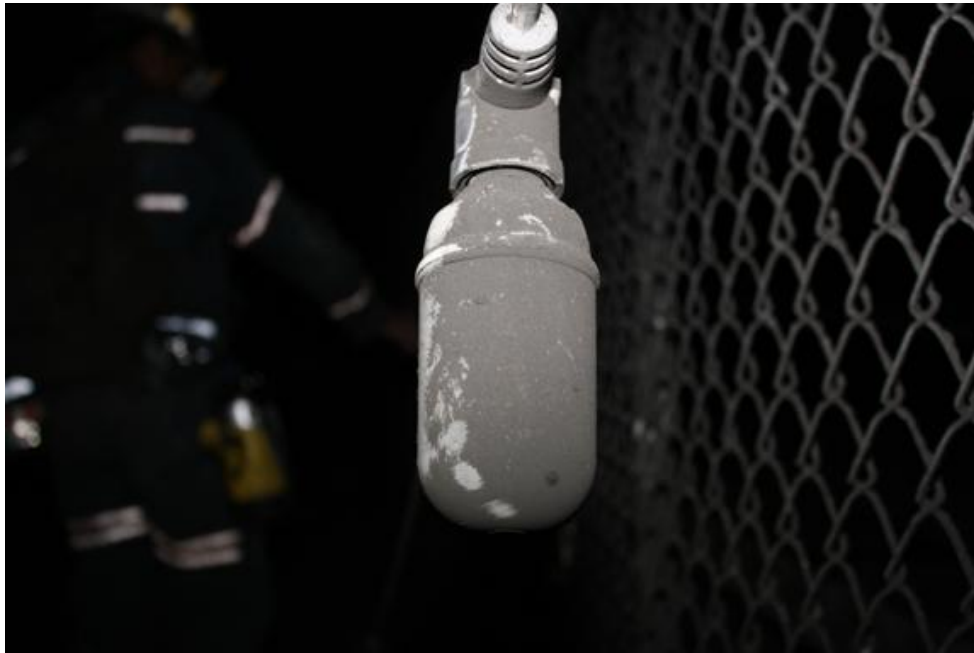
Figure 1. Undamaged lamp in the vicinity of the longwall mother drive unit

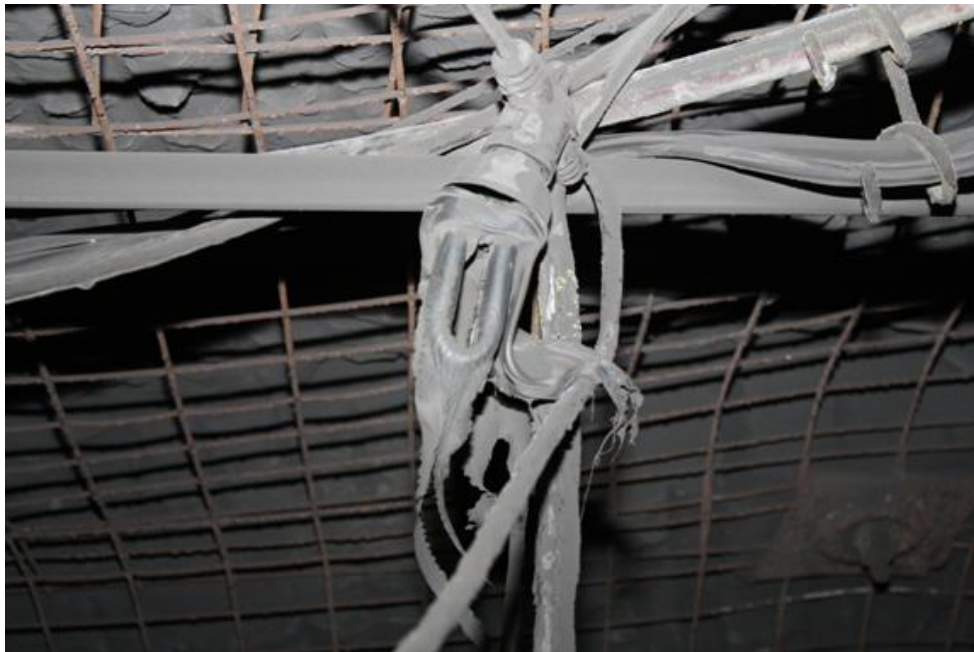
Figure 2. Undamaged lamp showing heat melting plastic cover on undamaged fluorescent lamp near longwall mother drive unit.

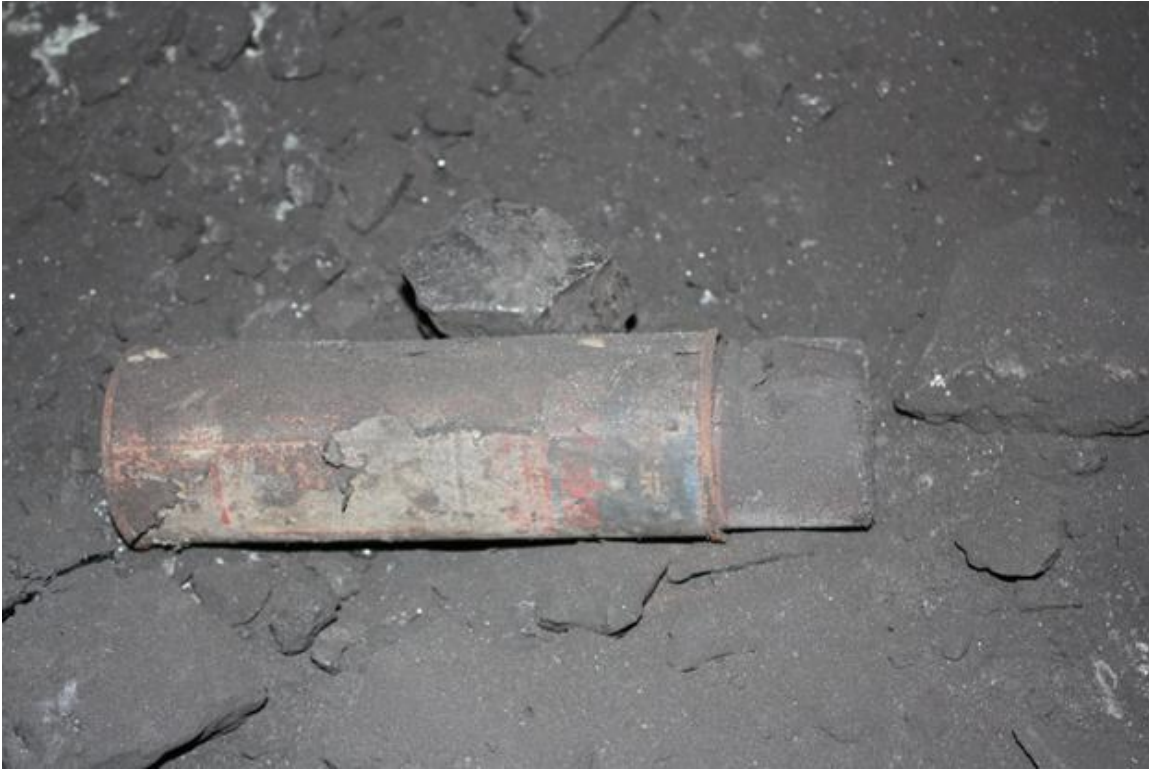
Another reasonable indicator of explosion pressure was an empty spray paint can found in crosscut 48, between tailgate entries 6 and 7 just outby the longwall face. This can was on the mine floor in a slight depression protected from the winds of the explosion, but not from the static pressure. Heat had burned away the paper label on the exposed surface but that portion of the can against the mine floor was unburned. The can was not at all collapsed by the static pressure. See photos in **Figures 10, 11 and 12**. Another empty spray paint can was found not collapsed near survey station 22629, in the headgate 21 entries just inby 21 crossover.

Figure 11. Spray can in crosscut 48 between entries 6 and 7 outby LW shearer. View looking South

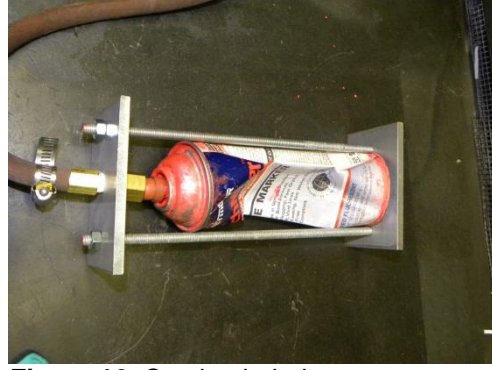
To determine the approximate static pressure to implode this can, it was first emptied by spraying the contents into a plastic lined cardboard box. An 1/8-in diameter hole vent was drilled through the can valve and a test tube septum with a feed through adapter bushing containing a small "O" ring (**Figure 14**) was held against the vent by gently clamping between two parallel plates to provide airtight seal. The barometric pressure was recorded at 14.2 psig and the pressure was slowly reduced inside the can by using a vacuum pump attached to the 20-L test chamber (**Figure 15**). The implosion pressure was determined from the output of a 0 – 200 psig strain gage transducer located in the wall of the 20-L chamber. The can abruptly collapsed when the inside pressure reached 1.04 psia (**Figure 16**). Therefore the minimum differential pressure between inside and outside to deform this spray can was 13.2 psig ($14.2 - 1.04 = 13.2$ psig).

Figure 16. Can imploded.

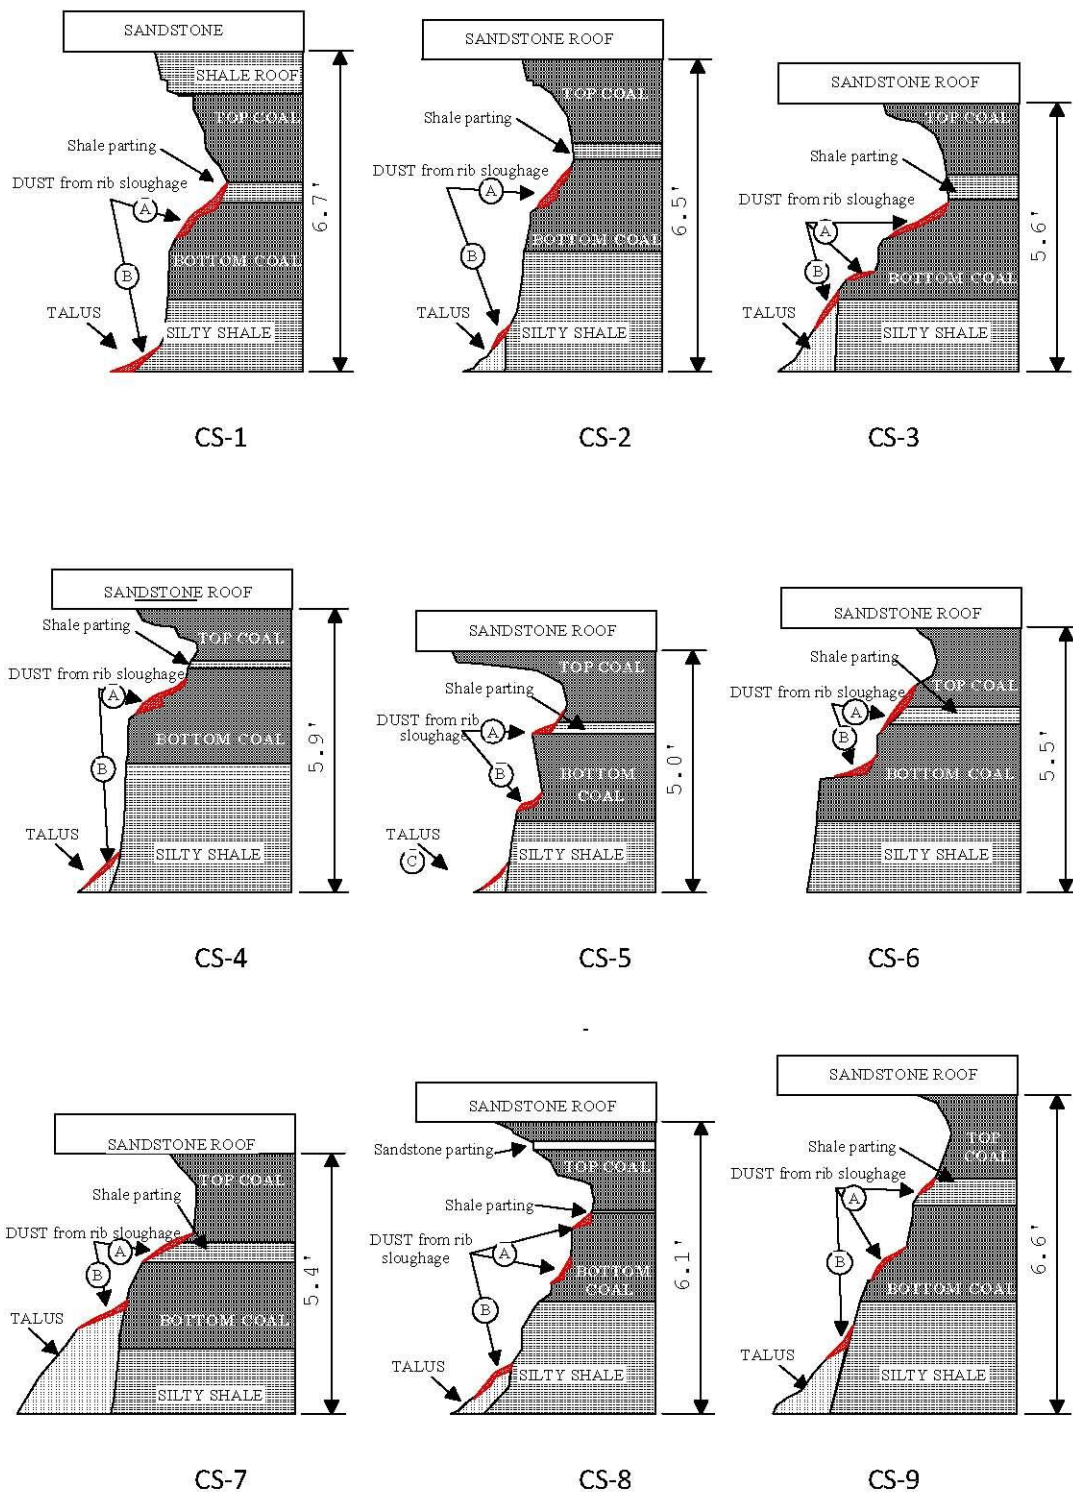
Figure 2. Geologic profiles where samples were collected of spalled rib dust that had accumulated in the 1.5 years since the explosion.

A close examination of the rib outlines indicate that much material was spalled off during the passage of time. The ribs as originally cut with a continuous miner would have been a straight line roof to floor. Top Coal spalled might yield more than the lean mixture needed to propagate an explosion. Additionally, spalled material was observed to have been ejected 10 feet or more from ribs and would be in addition to float dusts generated by mining. Fine accumulations are sometimes difficult to appreciate visually, but they are what pose the greatest risk of explosion. The fine sooty dust, contributed by the fusain partings of the Top Coal are unusual in their abundance. What might have happened at UBB is that the aggregated concentrations of float dust and rib spalling created a hazard that was not appreciated because it didn't "look that bad" and/or the dust contributions from mining seemed remote and insignificant.

The spalled dust found after the explosion did not exist at all locations in the same quantity, but where it did collect it would be available to be dispersed and aid in the explosion propagation. These ledges and dust deposits are formed naturally, over time and are believed to have been available prior to the explosion as elevated horizontal locations to collect additional float dust. This natural collection of dusts and the deposition of float dust created by normal mining emphasize the need for repeated rock dusting.

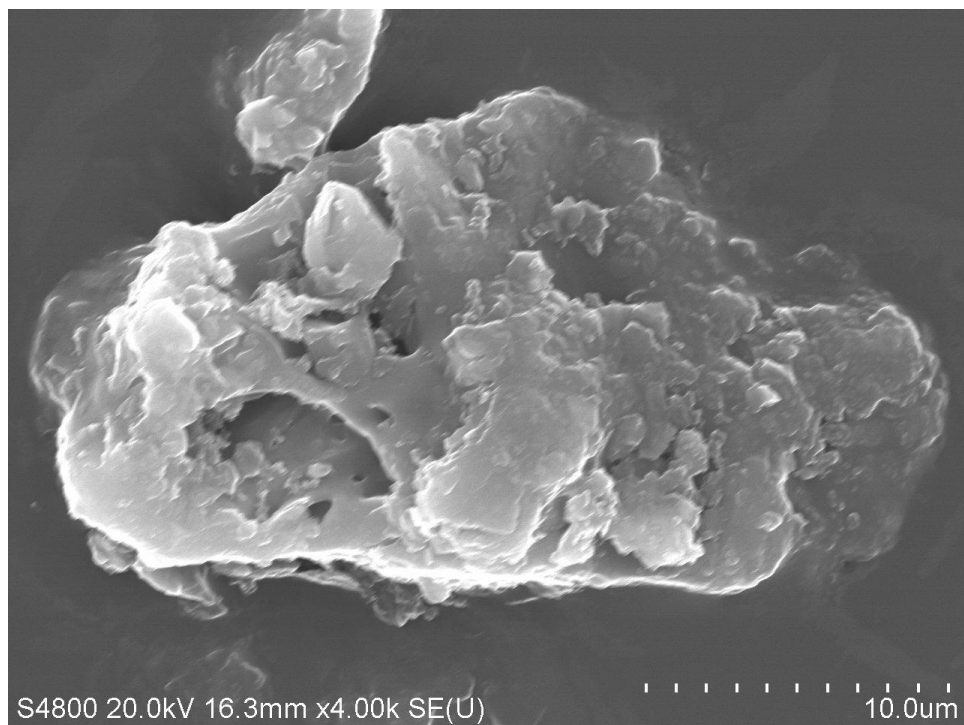
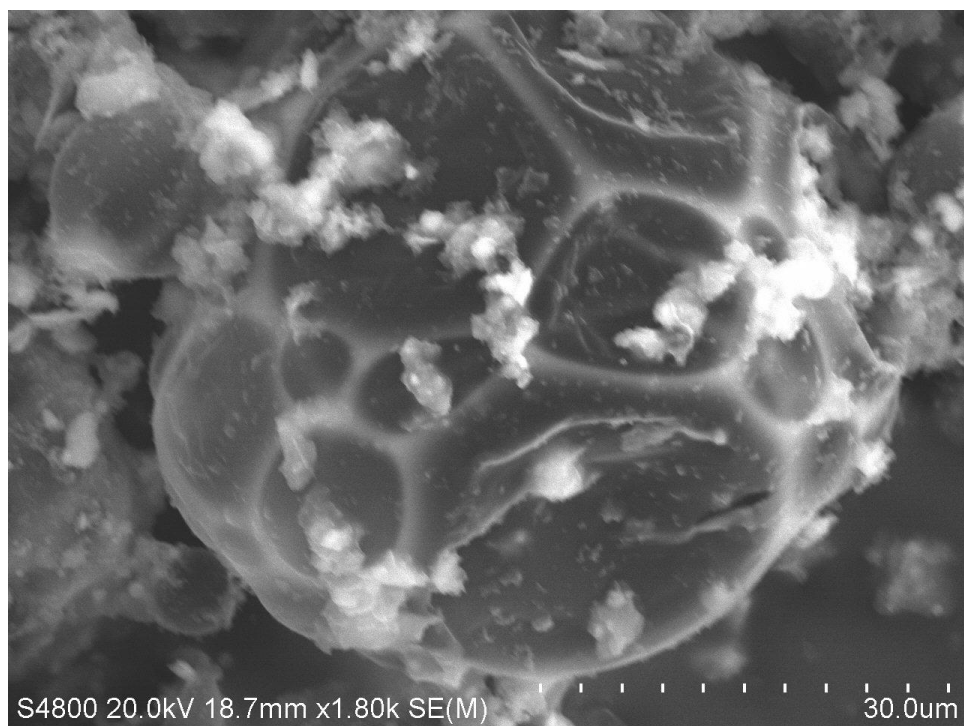
Figure 1.- Examples where heating was sufficient to at least melt the surface of particles producing rounded edges and smooth or wrinkled skin, and to produce sufficient vapor pressure to create blisters and blowholes.

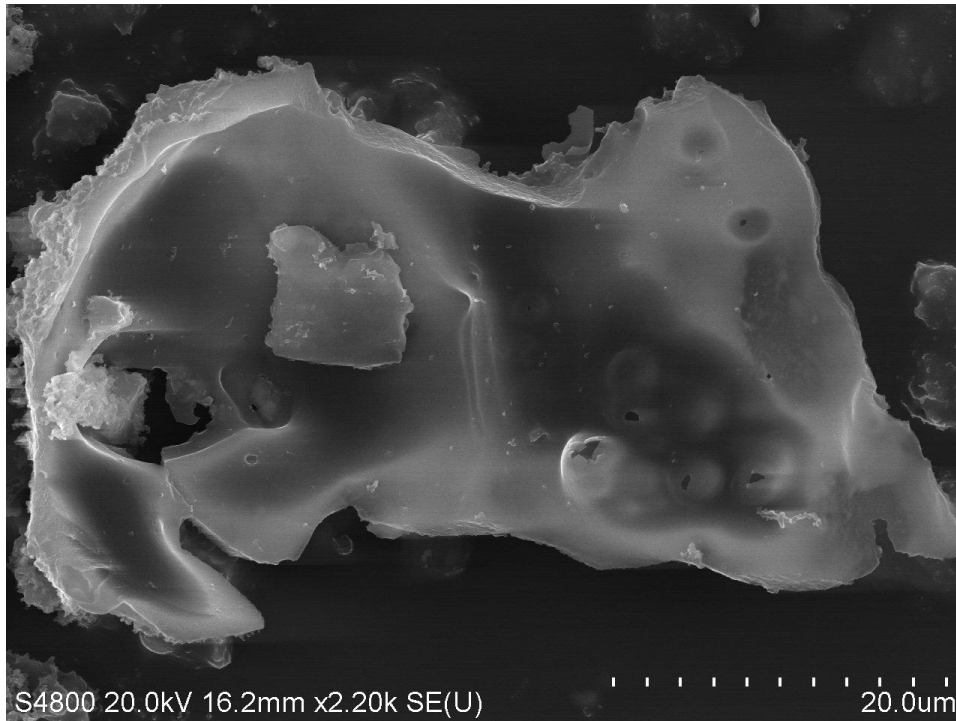
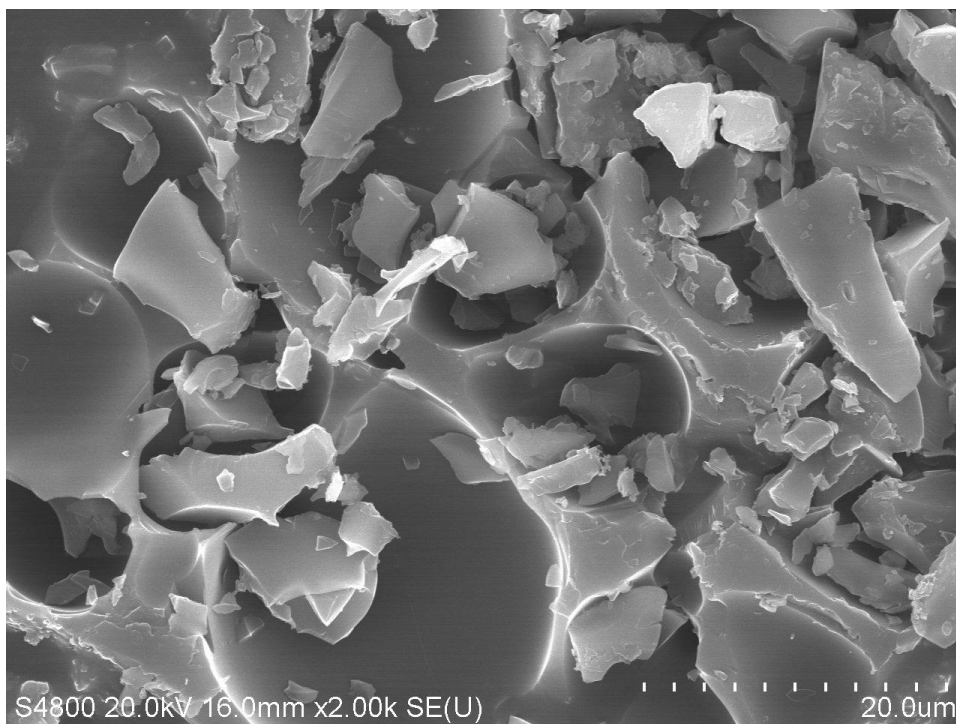
Figure 2.- Examples of particles and fragments showing a higher degree of heating were those which featured the skeletal remains of the original particles.

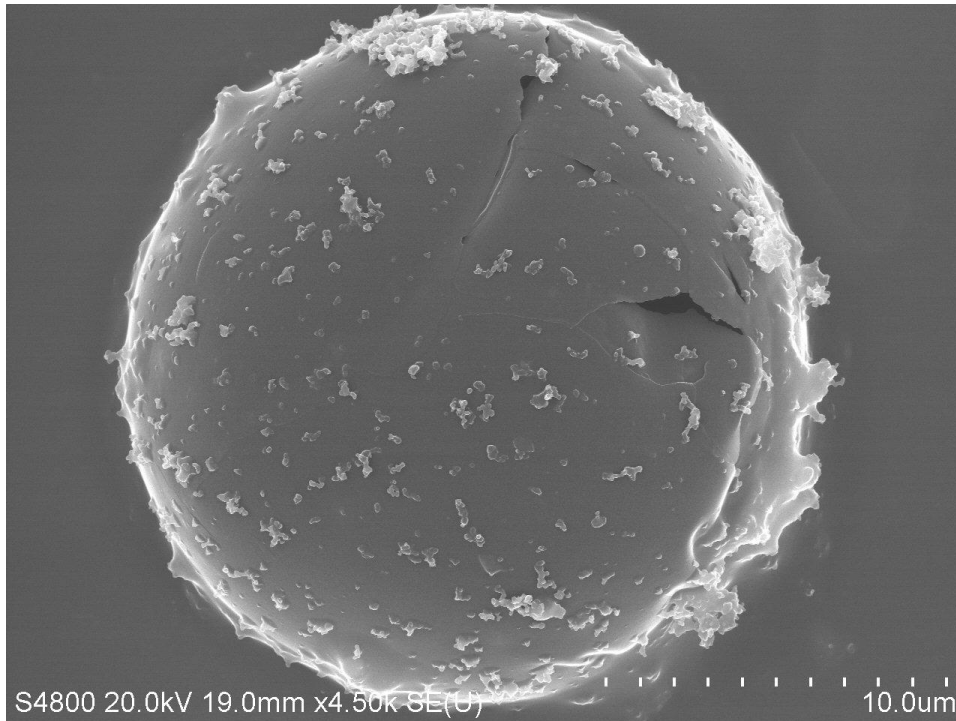
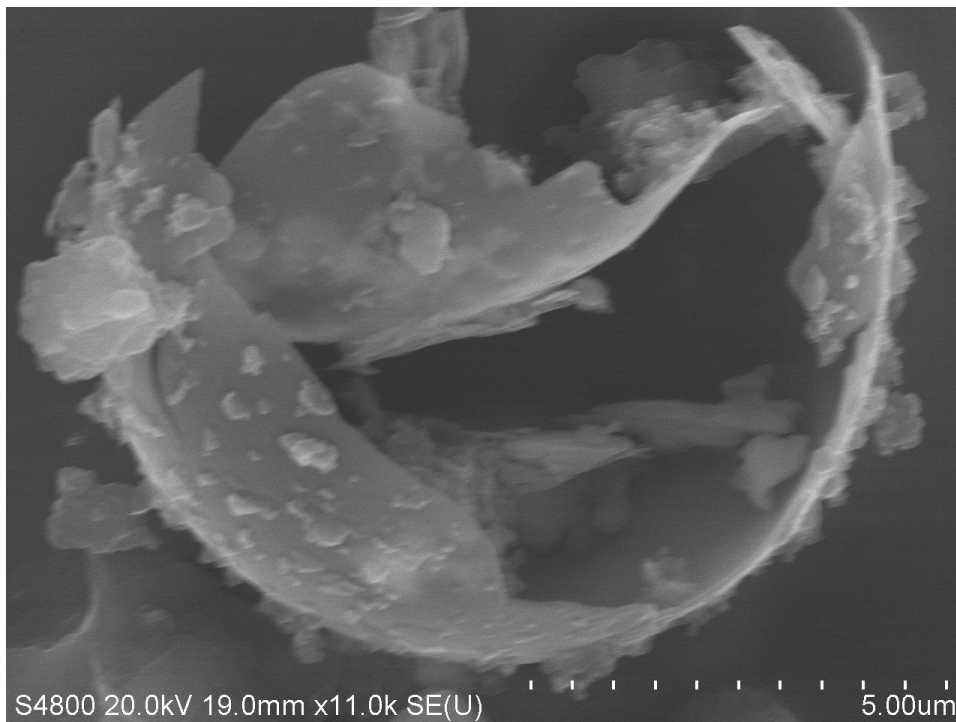
Figure 3.- Examples of particles with the highest degree of heating which formed ash-rich, hollow spheres.

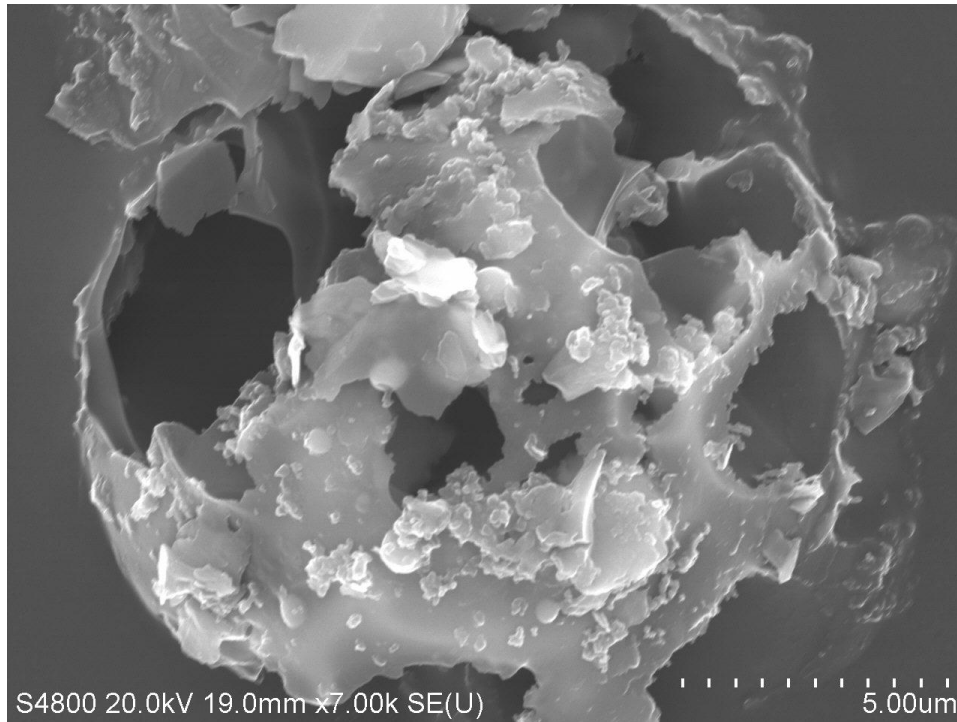
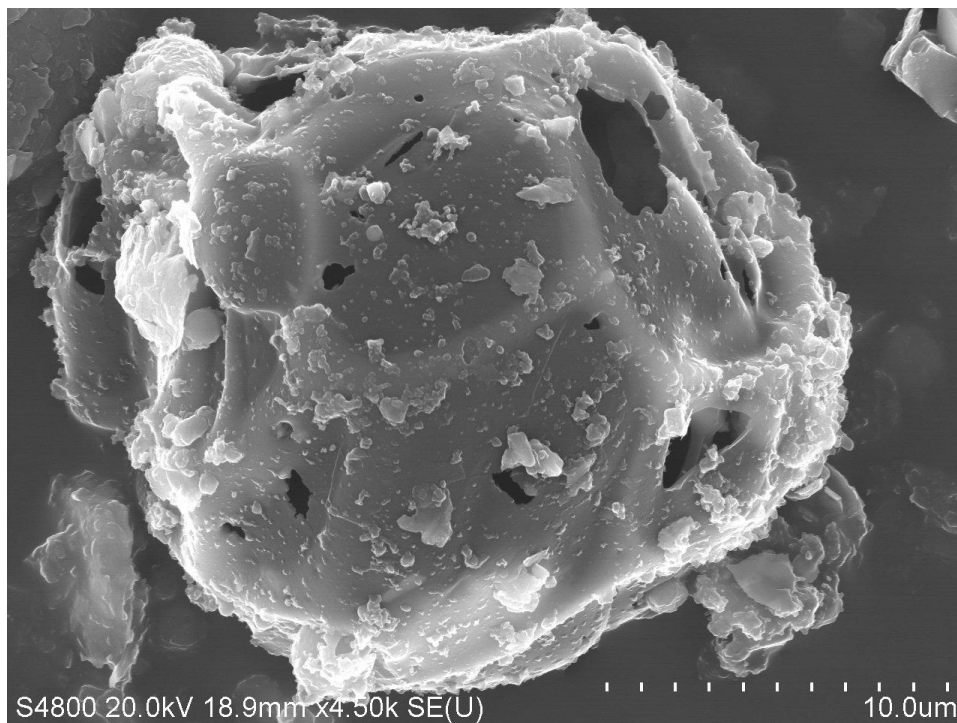
Figure 1a (899238HF); 1b (899235HFc). Examples of particle residues consisting of spherical and near spherical thin hollow shells with large holes are shown. One or several 1 μ m spheres that appear to be cenospheres are visible.

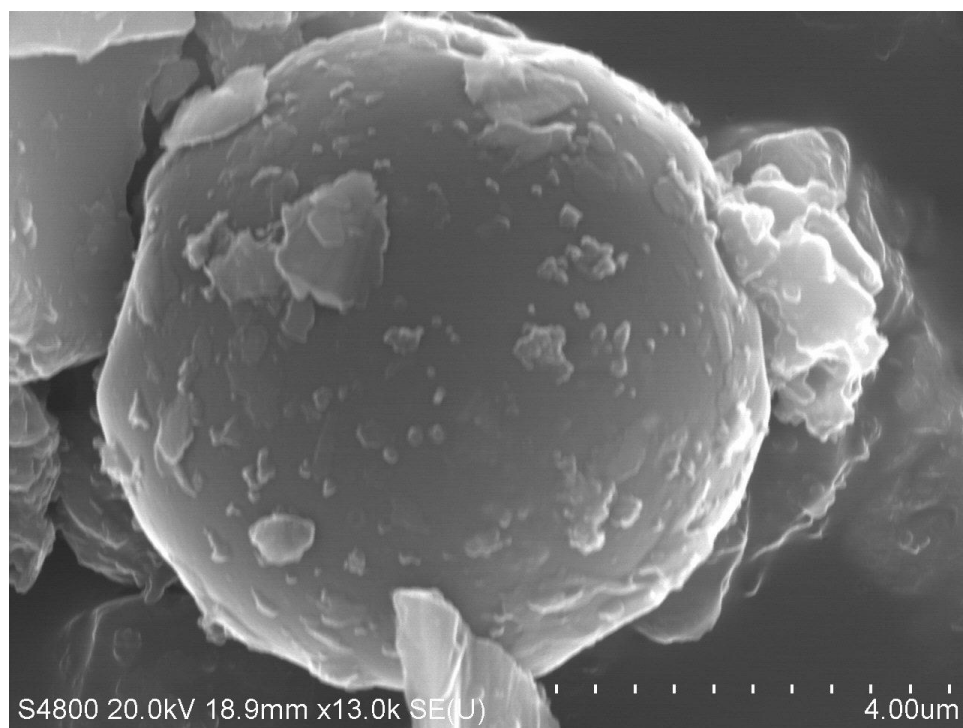
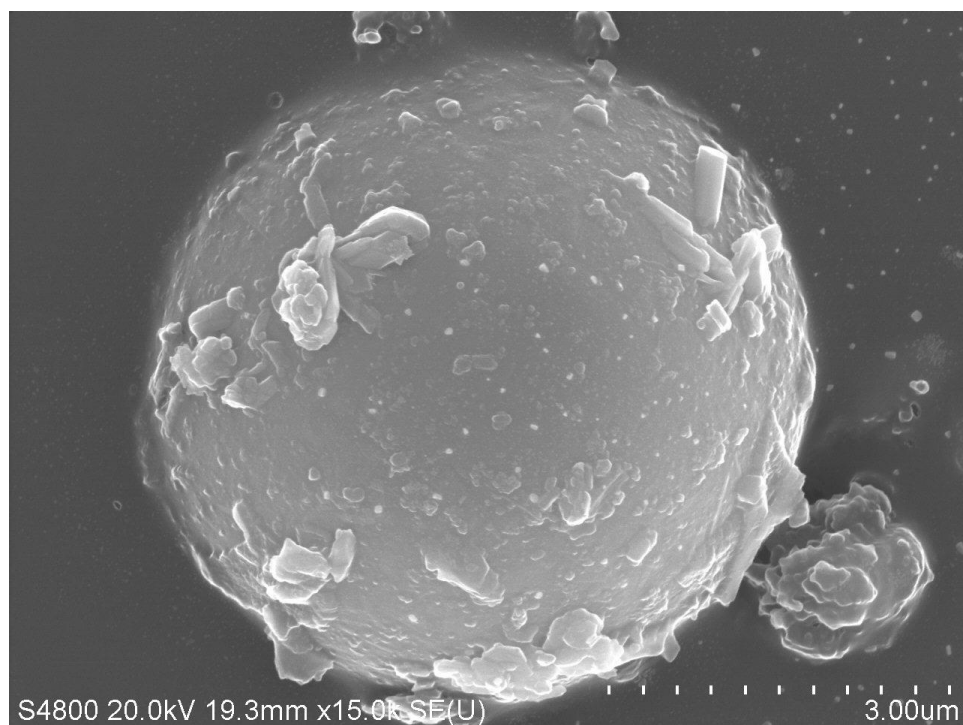
Figure 2a (899235HFe); 2b(899740HFc). Round particles.

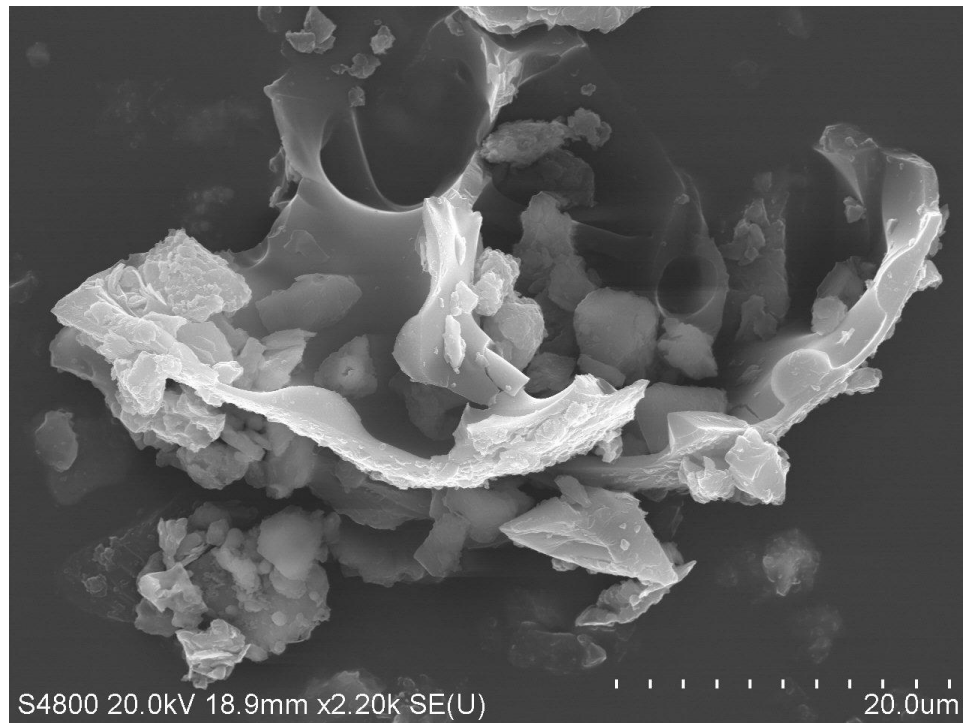
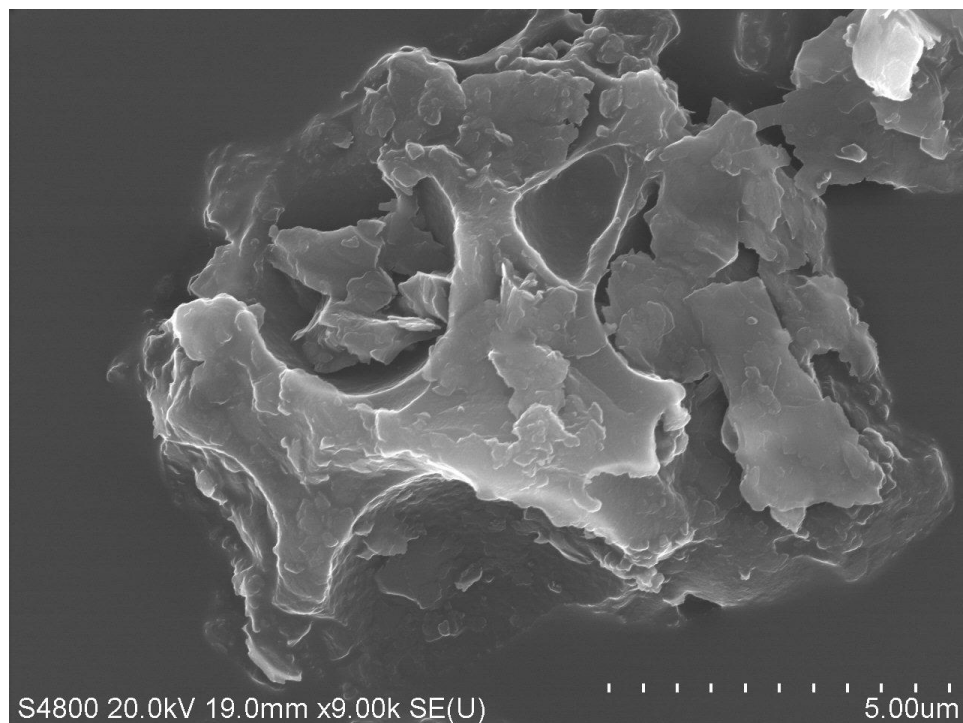
Figure 3a (899235HF); 3b (899235HFa). Cellular particle fragments.
