**REPORT of INVESTIGATION
into the
MINE EXPLOSION at the
UPPER BIG BRANCH MINE**

APRIL 5, 2010

BOONE / RALEIGH CO., WEST VIRGINIA

**WEST VIRGINIA OFFICE of MINERS' HEALTH,
SAFETY & TRAINING**

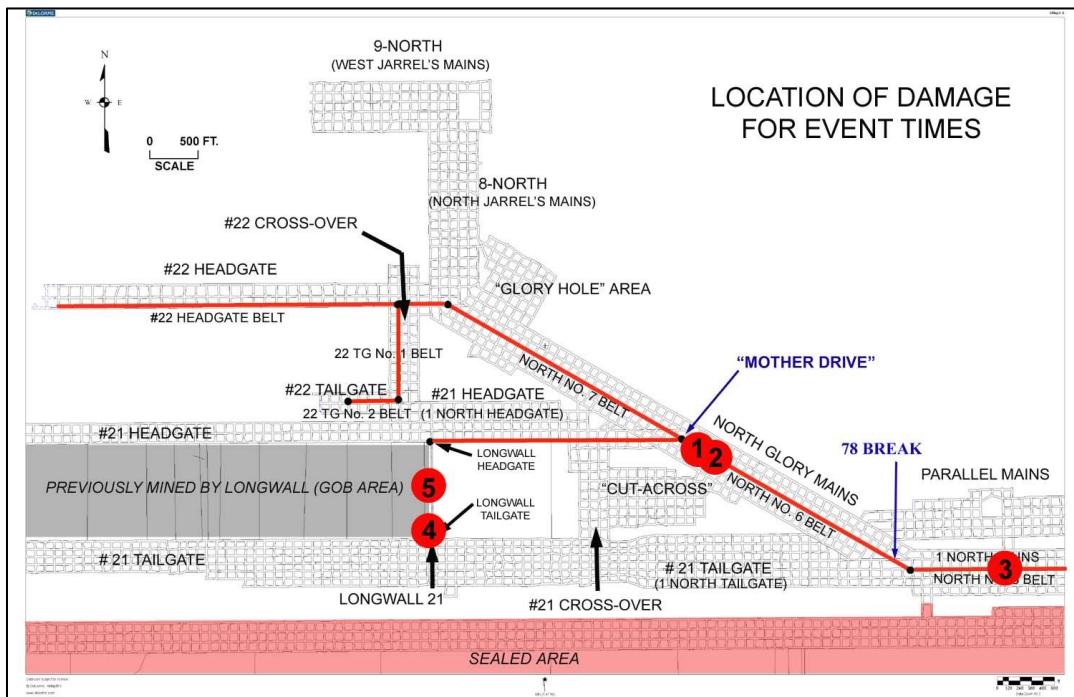
Figure 3. Location of events and damage summarized in the timeline below.

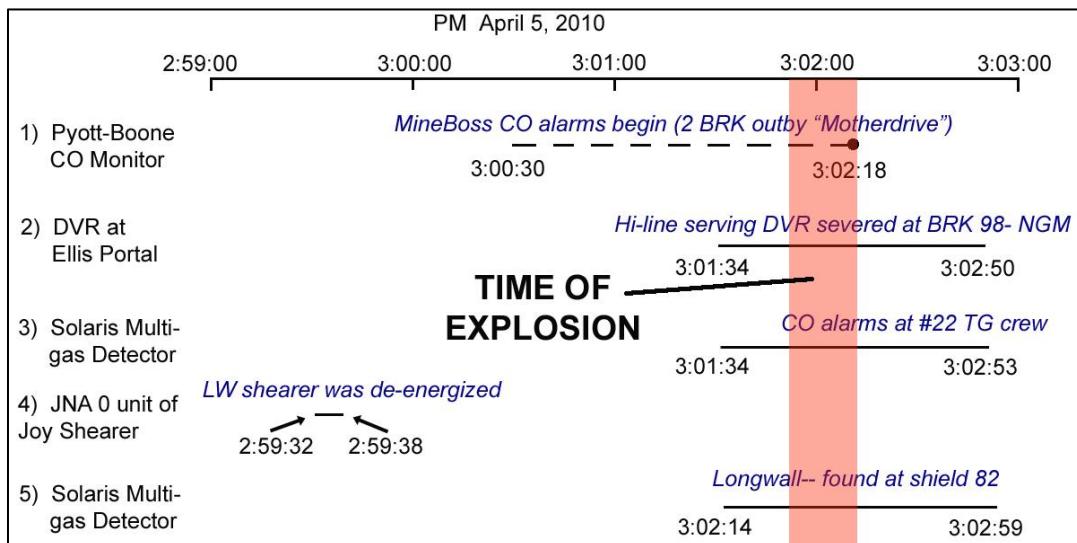
All of the surface power for Ellis Portal was supplied via the Green High Voltage 12,470 volt circuit, which originates at the main substation located at the UBB North Portal. A digital video recorder (DVR), installed on the surface at the Ellis Portal, was powered by this circuit. As was the mother drive (longwall belt drive), located at crosscut 102(see **Figure 3**). This circuit received enough damage around crosscut 98 to de-energize the power. The internal clock on the DVR stopped at 2:57.00 p.m. on April 5, 2010 due to power loss. After calculating time drift and factoring in that the DVR records a time stamp in one minute intervals, the actual time is from 3:01.34 to 3:02.50⁹ (see **Figure 4**).

Figure 4. The timing of events around the time of the explosion (corrected for clock drift) expressed as a range. NOTE: 3:02:18 p.m. is the first CO alarm, corrected for clock drift, and 3:00:30 includes the possible delay in the Pyott-Boone system response. See **Figure 3** for locations.

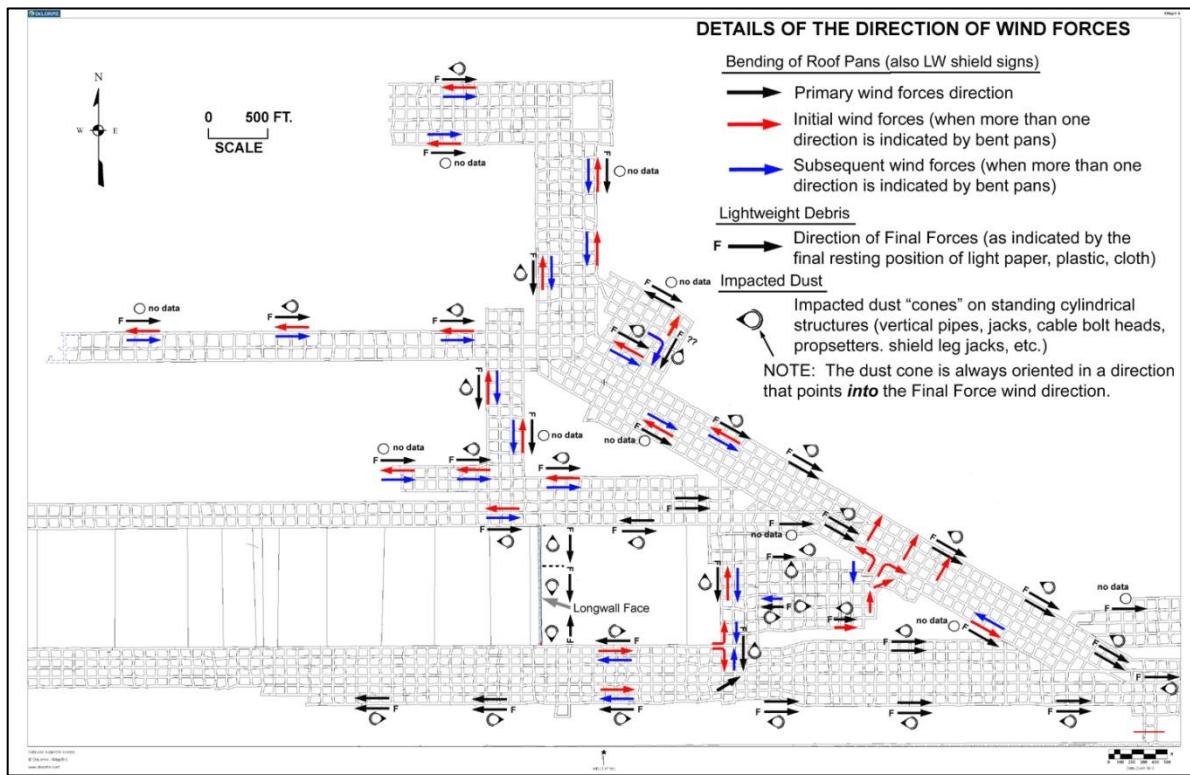
The origin of the explosion was determined initially by a process of elimination. Locations where explosion forces first propagated into, then propagated out of, cannot be where the explosion originated. Using the various tools and methods described in the report appendices, the sequence and direction of explosion wind forces can be established. Some of the essential information is summarized in **Figure 5**. Based on this information, candidate locations for the explosion origin were reduced to just a few possibilities. It was determined that the Tailgate region of the longwall was where the explosion began. Subsequent work narrowed the location further.

Figure 5. There are multiple directions of wind forces during a mine explosion. Using indicators of **initial** wind forces and **final** wind forces the explosion candidate locations for origin can be inferred. See **Section 7.9, Map 15** for larger map.

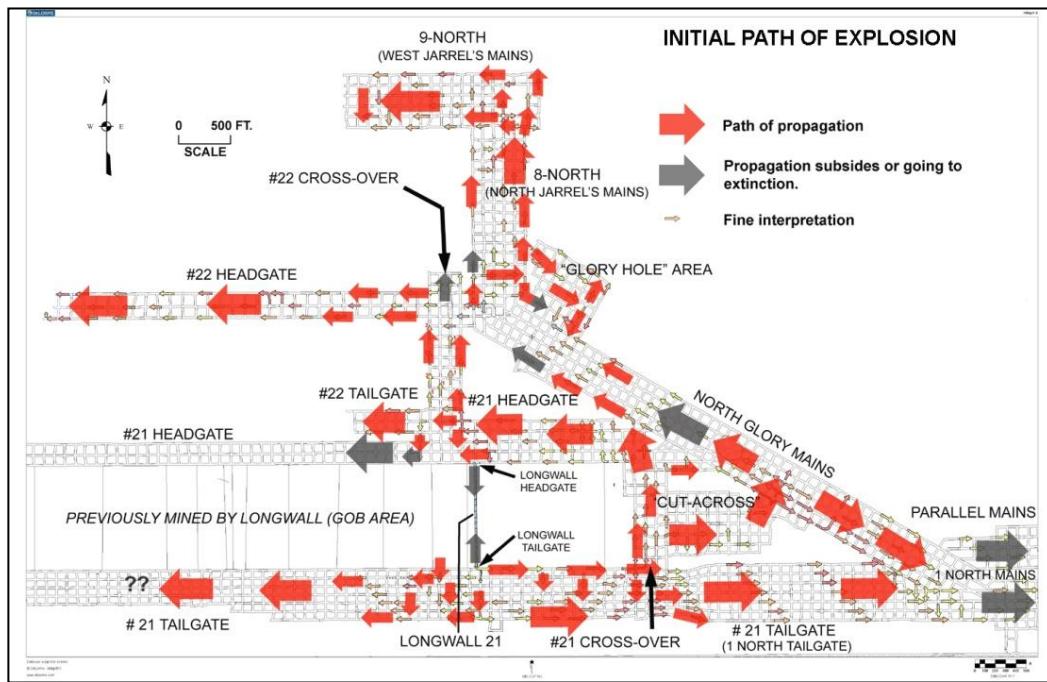
Information contained in the *West Virginia Flames and Forces Map*, various compilations of summary maps, and other information were used to determine the likely initial path of the explosion through the mine. This appears in **Figure 7**.

Initial explosion forces in #21 Tailgate propagated westward toward the Bandytown fan and also eastward toward the #21 Cross-over. Eastward, the leading edge occupied the #7 entry until the #21 Cross-over was reached, and from there the flame speed in the southern entries increased relative to the northern entries, producing high pressure damage to roof pans and resulting in the #1 entry assuming the leading edge. East of the #21 Cross-over the leading edge remained in the #1 entry of #21 Tailgate for the remainder of its initial propagation to approximately the switch near break 78 , where propagation subsided to extinction.

A branch into the #21 Cross-over propagated north and then branched eastward into the southern entries of the Cut-across, continuing eastward. These wind forces necked down to just three entries when they merged with the North Glory Mains, resulting in increased pressures and severe damage to roof pans and belt structures in the crosscuts of North Glory Mains at this confluence. The explosion quickly subsided to extinction to the northwest of the confluence. Southeast of the confluence the explosion leading edge was in the south entries, and propagation continued until reaching the 1 North Mains and Parallel Mains where the explosion quickly subsided to extinction.

Figure 7: After the explosion in the longwall gob exited into the #21 Tailgate, its **initial path** continued to find fuel and propagated along a path indicated with RED ARROWS. Indicated with GRAY ARROWS are locations where the initial explosion forces subside, due to lack of fuel or other factors.

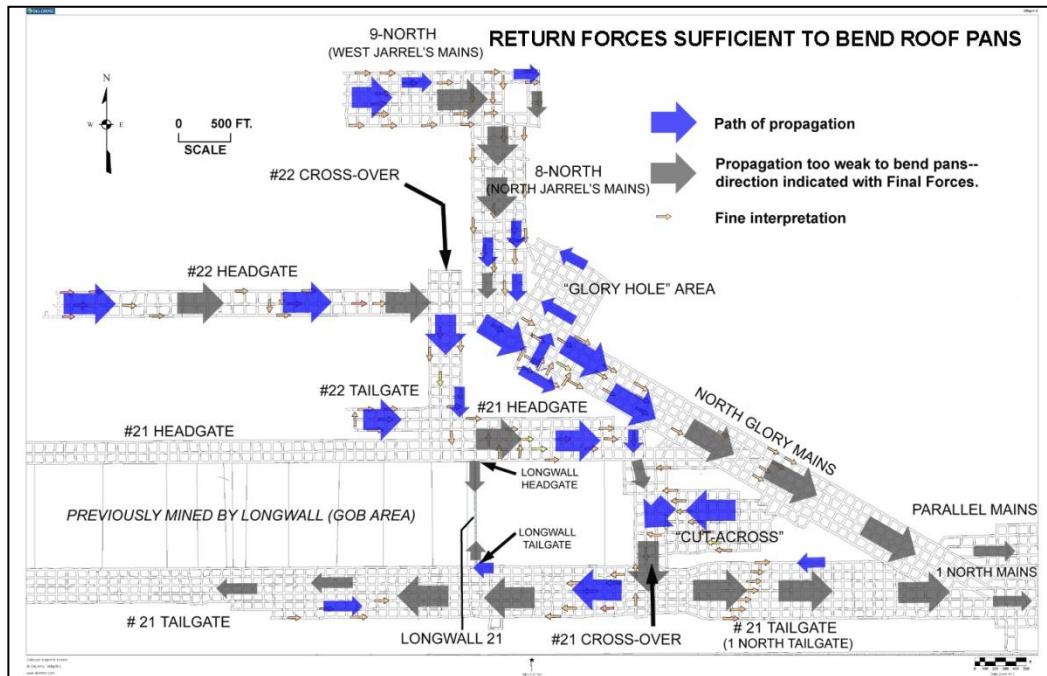
Figure 8: Return explosion forces of sufficient strength to bend roof pans are indicated with BLUE ARROWS. Indicated with GRAY ARROWS are locations where the initial explosion forces subside to extinction.

A sense of the relative strength of these secondary forces comes from the bending of roof pans. A summary of the subsequent bending of roof pans appears in **Figure 8**. The blue arrows show where explosion return forces were strong enough to bend roof pans. The gray arrows indicate

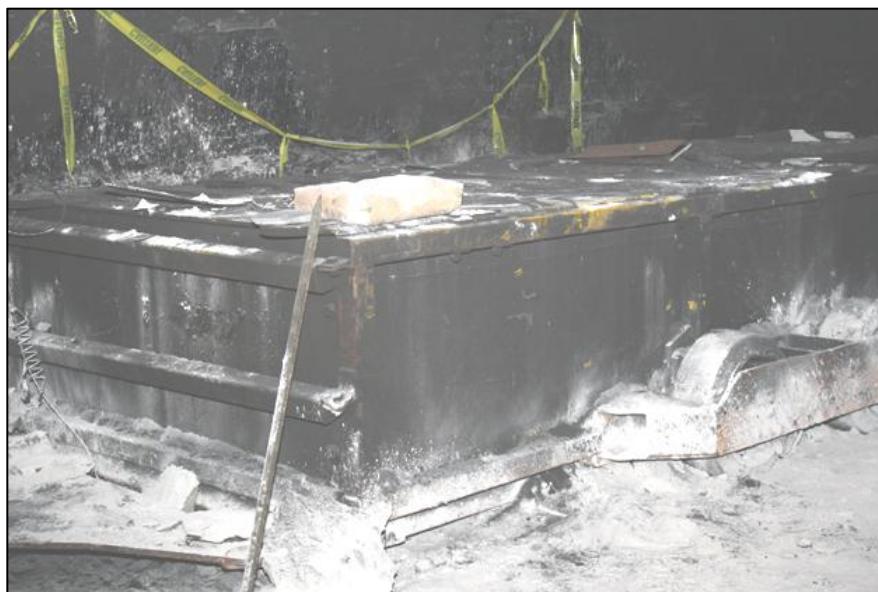
Figure 2. Strata Emergency Shelter/Refuge Chamber; #22 Headgate, approximately 20 feet north of survey station 24548 in the #2 to #3 crosscut approximately 1,060 feet outby the furthest advanced #1 face.

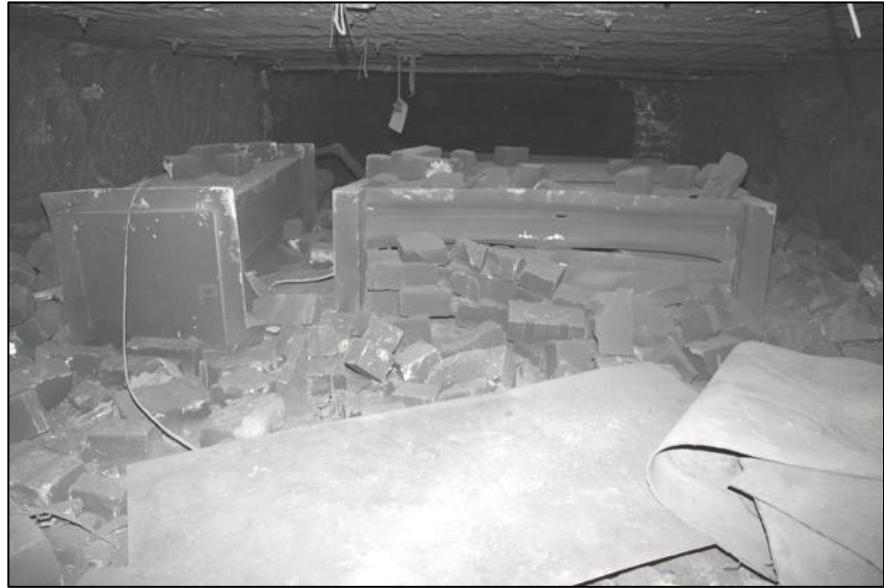
The second outby refuge alternative was located in the North Glory Mains at crosscut 89 between #3 and #4 entries, directly northwest of survey station 19698. The forces and pressures of the explosion destroyed the concrete block partitions and damaged the components of both of the erected outby refuge alternatives. The solid block walls erected as enclosure walls for the workers' refuge area were almost completely displaced. The bottom row of blocks and a small portion of the north end wall on the Outby Tailgate Refuge Alternative remained in place. Metal compartments with airlock doors integrated into the pre-built block room, where the workers would be housed during a disaster, were dislodged. Some of the access doors provided to the compressed air cylinders were damaged and open. Numerous compressed air cylinders enclosed in the shelter area were moved by the explosion forces but were intact. Although these shelters are not required by West Virginia Mining Law they were put in place as an additional alternative for workers in the event of a mine emergency.

Figure 3. This Mine Lifeline LLC Outby Refuge Alternative was located in the North Glory Mains at crosscut 89 between #3 and #4 entries, directly northwest of survey station 19698.

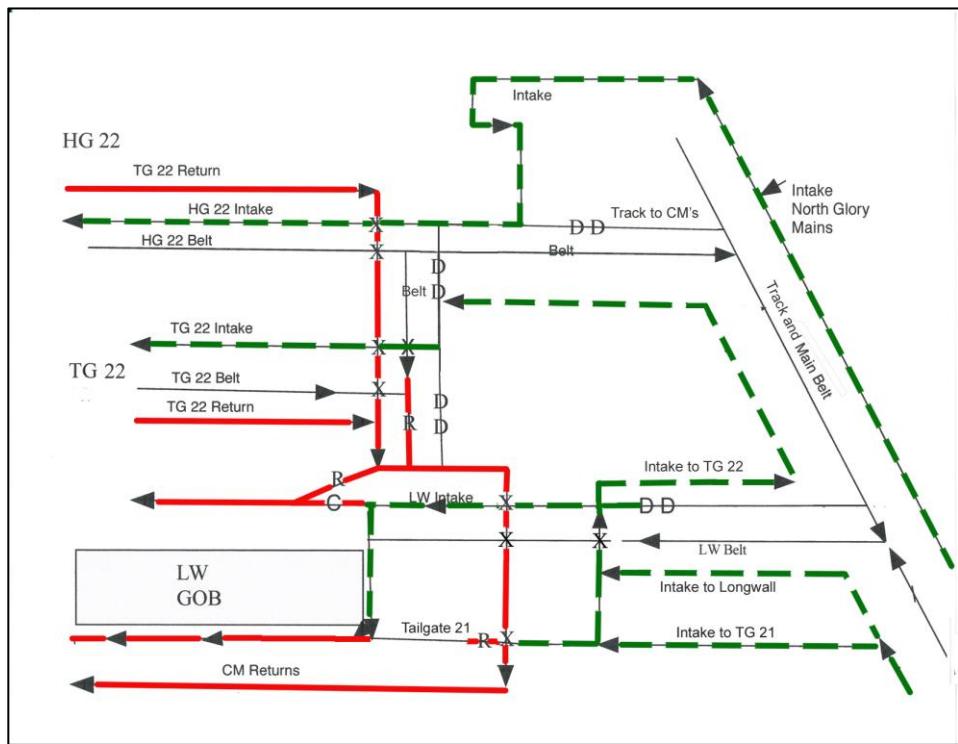
Figure 2: Schematic diagram of the approved ventilation plan at the time of the explosion

The ventilation system had some conditions that detracted from its effectiveness. The longwall headgate and tailgate air splits were connected together at the inby end of the panel through the longwall set-up rooms, and the headgate and tailgate entries were separately regulated inby this connection. The regulators were inby the longwall set-up entries, which remained at least partially open and provided a connecting path between the gate entries. Therefore, each regulator affected both the headgate and tailgate splits, leaving the amount of air in either split depending upon the relative resistance of the air courses. This situation caused the pressure across the longwall gob to be equivalent to the resistance on the longwall face and air course resistance. The returns for the continuous miner sections and a portion of their belt air which was regulated into the return were common in #1 and #2 entries of #21 Tailgate but separate from the longwall returns, except that some continuous miner section return may have entered #3 entry of #21 Headgate through EP-65.⁴ Increasing the longwall return regulation would result in minimal increases on the continuous miner sections and reduce the flow in the longwall section.

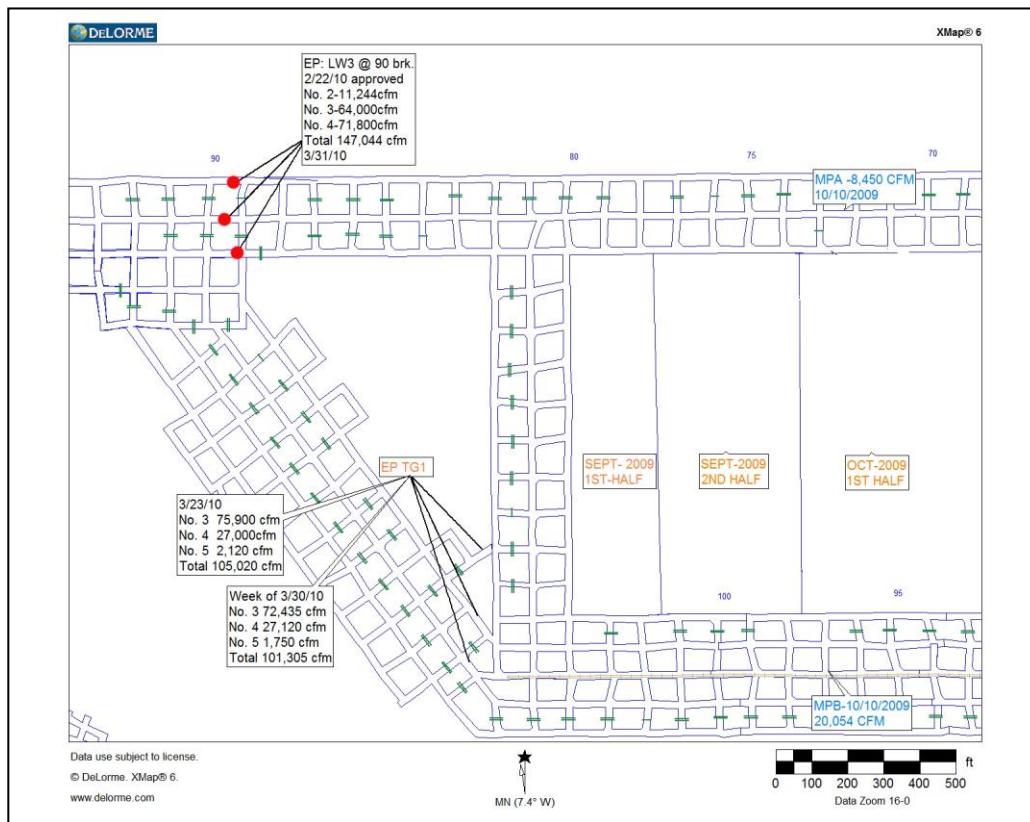
The regulator could have been closed off. This was also an evaluation point, EP-65, requiring a weekly air reading; none was found. The headgate entries had a quantity of 50,200 cfm recorded in the last weekly measurement at MP-36, located at crosscut 37. A problem exists in air balancing between MP-36 and EP LW-3, located in the headgate entries inby MP-36, where 147,000 cfm was measured the week of March 30, 2010. This is a difference of about 97,000 cfm that cannot be accounted for. It is possible the EP LW-3 location is such that some air from the tailgate entries were measured twice, which could account for the discrepancy (see **Figure 4**). Also, it appears that some of the EP LW-3 readings were taken in regulators, which introduce opportunities for inaccuracies.

Figure 4. Portion of mine map showing the location on EP LW-3 and tailgate measuring locations.

The #21 Tailgate entries #3 through #6 had air currents moving toward the longwall face. The weekly reading for March 30, 2010, at #3 through #6 entries had a combined total of about 43,500 cfm. The air velocity in these entries ranged from about 59 to 114 feet per minute (fpm). This leaves an uncomfortable situation with such low velocities, not enough to control methane layering⁵ or, for that matter, to have much energy to move methane away. The #7 entry readings were not available, but using information from the MSHA model about 10,000 cfm could have been moving inby in #7 entry. We have no record of the amount of air in this entry. The NIOSH model (WVMHS&T only has a draft of this model) shows 51,000, and the MSHA model shows 54,200 total in all tailgate entries.

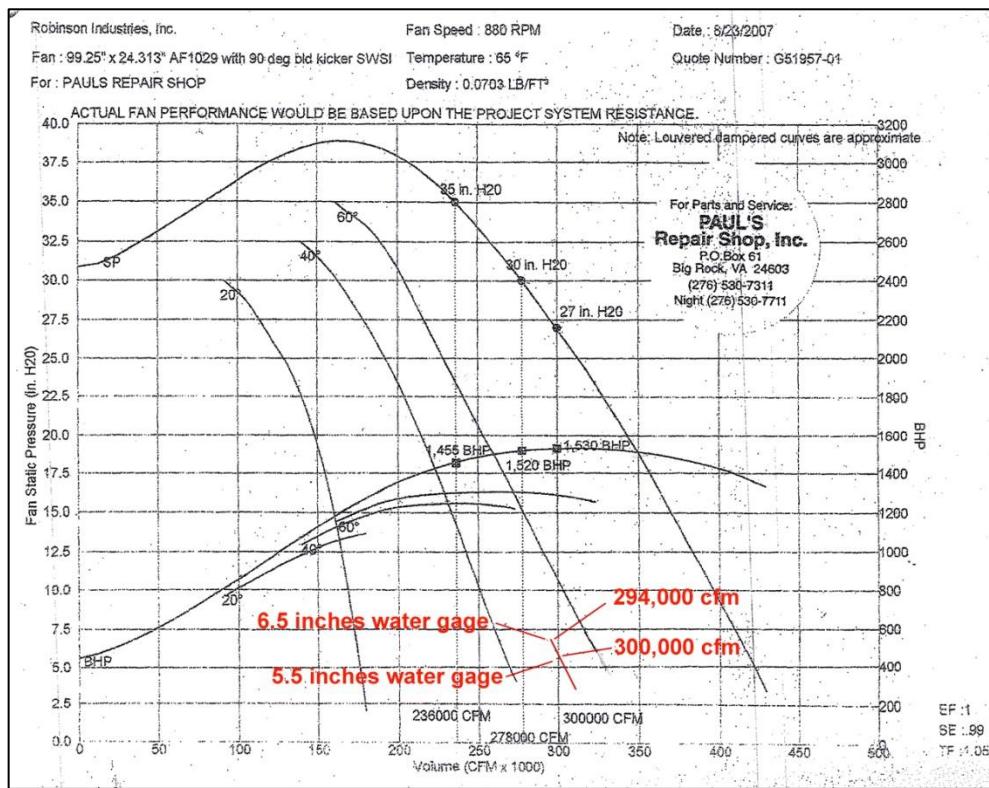
The investigators question the accuracy of the ventilation measurements at the Bandytown fan. Federal inspectors recorded quantities of 374,893 cfm on January 20, 2010, and 448,200 cfm on November 3, 2009. The latest mine examiner measurements recorded before the explosion were about 402,000 cfm.⁶ These measurements were taken in high velocity air currents, near or above 1,000 fpm, and in those conditions errors caused by measuring technique or condition of the anemometers have a significant impact on the results.

Immediately after the explosion, the Bandytown fan pressure reduced to slightly less than 3 inches water gauge. This extrapolates to about 315,000 cfm during the first few days after the explosion, and then the fan pressure gradually began to rise, (see **Figure 5** fan performance curves with operating points).

Figure 5. Performance curves for Bandytown Fan. The slope of the fan curve is such that the quantity increases about 6,000 cfm for each 1-inch drop in fan pressure.

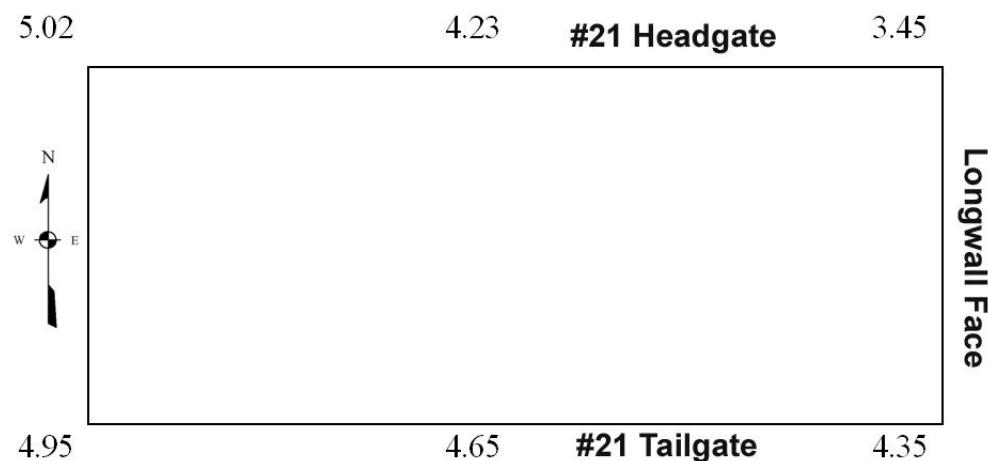
Figure 7. Sketch showing ventilation pressures in inches water gauge around the longwall gob, taken from the MSHA Ventilation Model. Pressure in the airstream is ventilating around the longwall gob. Pressures are negative and becoming more negative as one gets closer to Bandytown fan.

The longwall gob gases were probably expanding and exuding from the longwall gob at the time of the accident due to a decreasing barometric pressure. The barometric pressure had started increasing about 9 hours before the explosion, and about 11 a.m., or 4 hours before, had begun a decrease. At the time of the explosion it had decreased 0.07 inches mercury from the 11 a.m. high. Now, 0.07 is not much of a change but that amount is equivalent to 0.95 inches water gauge. The pressure across the gob created by the ventilating system was slightly less than 1 inch water gauge near the face; however, inby, about mid-point in the panel, the gob probably had no pressure across it from one side to the other (see **Figure 7**). Gas was likely exuding from the cracks in the mine floor just inby the shields where methane was found during the investigation. This gas was likely moving along the gob behind the shields and into the

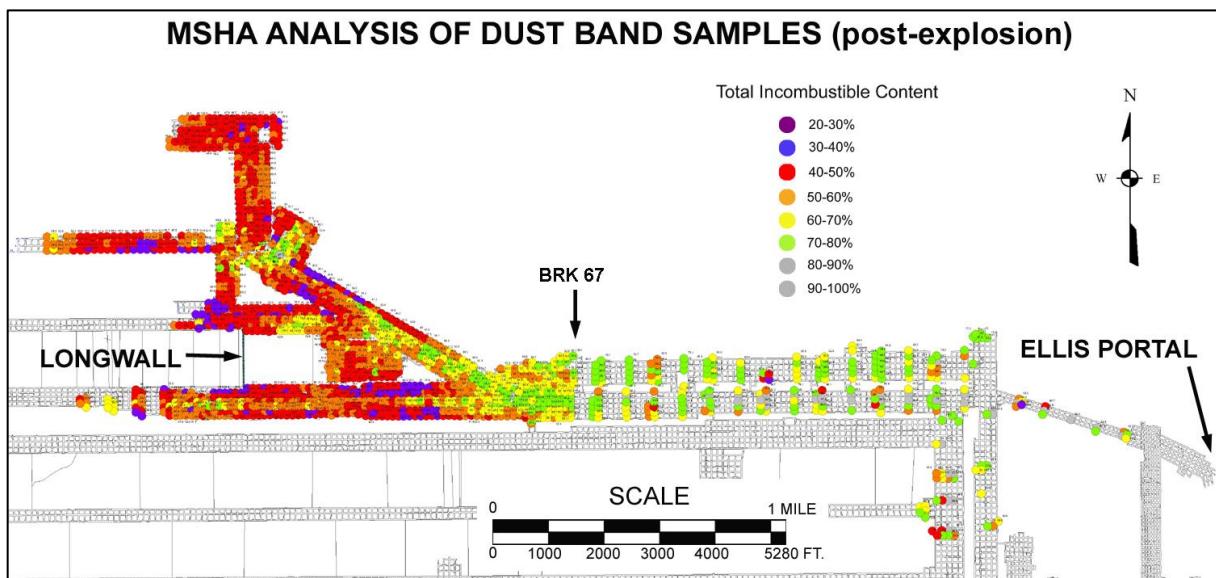
Ten dust collecting teams began collecting rock dust samples throughout the upper part of UBB in June 2010. The teams were led by MSHA and accompanied by members of the WVOMHS&T, Performance Coal Company and the UMWA. Approximately 1,803 samples were collected. The samples were sent to MSHA's Mount Hope lab to be analyzed for incombustible content and coke. They also were sent to an independent lab so the results could be verified. As illustrated in **Figure 10**, areas were sampled along selected profiles outby crosscut 67 and comprehensively sampled inby crosscut 67, the latter of which showed a generally deficiency of compliant rock dust amounts.

Figure 10. Locations (and results) of dust band samples collected after the mine explosion

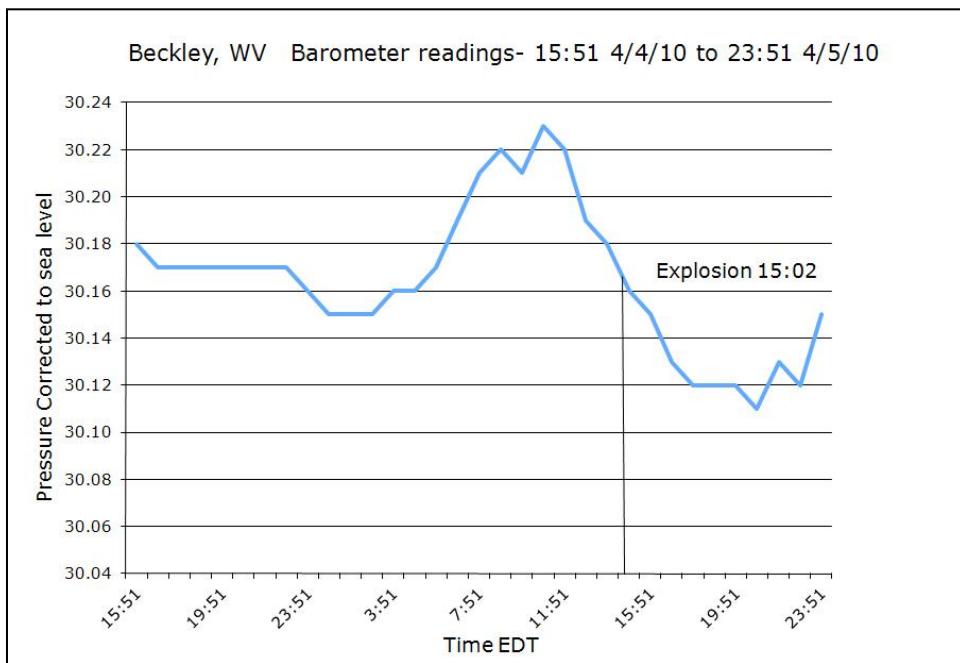
Rather than a dramatic outburst, it is more reasonable to believe that methane was liberated along the face in increased amounts caused by the breaks in the floor and from the gob, and that this increased liberation caused an undetected buildup against the gob behind the shields. Gas expansion, because of the decrease in the barometer 0.07 inches mercury or about 0.95 inches water gauge since 11 a.m., would cause additional methane to exude from the longwall gob, and this gas could come out near the face due to the ineffective pressure drop on the gob (see **Figure 2**). An unusual coincidence was discovered during a review of the ignition on the gob January 4, 1997. The barometer change was quite similar to the barometer trend during this explosion (see **Figure 6**).

Figure 2: Showing Barometric pressure decline prior to explosion

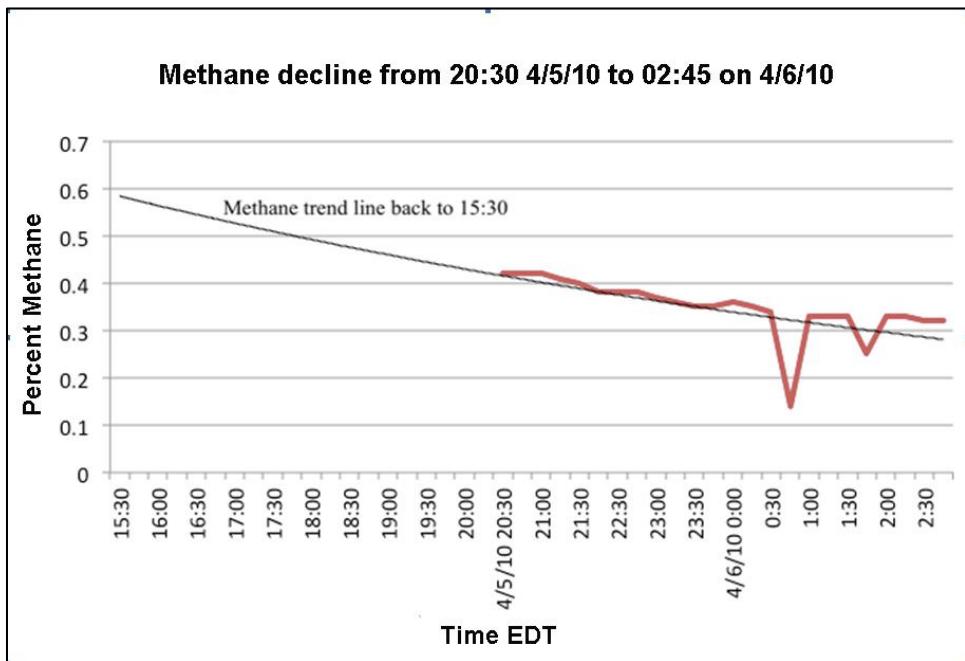
Figure 3: Methane trend after the sampling started projected back to 15:30

It is believed the combustion products started arriving at Bandytown about 3:30 p.m. and continued to be diluted and moved to the fan by the air currents. The combustion gases on the longwall gate entries and those mine openings in direct line with them should have been purged of the combustion gases within a few hours. Analysis of the gas trends suggest that about one-third of the combustion products had passed through the Bandytown fan by the time MSHA sampling was started at 8:30 p.m. (see **Figure 3**). Remnants of combustion gases remained in the continuous mining sections, the North area and Glory Hole area for some time until they were flushed out during recovery. The characteristics of this gas are found at Borehole #1 where sampling started at 10:55 a.m. April 7 (see **Table 2**).

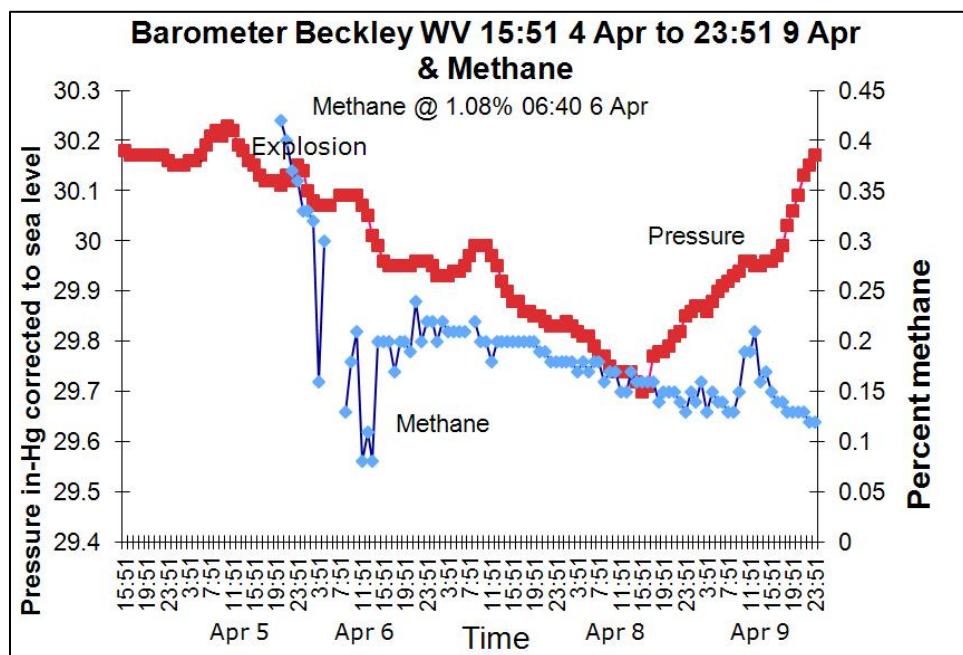
Efforts to use the ethane to methane ratio and determine how much of the methane coming out of the mine was from the floor cracks on the longwall face proved futile. Three gases that are combustion products, methane, carbon dioxide and ethane are also produced from other sources. Ethane is also contained in the floor cracks with methane. Carbon dioxide is also found in the mine returns and in increased amounts behind seals. Methane was normally liberated in the mine, and, in this instance, was entering the mine through the floor cracks. The primary gases in the mix that were only products of combustion were hydrogen, carbon monoxide and ethylene.

Figure 4: Showing barometer trend and methane at the Bandytown fan

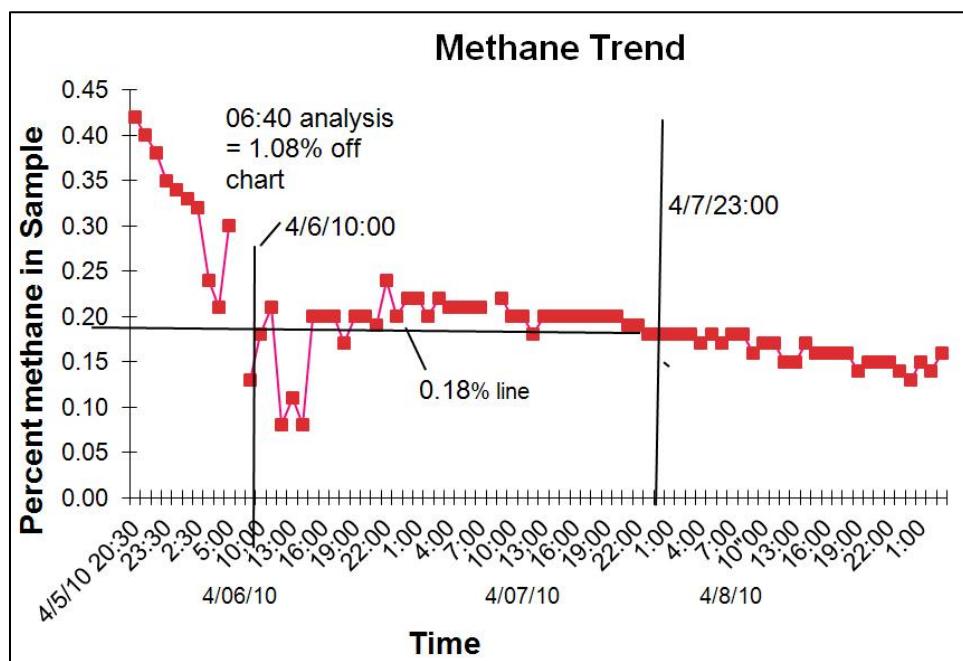
The trends of the methane, ethane and carbon dioxide varied significantly at 6:40 a.m. April 6. An air sample from Bandytown contained 1.08% methane as well as increased ethane and carbon dioxide. The increased carbon dioxide could only come from combustion or the sealed area. No one was in the mine at that time. The barometer had declined some additional amounts (see **Figure 4** for the pressure trend line) and could have been a factor. The increased methane and ethane could come from either combustion or additional liberation from the floor cracks. Other minor fluctuations occurred in the gas trends at intervals on April 6 while no one was in the mine.

Figure 5: Showing methane trends with time

It is believed that an increase in methane liberation from floor cracks behind the shields accumulated along the space behind the shields and was not moved away and diluted by the ventilation system. The excess methane observed coming from the mine after the explosion was from the combustion products, the floor cracks, and some from the large sealed area. The air analysis from samples collected at the shaft indicated that the methane content in the air reached near normal levels by 9:30 a.m., April 6, 2010, which was 18½ hours after the explosion. As the recovery work progressed the gases remaining began to be flushed out, increasing the methane content at the shaft until all areas were re-ventilated (see **Figure 5**).

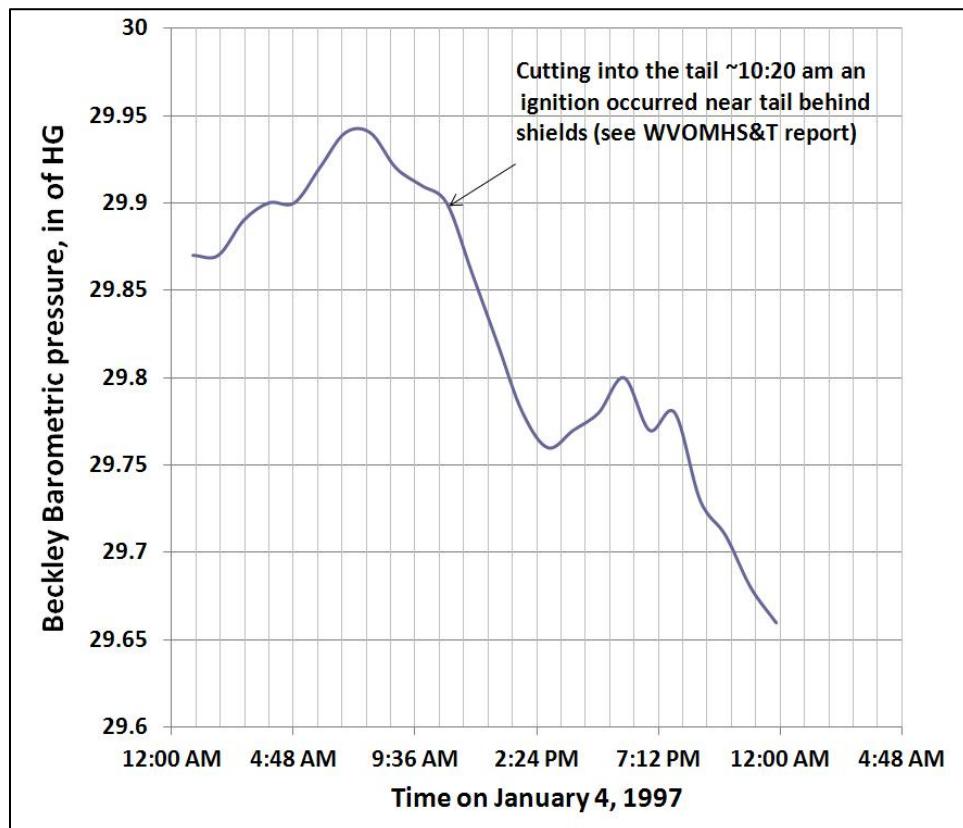
Figure 6: Barometer trend on January 4, 1997

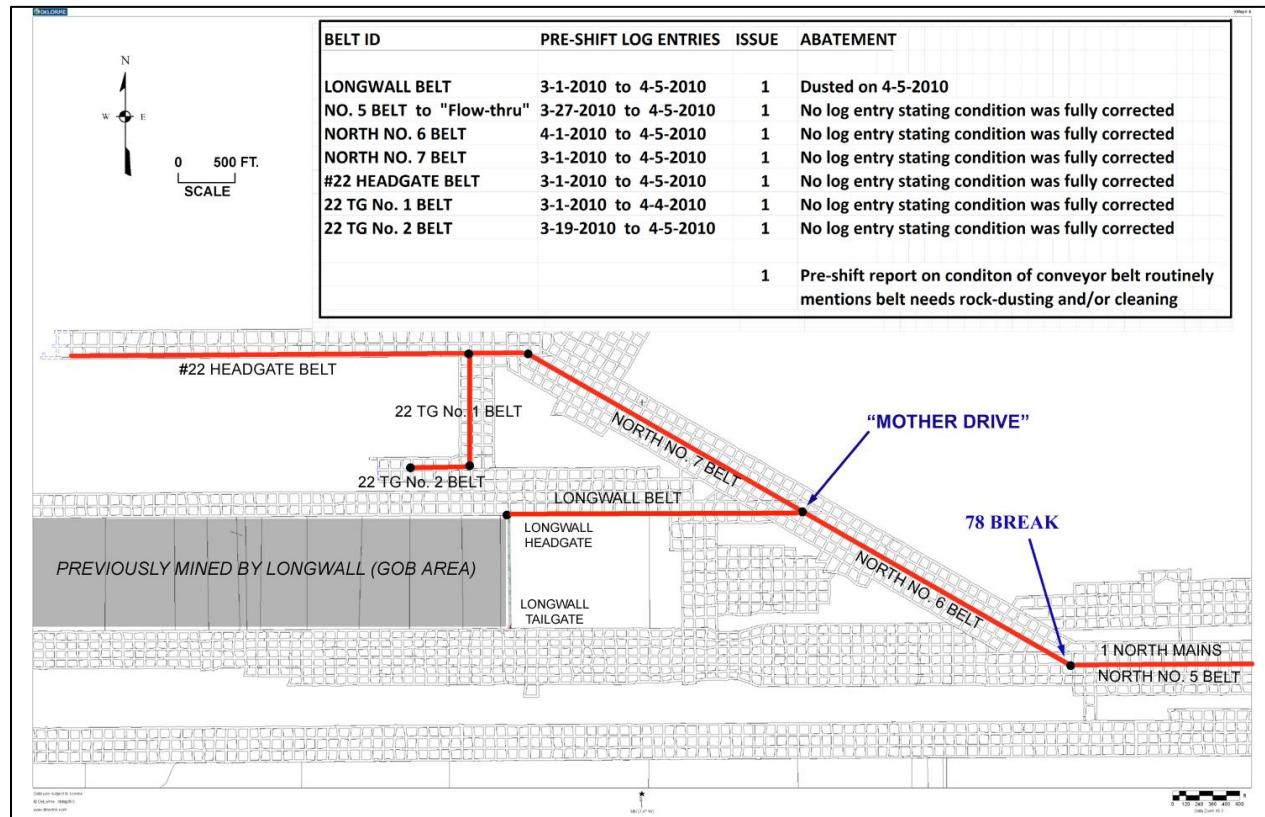
Table 4: Pre-shift log entries for the month preceding the explosion indicate the conveyor belts needed rock dusting /cleaning, but the condition was not confirmed to have been fully corrected.

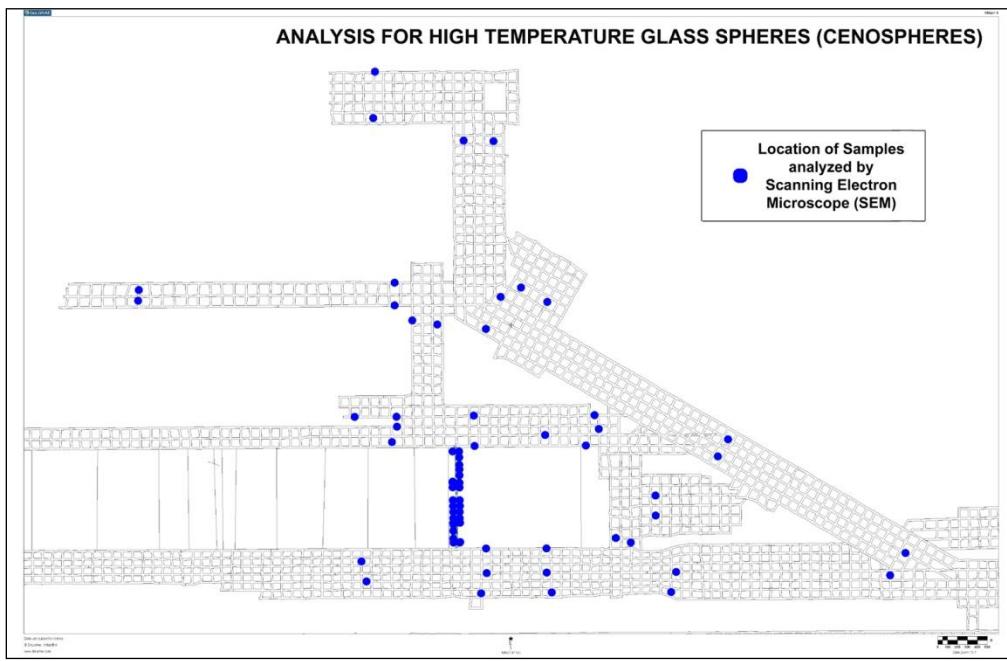
Approximately 65 samples of impacted dust taken at various locations by WVOMHS&T (see **Figure 8** for locations where samples were taken) were analyzed by NIOSH using a Scanning Electron Microscope. Nearly all 65 samples²³ demonstrate the presence of particles that have been heated, leading to the conclusion that coal dust participated in an explosion (see **Figure 9** for representative images of these particles).

Figure 8: Locations where impacted dust was analyzed for cenospheres. All locations had relatively abundant cenospheres, except for the Longwall, where cenospheres were present but less abundant.

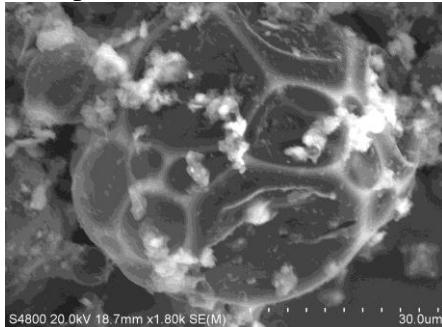
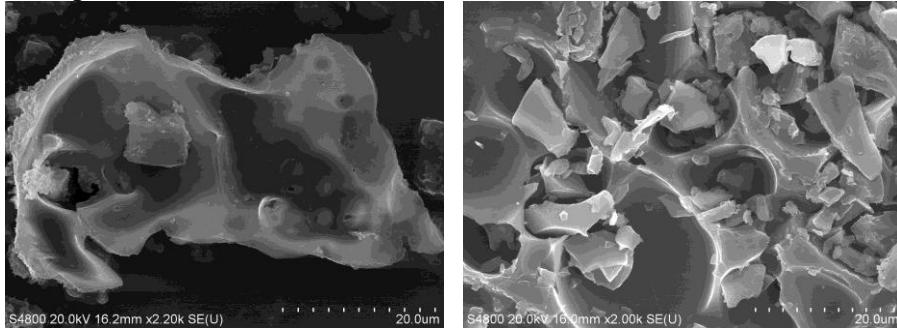
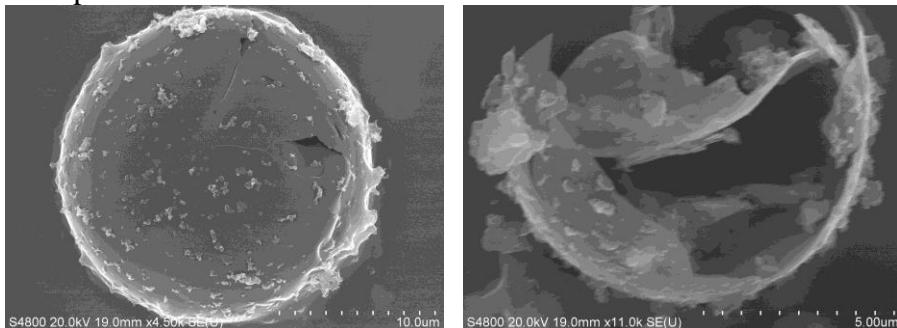
Figure 9: These photographs taken under a scanning electron microscope depict the type of burned residues present in the samples.
