<u>Slide 1</u> (Introduction). Begin 1st presenter: <u>Barry Fletcher</u>; Roof Control Specialist; Investigator

**Slide 2** We would like to begin the presentation with an overview of our investigation. This overview will be followed by a detailed account of our findings concerning the explosion which occurred on April 5, 2010 by Mr. Monte Hieb our Chief Engineer. We want to again thank you for your patience as we finalized our investigation and report.

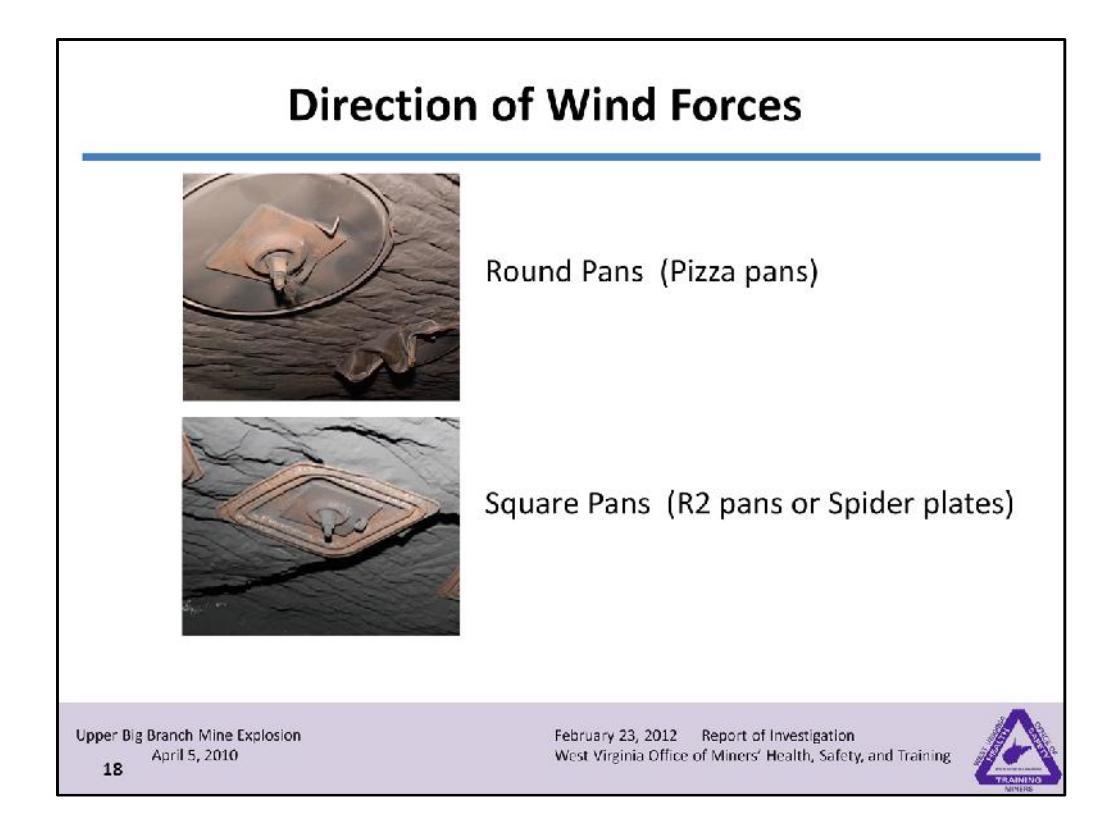
<u>Slide 18</u> One aspect of this effort focused on comprehensive documentation of the direction and sequence of wind forces through systematic description of damage to roof pans. Both round and square roof pans were typically installed under roof bolts at UBB as a supplemental roof control protection measure during mining. Explosion forces bent these and damaged their finish in ways that were useful for determining the direction the magnitude and the direction of propagation of explosion forces.

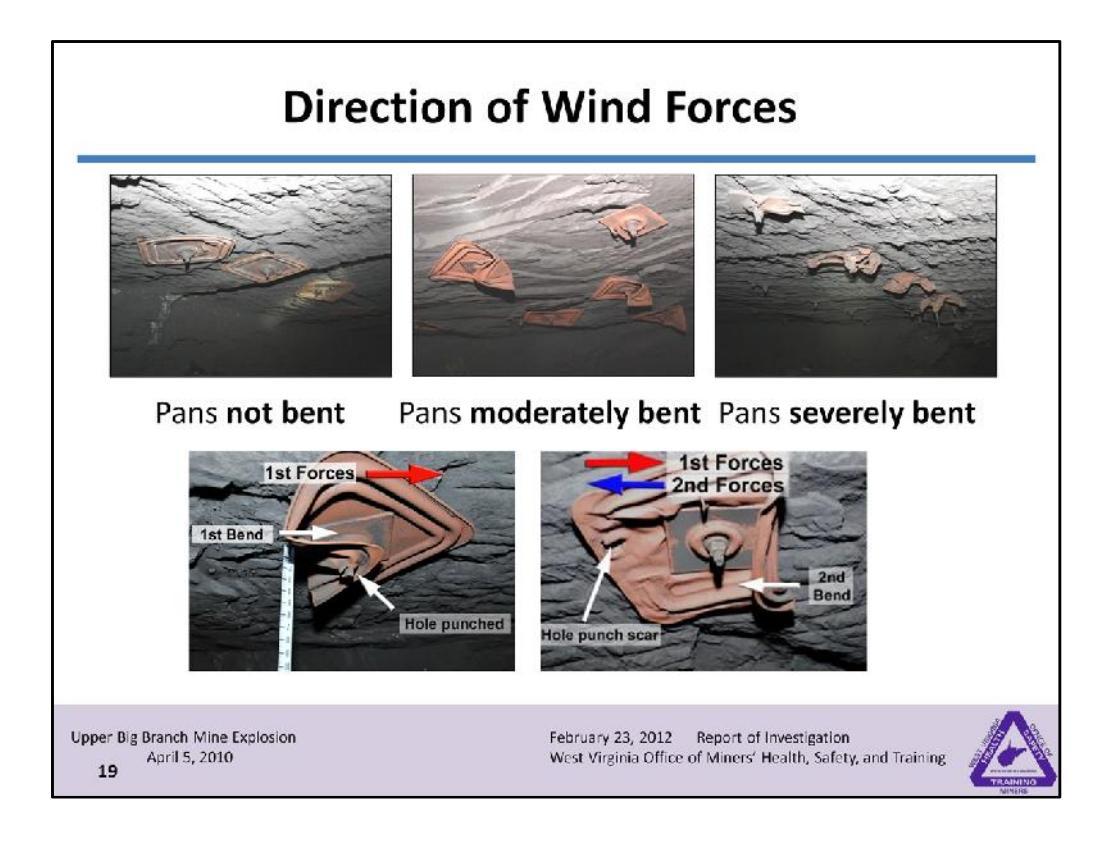
**<u>Slide 19</u>** Our maps classify pan bending into 3 categories:

Pans that are <u>"not bent"</u> means that their angles of bending from explosion wind forces was < 90 degrees.

it back against the mine roof, and also folded the opposite pan edge in the same direction.

This is one example, of the indicators used to help determined the relative sequence of wind forces from the explosion.

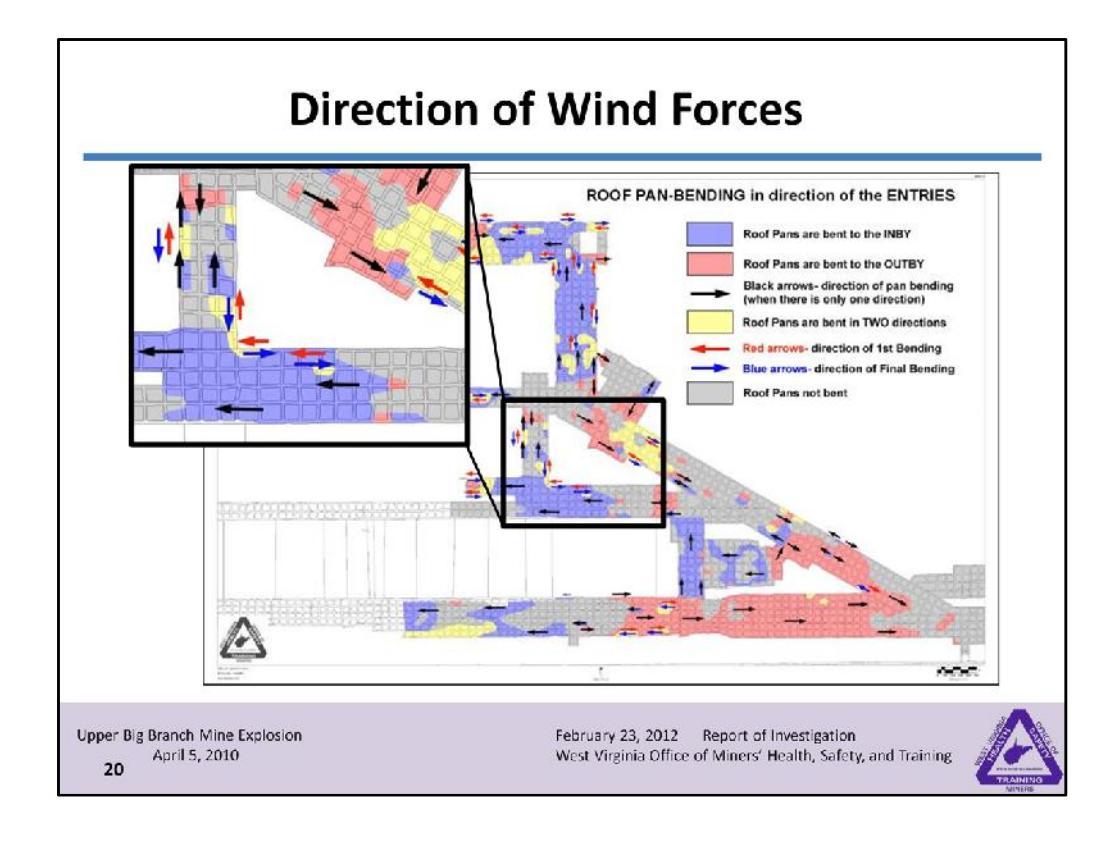
<u>Slide 20</u> Individually, pan damage did not readily lend itself to interpretation, however as the pertinent details were carefully recorded and systematically mapped the pattern of explosion forces gradually emerged. West Virginia investigators classified and mapped these pans across as much of the explosion region as could be safely accessed. Smaller summary maps like this one distill the information by subject so that they could be more readily compared analyzed.

This *particular* map summarizes the bending patterns of the roof pans in the direction of the *mine entries*.

(click) The gray regions are <u>quiet</u> areas where there is virtually <u>no</u> pan-bending from explosion forces. The regions shaded in <u>blue</u> are where pans are bent > 90 degrees to the <u>inby</u> and the regions shaded in <u>red</u> are where pans are bent > 90 degrees to the <u>outby</u>. The <u>yellow</u> regions indicate where pans are bent both ways. Red arrows indicate the direction of first bending, and blue arrows the direction of subsequent bending. When the bending sequence of individual pans could be determined, the 1<sup>st</sup> and Final bending directions are shown with red and blue arrows, respectively.

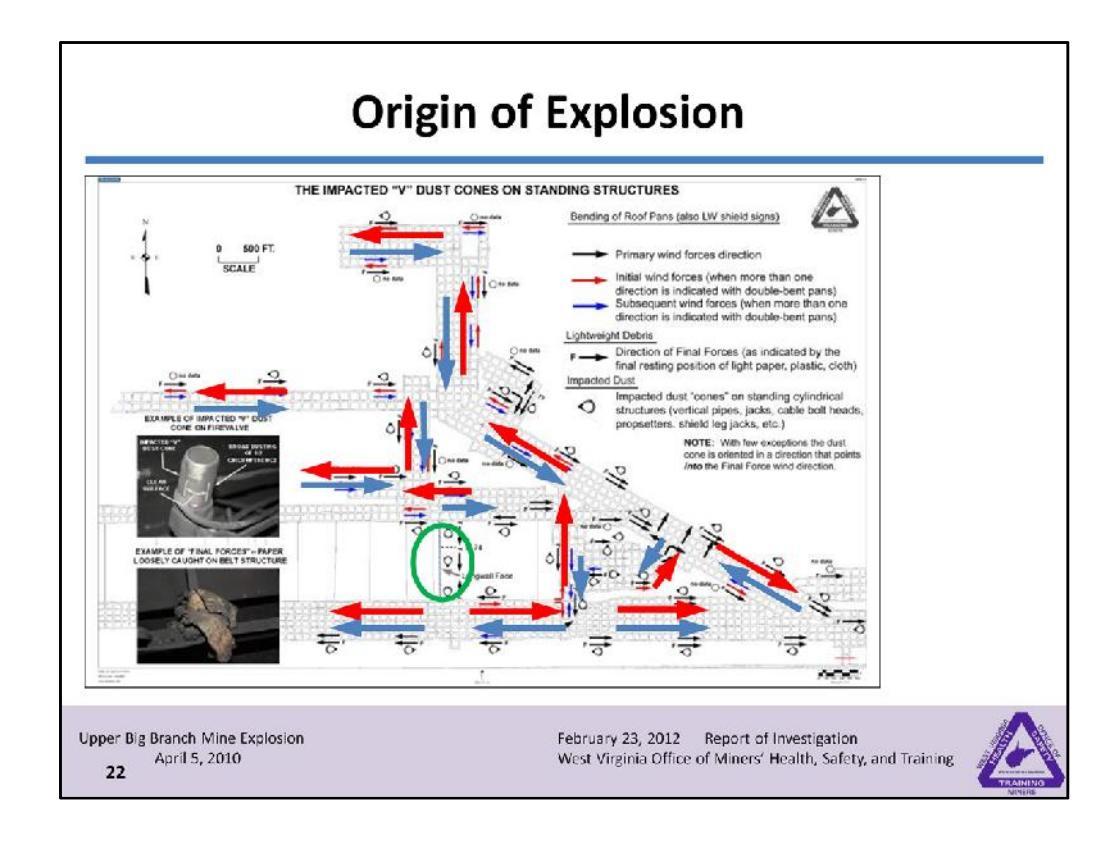
<u>Slide 22</u> By comparing roof pans and Final Force indicators we were able to determine the origin of the explosion using a *process of elimination*.

(click) Beginning at the *dead end* headings, we used this and other information to determine the direction of the *first wind forces* and the *final wind forces* of each area. For instance, dead ends where explosion forces *first* entered, *then* exited, could be discounted as the explosion origin.

(click) By doing each area this way, the candidate locations were reduced to just a few possibilities. It was there determined that the longwall region, specifically the region near the tailgate between Shield 117 and Shield 173, was where the explosion originated.

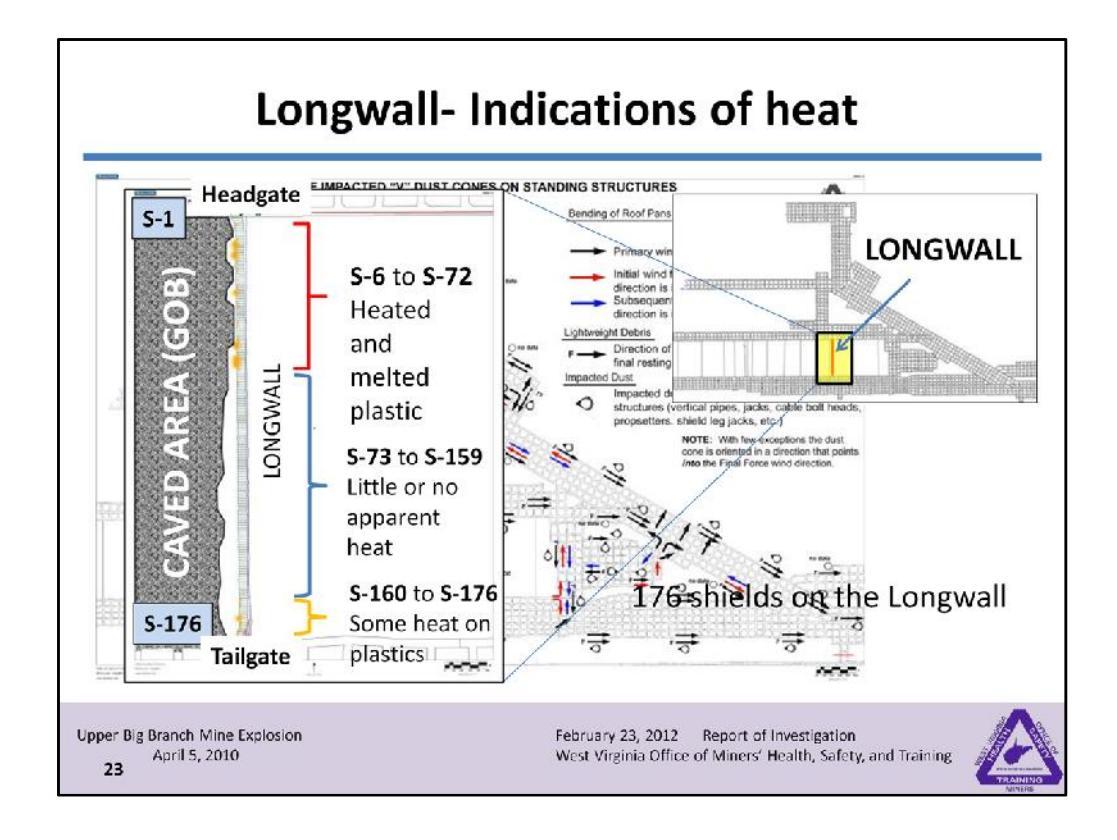
<u>Slide 23</u> Indicators of heat, pressure, and wind forces on the longwall were mapped and analyzed. The most extensive heating and melting of plastic shield components on the longwall was found between Shields 6 and 72. There was a region of heating also at the tailgate, between Shields 160 and 176. There was little evidence of heat in the middle part of the longwall.

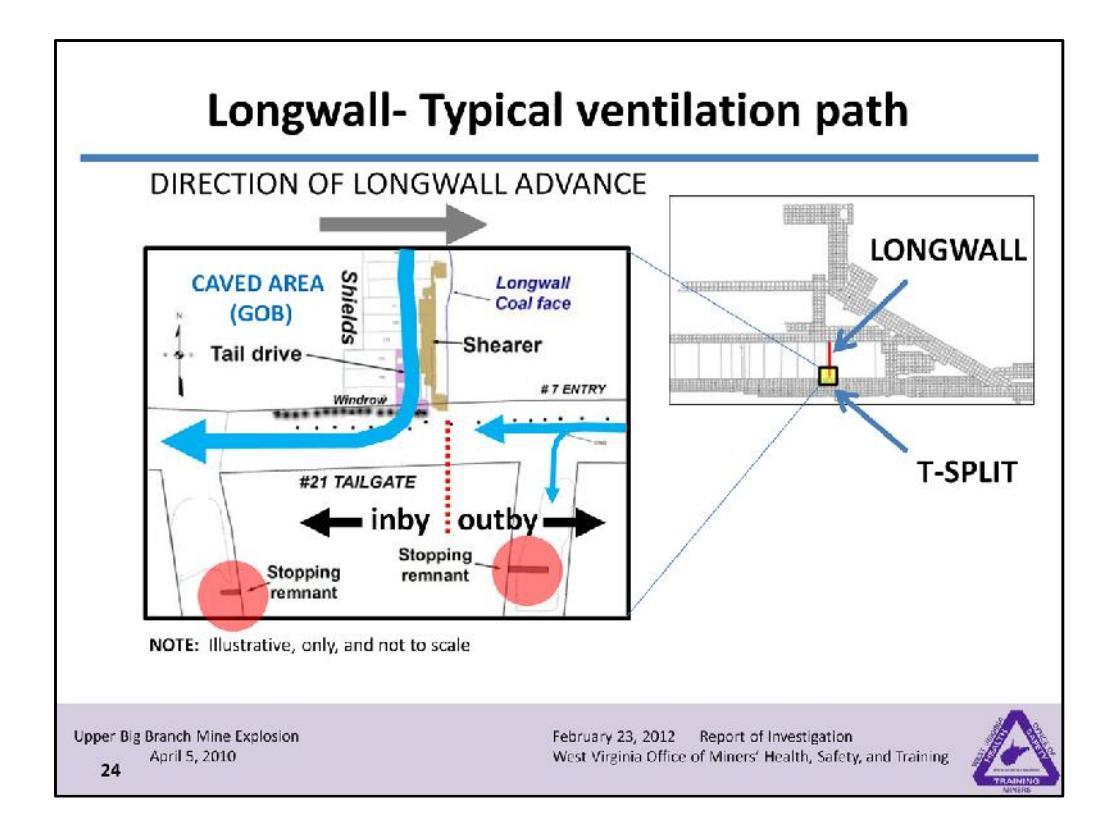
<u>Slide 24</u> In the tailgate region of the longwall the ventilating air currents exiting the longwall merged and flowed west with the airflows in the #7 entry to the exhaust fan at Bandytown.

(click) Operationally, ventilation stoppings between the #7 and the #6 entries to the south were typically breached in succession as the longwall approached them in order to provide a contingency path for the return air from the longwall to go, in the event the #7 entry became blocked inby.

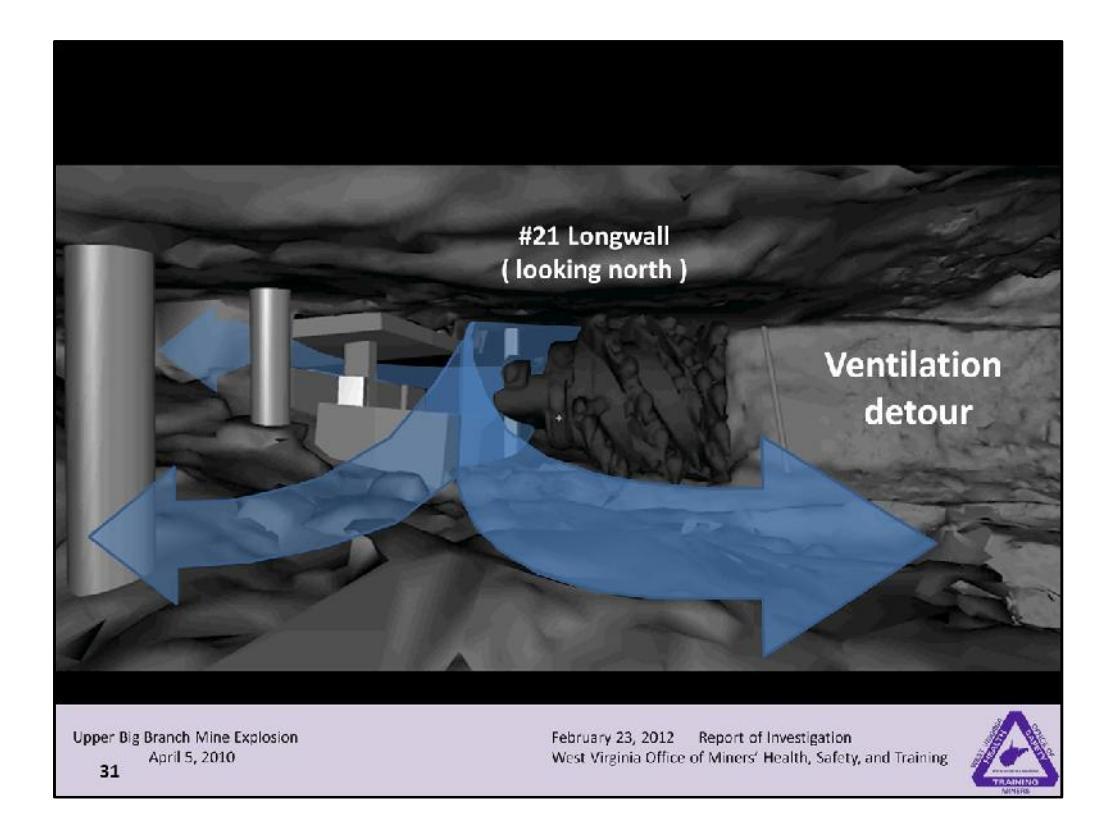
**<u>Slide 31</u>** When the #7 entry becomes blocked the affected air must take a <u>detour</u> to the <u>first</u> open cross-cut east of the longwall. To the extent that the roof fall is just partially blocked, some air also may flow inby (west).

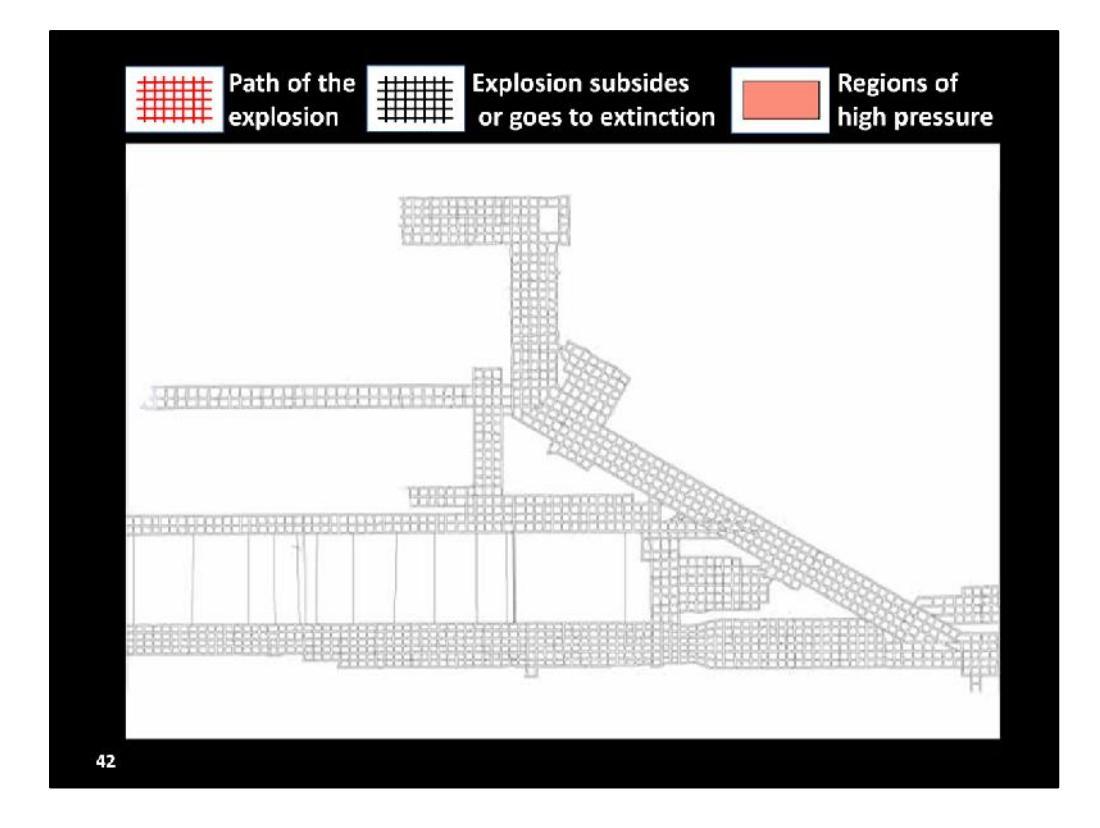
<u>Slide 41</u> After the initial explosion, stronger wind forces returned to the Tailgate from the south. Two large aluminum covers were stripped off the top of the tail drive and transported 100 feet and 256 feet respectively northward.

(click) This was followed by wave of explosion forces from the Headgate, which carried a lid from the head drive, comtrol boxes, and other debris southward through the longwall. The final forces through the longwall traveled north-to-south, from the Headgate.

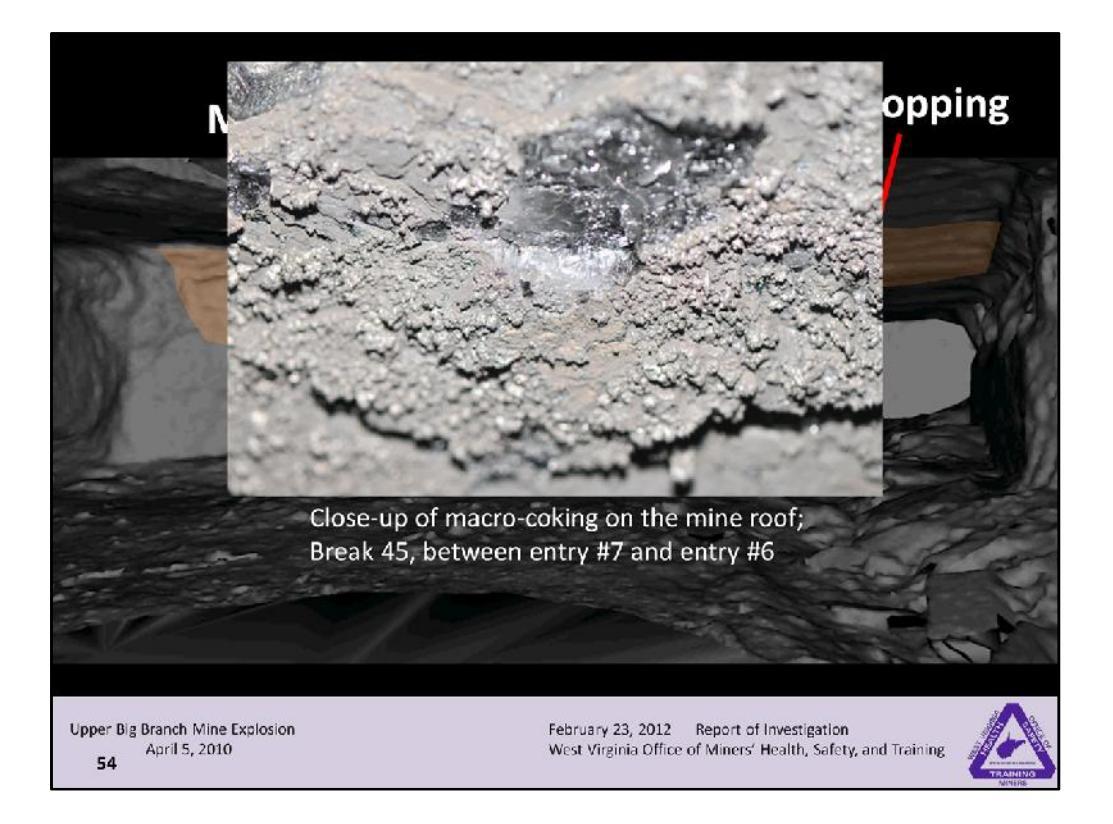
**Slide 53** The next cross-cut is Break 45. Here, the stopping in this cross-cut managed to survive the explosion. This location is marked as a regulator on the mine map, but it is fully intact-- although the previous stopping likely served that purpose before it was built back.

(click) The roof and east coal ribs at this location contain considerable *macrocoking*. This is coke that has <u>not</u> been transported by the explosion but is produced from coal dust on ribs and thin coal streaks of plant fossils in the mine roof.

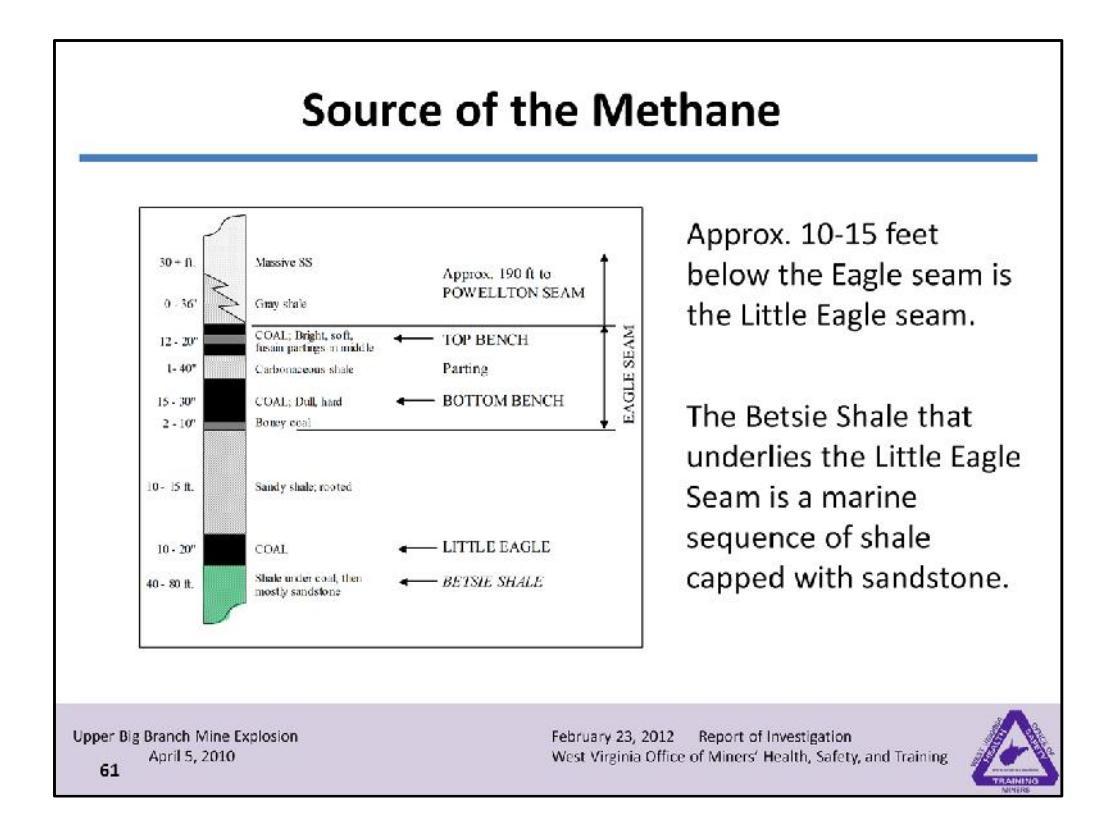
<u>Slide 60</u> In the events leading up to the explosion, methane was the primary fuel involved.

Initially, methane was ignited in the Tailgate area of the longwall and continued burning, resulting in the shearer being shut down.

(click) When the explosion propagated into the #21 Tailgate, fine coal dust became the fuel for the explosion. Rock dust is effective in stopping a dust explosion, but not a methane explosion. We find the explosion forces of the initial propagation are increasing in speed and intensity slowly which indicates the fuel for propagation was coal dust.

Rock dust was retarding the explosion, but was insufficient to stop it. Nonetheless, we are interested in the source of the methane too, because that is what started the explosion.

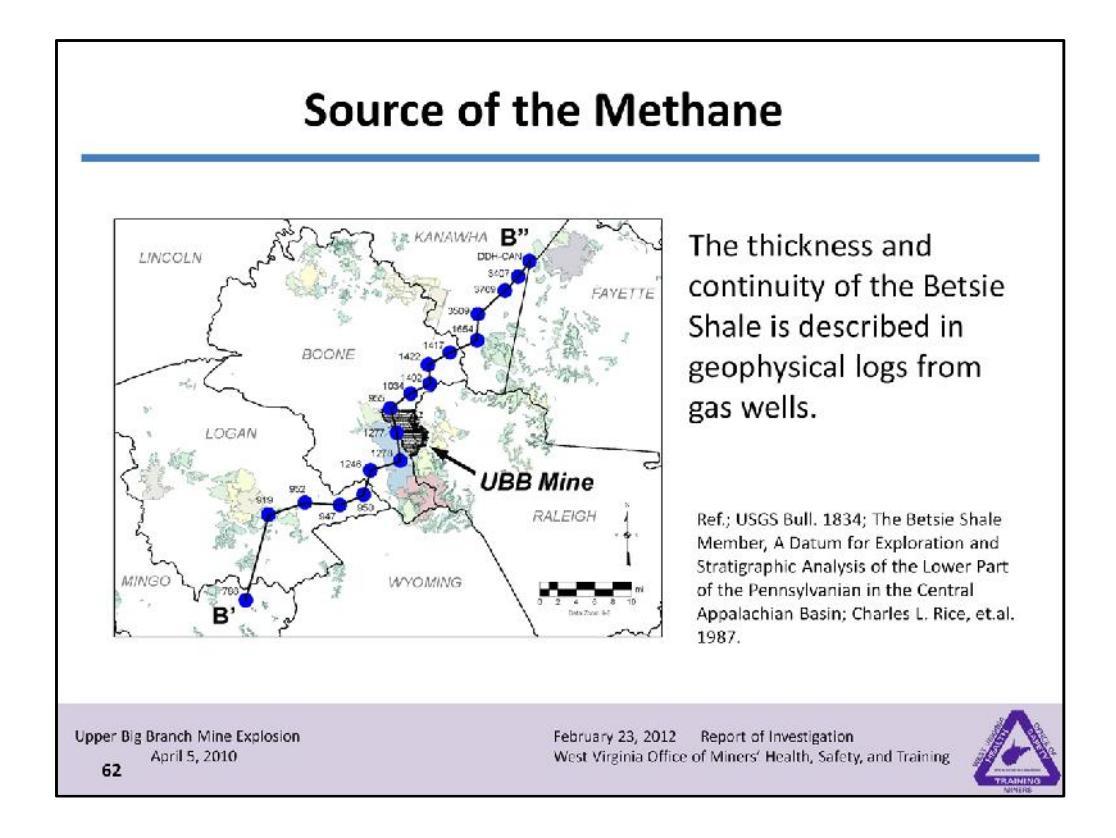
<u>Slide 61</u> The Eagle seam is not a gassy seam, but it has a history of gas emanating from cracks in the mine floor. Gas from coal is derived almost entirely from plant remains, resulting in light hydrocarbon gases of almost pure methane--or coalbed gas-- but containing trace amounts of the heavier hydrocarbons such as ethane and propane. These heavier gases are derived in greater amounts-- along with methane-- from source rocks rich in organics from microscopic animal remains, such as are contained in marine sediments. The gas that investigators noted coming from the mine floor contained more heavy hydrocarbons than would be expected from coalbed gas, alone.

Beneath the Eagle seam is a small but persistent leader seam called the Little Eagle, and beneath that is a marine shale that geologists refer to as the Betsie Shale. The Betsie Shale is capped with sandstone in the vicinity of UBB mine.

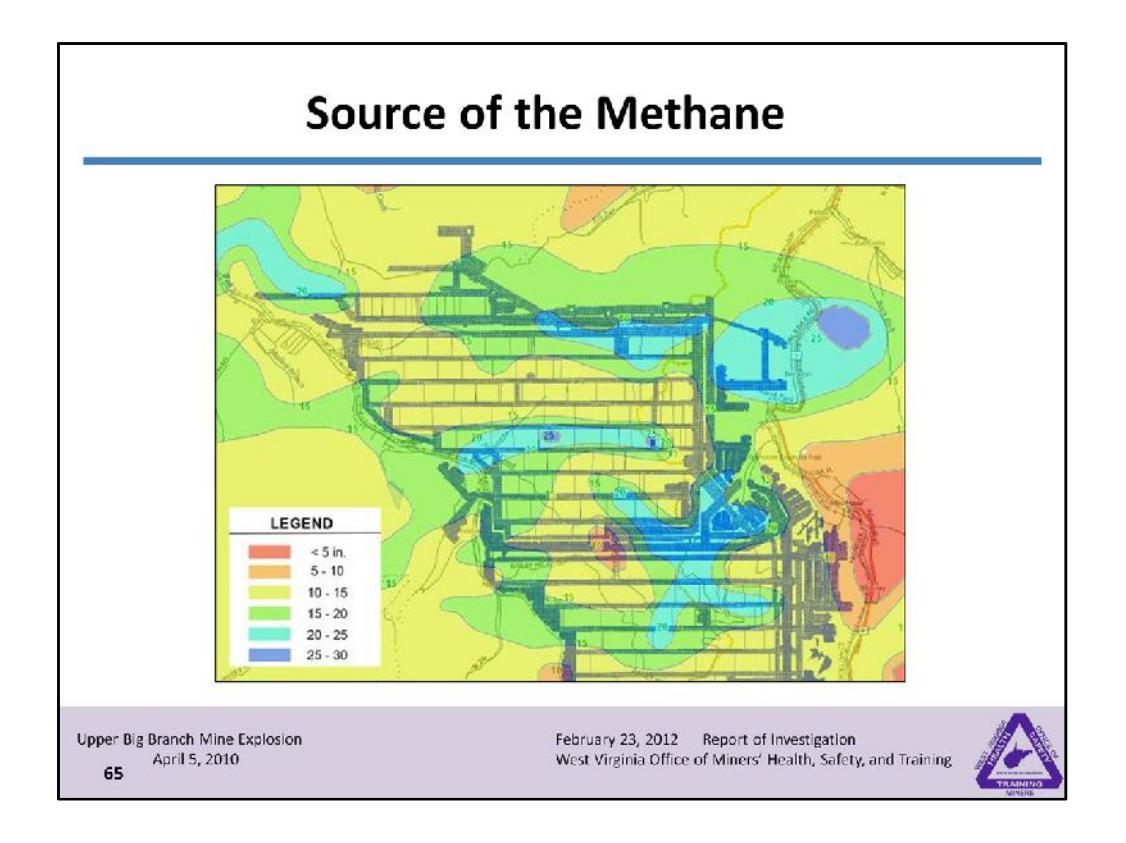
<u>Slide 64</u> Nearby core logs obtained from Performance Coal were plotted out in a graphic format. Although these logs do not penetrate very far below the Little Eagle seam, a few go as far as 50 feet and they show that the top 40 feet or so of the Betsie shale is actually comprised mostly of sandstone.

Sandstones make good reservoirs for hydrocarbons if they are porous and permeable and if they have an impermeable cap. Sandstone with sufficient porosity can collect hydrocarbons from neighboring shales.

Any marine shale below the sandstone, including the Betsie Shale itself or the deeper Devonian shales, could be a source for gas. Deep shales such as the Marcellus are rich in natural gas, but are unable to release it freely because the shales lack permeability. Creating fracture conduits by hydrofracking provides permeability in tight shales by interconnecting their existing pores and fractures.

There is not enough known about the Betsie Shale to draw firm conclusions. However, it is possible that it is both source rock <u>and</u> reservoir for accumulated small pockets of gas, which are inadvertently tapped during longwall mining.

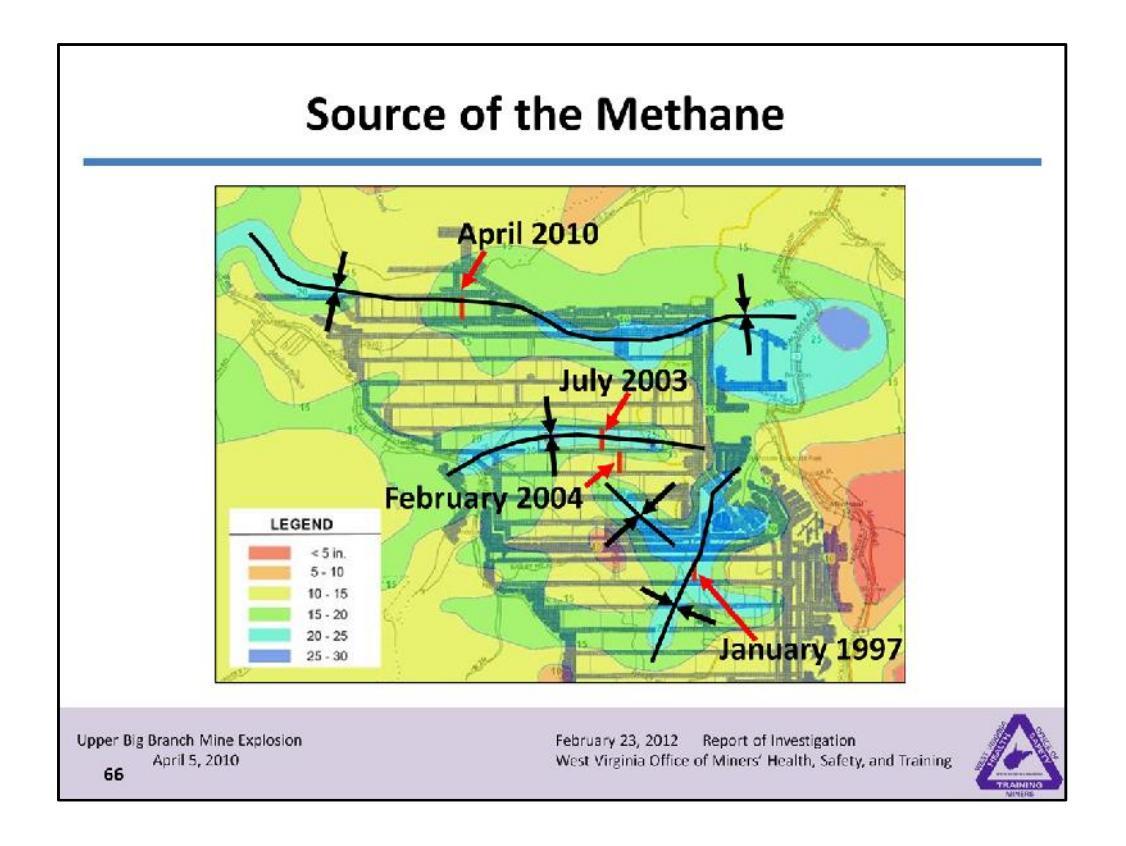
<u>Slide 66</u> This isopach map suggests an association between depositional troughs and the occurrence of known UBB gas events. The margins of such local subsidence troughs are frequently associated with slips and fractures, along which relatively weak and porous zones can occur, which facilitates gas accumulations. Weak mine floor would be more sensitive to abutment stresses under cover depths exceeding 800 feet.

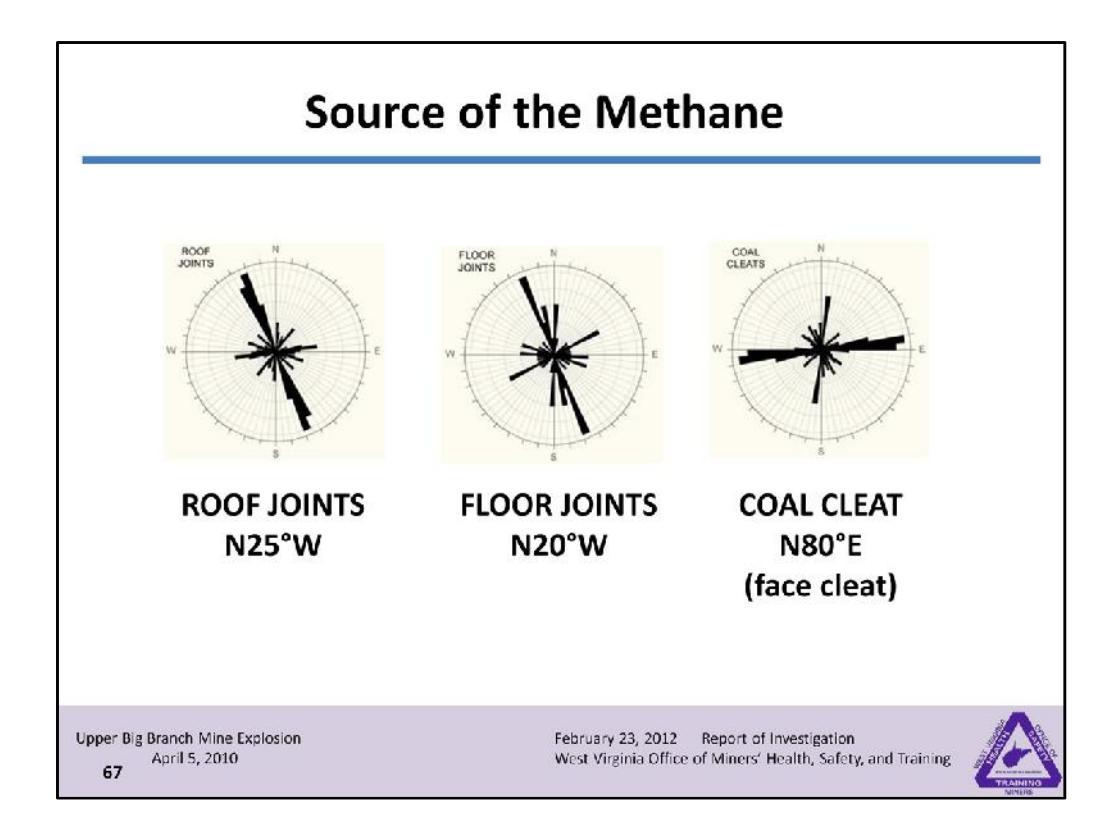
<u>Slide 67</u> Because the dominant fractures in the sandstone roof above the Eagle seam are of similar orientation to the mine floor fractures, pre-existing conduits for gas migration might exist which are inadvertently intercepted during mining. These conduits might be pre-established pathways for upward-migrating gas that ceased when gas pressures and resisting stresses of confinement reached equilibrium. The Eagle/Little Eagle interburden may act as a cap or seal for this confinement, and when ruptured by abutment stresses under areas of deep cover can release pockets of residual gas where the floor is locally weakened and fractured.

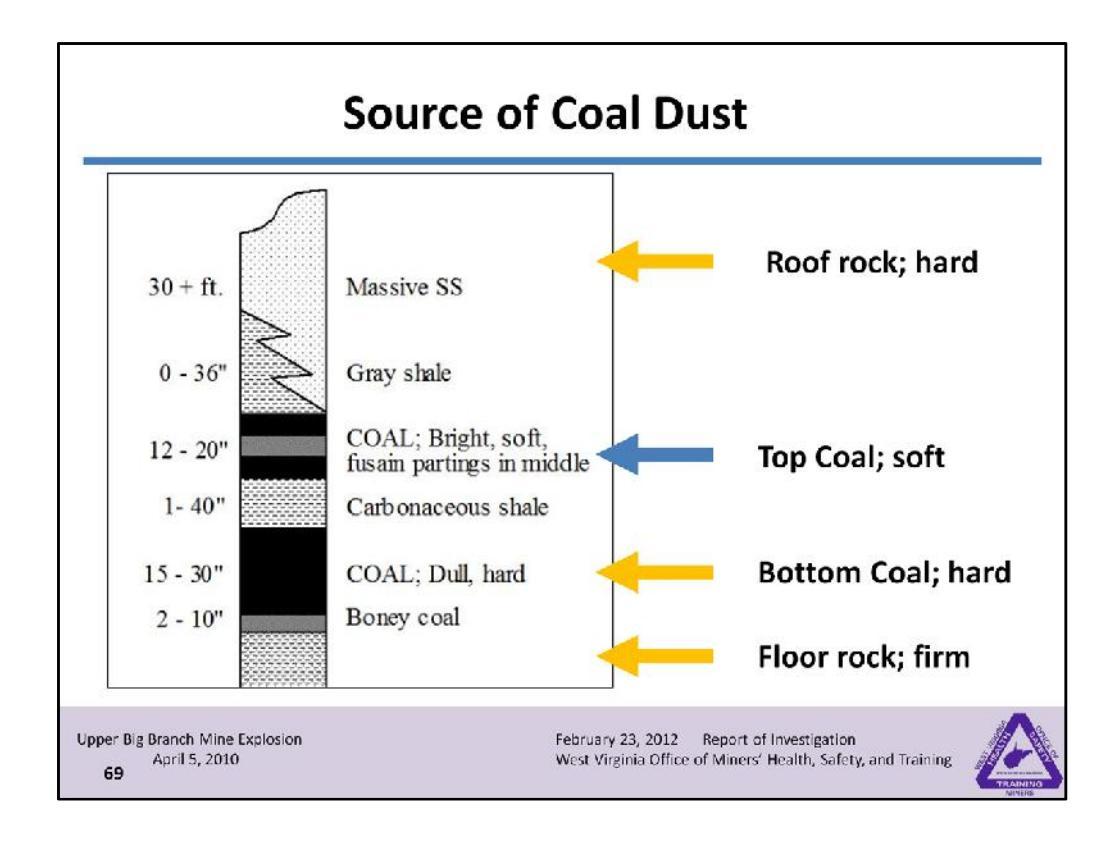
<u>Slide 69</u> The middle of the Top Coal bench of the Eagle seam is typically the softest geological strata exposed in the mine. When the mine ribs take weight under conditions of high depths of cover, this coal bench is prone to fracturing and spalling. It is composed chiefly of vitrinite (brittle, shiny coal), with discreet fusain partings (soft, sooty coal) that easily crumbles to a fine powder, making it a comparatively greater hazard.

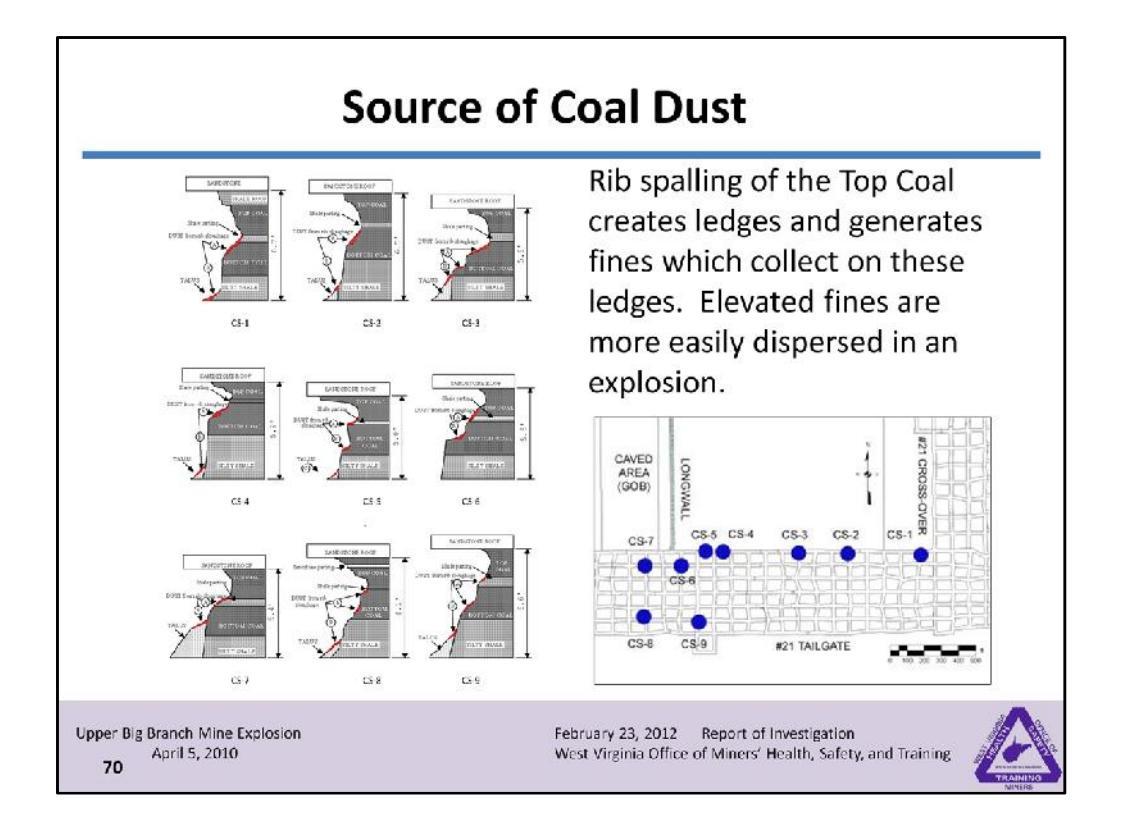
<u>Slide 70</u> Nine locations in the #21 Tailgate were sampled for coal and dust. Their general profiles are indicated in these seam sections. Dust and coarse particles were observed to collect on ledges created by the Top Coal spalling, and also at the floor along the ribs. Very fine coal particles that collect on elevated ledges are more easily dispersed in an explosion than dusts on the mine floor.

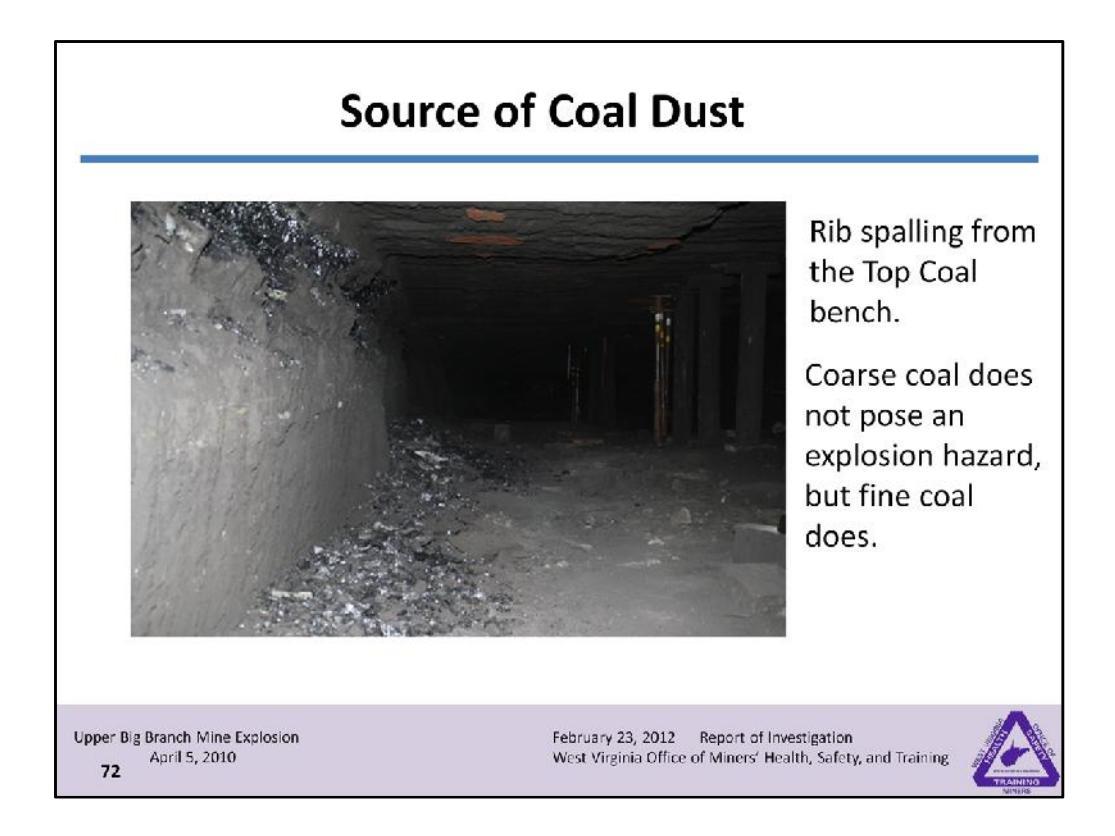
**<u>Slide 72</u>** These areas may not look that bad, but it is virtually impossible to determine the amount of fine dust and explosibility without close inspection, sampling and testing.

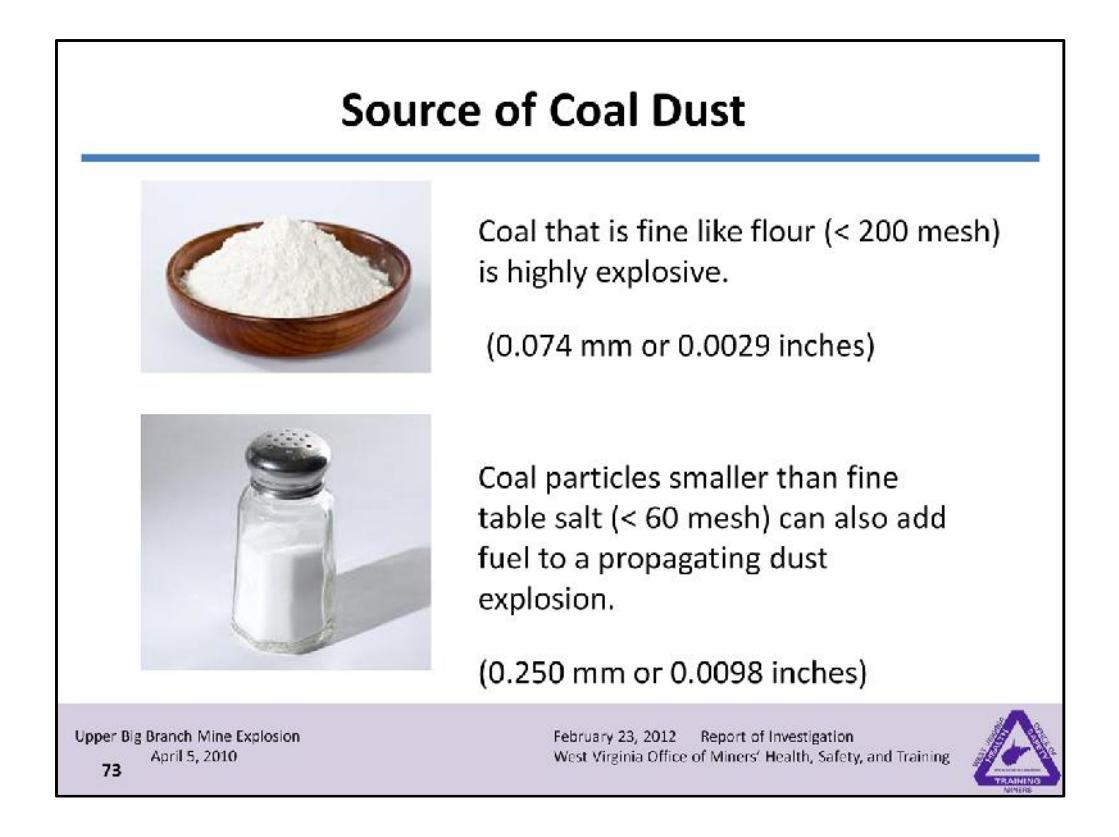
<u>Slide 73</u> The most explosive coal dust is < 200 mesh in size, which is fine like flour. Dust of this particle size more easily gets ignited in the transition to and development of a self-sustained dust explosion. Rock dust must contain at least 70% less than 200 mesh to effectively neutralize the explosion.

Once an explosion gets started, particles up to the size of fine table salt (60 mesh in size) can also participate in an explosion. Coal particles that are more coarse than 60 mesh do not seem to be a factor, but coarse coal accumulations along ribs receive more attention for rock dusting because they are more apparent.

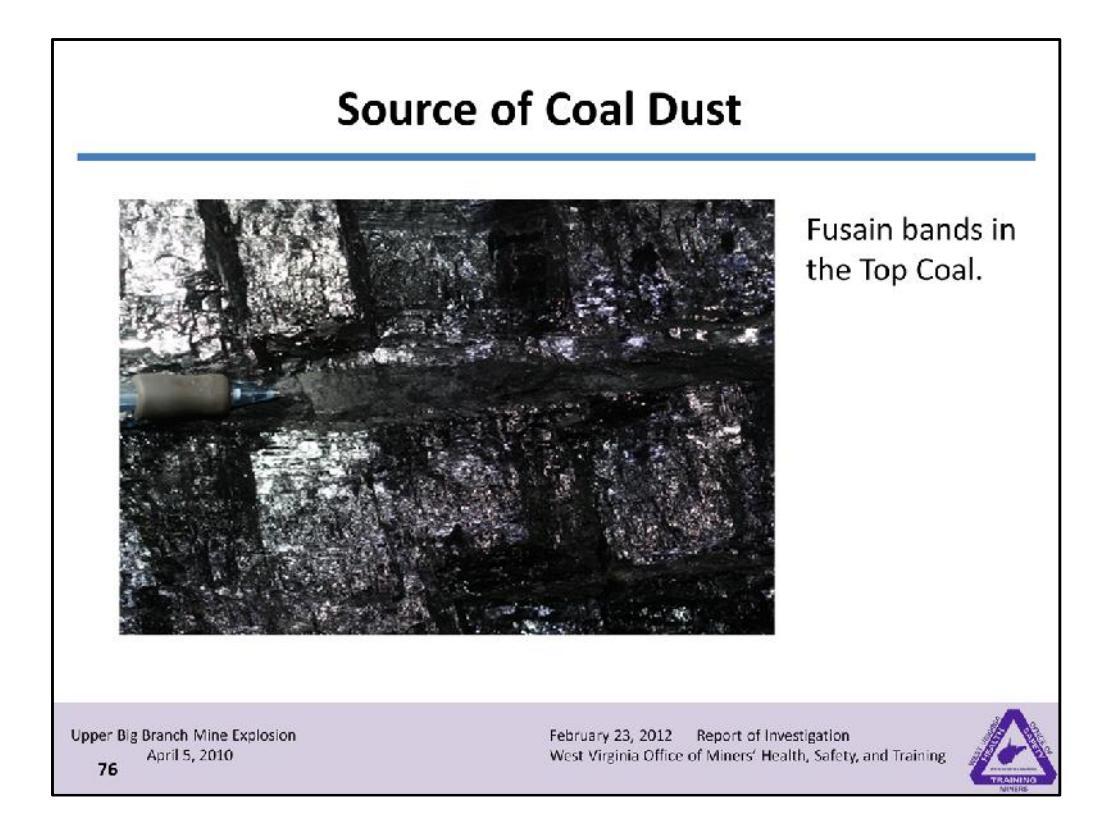
**<u>Slide 76</u>** Typically, the visible partings are less than ¼". On appearance in the coal seam, they do not appear to be a threat.

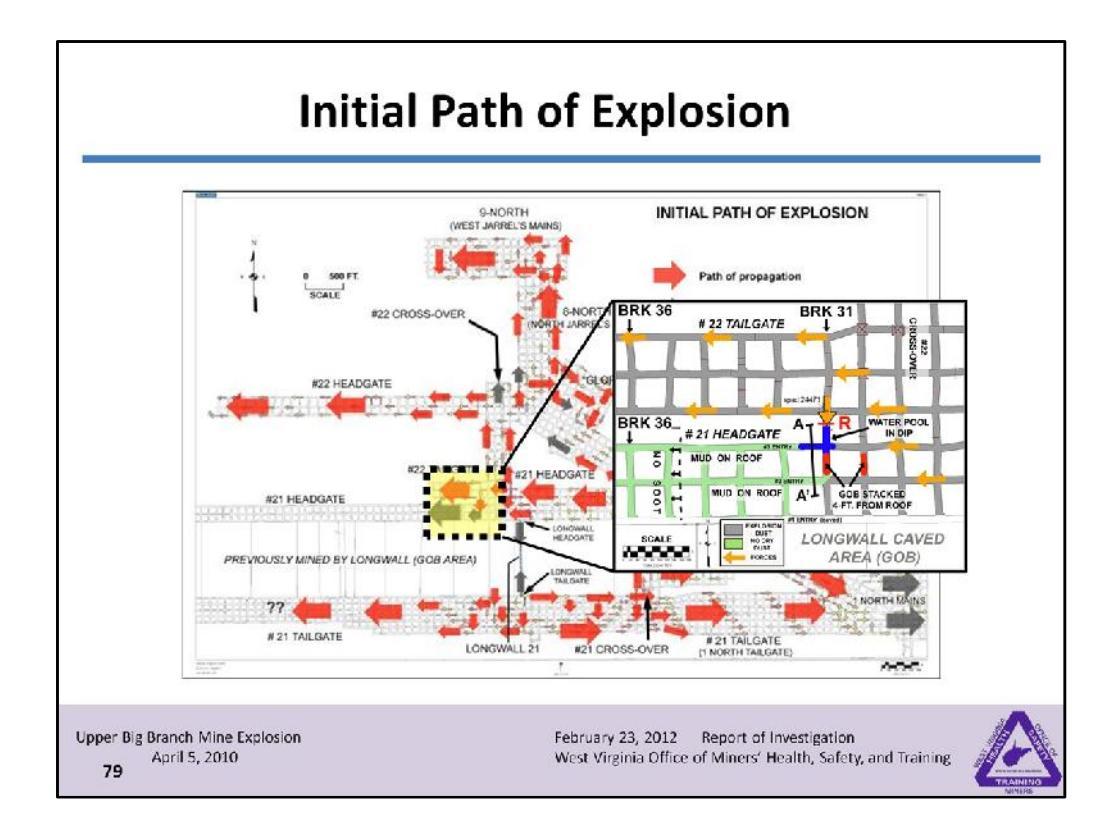
<u>Slide 79</u> During our detailed mapping we found at least one example where a water barrier stopped the explosion as it propagated through the mine.

(click) This area was in the #21 Headgate entries west of the #22 Cross-over.

(click) Study of this area shows that flame was extinguished and the explosion forces subsided to extinction shortly after crossing a water-filled depression and a gob pile south of the regulator between #22 Tailgate and #21 Headgate.

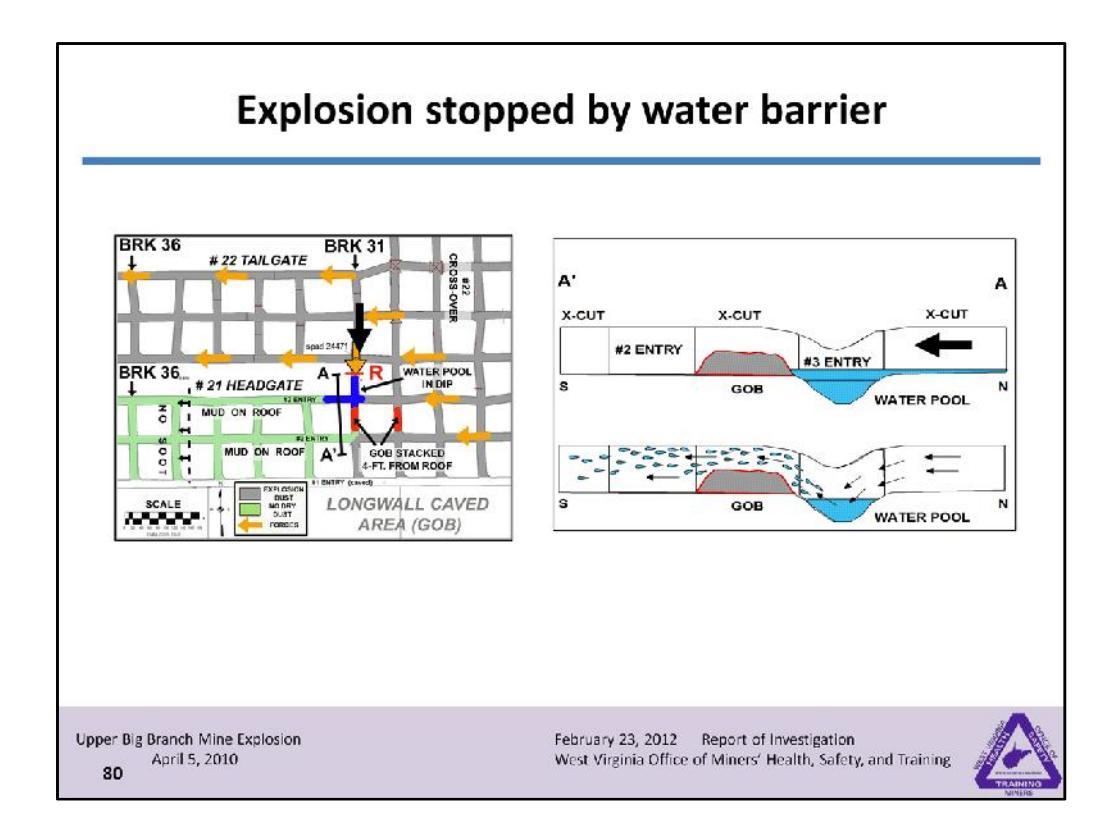
**Slide 80** Because the leading edge of the explosion was against the north side of #22 Tailgate, the first forces entering this part of #21 Headgate entered first through the cross-cut indicated with the black arrow. The intersection in #3 entry was a natural swag or depression which had filled with water.

(click) When explosion forces entered this intersection they were directed downward, into the water pool, and continuing south passing though a constriction created by a gob pile between the #3 and #2 entries.
