<u>Slide 1</u> (Introduction). Begin 1st presenter: <u>Barry Fletcher</u>; Roof Control Specialist; Investigator

**Slide 2** We would like to begin the presentation with an overview of our investigation. This overview will be followed by a detailed account of our findings concerning the explosion which occurred on April 5, 2010 by Mr. Monte Hieb our Chief Engineer. We want to again thank you for your patience as we finalized our investigation and report.

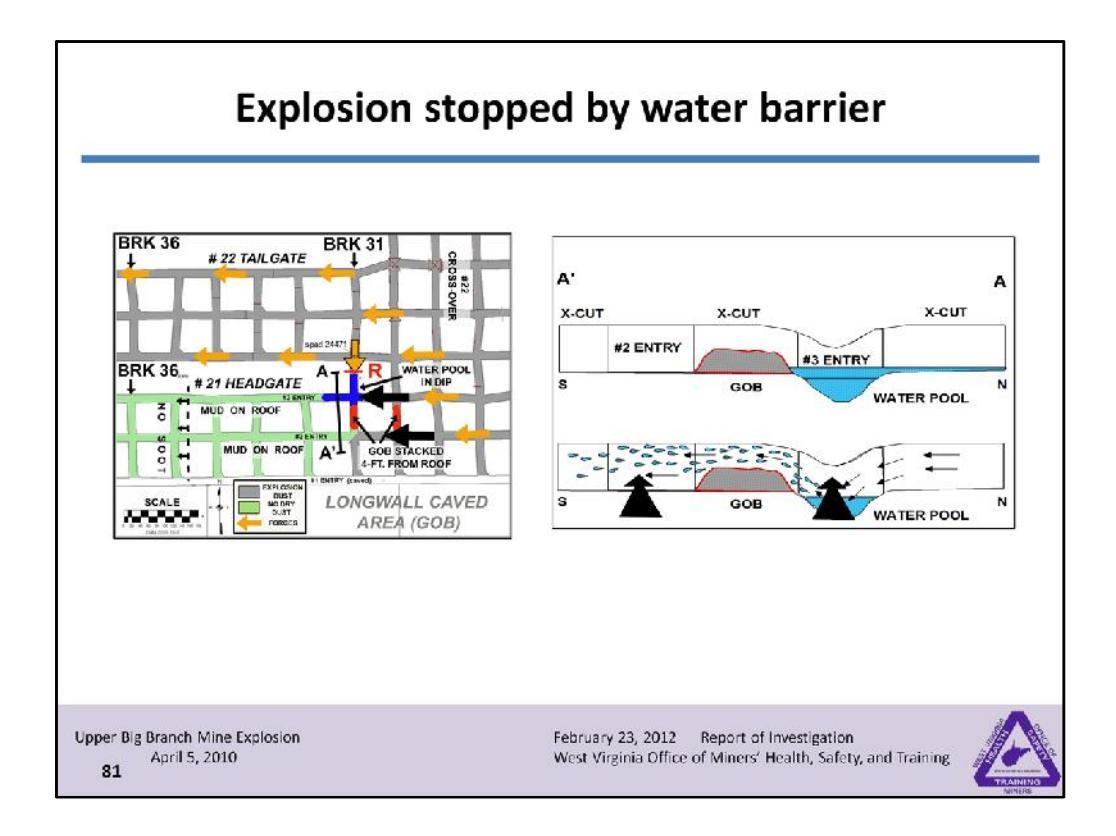
<u>Slide 81</u> An instant later, explosion forces from the east entered this same water hole through the #3 entry and also entered the unobstructed #2 entry. These forces dispersed water through the crosscut and then down the entries.

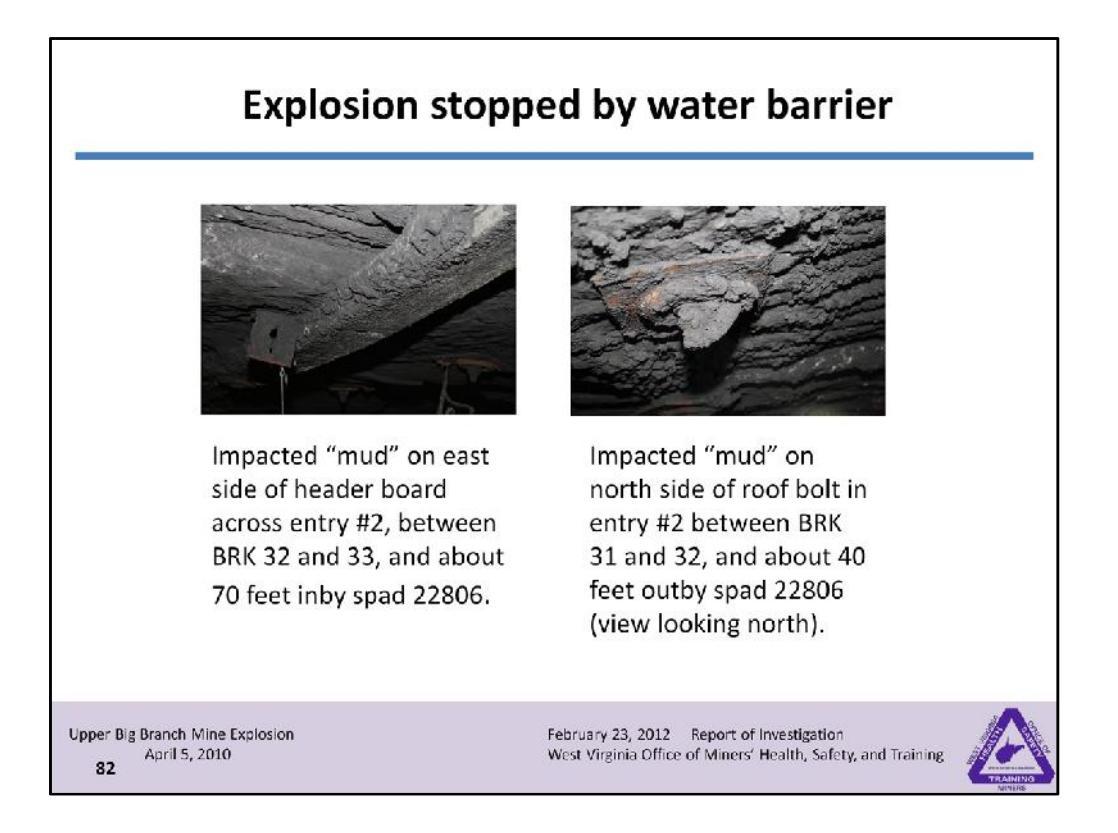
<u>Slide 82</u> The heads of roof bolts show mud deposits on their windward side, rather than dust. These deposits point in the direction of the source of water. Mud coated the mine roof for approximately 400 feet of the entries lying to the west, but not their crosscuts.

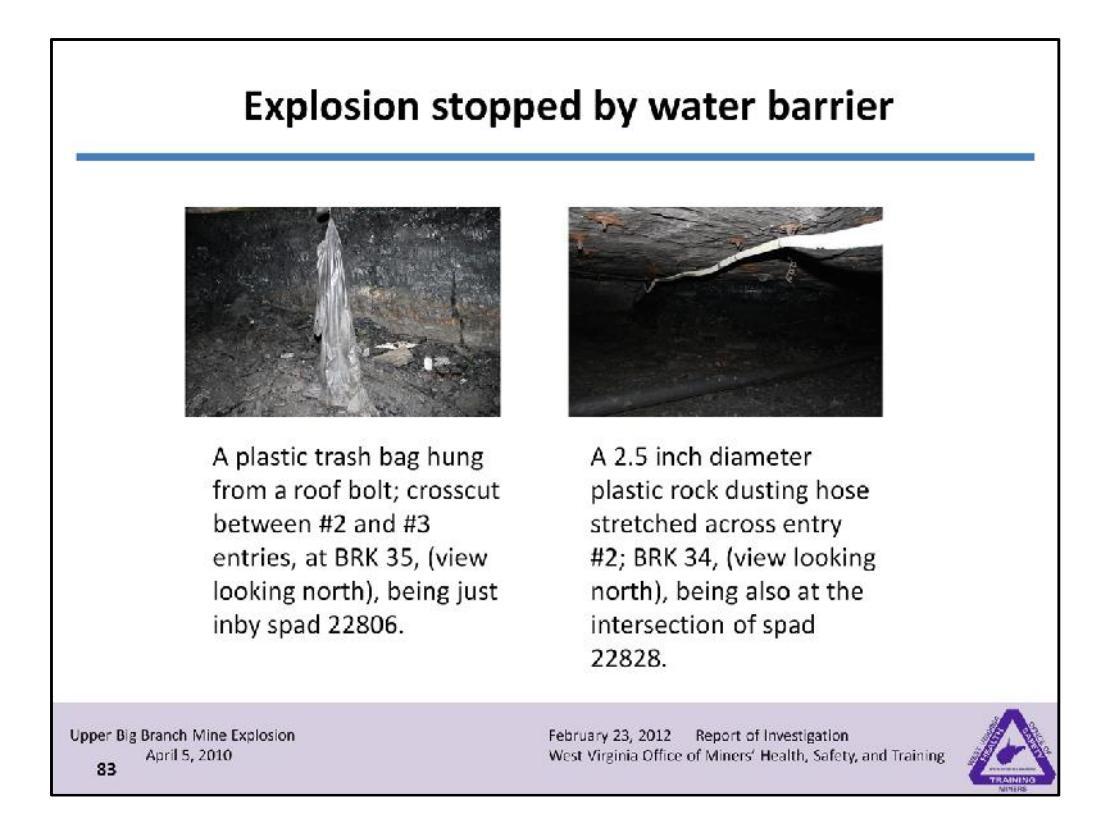
<u>Slide 83</u> By the time explosion forces reached BRK 36 the overpressures were insufficient to breach stoppings and heat was insufficient to melt plastic garbage bags hanging from the mine roof. Vulnerable structures such as a 2  $\frac{1}{2}$ " diameter plastic dust hose that was hanging transverse to the #2 entry with nylon rope ties were unaffected by heat.

From this and other evidence it was determined that explosion forces subsided to extinction between BRK 31 and BRK 35.

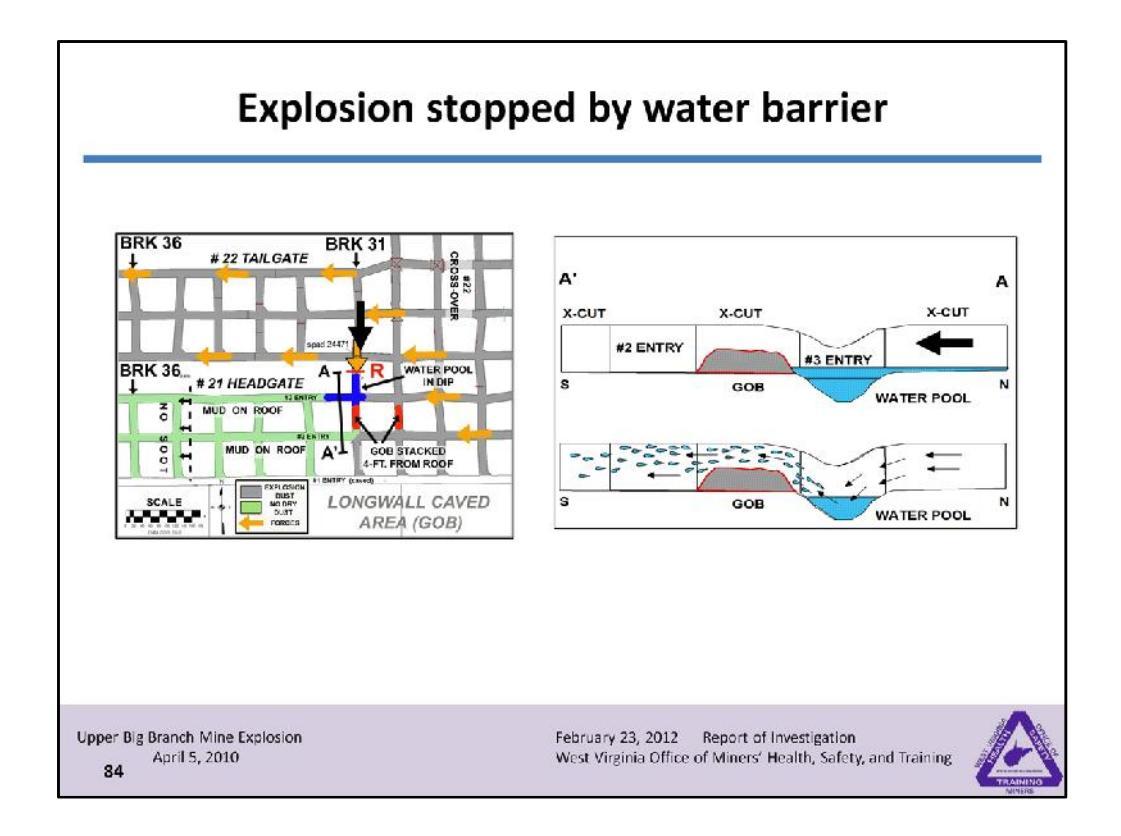
<u>Slide 84</u> Prior research has shown that water barriers where the water can be dispersed by forces can quench propagating dust explosions. Observations and mapping during the investigation showed that the gob pile and downward contours created sufficient force and turbulence to direct air and disperse water into the #2 entry from the north crosscut. This appears to have increased effective wind velocity and enhanced turbulence through reduction in cross-sectional area and slope of the mine roof.

This example seems to validate the idea that water dispersion into explosion flame is effective in arresting the propagation of a coal mine dust explosion.
