REPORT of INVESTIGATION
into the
SAGO MINE EXPLOSION
which occurred JANUARY 2, 2006
UPSHUR CO. WEST VIRGINIA

**WEST VIRGINIA OFFICE of MINERS' HEALTH,
SAFETY, AND TRAINING**
DECEMBER 11, 2006
RON WOOTEN, DIRECTOR

The cause of the explosion has been determined to be a methane explosion that occurred at 6:26 AM and 35 seconds behind the seals of the Old 2nd Left Section (sometimes referred to as Old 2nd Left Mains or even 3rd Left). Ten (10) mine seals built of Omega blocks to seal off this part of the mine from the active mine were completed exactly one year prior to the date of this report (December 11). It was 22 days after December 11, 2005 that an explosion involving up to 400,000 cubic feet of methane gas destroyed these seals. The effects of this blast—the dust, the smoke, the debris across the entries—resulted in entrapment of the men of Two Left Section, who perished there, with the exception of Randal McCloy. Also partly at fault were self-contained self rescuers that did not perform in the manner expected.

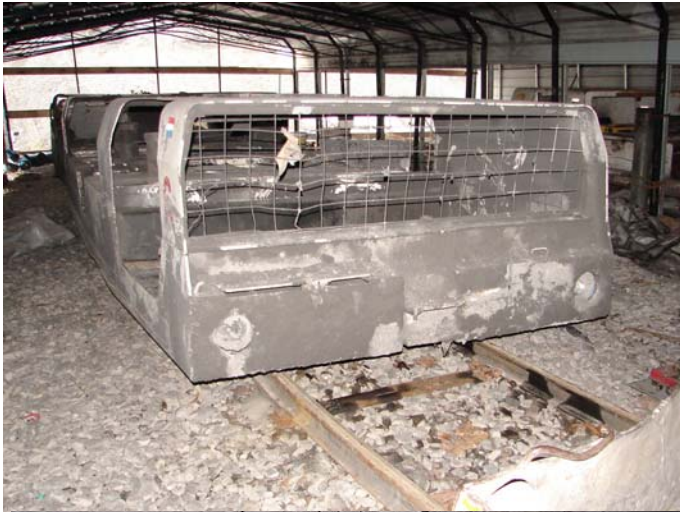
Photo 1

First-Left mantrip
Mantrip in buggy barn after it was
transported to surface

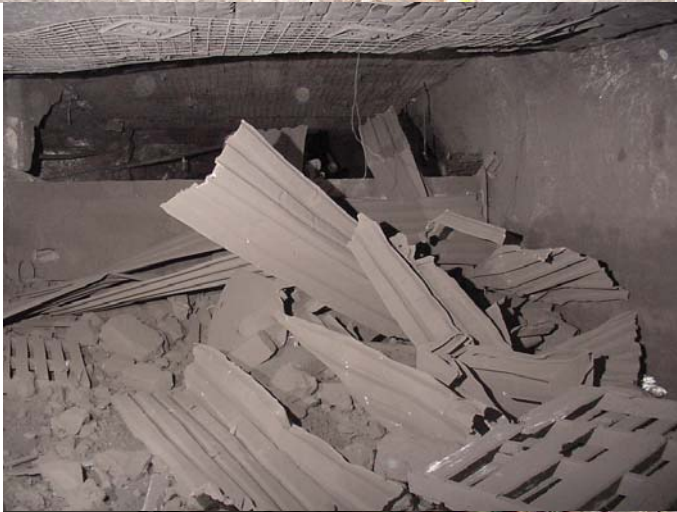
Photo 2

Example of the debris at track
overcast that would have prevented
the crew from escaping in their
mantrip

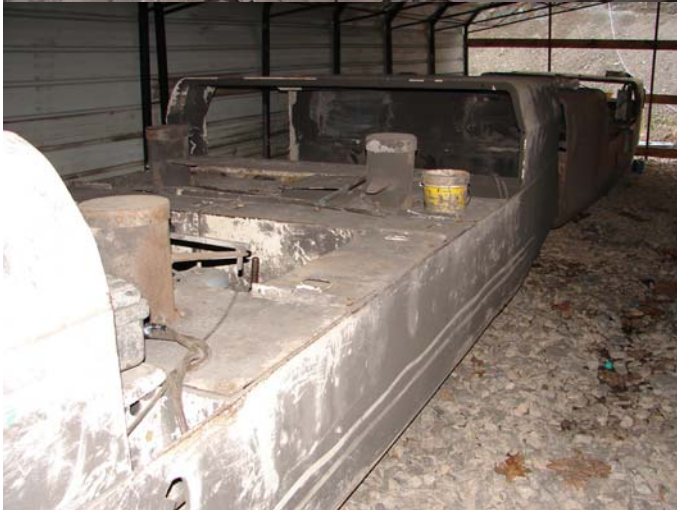
Photo 3

Second-left mantrip
Mantrip buggy barn after it was
transported to surface

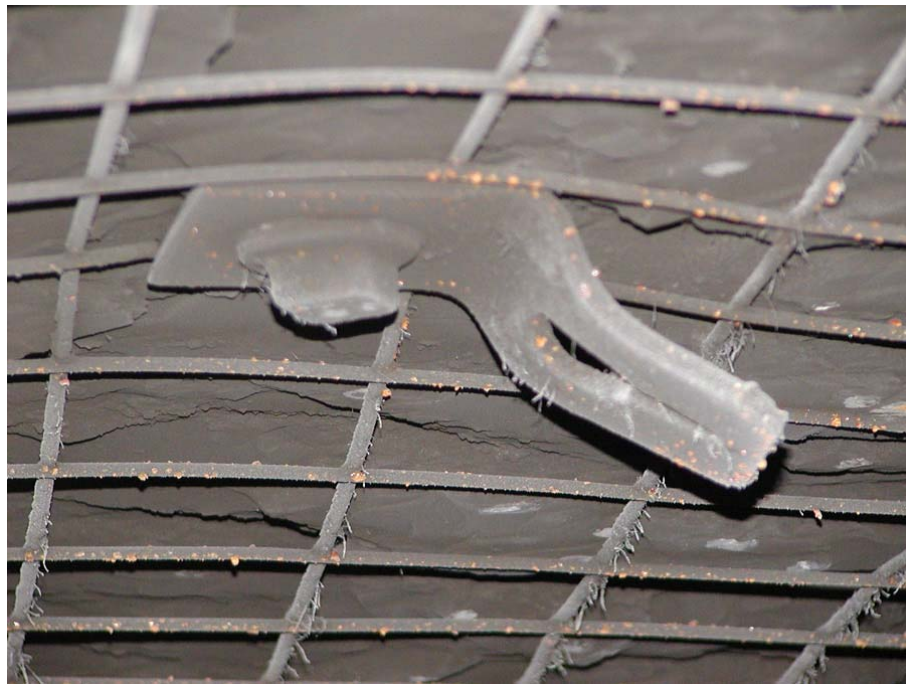
Photo 7. An example of a bent belt hanger, which were usually bolted directly to the mine roof with no pan underneath. Their purpose is to provide an anchor point to hook chains to suspend the conveyor belt structure. This is a smaller version of the 4" x 4" belt hanger flanges that were typically used throughout the mine. Originally the angle of the flange was 90° (+/- 1 degree). This bending was studied as another source of information to interpret blast force direction and magnitude.

Uncertainty exists as to exactly how the hangers came to be bent, although it has been postulated that hangers bent at the “keyhole” such as shown in **Photo 7** were likely impacted by flying debris. Hangers that were uniformly bent (as most were) likely were bent by air blast pressures⁶. Some of the hangers could have been bent in the course of normal mining operations or during the recovery of the belt structure after mining.

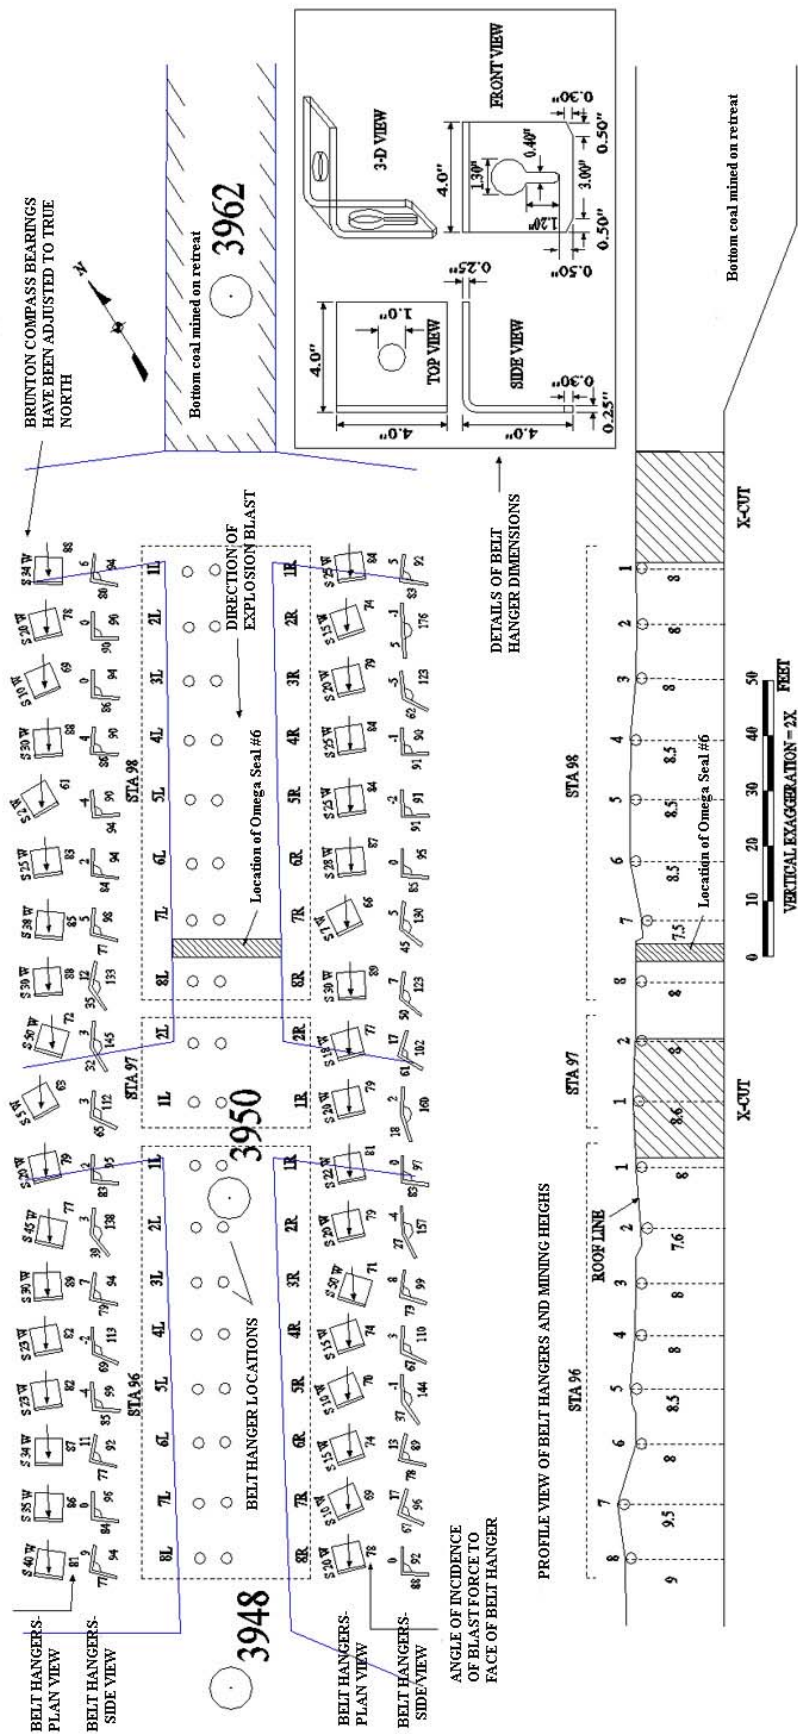
Figure 1. Results of Belt Hanger Survey 1 performed on February 16, 2006. Location is in the #5 entry (former belt entry) in the vicinity of Omega Seal #6. See Appendix 5.4 for more detail.

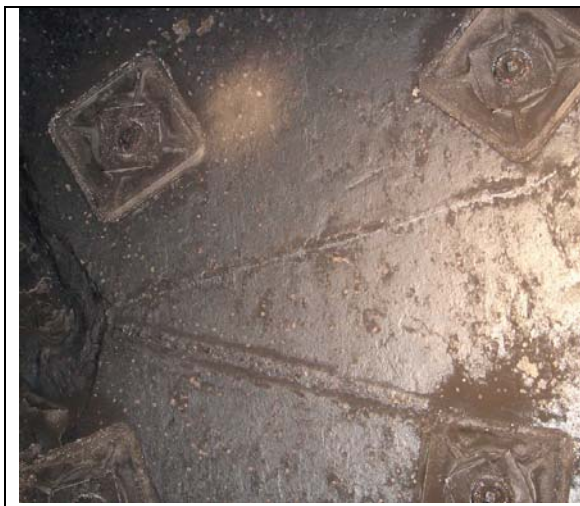
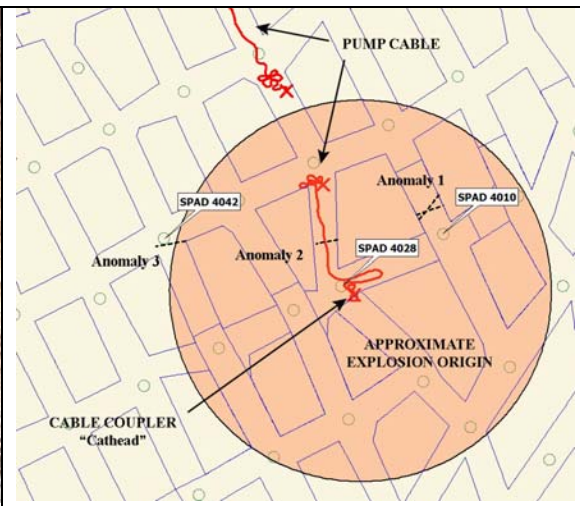
<p>Photo 1. These tracks in the mine roof are near the suspected explosion origin. They were examined in detail for possible evidence of involvement.</p>	<p>Map 1A. General location of “anomalies 1, 2, and 3” and part of an abandoned pump cable located within a zone where the explosion is believed to have originated.</p>

Interest waned somewhat when nothing unusual about their composition was discovered. A third “anomaly” was discovered nearby at spad 4042 and at approximately the same stratigraphic level in the roof as the others (diminishing their uniqueness), and geological analysis suggested they were simply an unusually straight cast of a plant fossil. In the end, there was no evidence that these unusual features were anything more than just unusually straight fossils casts.

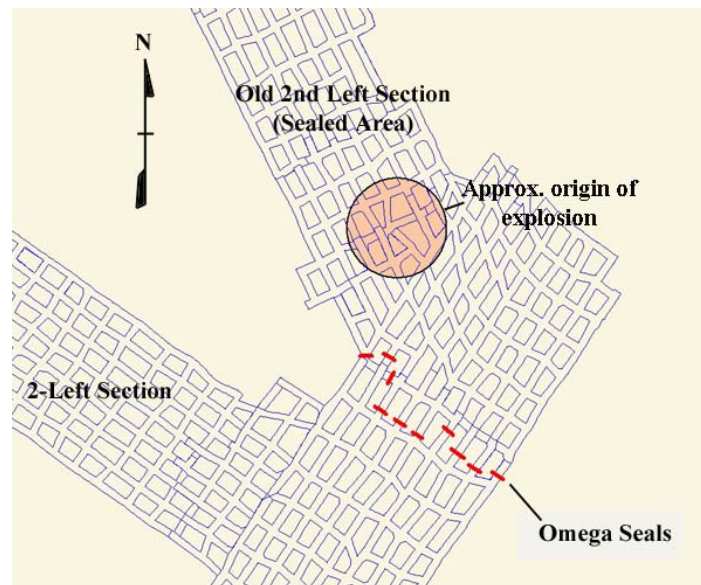
Ten (10) seals that were built to isolate the mined-out Old 2nd Left Section from the rest of the Sago mine were destroyed in an explosion on the morning of January 2, 2006 and there was little left after the explosion. Small pieces of Omega blocks and gray dust were found scattered a considerable distance outby from the seals. Very little if any of the debris field was found inby the seals, consistent with other evidence which indicates the origin of the explosion was a considerable distance inby the seals. Exactly where the seals had been installed was difficult to discern on casual inspection because hitching¹ of the seals was not required. But by locating subtle perimeter lines of mortar and other means all the seal locations were found and detailed maps of the foundation and remnants were made during the investigation. These are described in more detail in **Section 5.2**.

Figure 1. Location of the ten (10) Omega seals that were constructed to seal off the Old 2nd Left Section. Construction was complete on December 11, 2006.

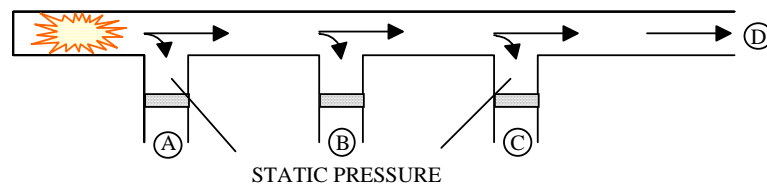
For the original testing, the Omega block seals⁵ were constructed in crosscuts adjacent to an entry where an explosion was created, as shown in **Figure 3**. This was basically an “open chamber” explosion test whereby the blast forces that passed by the crosscuts as they traveled down the entry were allowed to escape from the entry without any confinement. Although this does not simulate the conditions of an explosion in a small sealed area very well, it did satisfy the purpose and conditions of the test at the time-- namely the ability of the Omega block seals to hold forces produced by at least 20 psi static pressure.

Figure 3. This is a schematic of the “open chamber” test of Omega block seals. Set in the cross-cuts, the seals A,B, and C are subjected to a 20 psi “side-on” pressure from an explosion located at the back of the entry.

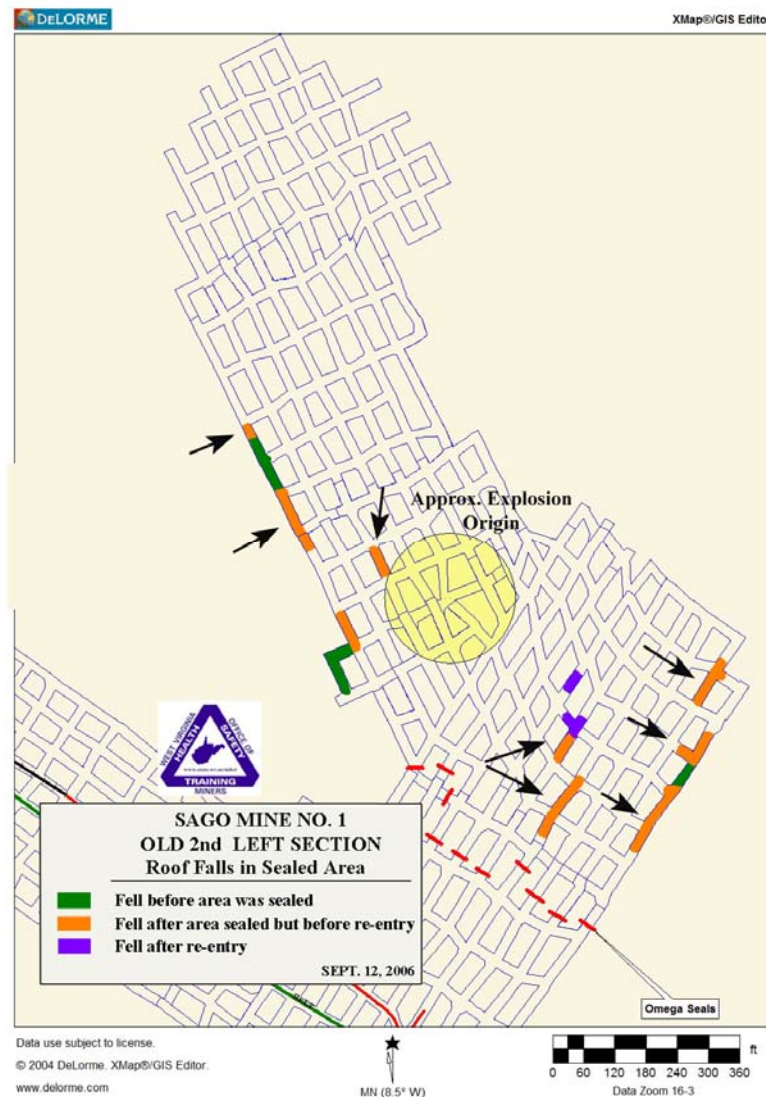
There are several roof falls that have been identified and mapped within the sealed-off area of the mine. **Map 1** illustrates the location of known roof falls. Rocks of certain types² are capable of creating sparks if they strike metal objects such as roof bolts.

Map 1.—The location of known roof falls in the area behind the seals. Arrows indicate those falls which occurred after the seals were built but before mine re-entry.

The domed top of the fall contains inter-bedded layers of sandstone that, under the right conditions, could have produced the necessary spark. However, after examining this area several times since the explosion, no evidence has been found that would indicate that the ignition started there. The balance of the inferred propagation directions of the blast favors a point-of-origin farther to the southeast.

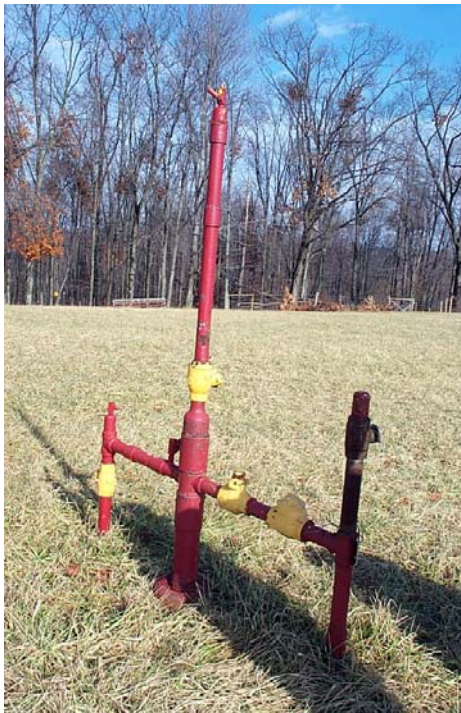
Soil resistivity testing was conducted at a gas well (**Photo 12**) located on the surface near the underground sealed area on January 18, 2006. A three (3) pole soil resistivity test was performed using a model DET5/4D Megger (**Figure 7**). The metal well casing was used for one connection and ground rods approximately eight (8) inches in length were driven into the ground at distances of thirty (30) feet and sixty (60) feet from the well. 2.62 ohms of resistance was measured. Measurements were then taken in a radial sweep pattern of

approximately thirty (30) feet each. Only two additional readings were taken and they were 4.83 ohms and 5.6 ohms of resistance.

Photo 12. Nearest known gas well to the Old 2nd Left Section. Soil resistivity tests were conducted here.

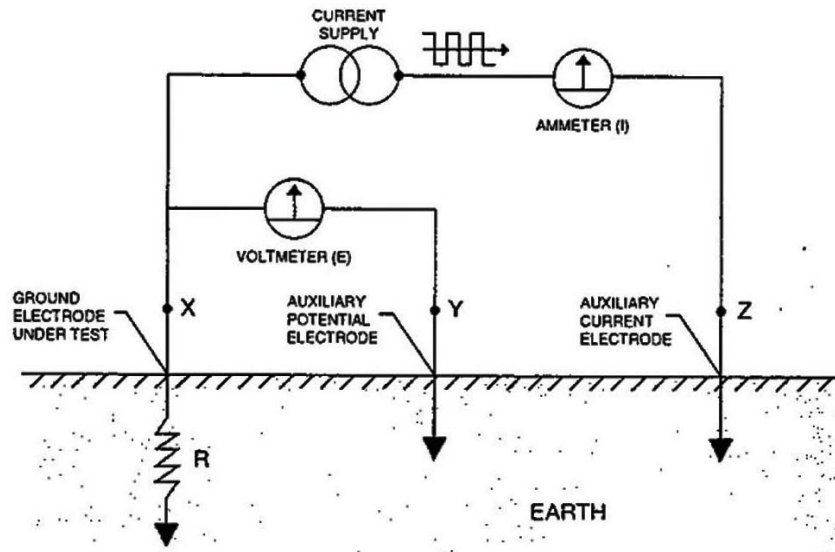
Figure 7. Three pole Resistivity testing

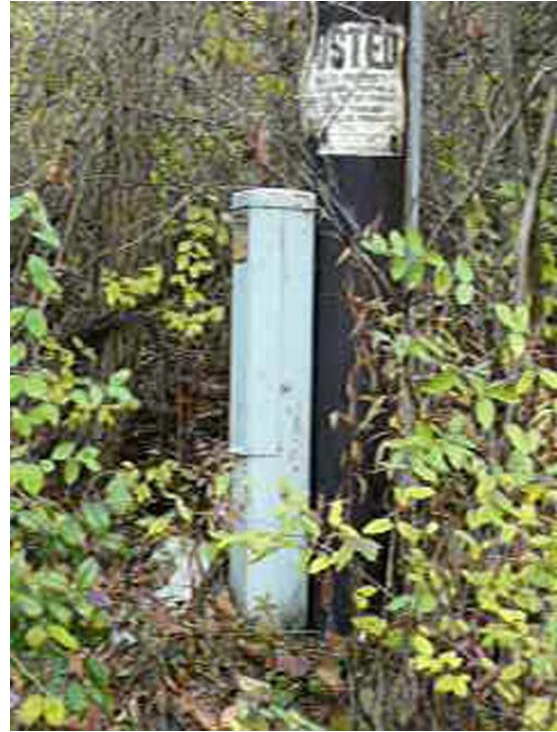
Photo 15: Junction box of 1981 line - where line changes from aerial to buried

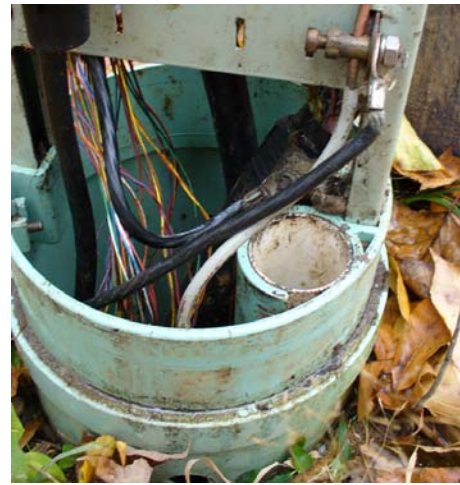
Photo 17: Typical grounding of buried cable at junction box

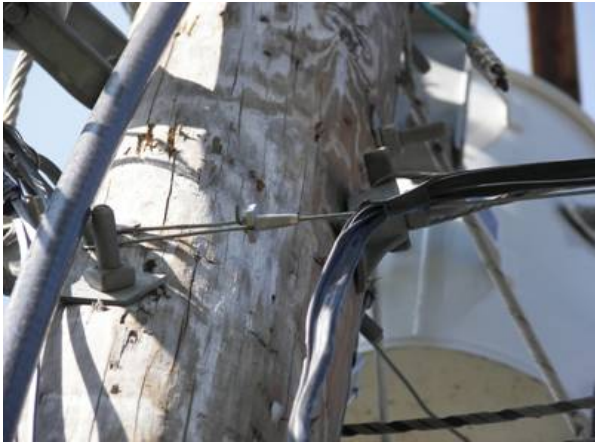
Photo 21: Messenger wire on new line (not grounded on pole)

New wiring had been run to the new distribution box by the phone company. This new wiring has a messenger wire attached but it is not connected to a ground on the pole or inside the new distribution box. The only ground wire is inside the distribution box. This wire is attached to a ground lug inside the Distribution Box and was only tied to the solid copper ground wire coming down the telephone pole. No other wires inside the distribution box were grounded.

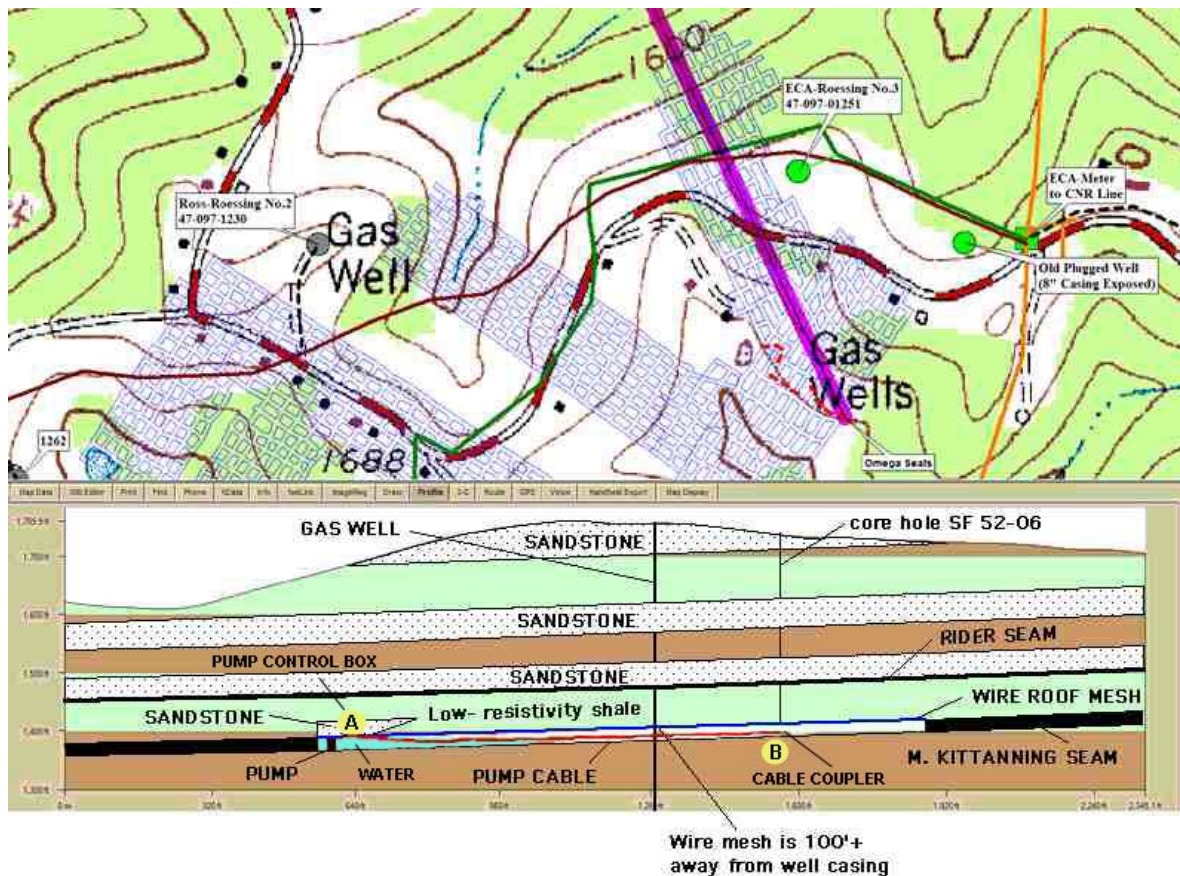
A cross-section view of Old 2nd Left Section is given in **Figure 8**. As shown, the rock strata contain sandstone layers that are separated by other layers²⁰. Measurements of resistivity are given in **Appendix 5.5-3: Geophysical Log for SF 52-06**. Layers of shale and sandy shale are between the sandstone layers, and have comparatively low resistivity. The layer of shale between the coal and the Rider seam appears to generally have the lowest resistivity of all.

Figure 8. Geologic cross-section through Old 2nd Left Section. E-log to SF 52-06 shows sandstones are high resistivity. The shale roof is low resistivity. The wire roof mesh is bolted to this shale. The pump cable is insulated from the wire roof mesh except at the pump control box.

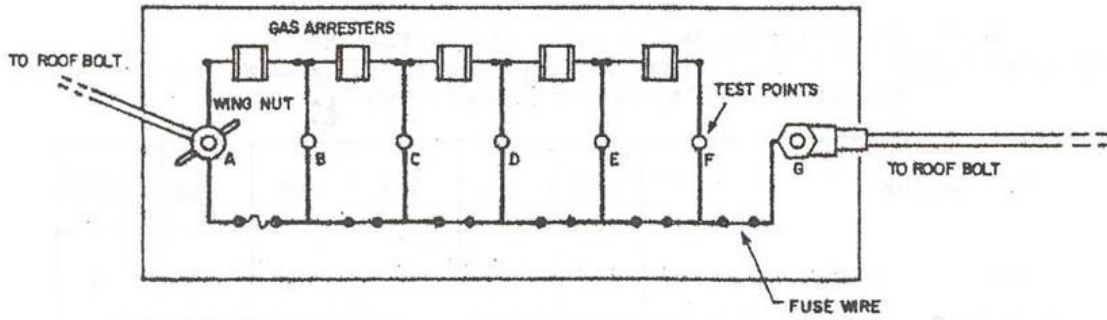
Figure 9. Schematic diagram of the fuse surge detector (FSD) for monitoring of transient currents underground. The FSD comprises six fusible wires in series, with gas arresters in parallel to five of the six fuses (the electronic circuit is not shown)²².

The region of the Sago Mine will continue to experience lightning and as the winter season approaches it is recommended that we install a number of FSD circuits (see **Figure 9**) within Old 2nd Left Section and at other points in Sago Mine in order to measure the transient voltages and currents that appear underground when there is lightning in the area. Due to the intensive investigations that have taken place at Sago during the past 11 months, we now know more about the arrangement of metallic structures at the surface and underground at Sago and will, hopefully, soon be able to supplement that information with a model of how the electromagnetic energy from lightning penetrated from the surface into the Sago mine²¹. If we can monitor and detect transient currents and voltages from future lightning activity we may be able to correlate them to specific types of lightning and field conditions. This is the first step in developing protective measures to guard against similarly destructive lightning accidents in the future.

The chances of obtaining positive lightning in the Sago area during the winter are as good or better than other geographical locations in the U.S. It is recommended that such a study be implemented at the Sago mine. The types of device that are proposed for monitors are available, inexpensive, and require very little maintenance. They could be left underground, unattended, and will monitor for any current and voltage surges continuously. When a surge is detected, the monitor will shut down and record the time until it is reset. The devices merely need to be checked periodically. By correlating readings of the lightning transient underground, to lightning detected on the surface, we will be in a good position to understanding how lightning entered this mine.

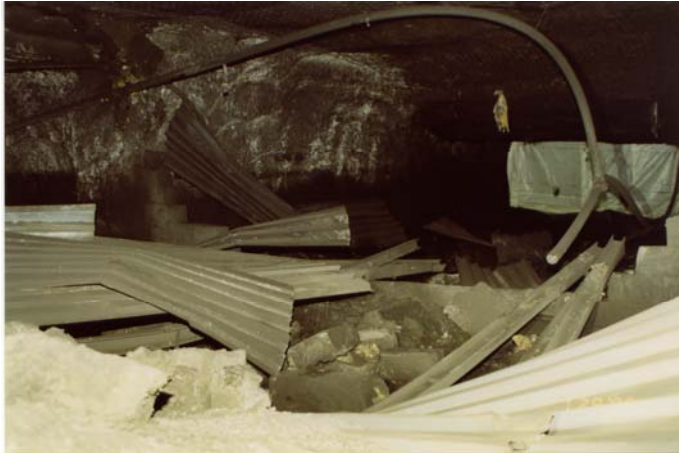
Photo 1

Example of debris from overcast at the mouth of second-left the crew would have encountered

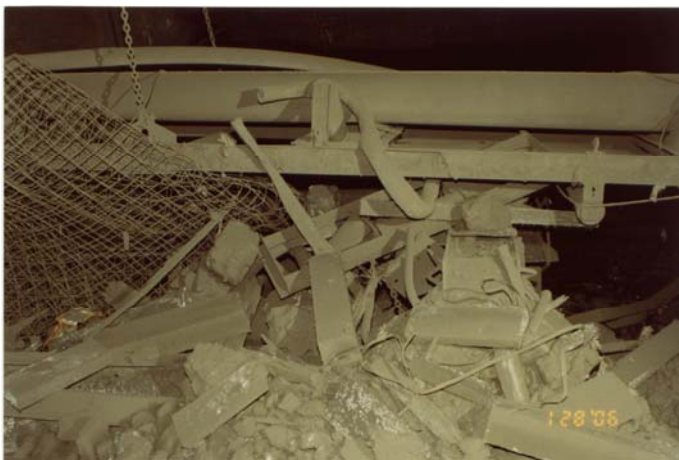
Photo 2

Example of debris on the belt at the mouth of second-left

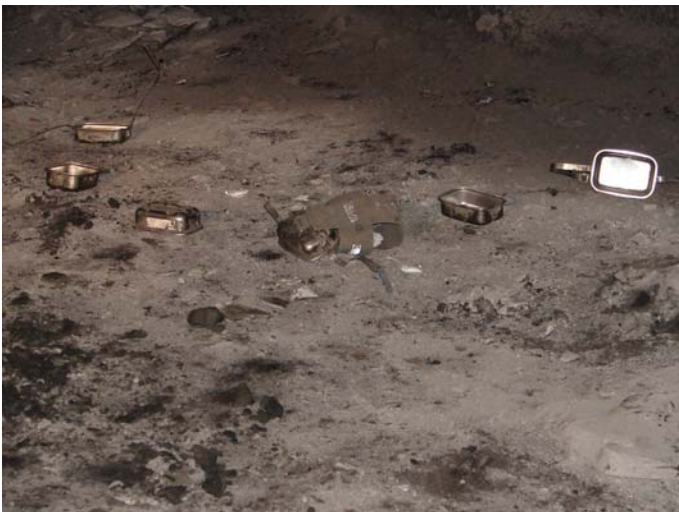
Photo 3

After the second-left crew abandoned their mantrip they crossed over into the intake and donned their SCSRs at 12-block leaving the covers on the floor in a circle – one unit's plastic outer casing was ripped off in an effort to remove a cover that apparently was stuck

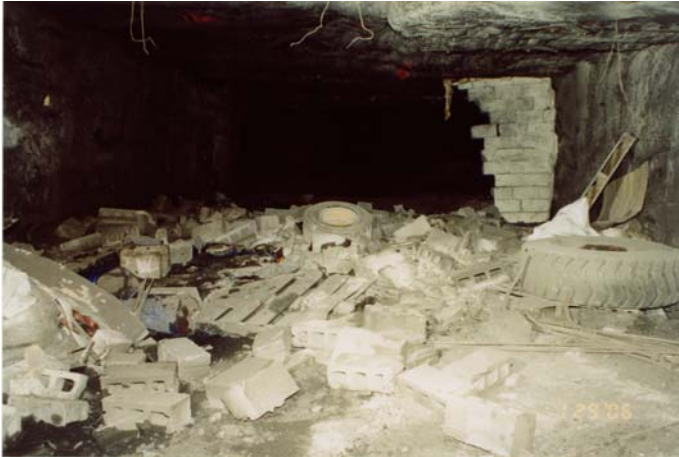
Photo 4

Example of debris from stoppings near end of second-left track.

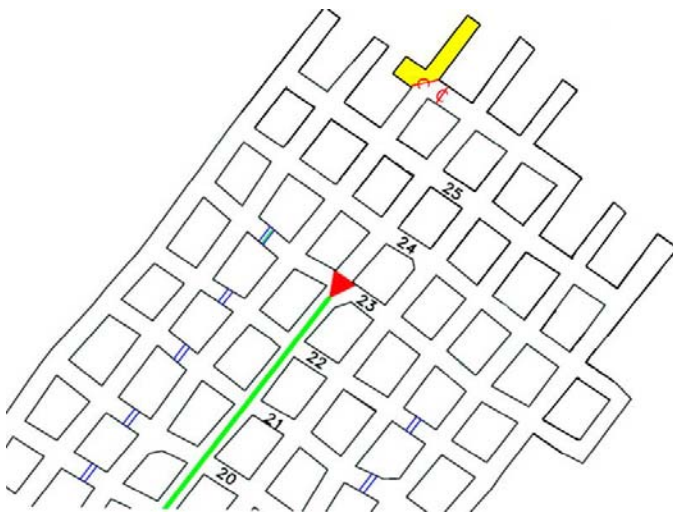
Figure 1

Location of second-left barricade in number three-entry at the face – shorter yellow area is the crosscut and the longer the number three entry

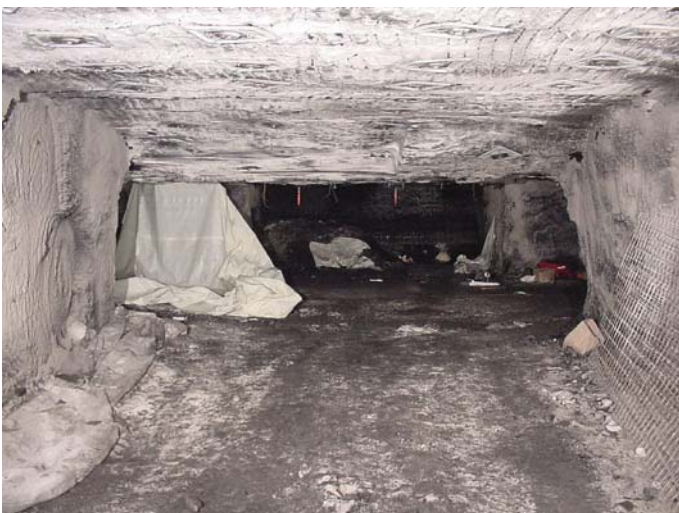
Photo 5

View into the barricaded crosscut looking from number four entry towards number three entry with the diagonal barricade curtain partly down

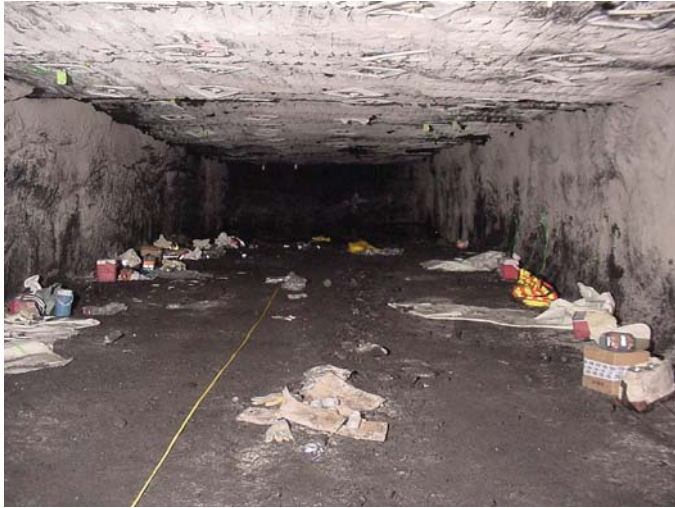
Photo 6

View into the number three entry
barricade at looking toward the face

(The case of SCSRs in right foreground
were brought by mine rescue teams for
use in evacuation of survivors – some
were used for evacuating Mr. McCloy)

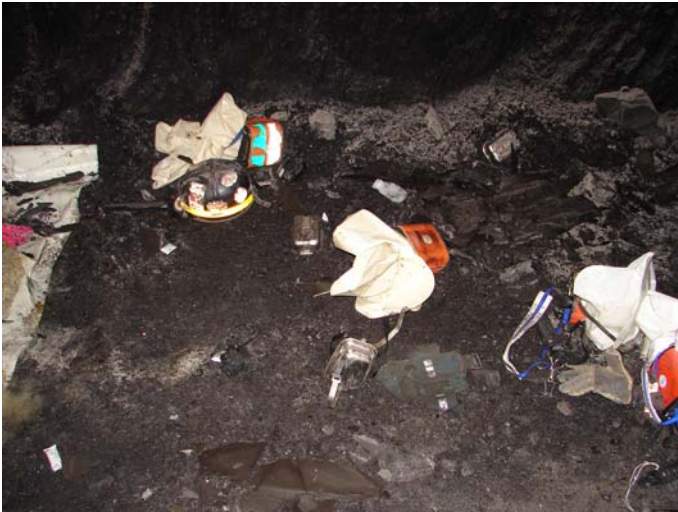
Photo 7

Mr. McCloy's hat and several of the
SCSRs used by the rescue team as they
provided aid while bringing him out

These items were located on the left rib
closest to the face of the number three-
entry portion of the barricade

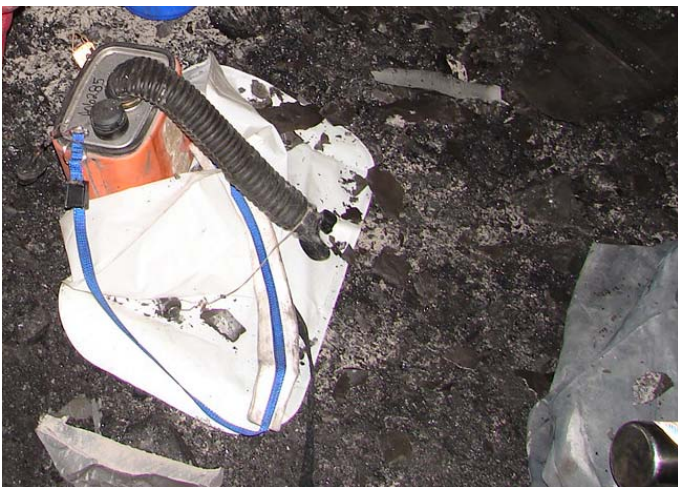
Photo 8

Second-left SCSR as found

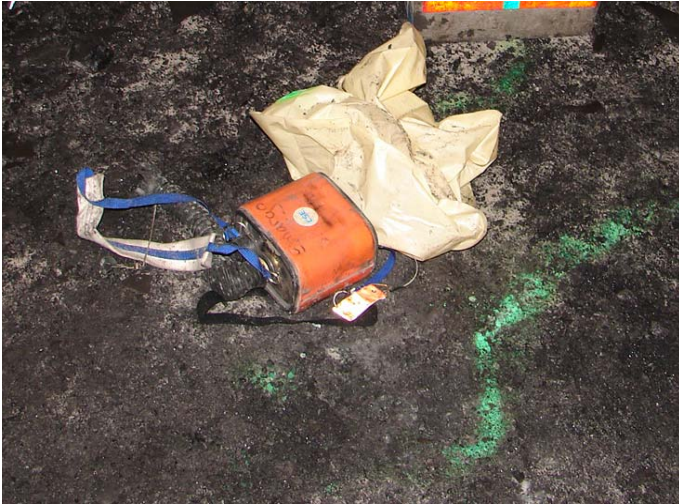
Photo 9

Second-left SCSR as found

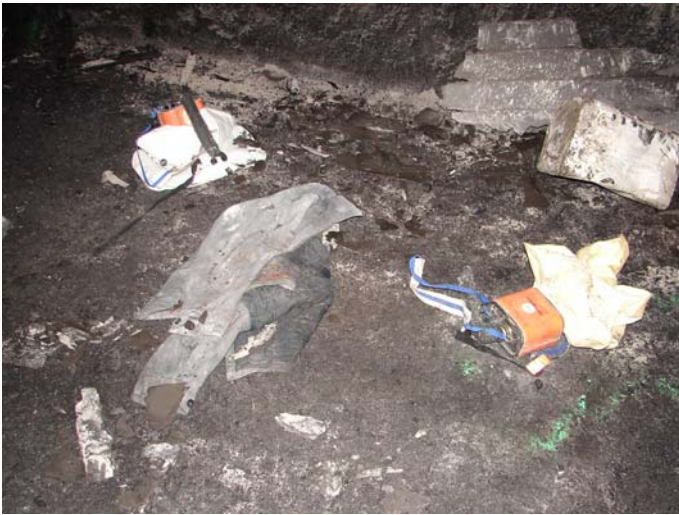
Photo 10

Second-left SCSR as found

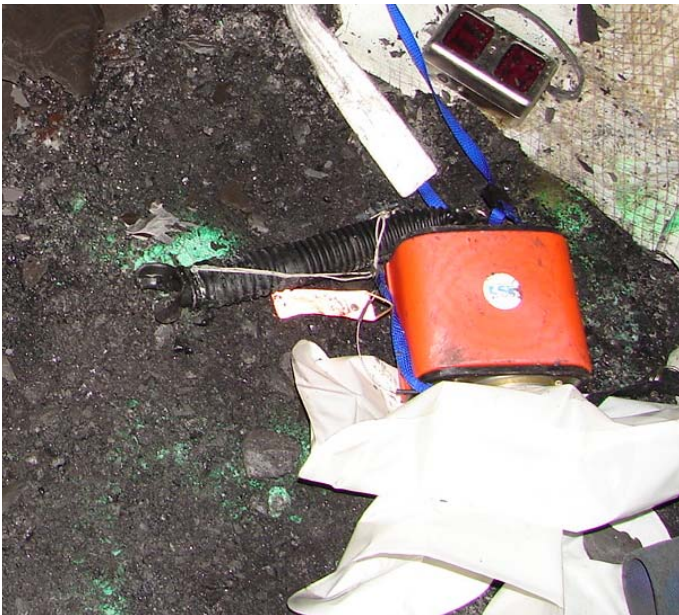
Photo 11

Second-left SCSR as found

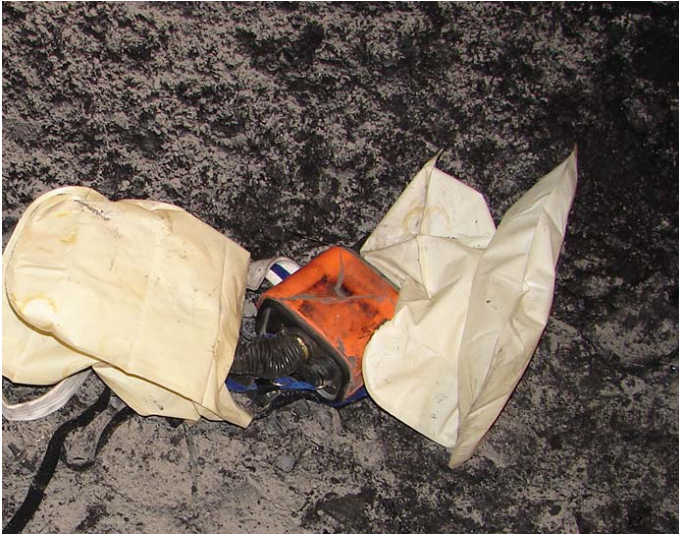
Photo 12

Second-left SCSR as found

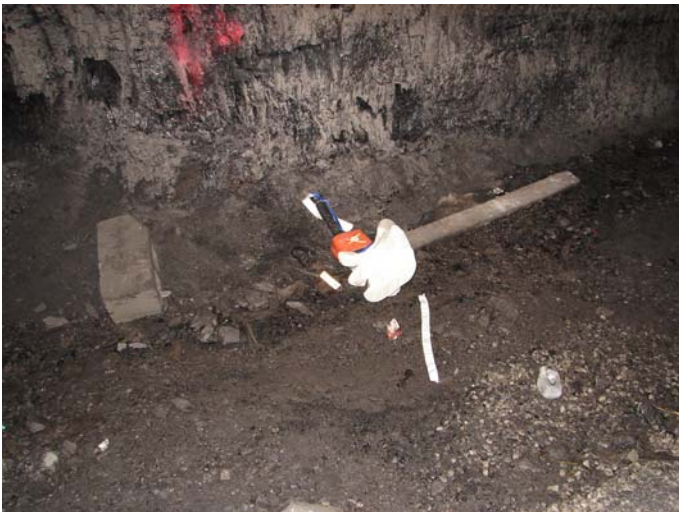
Photo 13

Second-left SCSR as found

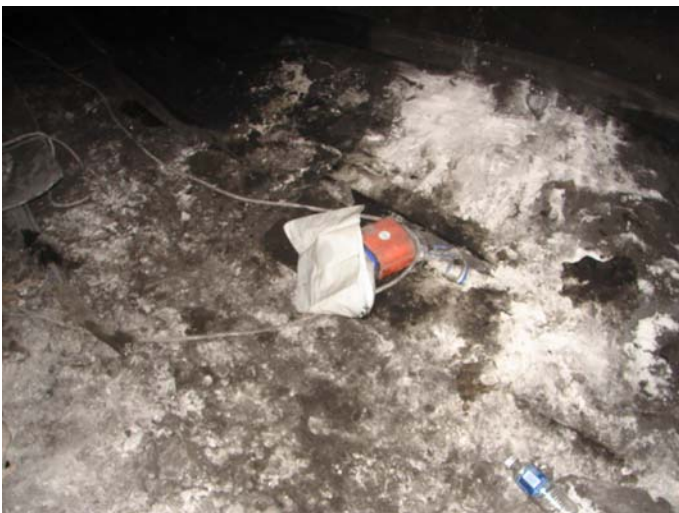
Photo 14

Second-left SCSR as found – white areas are where dust deposited by explosion has been disturbed revealing applied rock dust

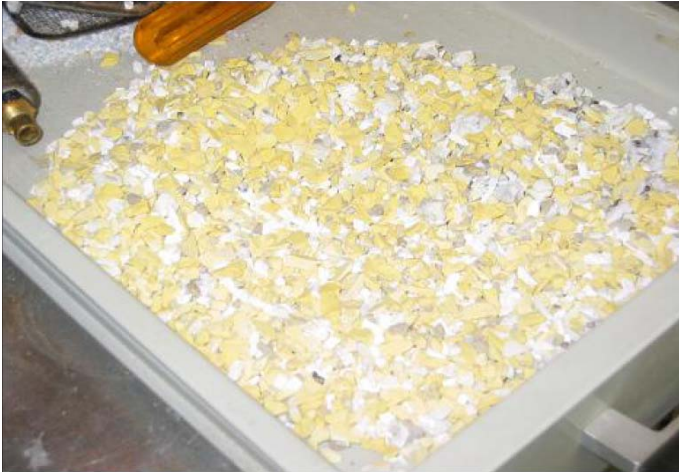
Photo 15

Contents of Sago SCSR from unit with 10% spent potassium superoxide

Note large percentage of bright yellow potassium superoxide – bright white particles are lithium hydroxide – pale yellow and gray particles are reacted potassium superoxide

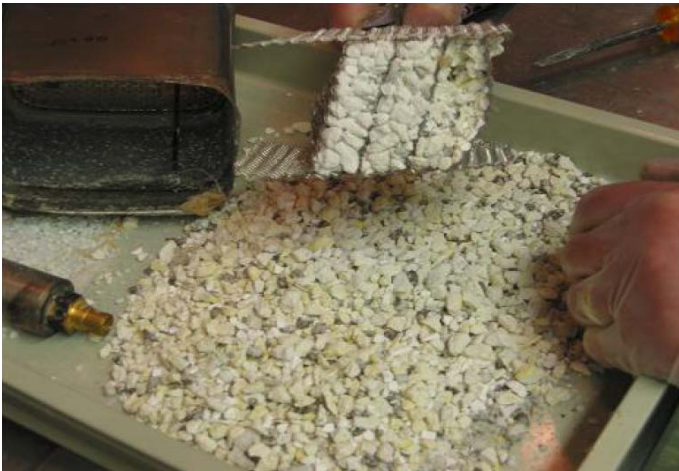
Photo 16

Contents of Sago SCSR from unit with 40-50% spent potassium superoxide

Note percentage of pale yellow potassium superoxide and moderate caking of chemical in canister mesh support

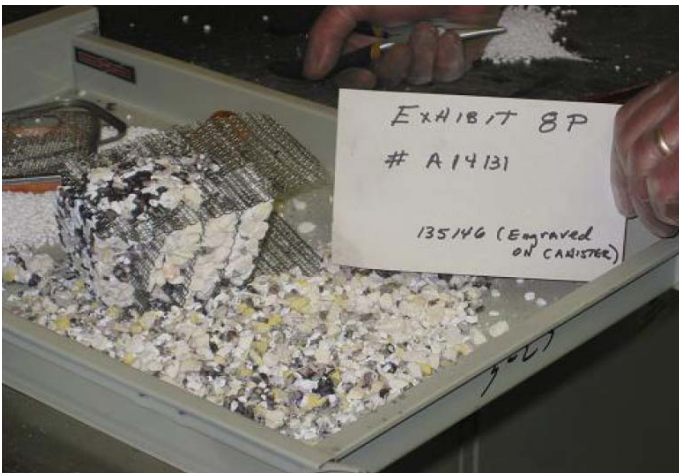
Photo 17

Contents of Sago SCSR from unit with 80-90% spent potassium superoxide
