5.4 FLAMES and FORCES

5.4-1 Mapping of Explosion Forces

5.4-2 Origin of Explosion

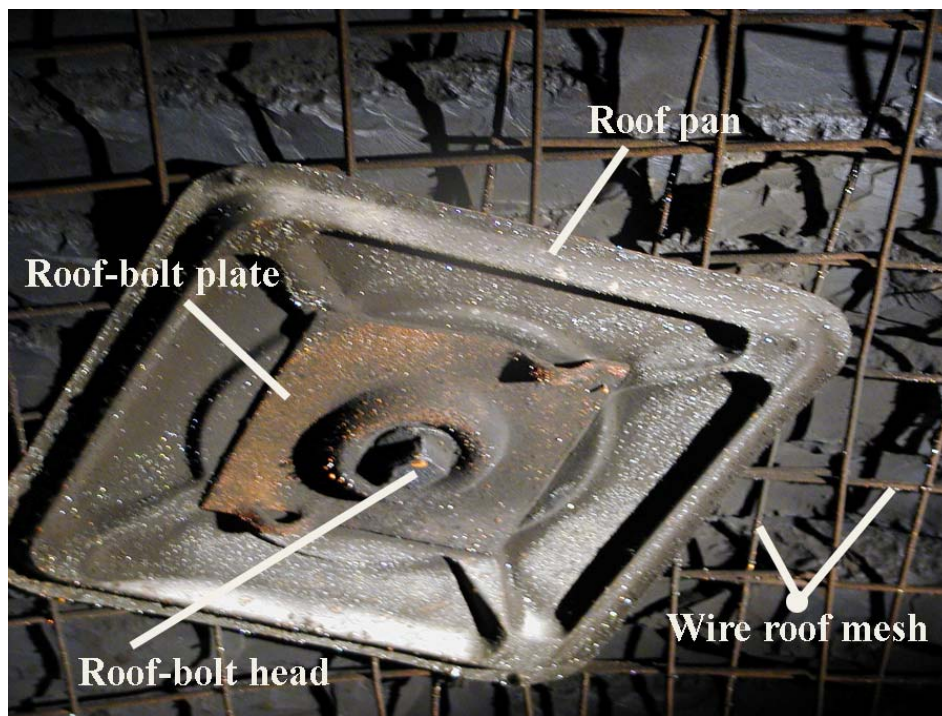
Photo 2. A typical arrangement of roof support, consisting of a roof bolt, roof bolt plate, roof pan, and wire roof mesh—all held against the mine roof by the head of the roof bolt. Square pans (commonly called “spider plates”) and round pans (commonly called “pizza pans”) are not used everywhere in the sealed area. Nor was the wire roof mesh used everywhere. Where it was used, the blast forces of the explosion altered their configuration in a way that helped us to reconstruct details of the blast.

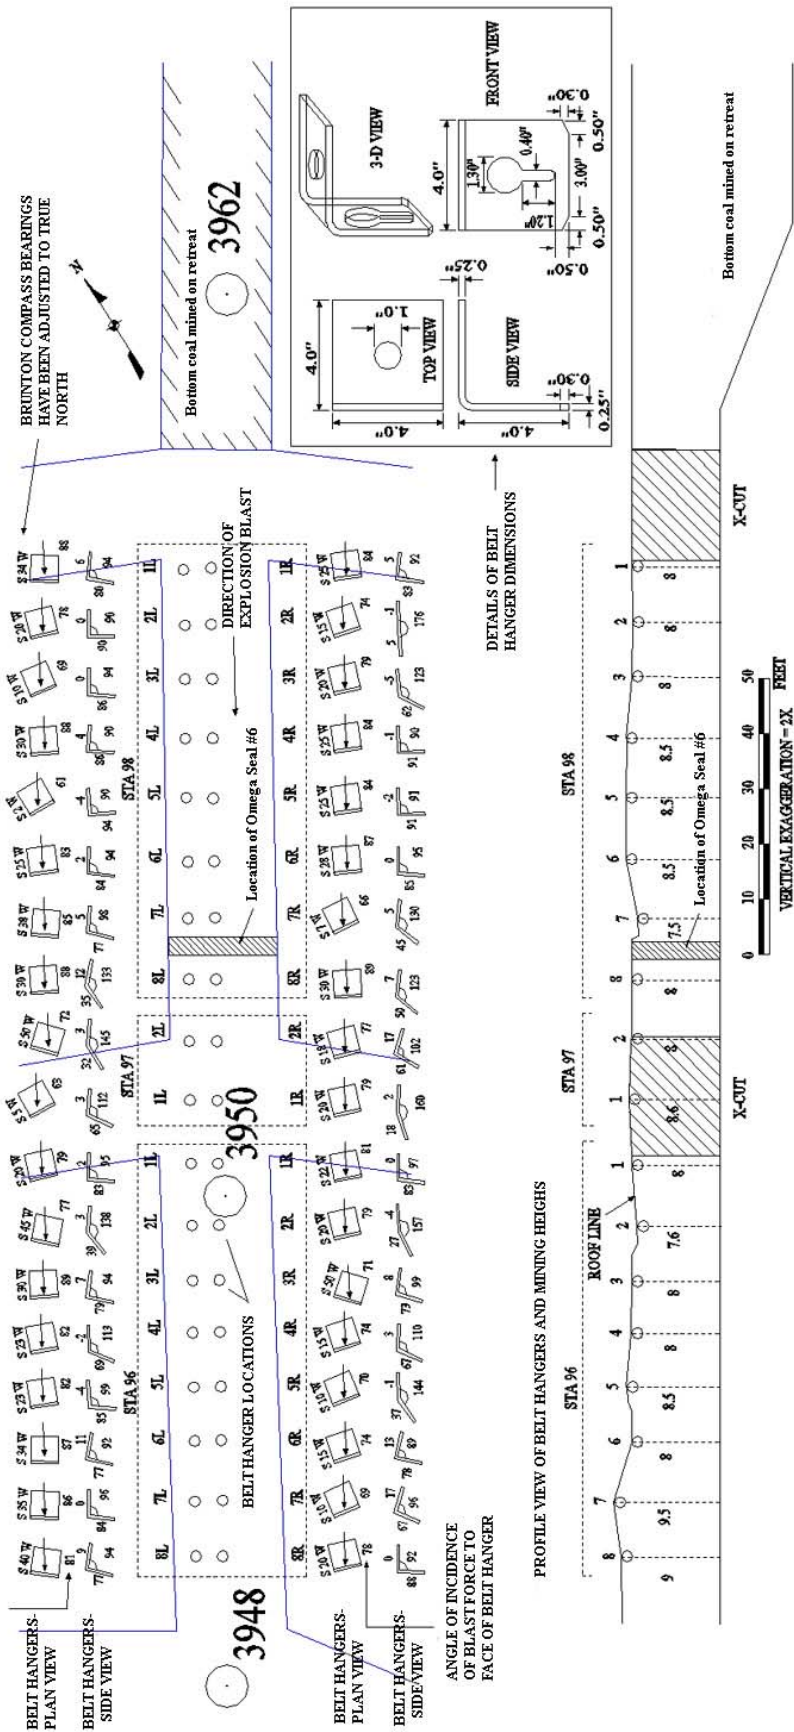
Belt Hanger Survey 1

PLAN VIEW OF BELT HANGERS AND MINE LAYOUT ALONG BELT ENTRY (#5 ENTRY)

ANGLE OF INCIDENCE
 OF BLAST FORCE TO
 FACE OF BELT HANGER

This first effort at mapping the belt hangers started with 36 belt hangers in the #5 belt entry in the vicinity of the Omega seal #6 location—14 of which were located behind Omega Seal #6 and 22 on the front (outby) side (see **Figure 1**).

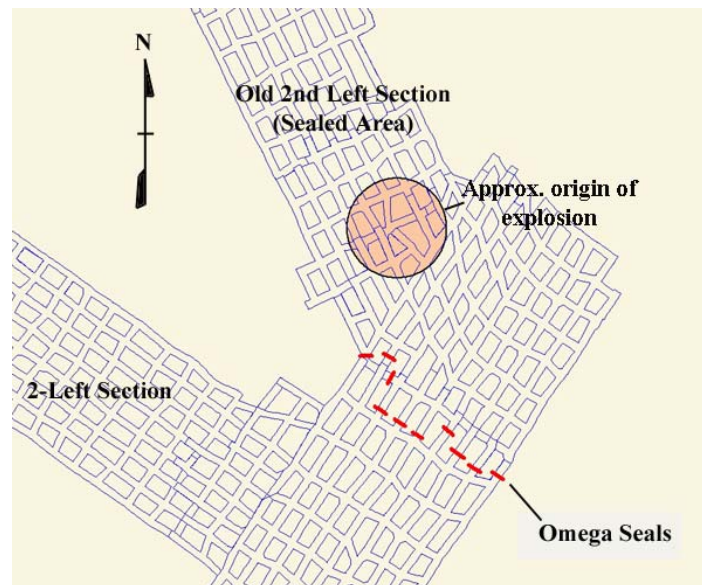
Ten (10) seals that were built to isolate the mined-out Old 2nd Left Section from the rest of the Sago mine were destroyed in an explosion on the morning of January 2, 2006 and there was little left after the explosion. Small pieces of Omega blocks and gray dust were found scattered a considerable distance outby from the seals. Very little if any of the debris field was found inby the seals, consistent with other evidence which indicates the origin of the explosion was a considerable distance inby the seals. Exactly where the seals had been installed was difficult to discern on casual inspection because hitching¹ of the seals was not required. But by locating subtle perimeter lines of mortar and other means all the seal locations were found and detailed maps of the foundation and remnants were made during the investigation. These are described in more detail in **Section 5.2**.

Figure 1. Location of the ten (10) Omega seals that were constructed to seal off the Old 2nd Left Section. Construction was complete on December 11, 2006.

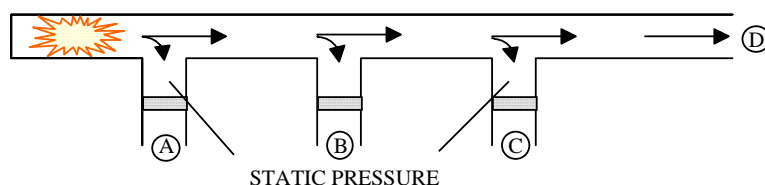
For the original testing, the Omega block seals⁵ were constructed in crosscuts adjacent to an entry where an explosion was created, as shown in **Figure 3**. This was basically an “open chamber” explosion test whereby the blast forces that passed by the crosscuts as they traveled down the entry were allowed to escape from the entry without any confinement. Although this does not simulate the conditions of an explosion in a small sealed area very well, it did satisfy the purpose and conditions of the test at the time-- namely the ability of the Omega block seals to hold forces produced by at least 20 psi static pressure.

Figure 3. This is a schematic of the “open chamber” test of Omega block seals. Set in the cross-cuts, the seals A,B, and C are subjected to a 20 psi “side-on” pressure from an explosion located at the back of the entry.

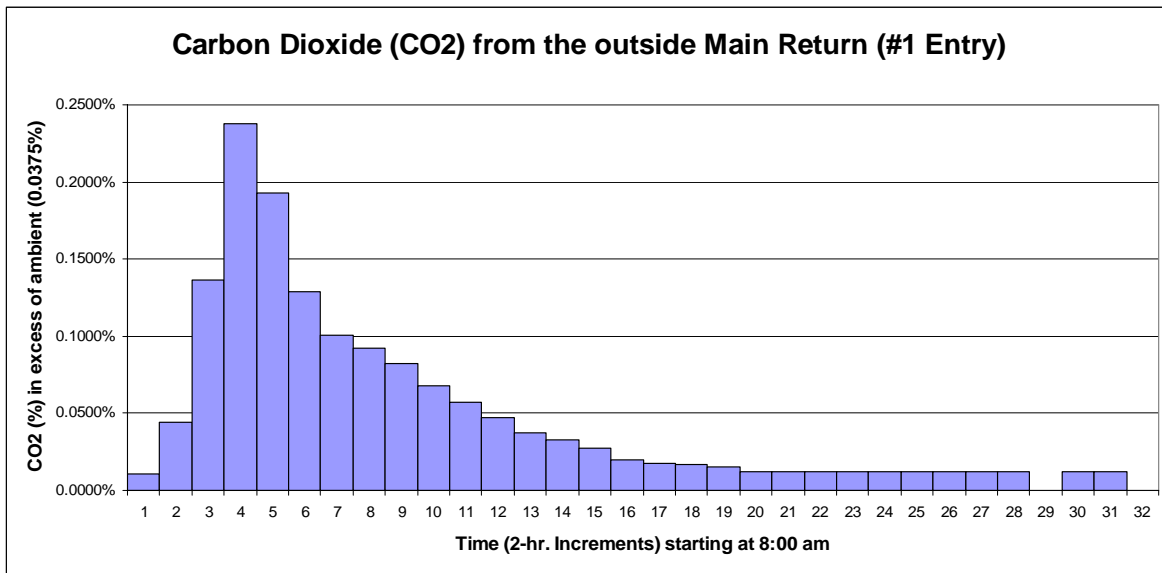
The molecular weights of CO and CO₂ were calculated and converted to kg/mole at 1.03 bar and 59-degrees F. The volumes of CO and CO₂ gases coming out the #1 Main Return for a 60-hour period following the explosion (in 2-hour increments) were totaled using an average of seven (7) flow readings⁶ out this entry and converted to total weight using densities at 1.013 bar and 59-degrees F.

Figure 1. Carbon dioxide (CO₂) % concentration as measured at the Main Return (#1 entry). Time units are shown in 2-hr. increments over a 60-hr period starting at 8:00 am on 1-2-06. Volumes have been adjusted for the 375 ppm ambient air concentration.

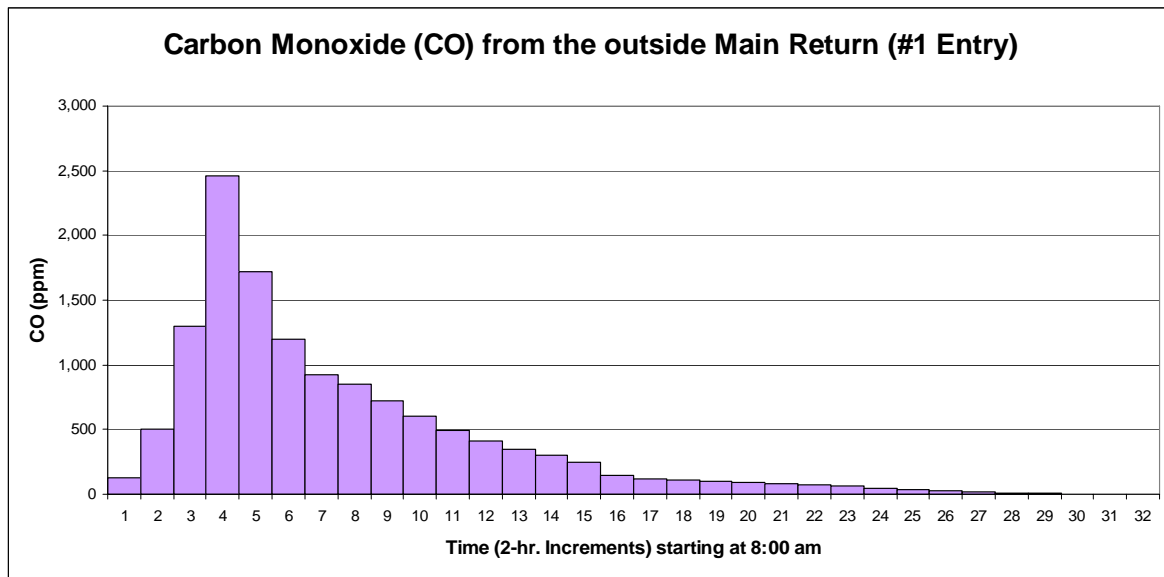
Figure 2. Carbon monoxide (CO) concentrations expressed in “part per million” as measured at the Main Return (#1 entry). Time units are shown in 2-hr. increments over a 60-hr period starting at 8:00 am on 1-2-06.

The sensitive variable in the mass balance calculation is the #1 Main Return flow volume (for which we have only a few actual readings). The #1 Main Return is estimated to have discharged on average approximately 40% of the total exhaust volumes and 85% of the exhaust concentrations during the 60-hr. period. The remaining volumes and concentrations were assigned to the #2, #3, and #4 entries.

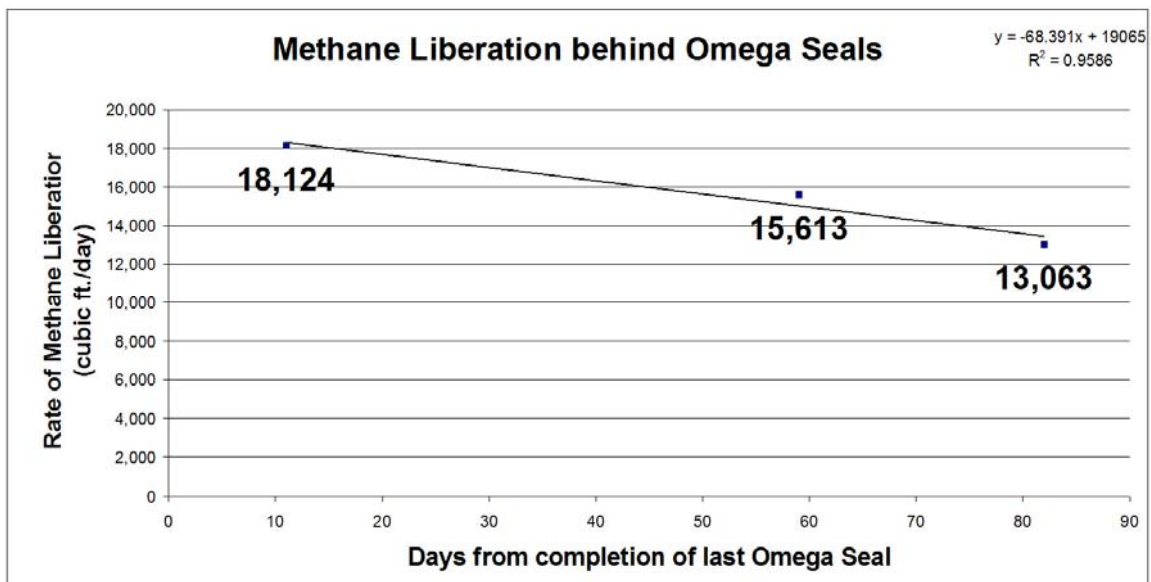
These data were made available to this agency and have been used to help construct a methane liberation rate chart (**Figure 3**).

As a final step the two (2) MSHA and one (1) OMHS&T values for average daily methane liberation volumes were plotted on a chart for comparison. This chart (**Figure 3**) shows a linear rate of decline for methane liberation over the three (3)-month time period.

Figure 3. This graph shows the history of average daily methane emissions over time within the sealed area of Old 2nd Left, as determined by an analysis of gas data recorded at Sago Mine.
