5.5 Cause of Explosion

5.5-1 What caused the explosion?

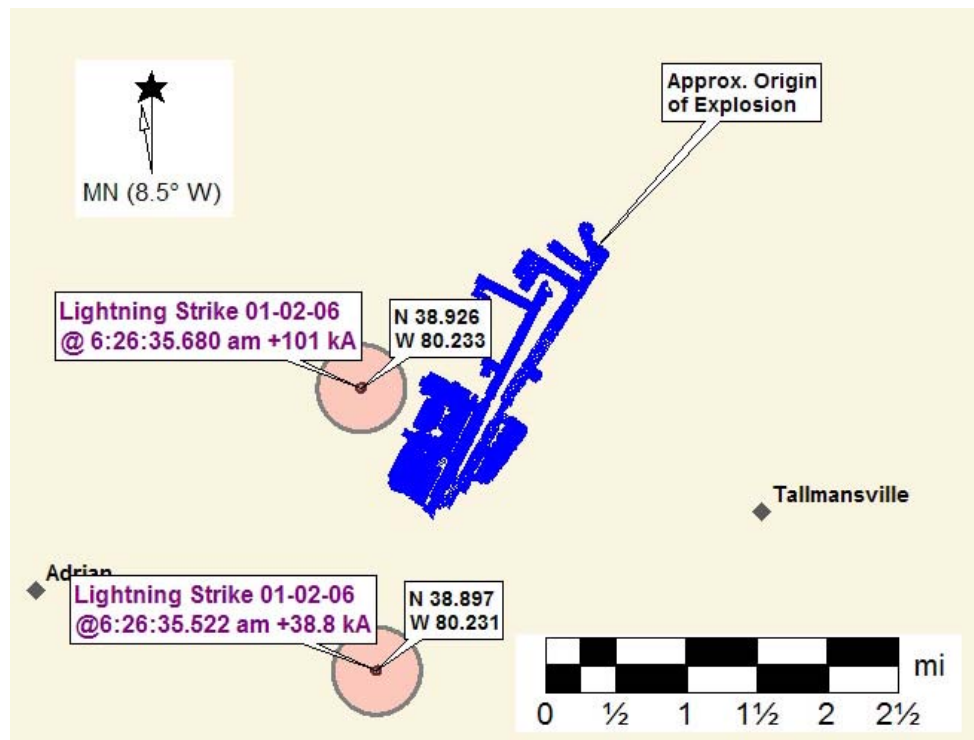
Map 2. Two (2) of the lightning strikes reported by Vaisala between 5:00 AM and 7:00 AM EST on January 2, 2006 within a 5- mile radius of the top end of Sago Mine. The closest strike to the mine was also the strongest (101,000 amperes).

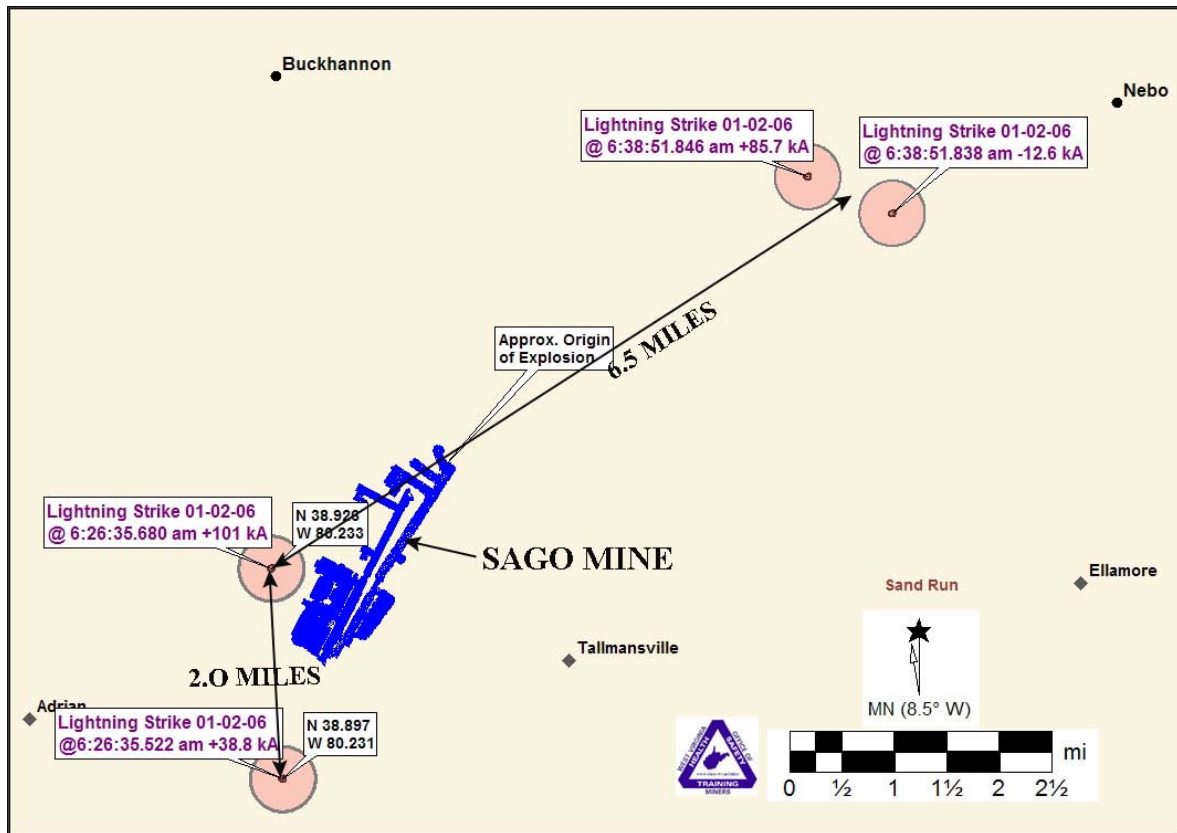
<u>Date / Time</u>	<u>Latitude</u>	<u>Longitude</u>	<u>Amperes (000's)</u>
01/02/06 06:26:35.522 EST	38.897	-80.231	+38.8
01/02/06 06:26:35.680 EST	38.926	-80.233	+101.0
01/02/06 06:38:51.838 EST	38.975	-80.123	-12.6
01/02/06 06:38:51.846 EST	38.980	-80.138	+85.7

Map 1. Location of lightning strikes within a 5 mile radius of the center of the Sago Old 2nd Left sealed area between the hours of 5:00 AM and 7:00 AM on the morning of January 2, 2006. Strike coordinates, magnitudes, and polarities were provided by Vaisala-Thunderstorm Unit in Tuscon, Arizona-- owned and operated by the National Lightning Detection Network (NLDN).

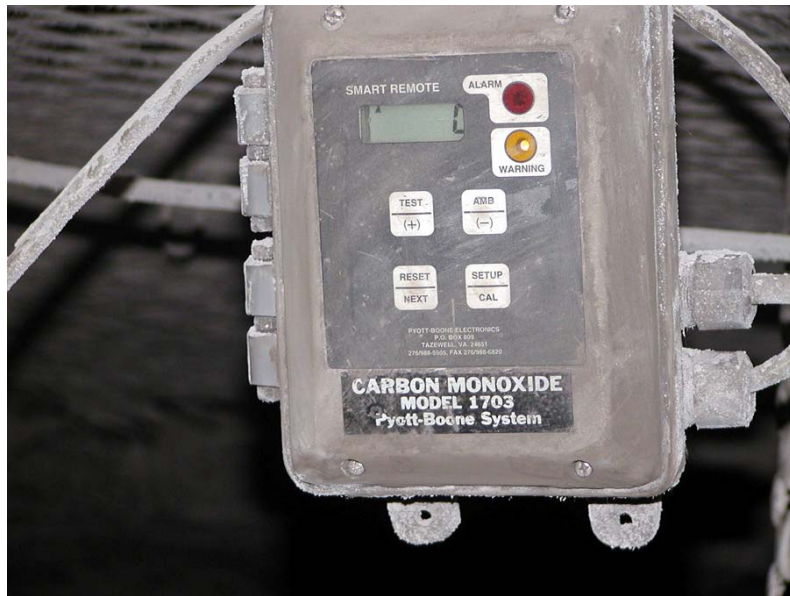
Photo 2. An example of the CO (carbon monoxide) monitors used to monitor the conveyor belt for mine gases underground at the Sago mine.

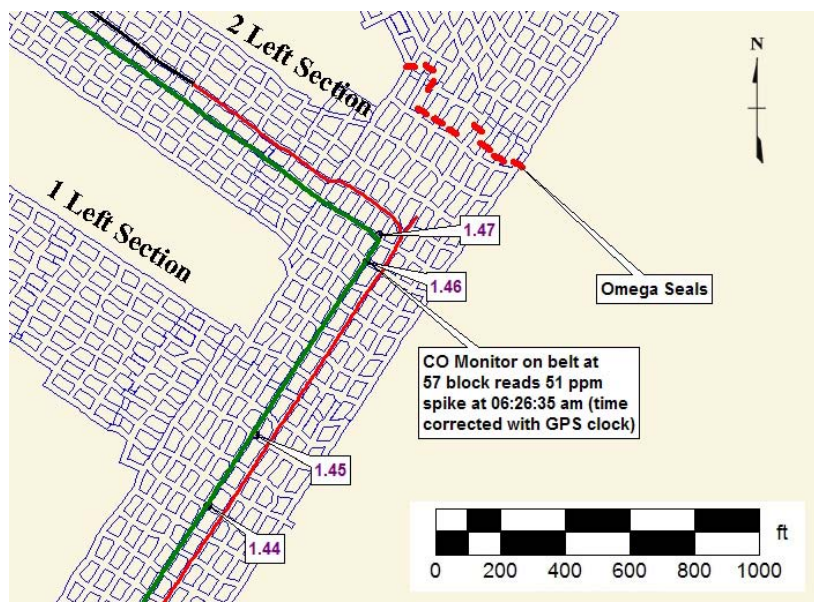
Map 2 (below) shows the location underground of CO monitors 1.46 and 1.47 on #4 Belt at or near where it adjoins #6 Belt. Unit 1.46 was located at #57 Break on #4 Belt—a distance of approximately 500 ft. from the front of the Omega seals and in-line with the explosion forces. The system is set up to signal trouble as follows:

According to the computer log at 31 seconds after 6:31 AM sensor unit 1.46 on #4 Belt sent an alarm for 51 ppm³ CO concentrations, and it was never heard from again. Seconds later the two monitoring units downstream on #4 Belt reported 107 ppm just before they too disappeared from the system. CO monitors and belt systems suddenly began reporting trouble, reporting CO, power loss, and dead communications along #4 Belt and also along # 5 Belt and #6 Belt⁴. These events document the timing of the explosion which, according to the computer clock apparently began with the 51 ppm alarm at 6:31:31 AM.

Map 2. Location of some of the CO monitors on the mine conveyor belt at the time of the explosion.

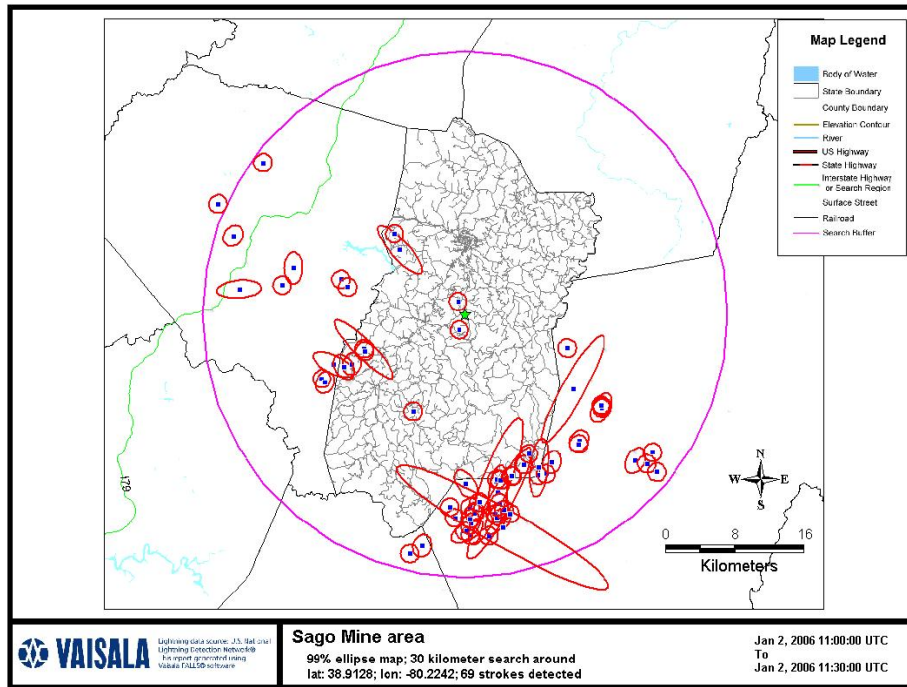
On the morning of January 2, 2006, the NLDN detected 69 CG strokes within 30 km of the mine entrance in the interval from 06:00 to 06:30 EST. A map showing the locations of these strokes is given in **Figure 1**, and a detailed listing of the stroke parameters is given in **Appendix 5.5-2: Attachment A**. It should be noted that the NLDN reported two, large positive events within 6 km of the mine at about the time of the explosion. The times of the first and second strokes were 11:26:35.523 UT (06:26:35.523 EST) and 11:26:35.680 UT (06:26:35.680 EST), respectively, and the interval between them was 157 milliseconds. The first stroke had an estimated peak current (I_p) of about +39 kiloamperes (kA), and the second had an I_p of +101 kA. A map showing the locations of all strokes that occurred in the 4-hour interval from 04:30 to 8:30 AM EST within 5 miles of the mine entrance is given in **Figure 2**, and the locations of all strokes detected in the 2-hour interval from 05:00 to 07:00 EST within 5 miles of the point-of-origin of the methane explosion is given in **Figure 3**. The elliptical regions shown in red

Figure 1. Cloud-to-ground lightning strokes detected by the NLDN within 30 km of the entrance to the Sago mine between 06:00 AM and 06:30 AM EST on January 2, 2006. The red circles and ellipses show the boundaries of the 99% confidence regions.

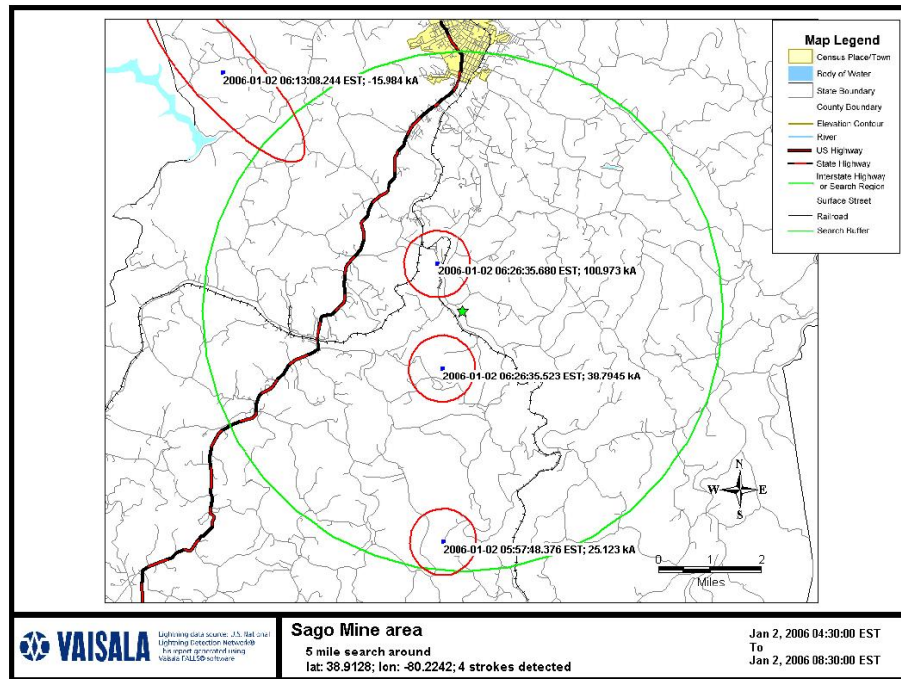
Figure 2. Cloud-to-ground lightning located within 5 miles of the entrance to the Sago mine between 04:30 AM and 08:30 AM EST on January 2, 2006.

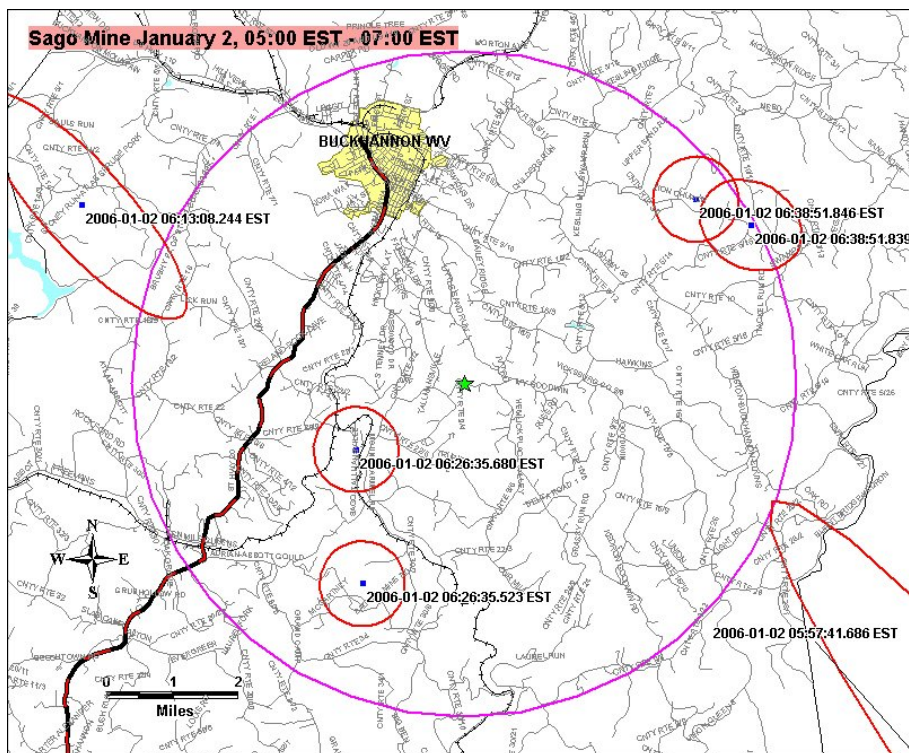
Figure 3. Cloud-to-ground lightning located within 5 miles of the point-of-origin of the explosion at the Sago mine between the hours of 05:00 AM and 07:00 AM EST on January 2, 2006.

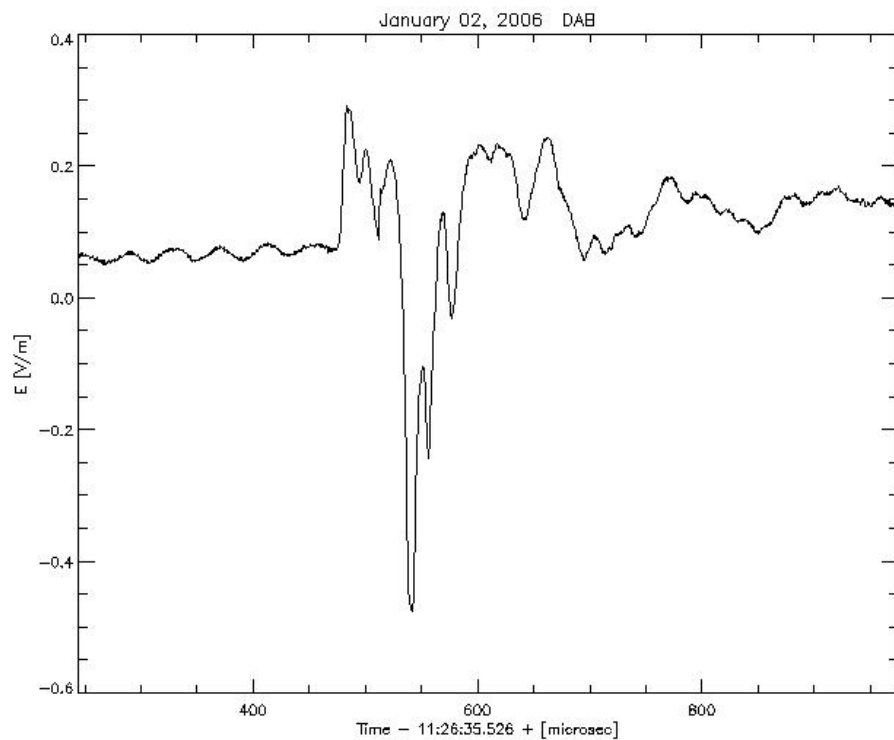
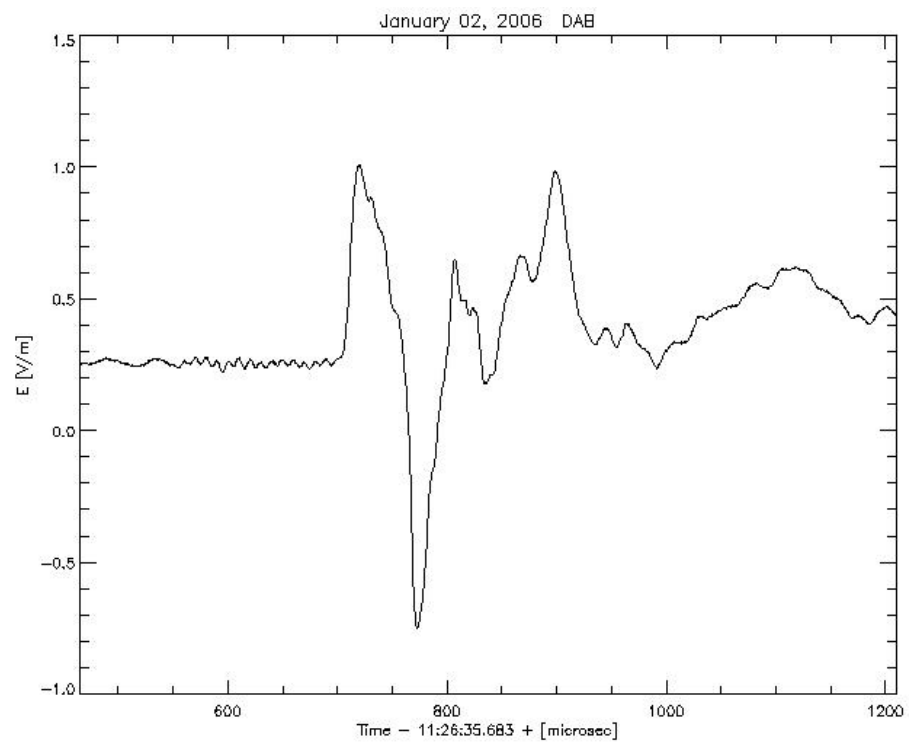
The Los Alamos Sferics Array (LASA)^{12,13} recorded broadband lightning waveforms at 3 sensor sites on January 2, 2006, at times that were consistent with the first and second strokes detected by the NLDN, after the times for electromagnetic propagation were subtracted from the times that the signals were received. **Figures 4, 5, and 6** (courtesy of Dr. X-M Shao) show the electric field waveforms recorded at Daytona Beach, FL; Lincoln, NE; and Garden City, KS, respectively, at the times of the first (top) and second (bottom) NLDN strokes near the Sago mine. Note in **Figures 4 to 6** that all pulses begin with a positive excursion that is characteristic of a positive lightning impulse propagating over the ground, and then there is a large, negative excursion that is caused by the first ionospheric reflection at the distances involved.

Figure 4. Electromagnetic pulses recorded by the LASA sensor at Daytona Beach, FL.

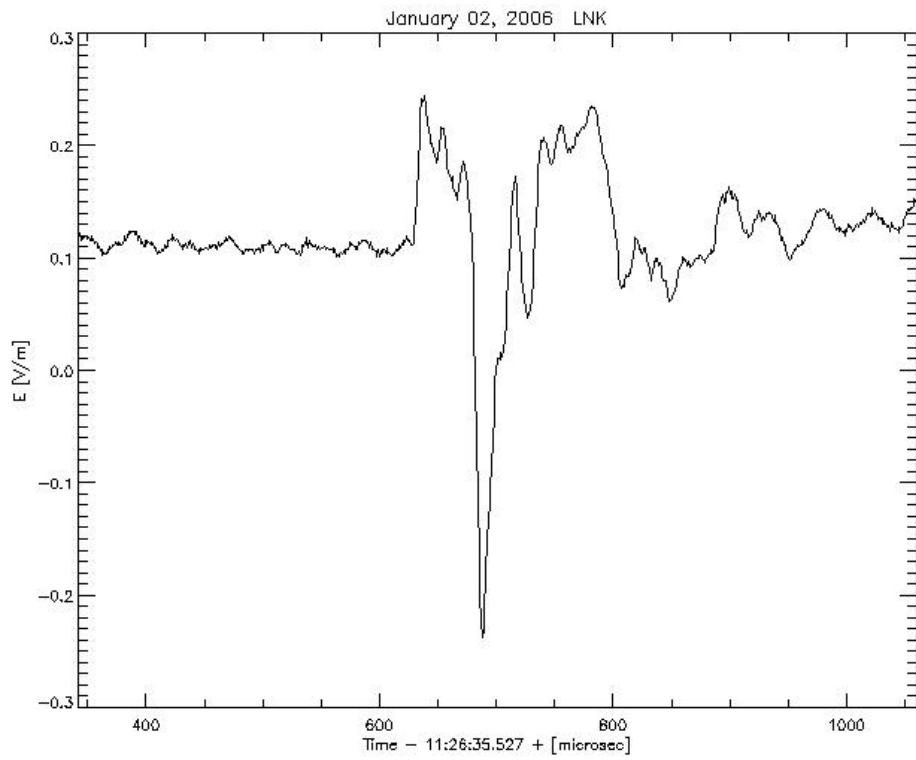
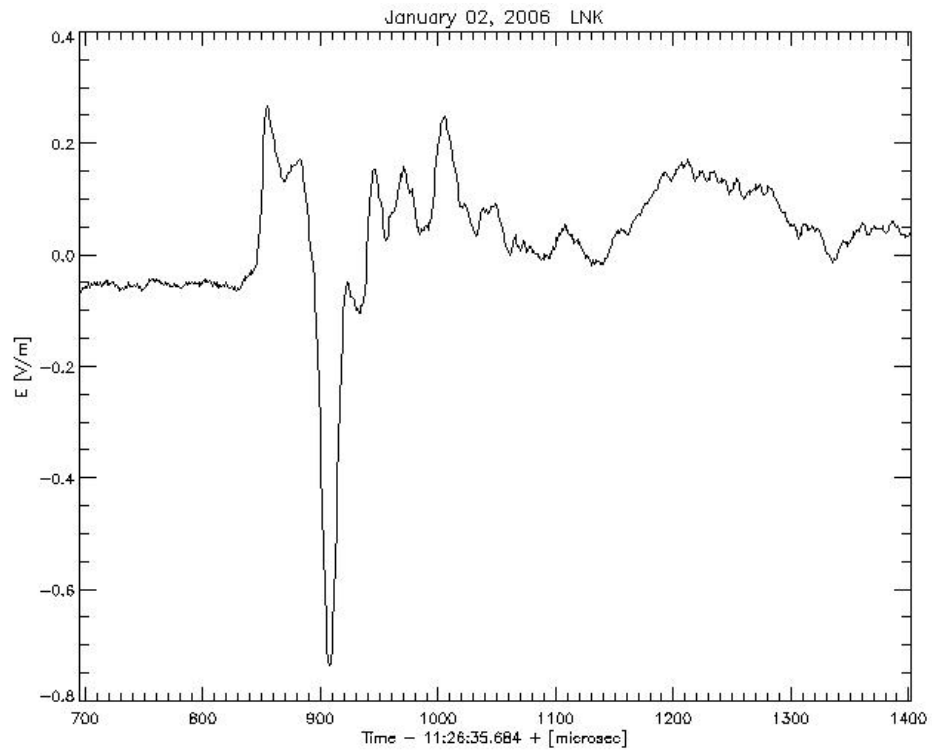
Figure 5. Electromagnetic pulses recorded by the LASA sensor at Lincoln, NE.

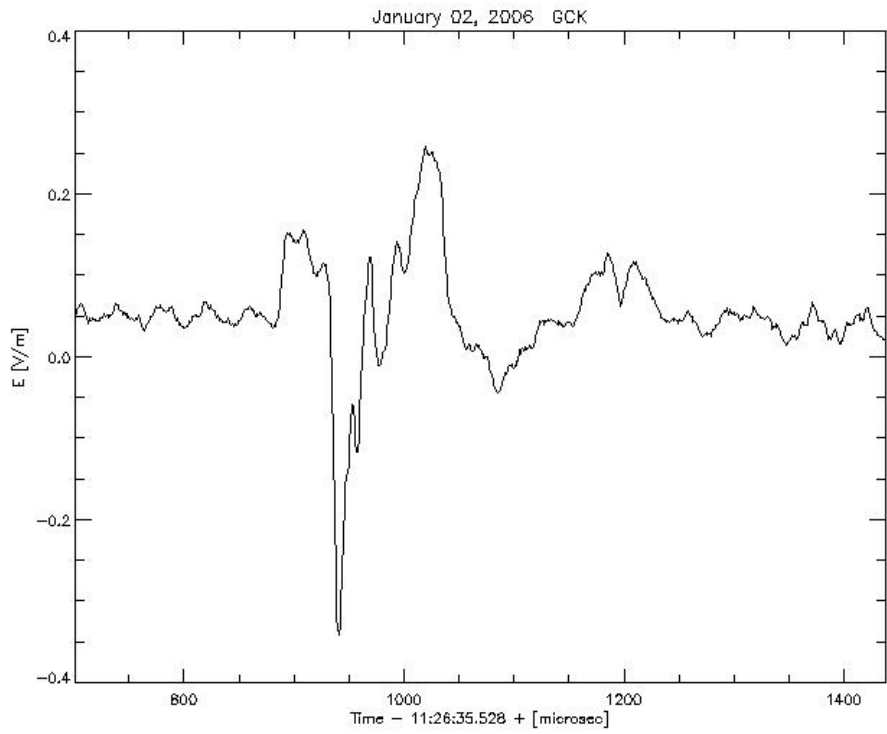
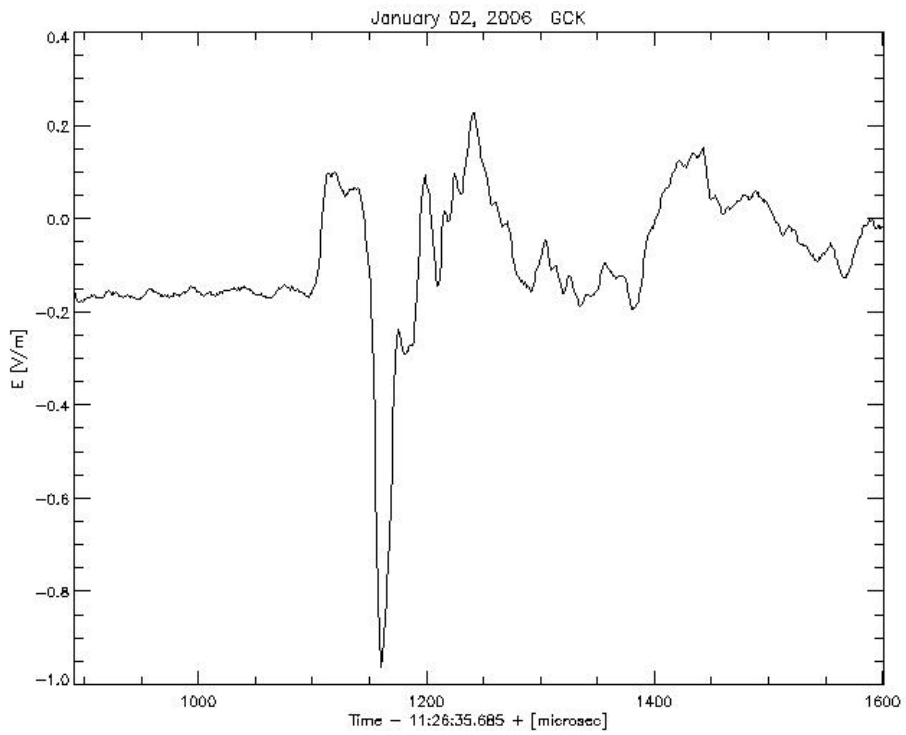
Figure 6. Electromagnetic pulses recorded by the LASA sensor at Garden City, KS.

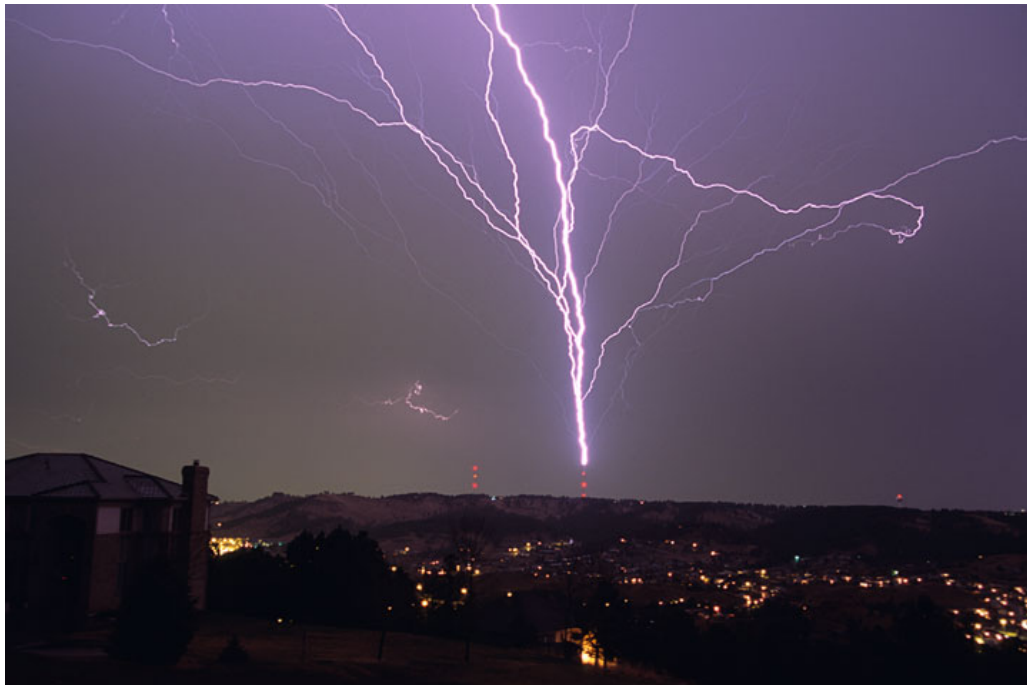
Significantly, the upward flash in **Photo 1** was *not reported* by the NLDN, either because it did not contain return strokes, or if such strokes did occur, their peak currents were below the NLDN trigger detection threshold⁵ and/or they had improper waveforms.

Photo 1. An upward, ground-to-cloud lightning flash in Rapid City, SD, on 26 March 2004. [Photo © 2004 by Tom Warner]

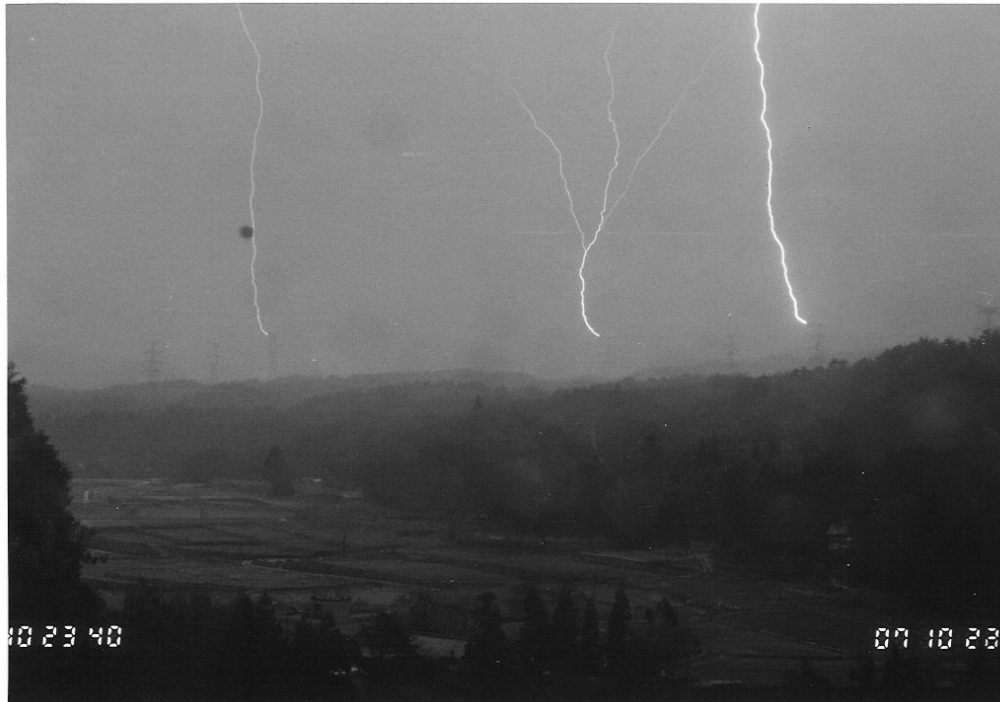
Upward lightning is also known to strike power lines, especially in the winter months, and an example of this phenomenon is shown in **Photo 2**. The exposure for the image in Photo 2 was ¼ second or 250 milliseconds.

Photo 2. Upward discharges to a power line in Japan (courtesy of N. Honma)

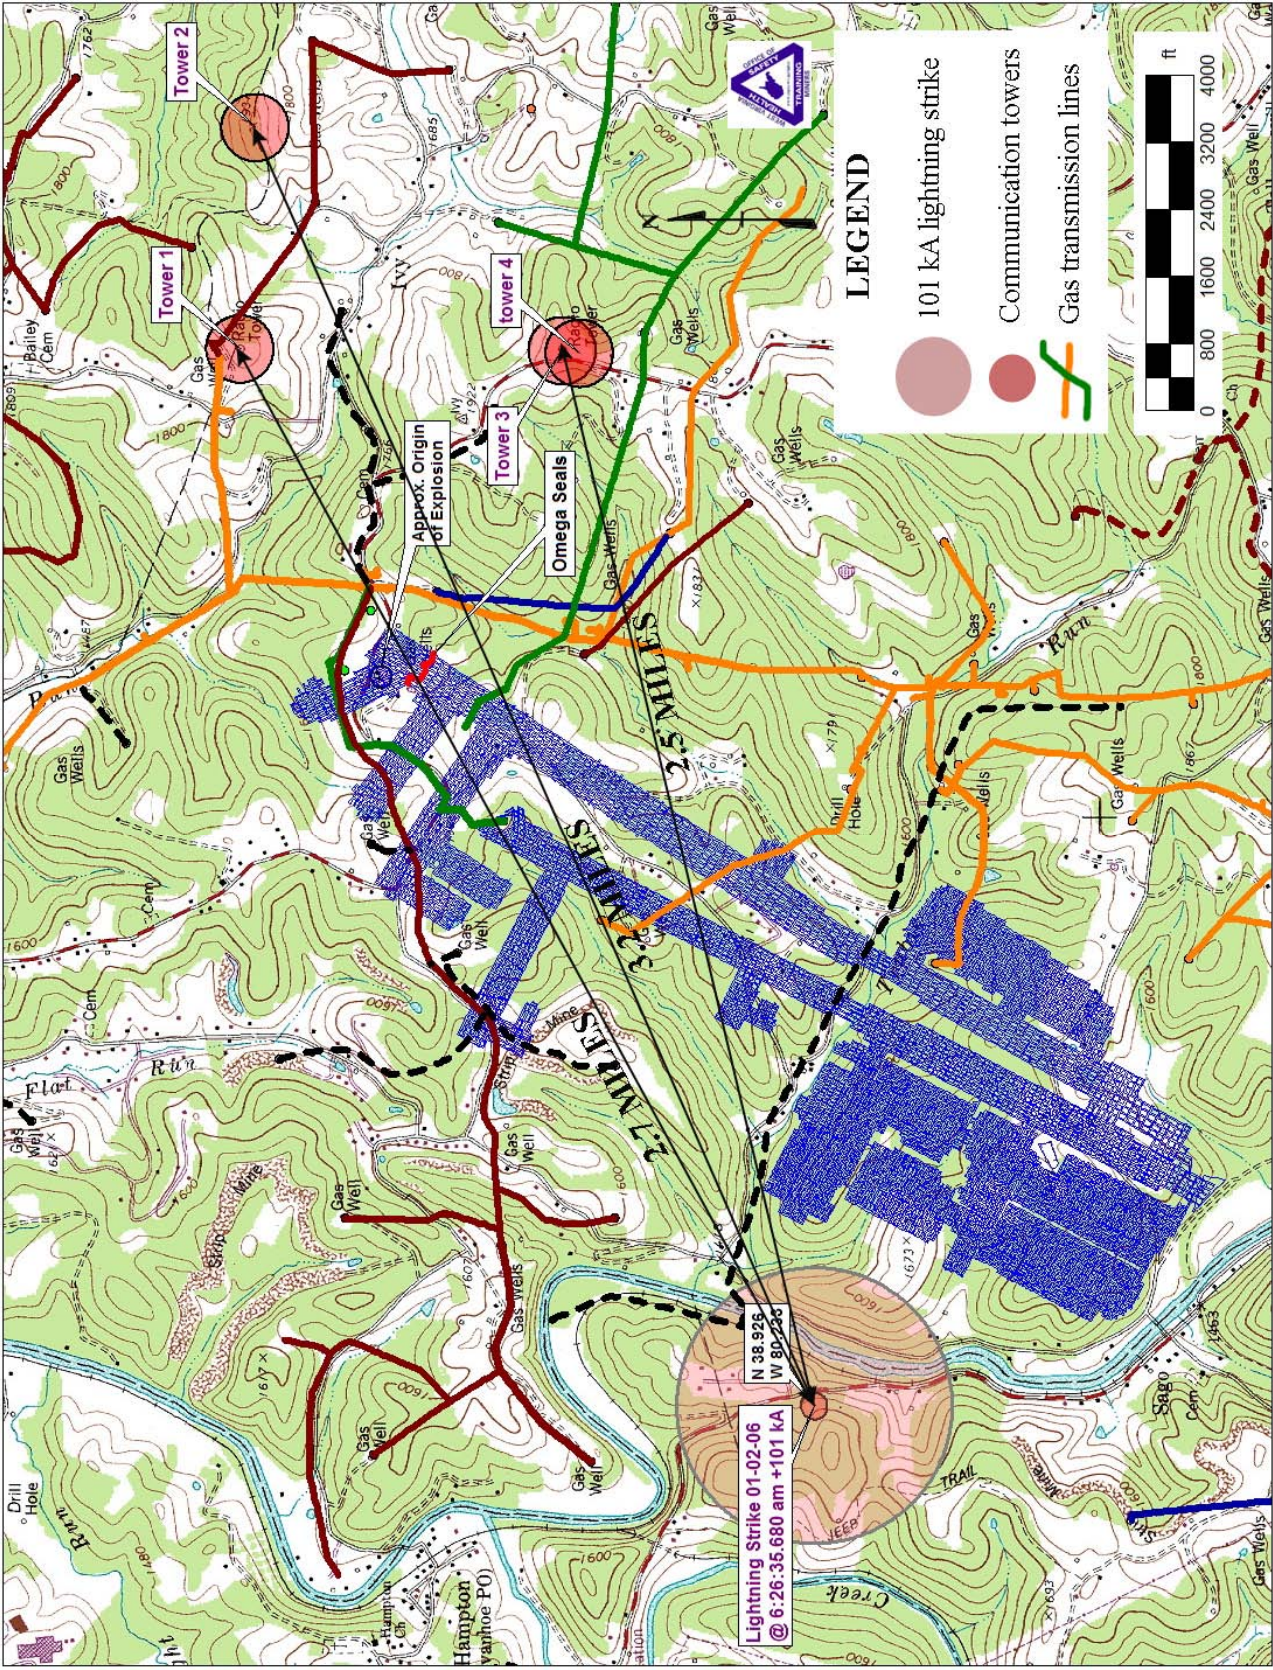
The locations of tall towers in the region above the Sago mine, and that are located close to pipelines or other ground conductors, are shown on **Map 1**. The two positive cloud-to-ground strokes that were located by the NLDN had very large amplitudes, and it is possible that one or both of these strokes initiated one or more upward discharges from tall, nearby structures.

Map 1. Location of high antennas east of Sago Mine. Upward lighting from such structures can be initiated from cloud-to-ground strikes that occur several miles away.

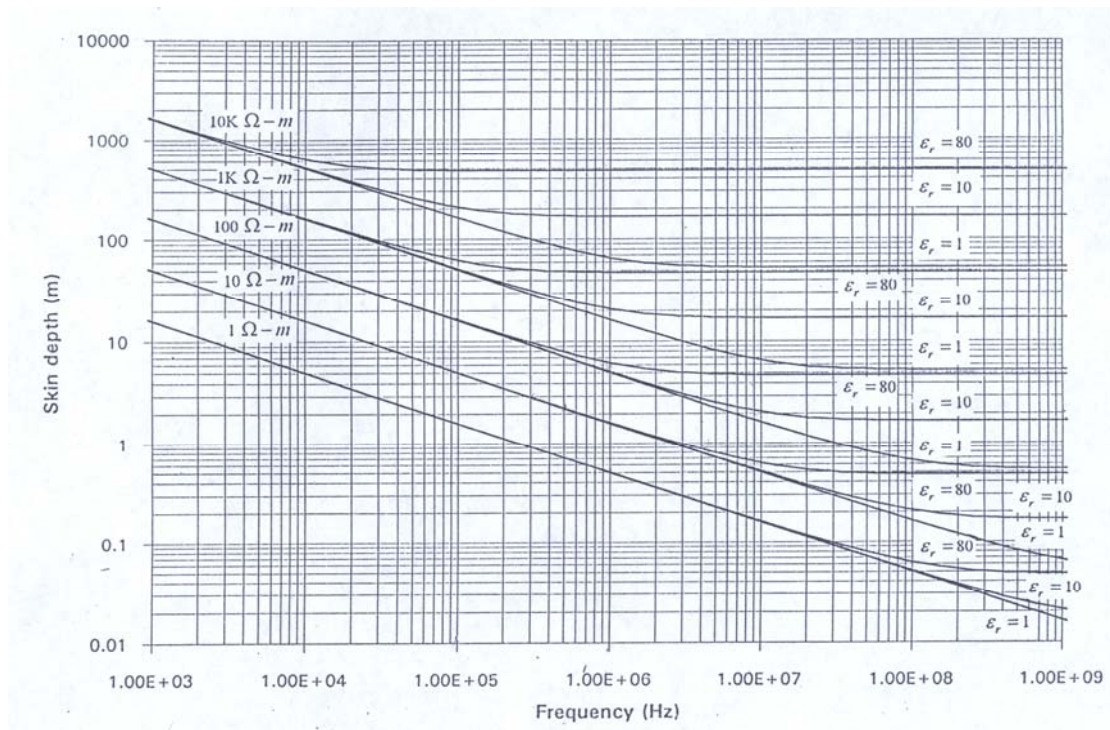
frequencies of the order of one kilohertz or less. It should be noted in **Figure 1** that a material with an average resistivity of 100 ohm-meters has a skin depth of 100 meters at frequencies of 3 kilohertz or less.

Figure 1. Skin depth as a function of soil resistivity and frequency.

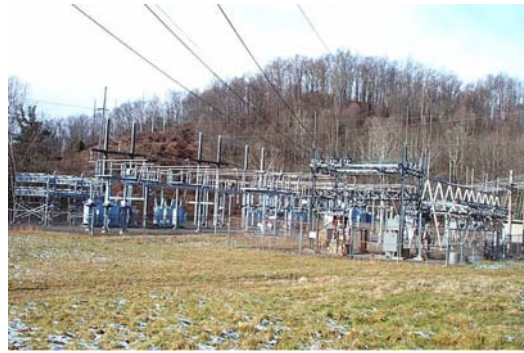
The French Creek sub-station (see **Photo 3**) receives 138,000 volts 3 phase AC from Allegheny Power Company¹¹ and steps down to 12,470 volts 3 phase AC thru a Delta-Wye Transformer. This power then feeds a substation located behind the Sawmill Run Preparation Plant, (**Photo 4**) on approximately 2.6 miles of privately-owned and maintained

Photo 3. French Creek Substation

All three sub-stations were checked for possible lightning damage or equipment malfunction. No apparent damage or malfunction was found. Two areas, one on the main line (**Photo 8**)

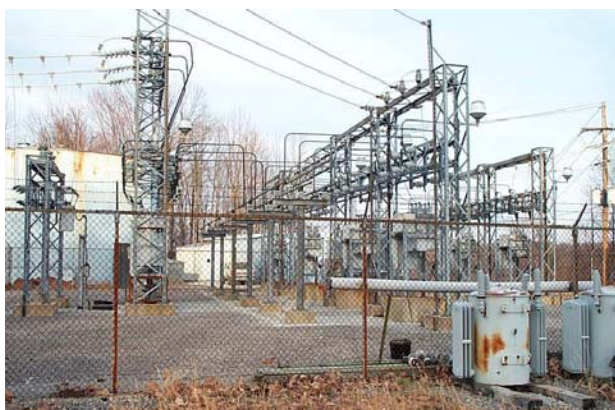
Photo 4. Sawmill Run Preparation Plant Substation

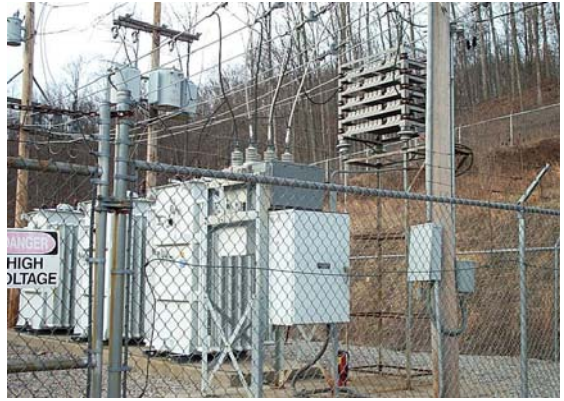
Photo 7. Sago Sub-station

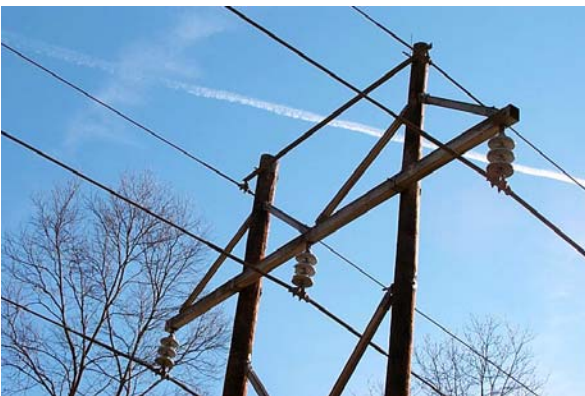
The butt-grounds are tied to the overhead ground wire. None of the guy wires were grounded or insulated at the time of the explosion. This was not a requirement when the pole structures were installed, however guy wires located above phase conductors and have a potential of becoming energized are now required to be grounded or insulated. All of the affected guy wires are now either grounded to the system ground or insulated. There are at least two more sets of lightning arrestors between this area and where the high voltage cable enters underground so required lightning protection was being provided. The lightning arrestors are rated at a phase-to-ground voltage (10kV). The damaged center phase insulators (**Photo 8**) have two (2) prominent chips in the lower two bells and this damage could have been caused by lightning. It is unknown when this damage occurred but the insulators are used for insulation purposes—not lightning protection. The displaced earth at the base of the pole and the discolored ground wire could be indications of lightning (**Photo 11**).

Photo 10. This two pole structure is butt-grounded at each pole. Note “antenna” atop each pole.

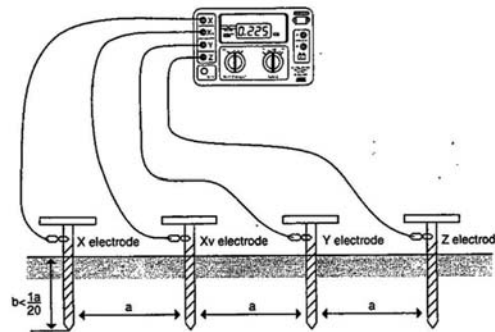
Four pole resistivity tests (**Figure 2**) were conducted using a NGI Unilap GEO x resistance tester. Four metal rods were driven in the mine floor at 20 foot intervals, starting at the end of the track and continuing up into the region where the explosion is believed to have originated. Measurements were taken every 60 feet for a total distance of approximately 1250 feet. Readings were also taken between roof bolts and/or wire mesh screen in the same areas.

Resistance measurements between roof bolts and/or wire mesh screen for the first 1130 feet averaged 3 ohms. Resistance measurements between the rods in the mine floor averaged 7.5 ohms. Resistance measurements across the next 120 feet ranged from 3000 ohms to infinity.

Figure 2 Four Pole Resistivity Test

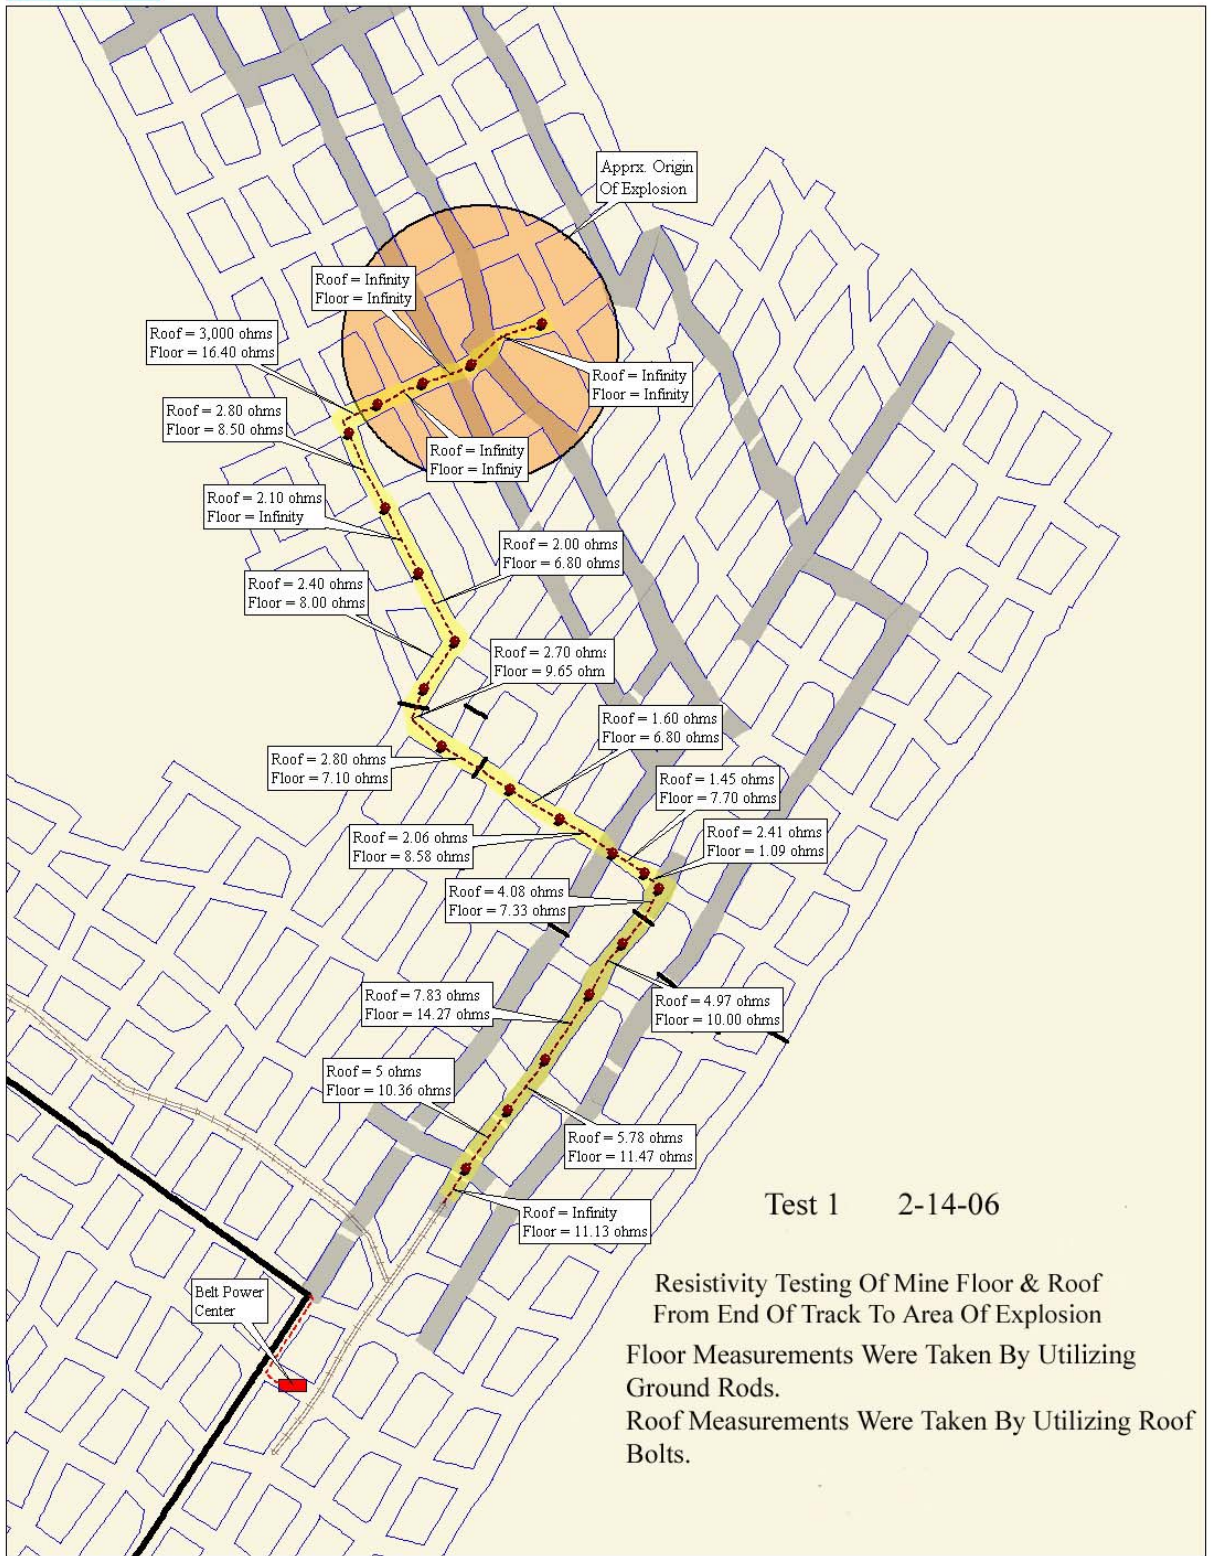
Figure 3

Resistivity testing of the roof bolts, wire mesh screen, and mine floor was conducted on February 14, 2006; (**Figure 3**) to determine if a low-resistance electrical path exists from outside the sealed area to an area behind the seals where the explosion is believed to have originated. Testing was first conducted from the end of the track and continued back to this area.

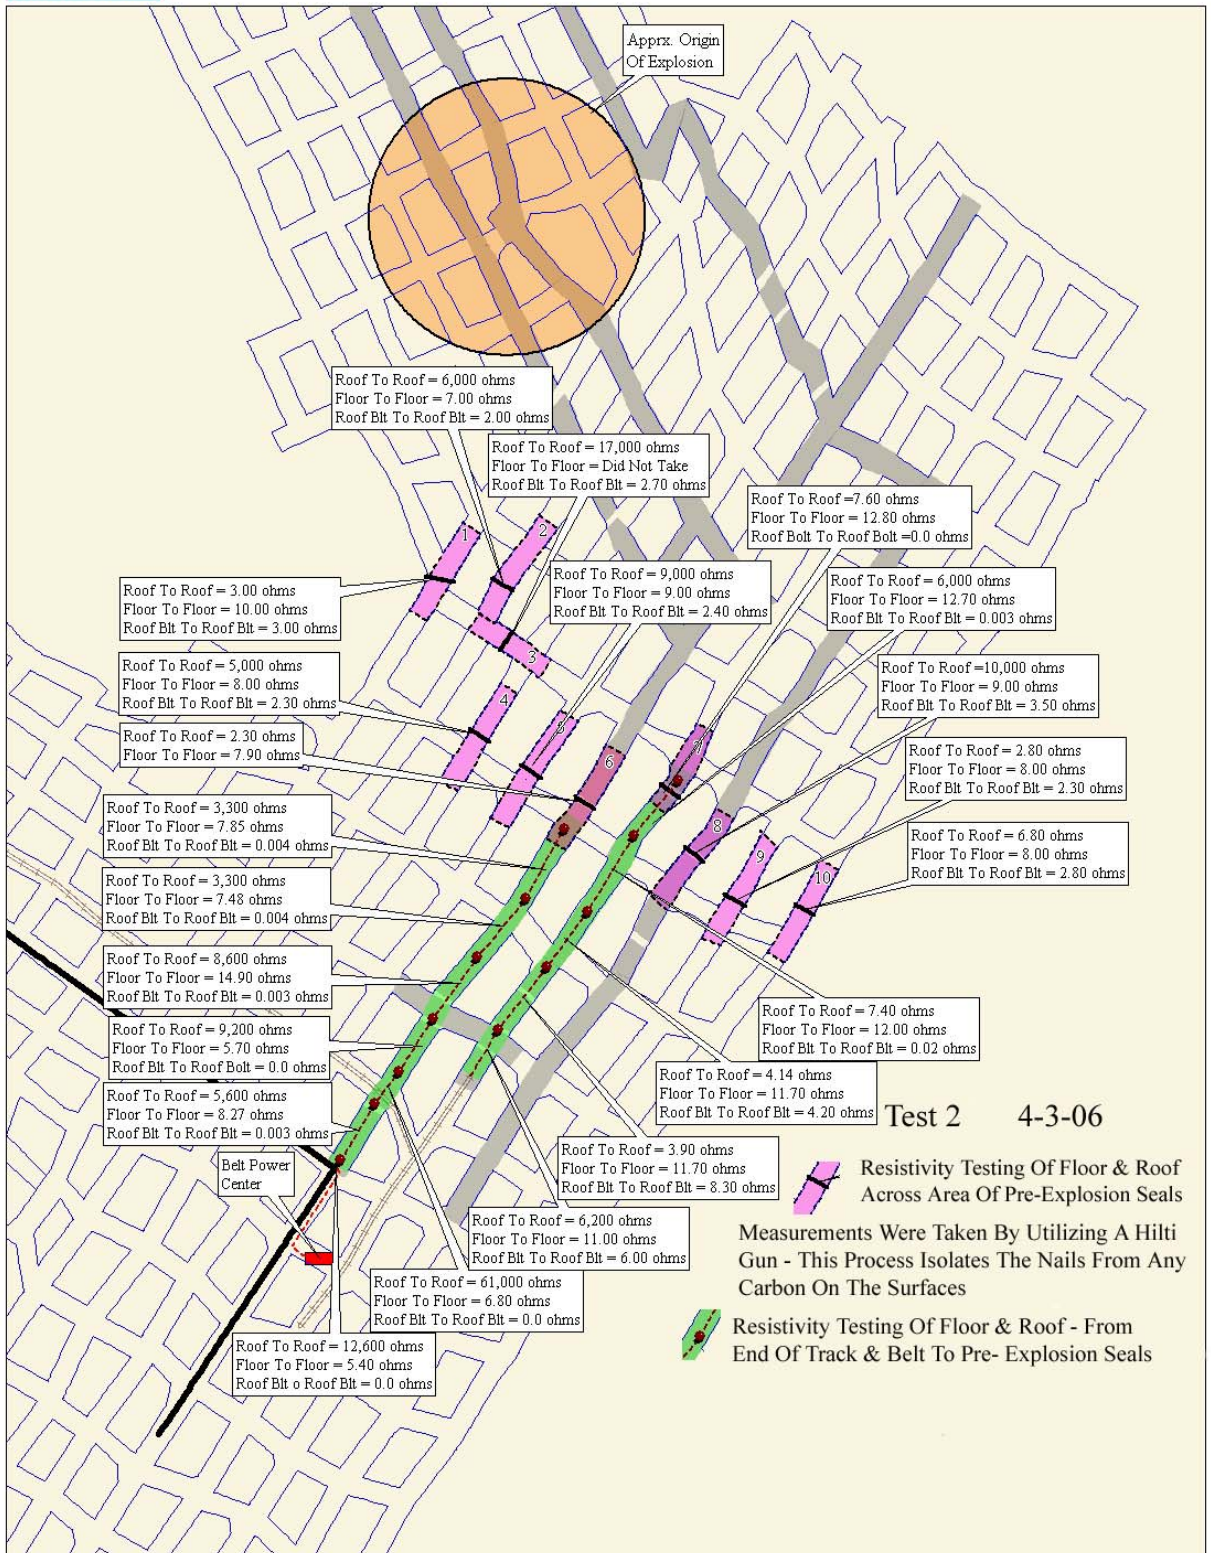
Figure 4

A four pole resistivity test was conducted on April 3, 2006, (**Figure 4**) across the area where the seals had been installed prior to January 2, 2006.

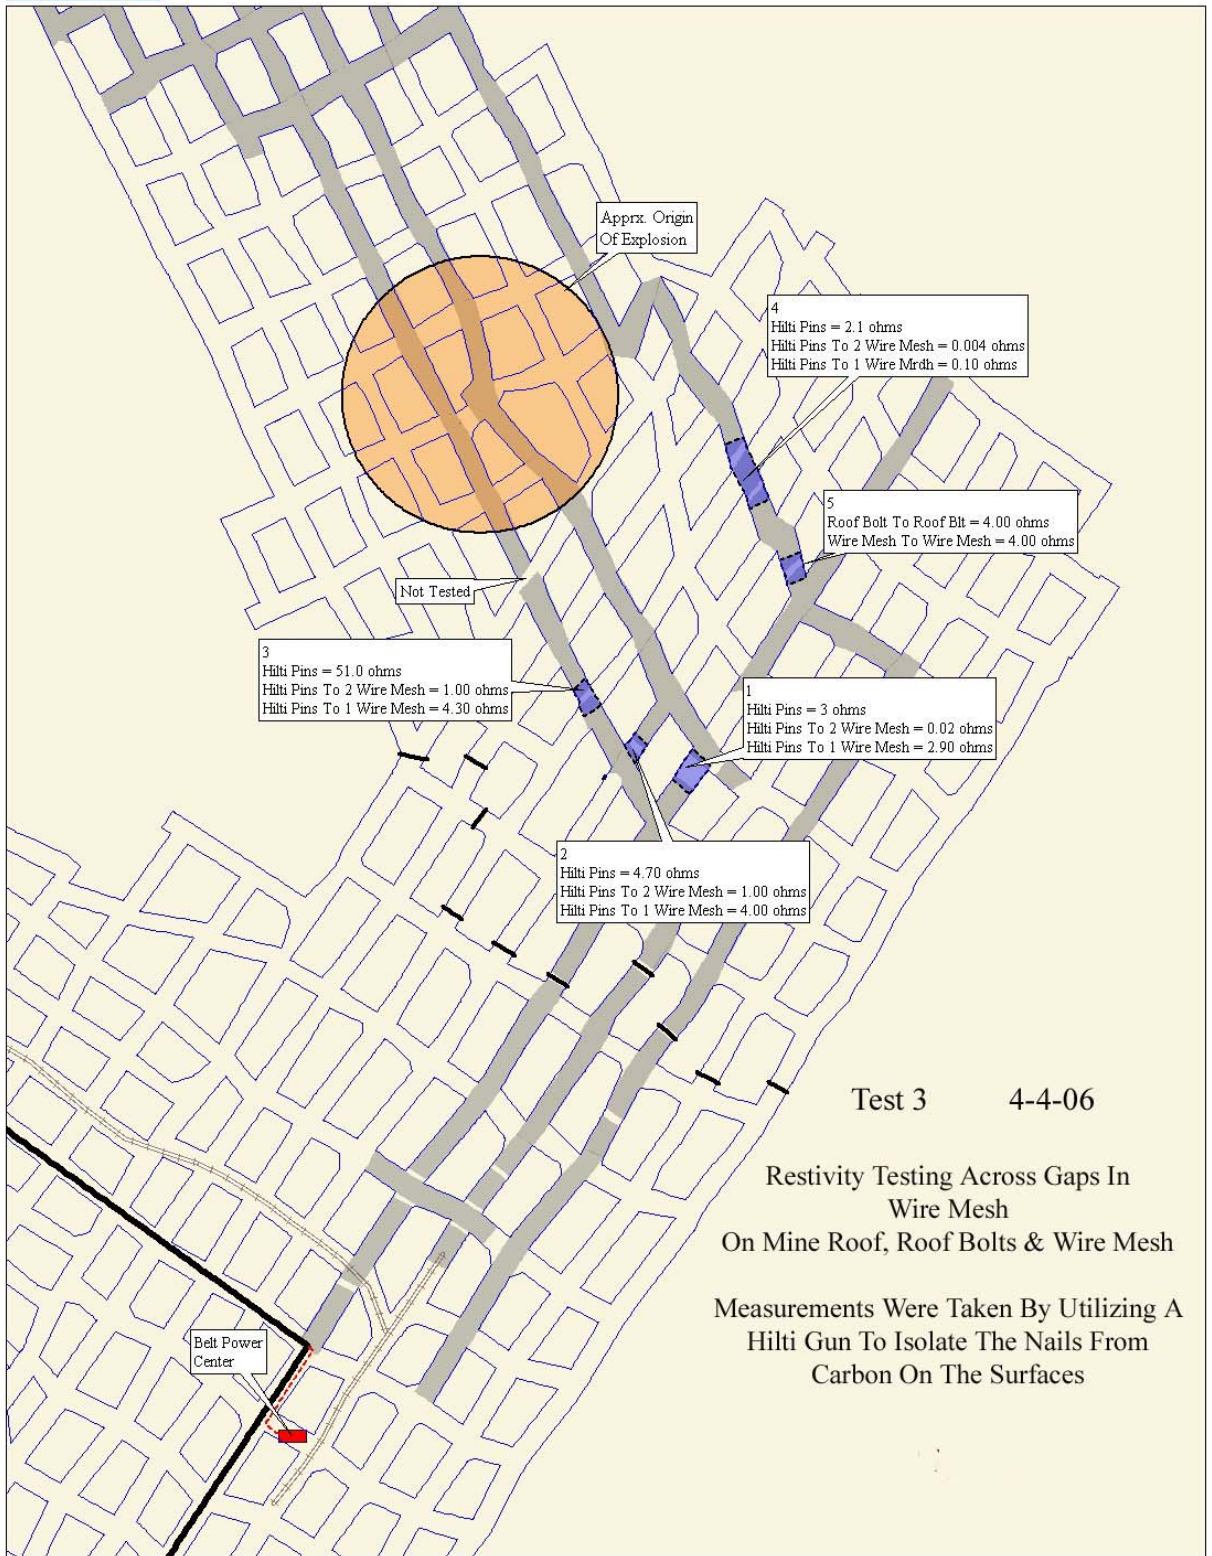
Figure 5

Four pole resistivity tests were conducted on April 4, 2006, (**Figure 5**) across the gaps in the wire mesh roof screen in several locations in the formerly sealed area. 5/8 diameter holes were drilled into the mine roof and steel nails were installed with a Hilti nail gun. The nails were installed at different intervals (depending on the length of the gap in the roof screen) and measurements were taken with a NGI Unilap GEO x resistance tester in locations # 1 thru 4. Measurements at location #5 were taken with a Fluke Model # 27 Volt-Ohm meter.
