5.5 Cause of Explosion

5.5-1 What caused the explosion?

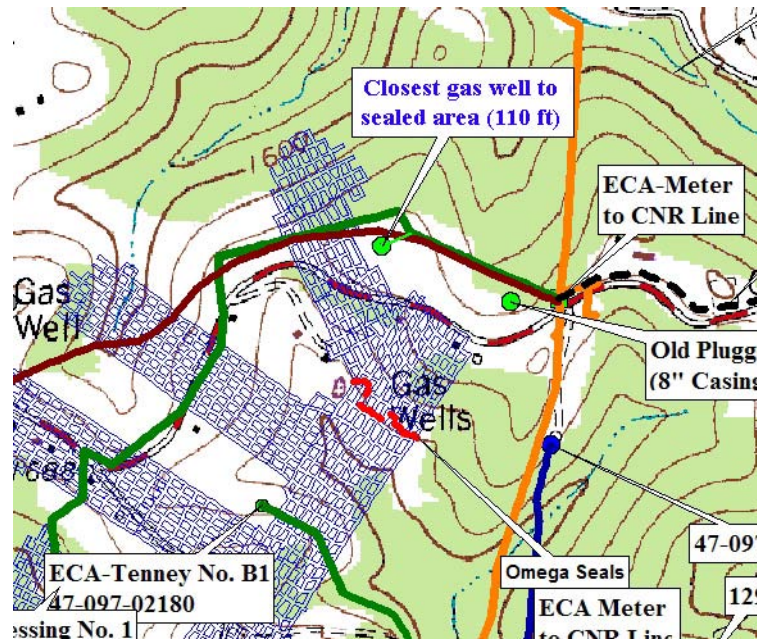
An extensive network of gas lines connects conventional gas wells on the surface over the Sago Mine and surrounding areas. Two lines are known to cross the surface over the Old 2nd Left sealed section. One well is located approximately one-hundred ten (110) feet from the sealed area mine works (see **Map 3**). A map showing the geometry of these lines within a 1.5 mile radius of Old 2nd Left Section is given in **Map 4**. A larger and more detailed map is included in **Appendix 5.5-3: Map of Gas Lines and Wells**.

Map 3. The closest gas well to the sealed area is approximately 110 ft.

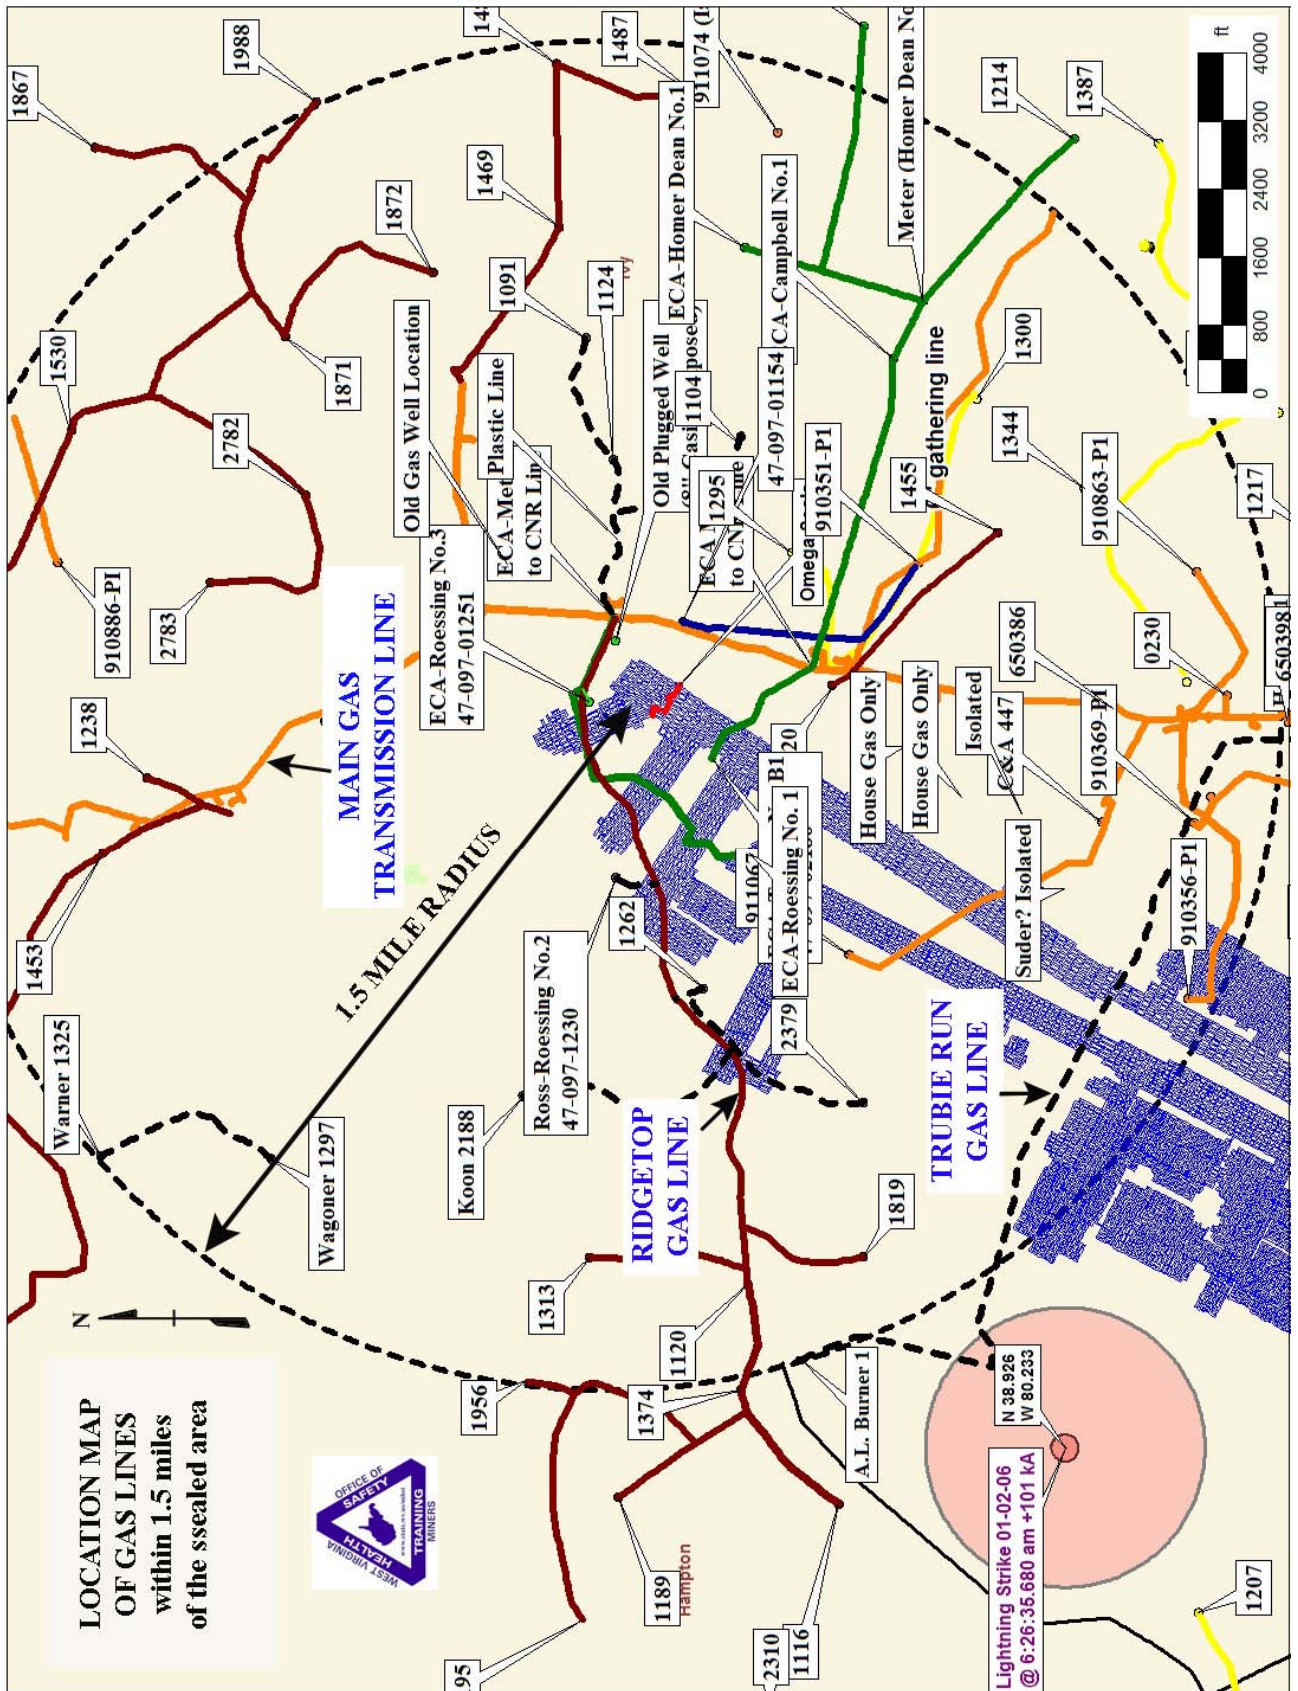
Map 4. Illustration of the location of gas wells and gaslines within a 1.5-mile radius of the Old Second Left Section of Sago Mine.

All known gas well and gas line owners and operators in the area were contacted to inquire if there was any damage to their equipment or infrastructure from the electrical storms of January 2, 2006. None were reported. Almost all the lines and wells within a 1.5 mile radius around Old 2nd Left Section were traveled and examined at the surface for evidence of damage. No visible damage attributable to lightning was discovered in the course of this work.

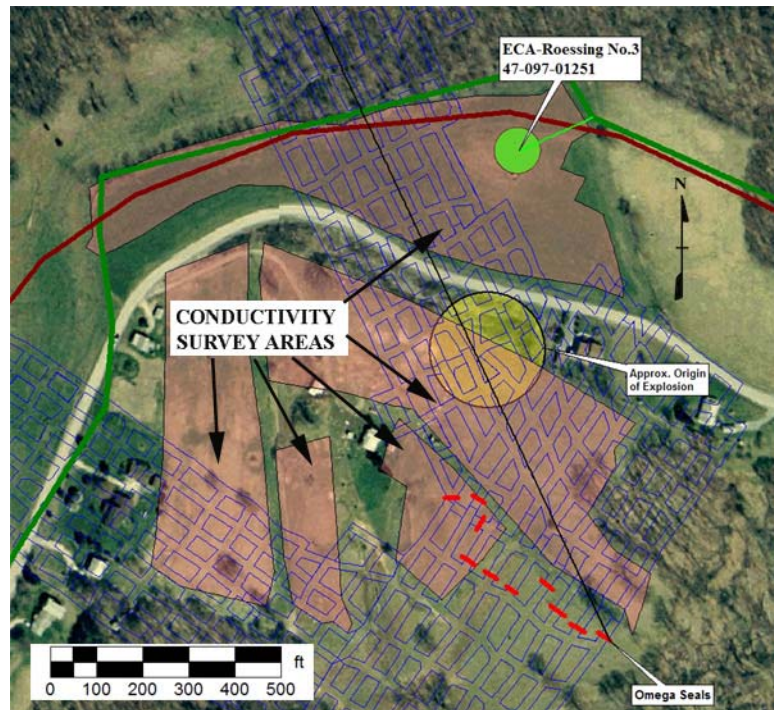
Map 5: Location the areas where the electromagnetic conductivity surveys were performed.

This involved searching for metallic infrastructure such as pipelines, wells, powerlines, or other features that could have provided a low resistance path from the surface to the underground mine works. Testing methods involved magnetic gradiometer (MAG survey) and electromagnetic induction (EM survey **Map 5**).

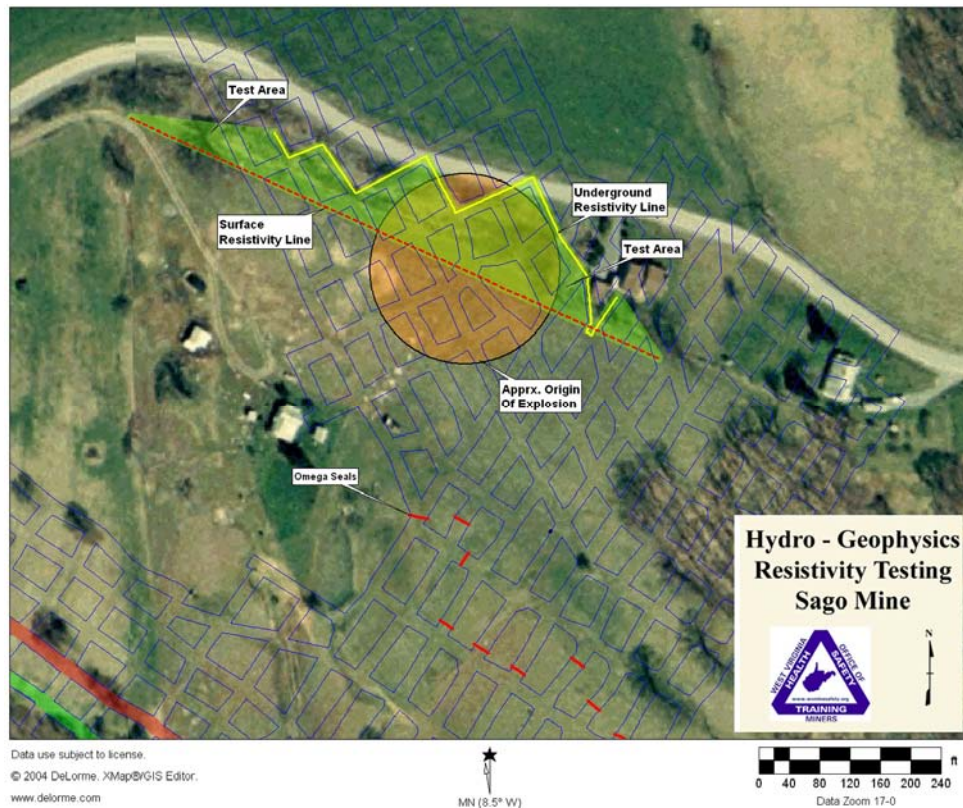
Map 6: Location of area where high-resolution resistivity survey was performed

This involved measuring the electric potential on a series of electrodes while injecting current on a nearby electrode. Testing methods involved High Resolution Resistivity (HRR) survey which utilized a nearby recently-drilled open borehole to drop lines to the mine to measure electric potentials between the surface and underground at various intervals along a baseline (see **Map 6**). The survey was arranged such that a set of electrodes at the surface could be used in combination with electrodes on the mine roof. Testing occurred over the vicinity of the approximated origin of the explosion.

This survey consisted of individually wiring existing roof bolts (total of 56) in the mine to a communication center and connecting electrodes (total of 56) placed on the surface to the same communication center. An electrical current at varying frequencies (5, 7, 10, 15 and 20 kHz) was injected to an individual surface electrode and resistivity readings were recorded from all the wired roof bolts. This was repeated, injecting current to all 56 electrodes individually. This procedure was then reversed by injecting current to an individual roof bolt and recording resistivity at all the wired surface electrodes. Each roof bolt (total of 56) was injected with electrical current. The data were then processed to determine if any electrically conducting structures existed within the test area.

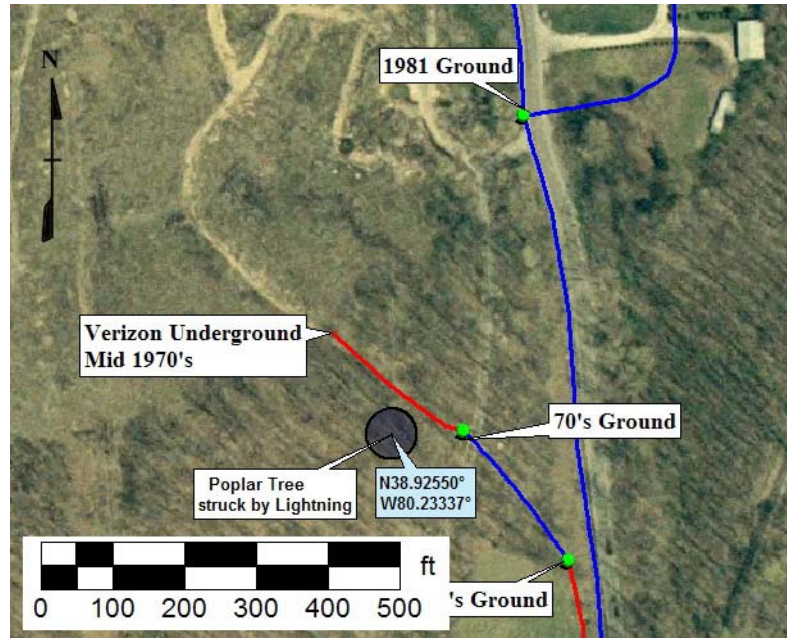
The poplar tree that is believed to have been the strike object of the +101 kA lightning stroke is located about 50ft from a buried telephone utility line that is owned by Verizon. This line was examined for evidence of lightning damage.

Photo 13. A buried telephone cable lies within approximately 50' of the poplar tree that was struck by lightning.

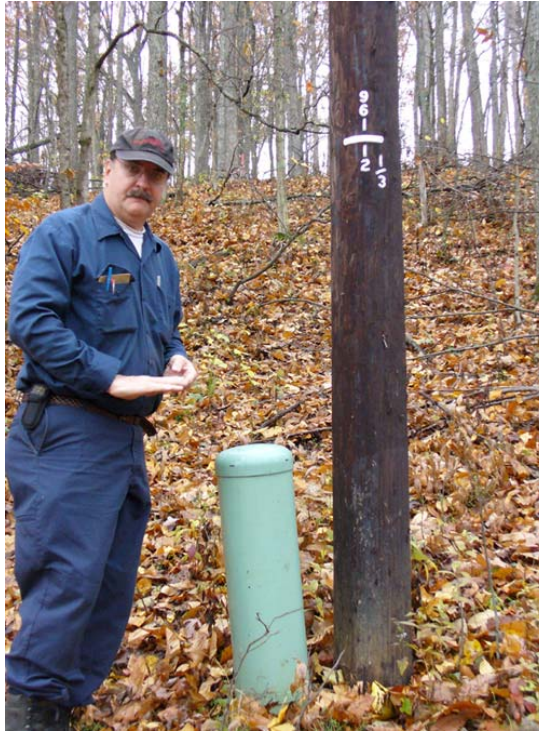
Photo 14: Junction box of 1970's line (closest box to lightning-struck poplar tree.

The nearest line that the lightning could have contacted and used as a conductor of electricity is the 70's buried line. The closest junction box (70's Ground 1) to the poplar tree is approximately one hundred (100) feet. At this time the line temporarily becomes aerial for a road crossing and then is buried again at junction box (70's Ground 2). This is where the Verizon engineer indicated repair service for the nearby resident was done. OMHS&T staff had found wire at the previous junction box (70's Ground 1) and assumed that the repairs were there.

The Verizon engineer indicated that that box is safely off the road and the service/repair men often use it to trouble shoot. They can narrow down any problem by checking for faults and determine if the problem is inby or outby that box. When the “70's Ground 1” Junction Box was opened it was found that rodents were living in the junction box, and several wires had places where they had eaten the insulation from them (see **Photo 18**). The wire insulation was tarnished from animal waste. The nest was rather large; the occupants had been there for quite some time. Connections are coated with a gel to prevent moisture intrusion at the splices. The individual insulated lead wires in the telephone line are roughly 19 gauge wires (visually the diameter of “0.5 mm pencil lead”). The Verizon engineer stated that the 70's line and 1981 line are 70 to 80 pair lines (140 to 160 leads).

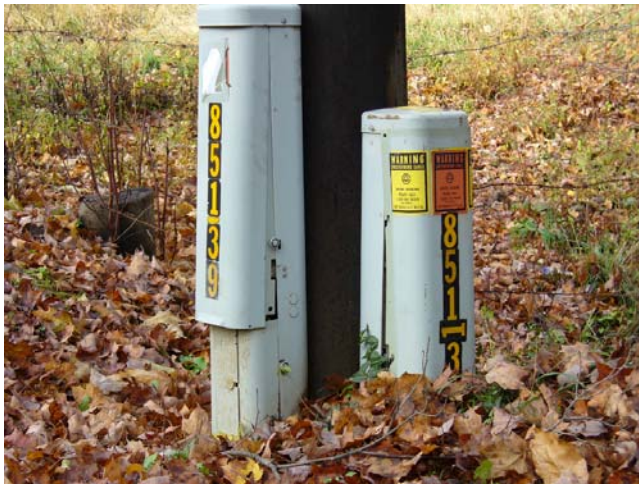
The Verizon engineer indicated that when the lines are spliced a junction box is used. At each junction box the line is grounded, and the ground is common with the incoming line and the outgoing line. This is done to insure that no interference will cause poor line service to the customers. The location of the junction box is site-specific and is referred to as: 70's Ground for the 1970's Line and 1981 Ground for the 1981 Line, on the attached map. These two lines are grounded separately.

Photo 16: Junction boxes of the 1970's buried line and the 1981 buried line.

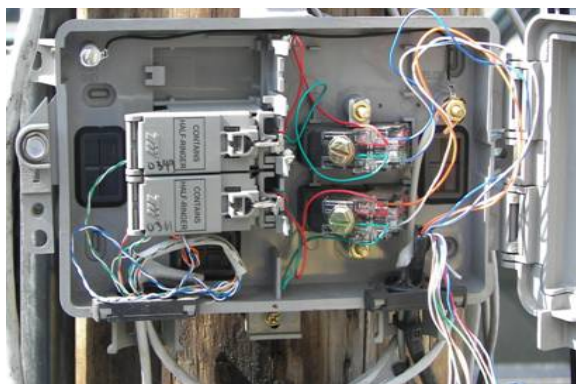
The public telephone distribution boxes at the Sago Mine were also examined. The Verizon phone company had installed a larger box after the January 2, 2006 explosion, but the original box and wiring were still there. The old wiring, coming in from across the Buckhannon River, did not have a ground or messenger wire attached. The only ground wire is inside the distribution box. This wire is attached to a ground lug inside the distribution box and is only tied to the solid copper ground wire coming down the telephone pole. No other wires inside the Distribution Box were attached to the ground lug.

Photo 19: 1 of 2 original phone distribution boxes (still in use). Only the distribution box itself is

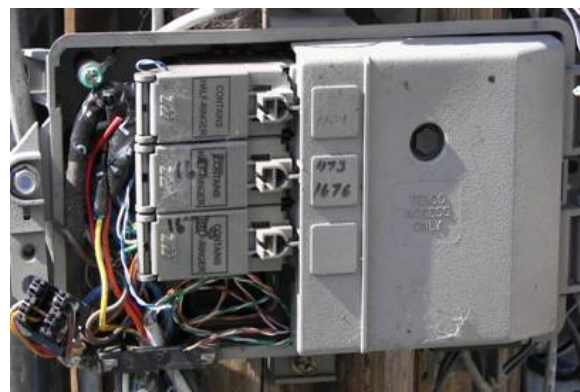
Photo 20: 2nd Original distribution box (still in use)

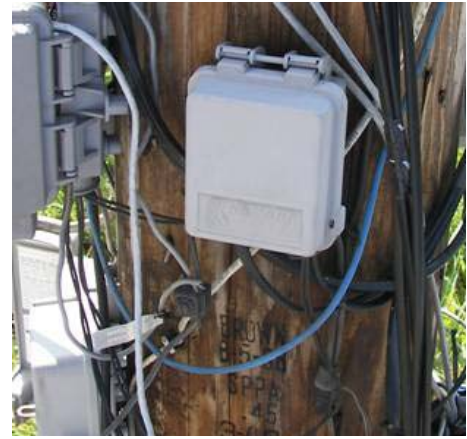
Photo 22: Ground Connection On Pole For Distribution Box

New wiring had been run to the new distribution box by the phone company. This new wiring has a messenger wire attached but it is not connected to a ground on the pole or inside the new distribution box. The only ground wire is inside the distribution box. This wire is attached to a ground lug inside the Distribution Box and was only tied to the solid copper ground wire coming down the telephone pole. No other wires inside the distribution box were grounded.

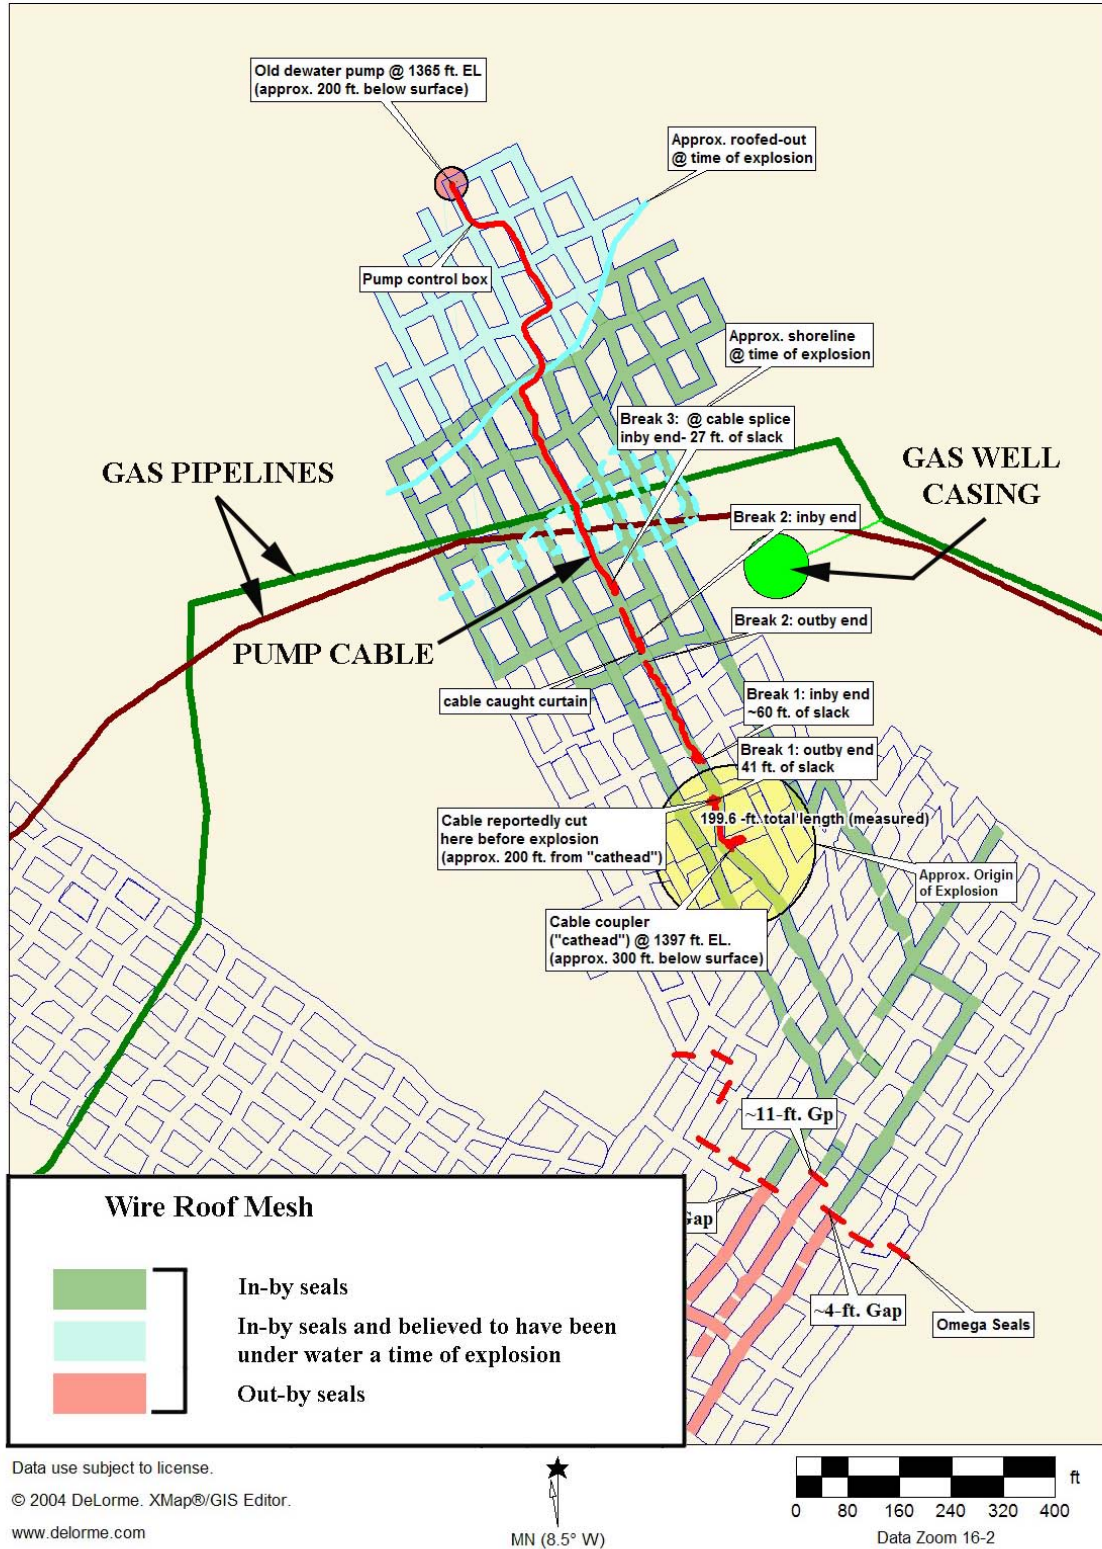
Map 8. Illustration of the arrangement of wire roof mesh to a pump cable and gas well. The gas well is part of a system of approximately 60 wells within a radius of approximately 1.5 miles that are interconnected by a network of gas transmission pipelines at the surface.

A local channel sandstone has replaced the shale roof at location “A,” and at this location a pump control box connects that cable to a submersible pump. The pump control box was tied to the wire roof mesh at this location. The channel sandstone at “A” produces considerable water, and at the time of the explosion the pump, the pump control box, and the wire mesh at location “A” were underwater. Because the pump control box does not have a waterproof gasket, it was full of mine water and thus the pump cable was probably electrically connected to the wire mesh at “A.”

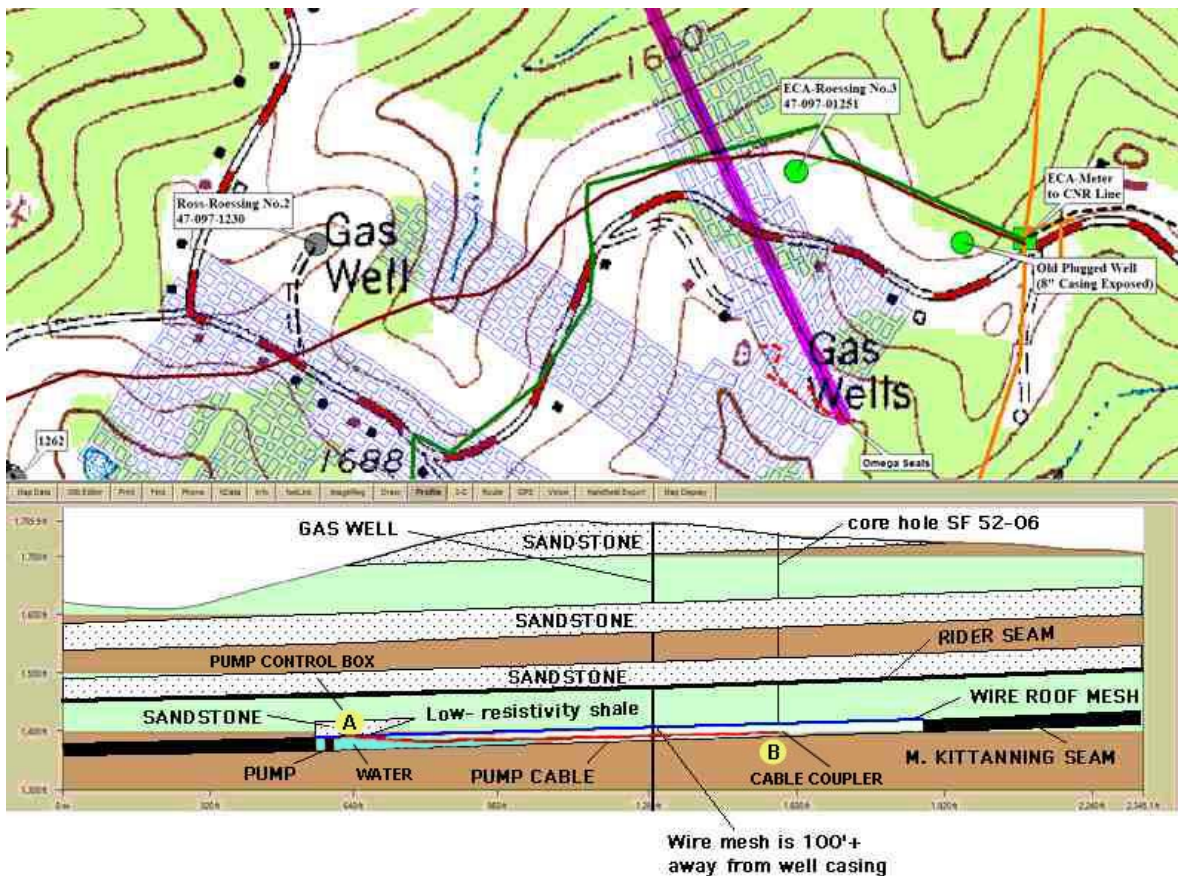
A cross-section view of Old 2nd Left Section is given in **Figure 8**. As shown, the rock strata contain sandstone layers that are separated by other layers²⁰. Measurements of resistivity are given in **Appendix 5.5-3: Geophysical Log for SF 52-06**. Layers of shale and sandy shale are between the sandstone layers, and have comparatively low resistivity. The layer of shale between the coal and the Rider seam appears to generally have the lowest resistivity of all.

Figure 8. Geologic cross-section through Old 2nd Left Section. E-log to SF 52-06 shows sandstones are high resistivity. The shale roof is low resistivity. The wire roof mesh is bolted to this shale. The pump cable is insulated from the wire roof mesh except at the pump control box.

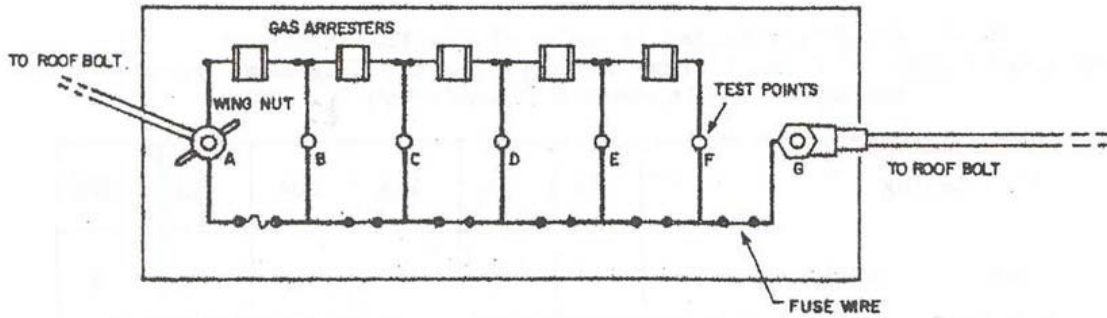
Figure 9. Schematic diagram of the fuse surge detector (FSD) for monitoring of transient currents underground. The FSD comprises six fusible wires in series, with gas arresters in parallel to five of the six fuses (the electronic circuit is not shown)²².

The region of the Sago Mine will continue to experience lightning and as the winter season approaches it is recommended that we install a number of FSD circuits (see **Figure 9**) within Old 2nd Left Section and at other points in Sago Mine in order to measure the transient voltages and currents that appear underground when there is lightning in the area. Due to the intensive investigations that have taken place at Sago during the past 11 months, we now know more about the arrangement of metallic structures at the surface and underground at Sago and will, hopefully, soon be able to supplement that information with a model of how the electromagnetic energy from lightning penetrated from the surface into the Sago mine²¹. If we can monitor and detect transient currents and voltages from future lightning activity we may be able to correlate them to specific types of lightning and field conditions. This is the first step in developing protective measures to guard against similarly destructive lightning accidents in the future.

The chances of obtaining positive lightning in the Sago area during the winter are as good or better than other geographical locations in the U.S. It is recommended that such a study be implemented at the Sago mine. The types of device that are proposed for monitors are available, inexpensive, and require very little maintenance. They could be left underground, unattended, and will monitor for any current and voltage surges continuously. When a surge is detected, the monitor will shut down and record the time until it is reset. The devices merely need to be checked periodically. By correlating readings of the lightning transient underground, to lightning detected on the surface, we will be in a good position to understanding how lightning entered this mine.
