5 THE INVESTIGATION

The purpose of this investigation was to carefully observe, inquire and examine systematically the events surrounding the January 2, 2006, Sago Mine Disaster. The WVOMHS&T investigation started on the morning of January 2, 2006, and certain aspects of it continue.

5.3 Omega Seals

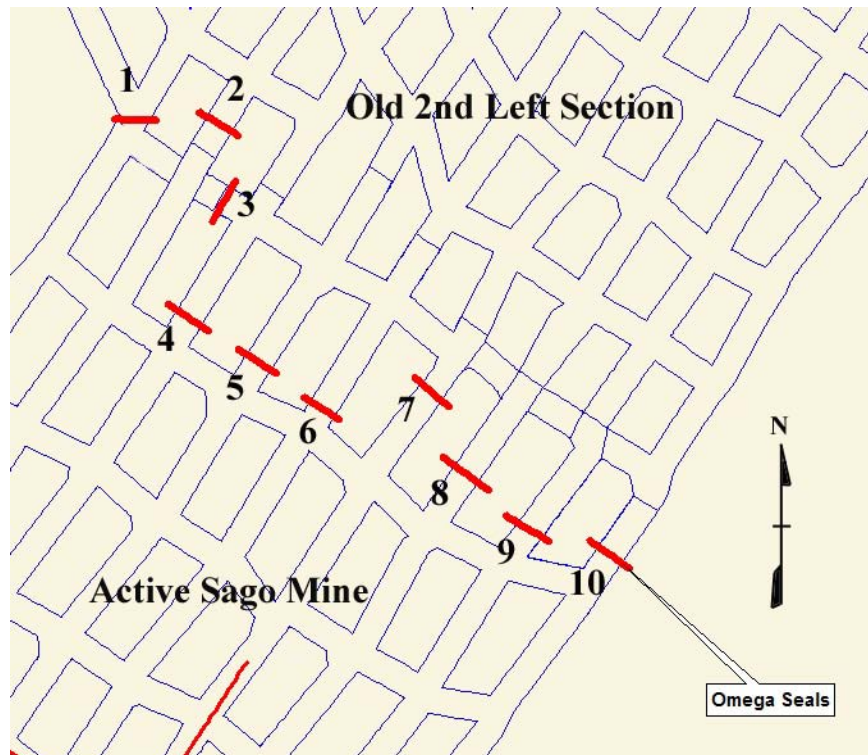
Ten (10) Omega block seals were installed to isolate the Old 2nd Left Section from the remaining active Sago Mine (**Figure 1**). Constructed of Omega 384 Blocks and a high-strength (2,000 PSI) Bloc Bond mortar, these seals are considered an alternative seal to the standard Mitchell/Barrett seal¹. This seal design creates a forty inch (40”) thick barrier between the abandoned area of the mine and the active area of the mine. This seal has been designed, tested, and approved to be installed without hitching into the roof, floor or ribs and construction utilized this no-hitching proviso. The actual design specifications are detailed in the approved plan (see **Section 5.3-1**). Mine seals should conform to the following guidelines:

Figure 1: Location of Omega seals in the Sago mine.

All ten (10) Omega Block seals were totally destroyed in the explosion. Remnant pieces of Omega blocks ranged in size from baseball-sized pieces to sand-sized. The majority of the debris appeared golf ball-size or smaller².

Mapping of the seal remnants and debris was performed in order to document the manner and the extent of damage. The force of the explosion completely removed and pulverized the seals to the point that mapping teams could determine the location of the seals only by locating the concrete and mortar attached to the roof, ribs or floor. Only three (3) seals had Omega blocks still remaining at their installed seal locations (seals #1, #2 and #9). The debris from the seals was distributed in an outby direction from their installed location over a distance of several hundred feet. This, together with other evidence, led to a determination that the explosion forces originated from inside the sealed area (see **Figure 2**).
