West Virginia Office of Miners' Health, Safety and Training

MARCH 13, 2013

**Report of Investigation
Underground Coal Mine Fatality
(Roof Fall Accident)**

**Newtown Energy Inc.
Peerless Rachel Mine
Permit Number U-00500504**

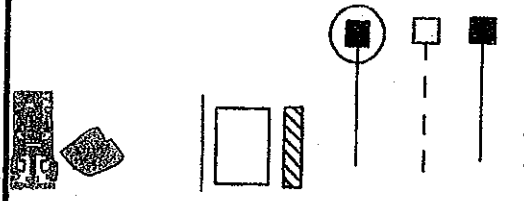
Incident Print

Roof Bolt Line Curtain In Place Hanging from Bolts Along Rib

Roof Bolt with 8in Roof Bolt Plate Hanging Down 1FT

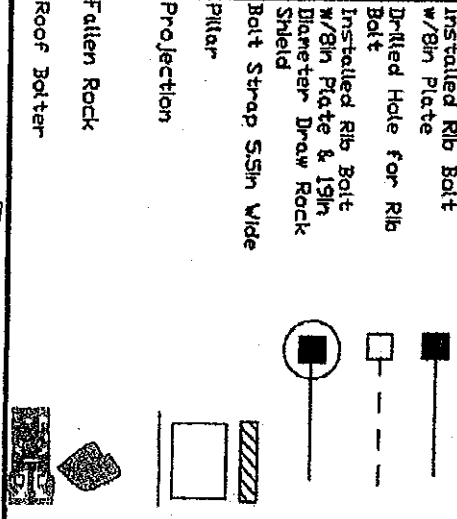
Incident Print

NOTES:
X Approximate Location Of Victim

Based on the information provided during the interviews of witnesses who were present at the time of the accident or shortly thereafter the West Virginia Office of Miners' Health, Safety & Training marked this drawing with the symbol - X identifying the approximate location where it concluded the victim was found immediately after the accident.
