West Virginia Office of Miners' Health, Safety and Training

JUNE 13, 2017

**Report of Investigation
Underground Coal Mine Fatality
Machinery / Crushing**

**Rockwell Mining LLC
Gateway Eagle Mine
Permit Number D00008482C**

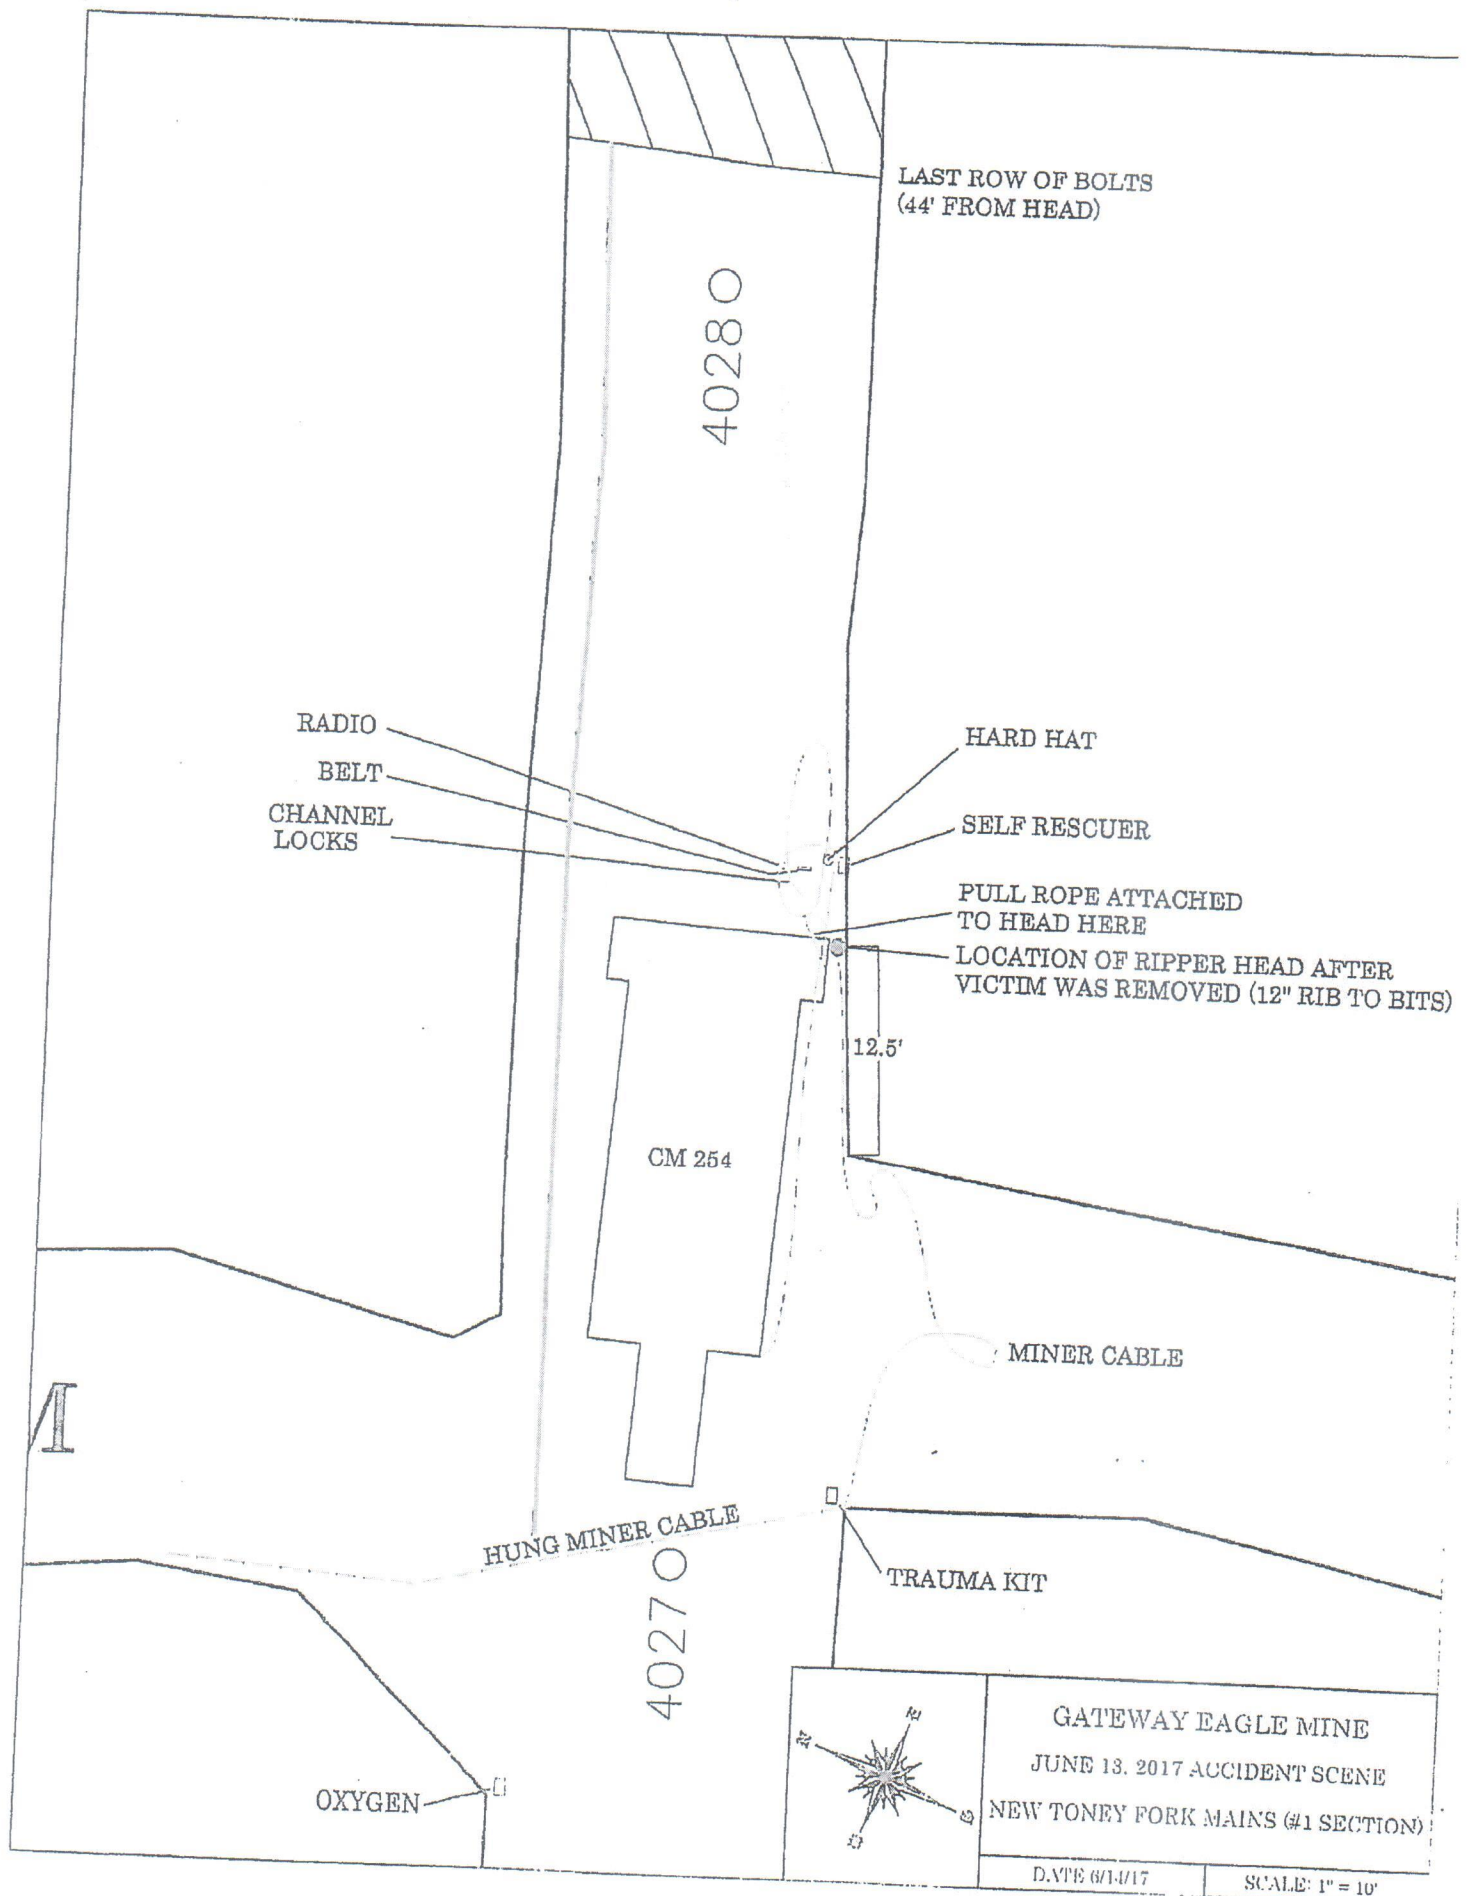
MMU-011-0

Rodney S. Osborne, an employee of Rockwell Mining LLC, Gateway Eagle Mine located in Boone County on Route 85 near Bald Knob, West Virginia, was fatally injured in an accident at approximately 8:47 p.m. on June 13, 2017. Mr. Osborne was operating a Joy Model 14CM15-JM5801 (continuous miner) on the No. 1 section in the No. 3 entry when he received a fatal crushing injury after being pinned between the continuous miner cutter head and the coal rib.

shuttle car outby and proceeded back to the No. 3 entry to help with the move of the continuous miner. Mr. Blankenship walked up to the continuous miner conveyor boom and observed Mr. Osborne pinned between the continuous miner cutter head and the coal rib on the operator's side. Mr. Blankenship then went to the left side roof bolter and informed Mr. Christopher Atkins (Section Foreman), Mr. Steve Elswick (Left Side Roof Bolt Operator) and Mr. Jarrod Terrell (Left Side Roof Bolt Operator) what he observed. Mr. Atkins and Mr. Elswick went to the continuous miner and saw Mr. Osborne pinned between the continuous miner cutter head and the coal rib. Mr. Elswick then checked for a pulse and testified, "none was found". At that time, Mr. Elswick stated that Mr. Atkins became overwhelmed and he left the scene and went to the section mine phone to report the accident and to help retrieve first aid equipment. The first aid equipment was brought to the No. 3 entry from the section power center by Mr. Mark Stepp (Right Side Shuttle Car Operator). Mr. Elswick asked for a few men who can handle this kind of event to assist him. Mr. Elswick asked Mr. Dave Havey (Right Side Continuous Miner Operator) to help. Mr. Havey replied "I don't know if I can do this". Mr. Elswick then said, "you must, I don't have a PTO (Power Take Off) to operate the continuous miner, I need you". Mr. Elswick removed Mr. Osborne's remote control box and gave it to Mr. Havey. Mr. Elswick then went to the front of the continuous miner with Mr. Rusty Nelson (Electrician) and Mr. Daniel Moore (Right Side Roof Bolter Operator). On the count, of 3 Mr. Elswick instructed Mr. Havey to move the continuous miner to the left away from Mr. Osborne. Utilizing the ESO (Emergency Stop Override) to bypass the proximity detection system, Mr. Havey moved the continuous miner. Mr. Elswick and Mr. Jarrod Terrall lowered Mr. Osborne to the mine floor. Mr. Elswick then instructed Mr. Havey to move the continuous miner away from them. While moving the continuous miner, Mr. Havey stated that "he noticed that one of the cats had spun and tried to kick back in the direction of the right rib". Mr. Osborne was then placed on a backboard and loaded onto a Brookville mantrip that was located at the outby end of the continuous miner. Boone County Ambulance Unit 60 arrived at the mine site at 9:16 p.m. The mantrip arrived on the surface at 9:22 p.m. An Electrocardiogram was performed by the Boone County Ambulance Authority Medics. Boone County Ambulance Authority Unit 60 then transported Mr. Osborne from mine property. Mr. Osborne was pronounced deceased by Dr. Marie Nowak, M.D. at 9:37 p.m. through Central Med Base.
