West Virginia Office of Miners' Health, Safety and Training

Fatal Roof Fall Investigation Report
Independence Coal Company, Inc.
Justice No. 1 Mine
Permit No. U-5013-98

Region Three - Danville Office
425 Lick Creek Road
Danville, West Virginia 25053
Harry Linville, Inspector-at-Large

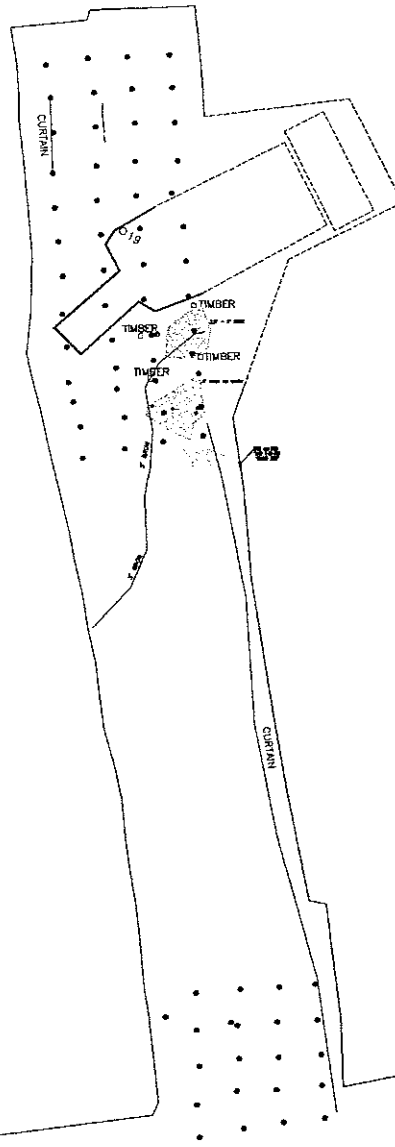
Independence Coal Company
Justice No. 1 Mine
No. 2 Entry

6. Four (4) of the damaged roof bolts were located in the last row adjacent to the crosscut turned to the right. Three (3) damaged roof bolts were located in the next to last row adjacent to the crosscut.
7. The roof fall, as described by eyewitness Roger Cox, started in the unsupported face area of the crosscut and extended outby into the area where the roof bolts were damaged.
8. The victim was located under the area where the three (3) roof bolts had been damaged in the next to last row when the fall occurred.
9. Those involved in the recovery indicated that the victim was completely covered by the fallen roof material and was found with his feet pointed toward the crosscut.

- 2. The continuous mining machine will be removed from the turn and spot bolting done when a roof bolt is damaged between the operator's position and the centerline of the crosscut being mined. This provision will also be included in the operator's comprehensive mine safety program.
