West Virginia Office of Miners' Health, Safety and Training

February 5, 2004

Underground Mine Fatality Investigation Report
Spartan Mining Company
Ruby Energy Mine
Permit No. U-5019-96-A

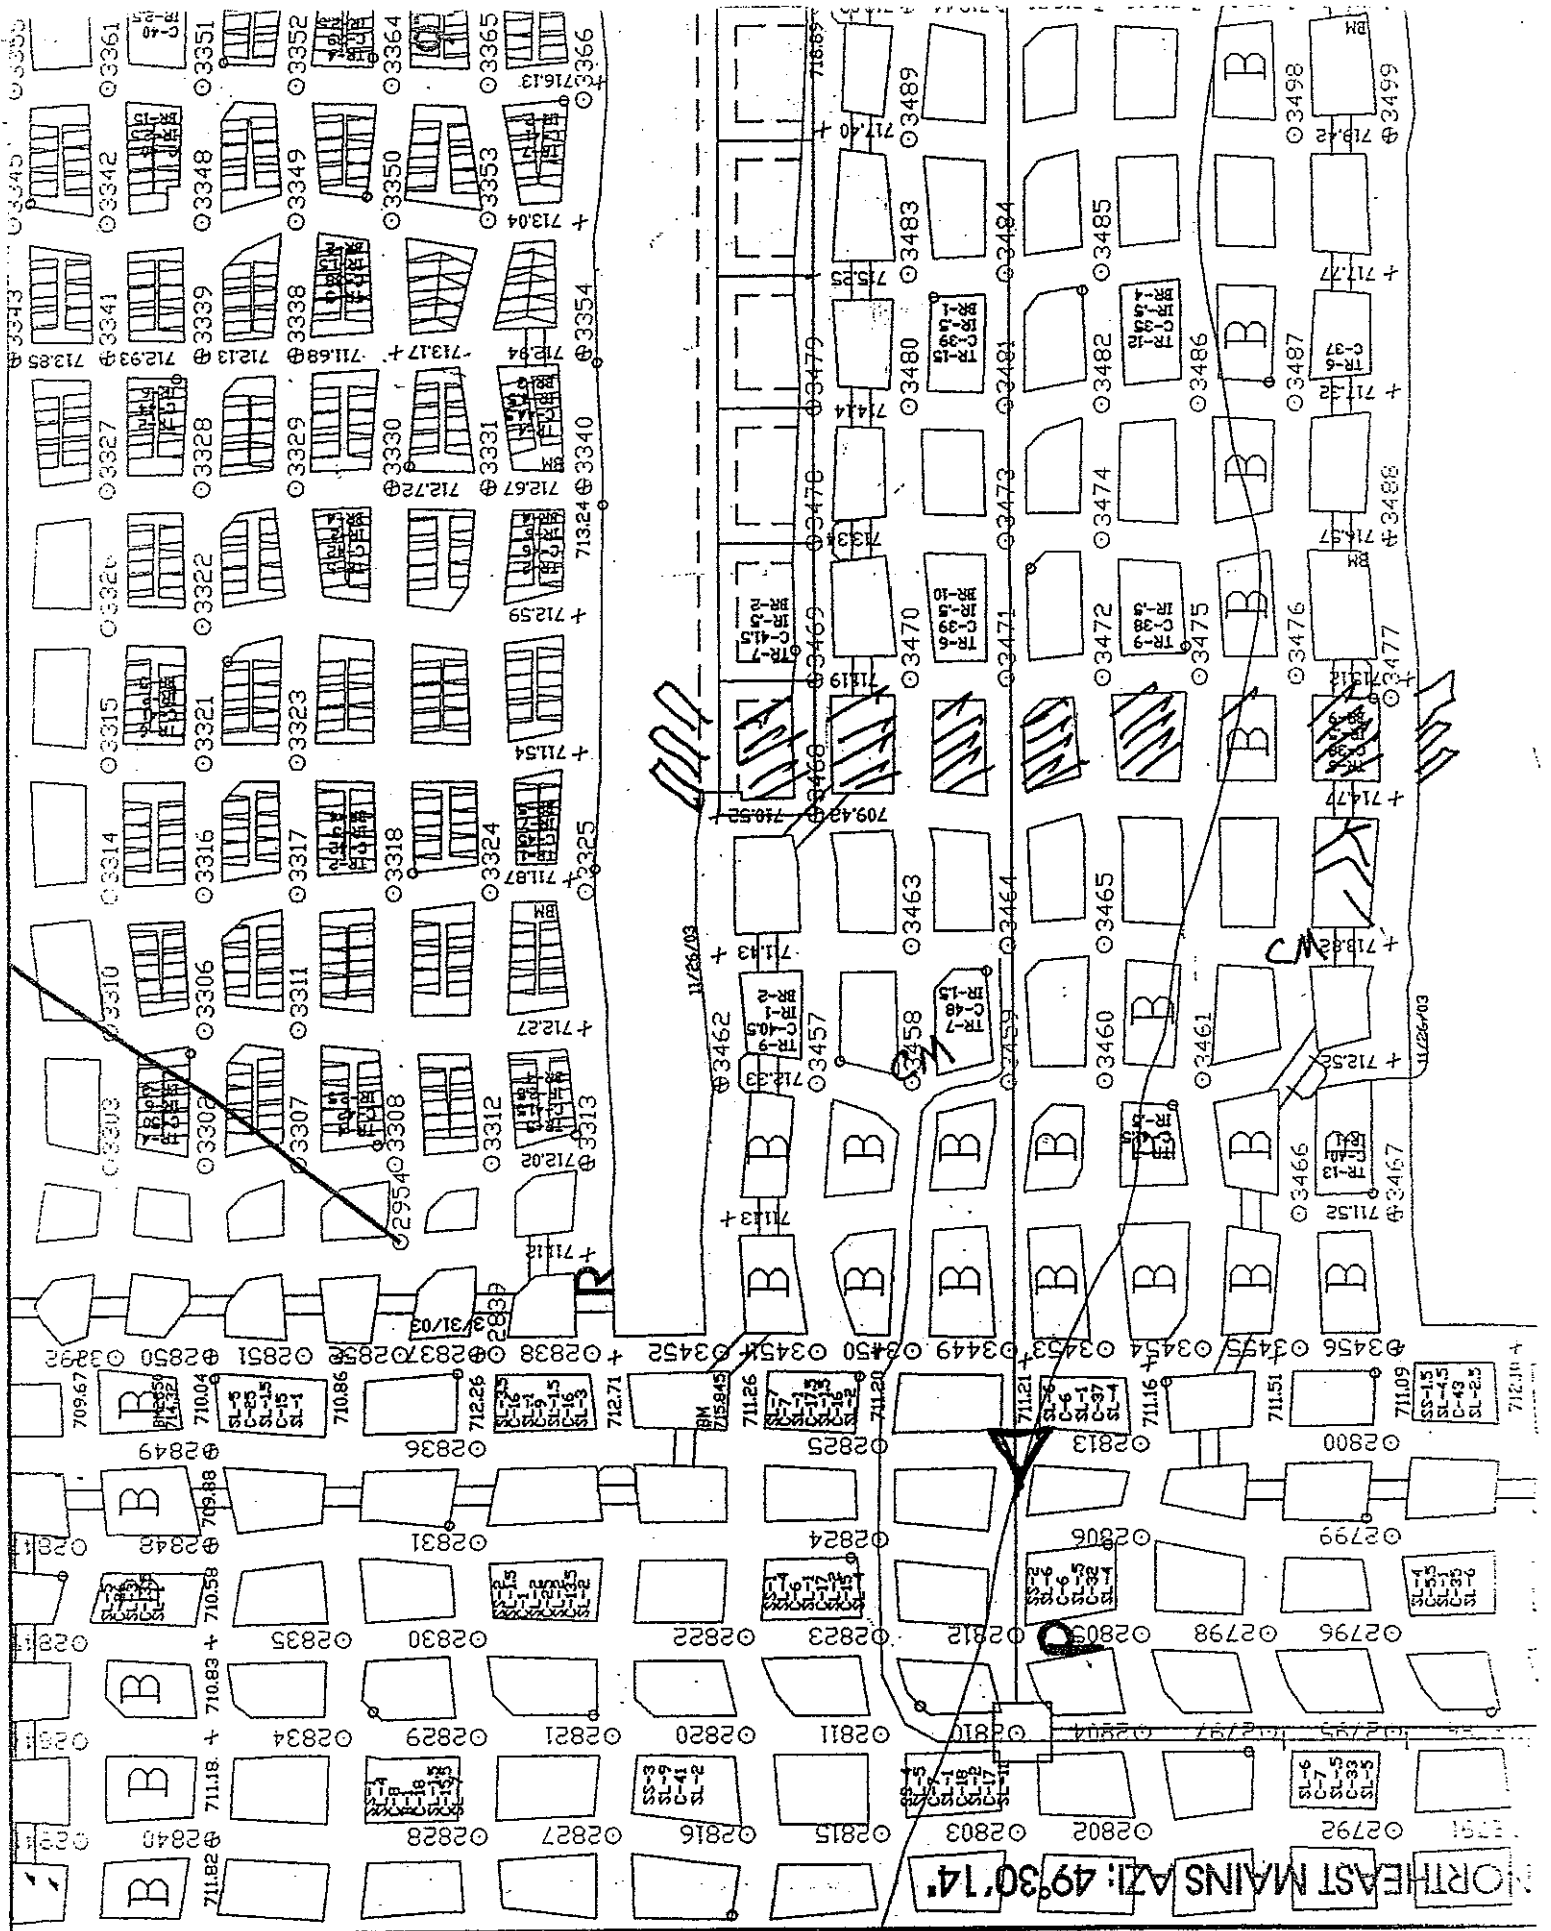
**SPARTAN MINING COMPANY
RUBY ENERGY #2 SECTION**

The victim was performing electrical repairs on a trailing cable, and the power source had not been suitably locked out and tagged. The accident occurred when the circuit was energized by the victim's supervisor who was unaware that electrical work was in progress.

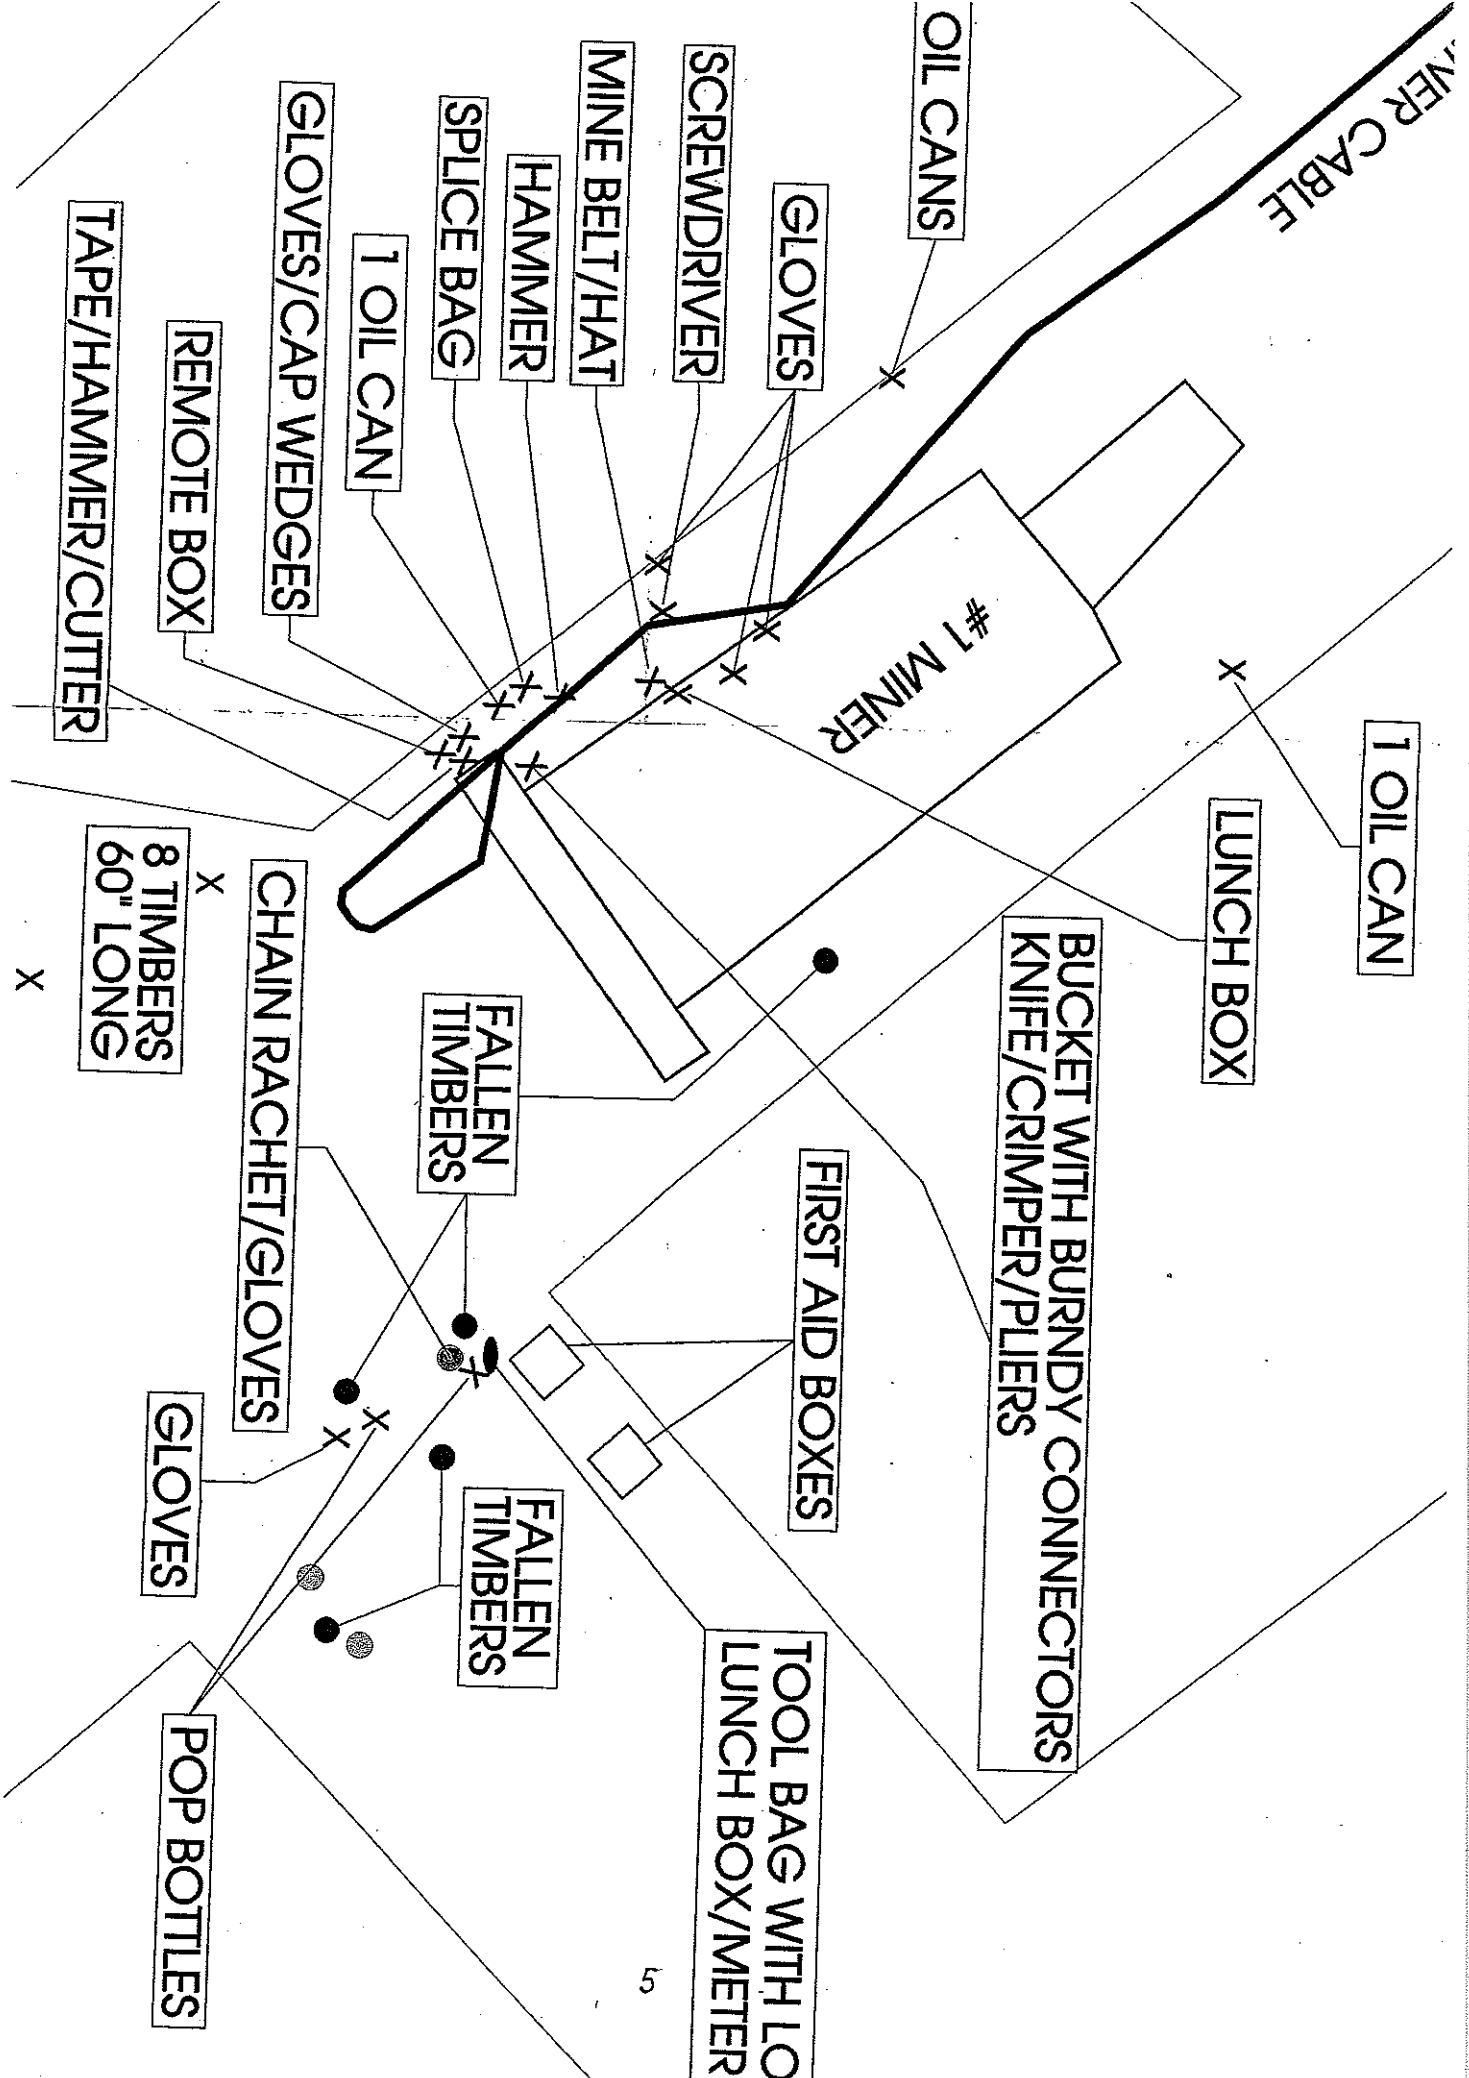
MINNER CABLE

#1 MINNER

BUCKET WITH BURNDY CONNECTORS
KNIFE/CRIMPER/PLIERS
