**State of West Virginia  
Office of Miners' Health, Safety & Training  
205 Marion Square  
Fairmont, West Virginia 26554**

**May 11, 2005**

**Fatal Power Haulage Accident  
(Underground Coal Mine)**

**Consolidation Coal Company  
Shoemaker Mine  
Permit No. D-4791**

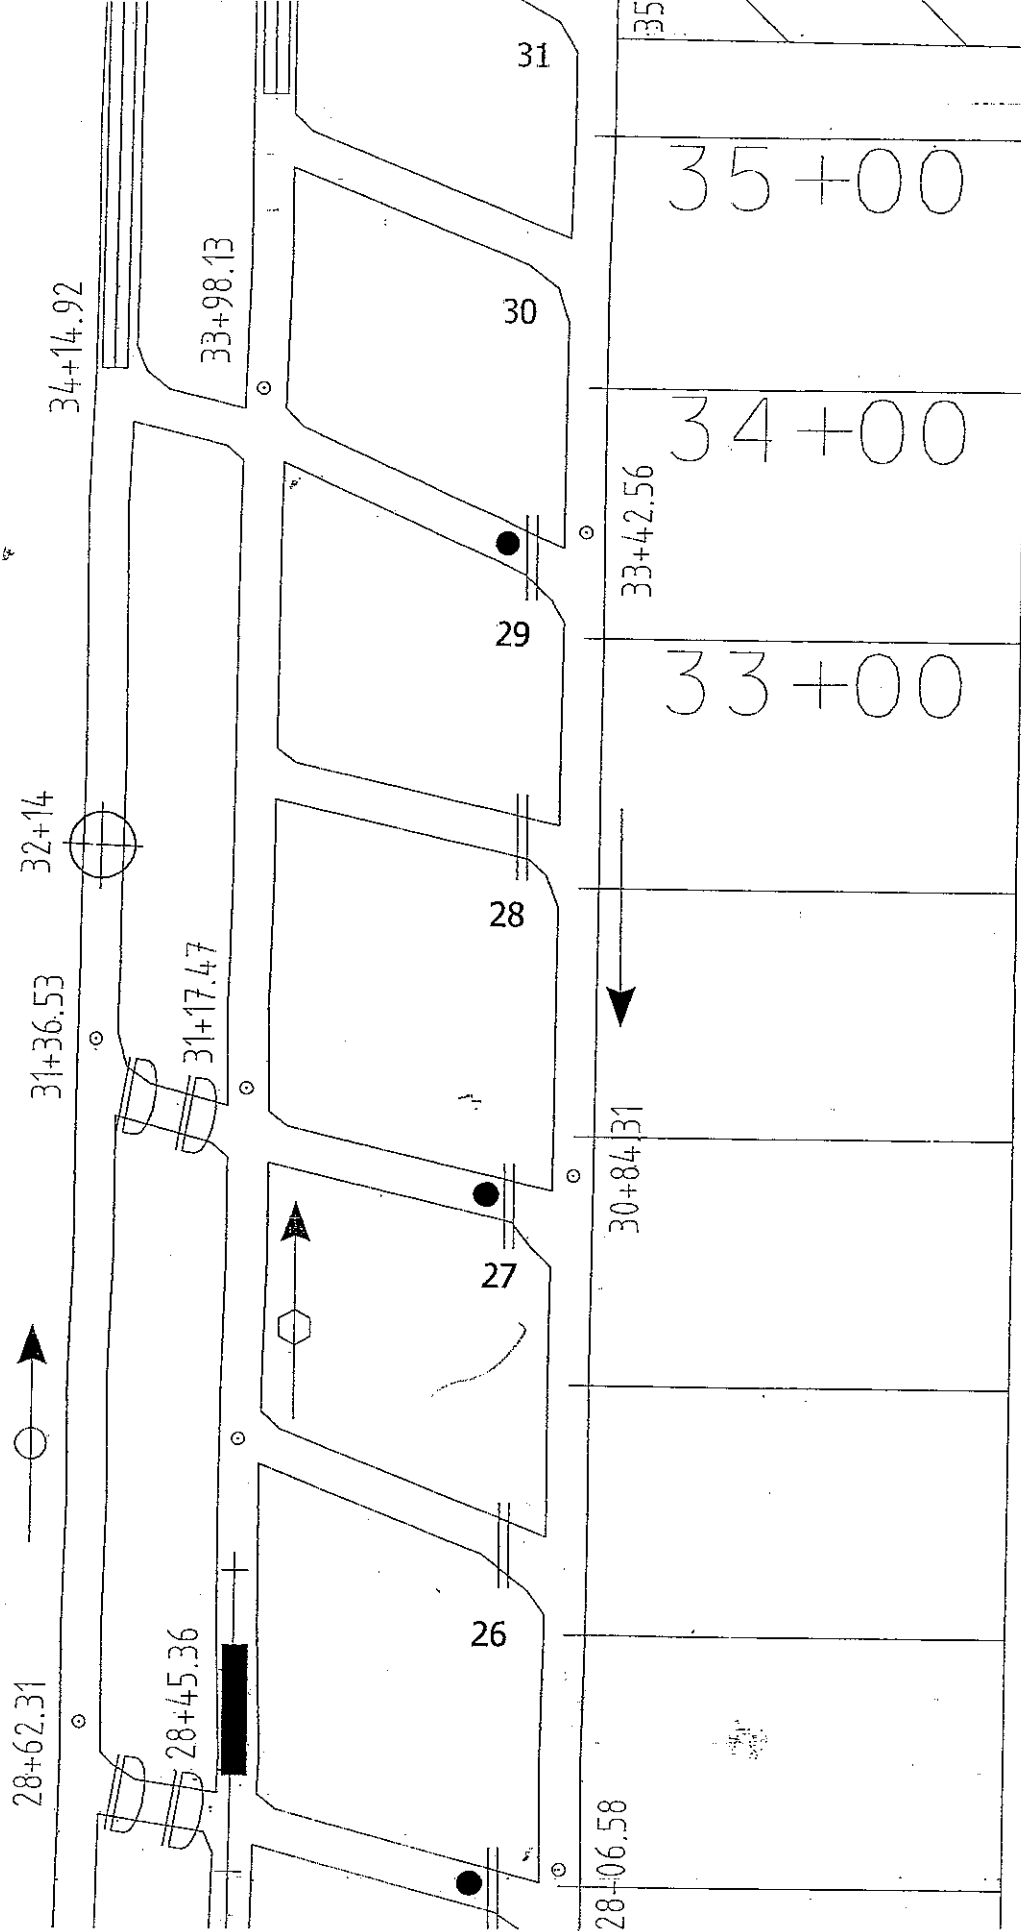
14-A Accident Site:

A fatal power haulage related accident occurred at approximately 1:15 P.M. on May 11, 2005 at the Consolidation Coal Company, Shoemaker Mine. The accident occurred on the 14-A Longwall section where blocking material was being delivered by a scoop in the number one entry. Mr. Clyde Willis, age 47, was fatally injured when struck by the Eimco scoop. He was walking approximately five to six feet ahead of the scoop.

- 12) An inspection of the #11 scoop revealed no deficiencies or violations.
- 13) An inspection of the number one entry revealed no obstructions in the tram way. Visibility was not hindered from any dust in suspension. The roadway had been dampened. The entry had sloughage along both ribs and two tire tracks in the mine floor.

1. Operators of off track mining equipment shall inspect travel ways before operation of their equipment to make sure it is free of hazards.
2. If it is necessary to walk in front of a piece of moving equipment, always walk in direct line of sight of the operator and at a safe distance from the machine.
3. If operating a piece of equipment and another employee is walking in front of you, do not operate this machine unless this individual is in direct line of sight of the operator's compartment and is positioned a safe distance from the machine.
4. Whenever possible, if it is necessary to walk in the same entry and direction as a piece of equipment, do so from behind the machine.
