West Virginia Office of Miners' Health, Safety and Training

June 10, 2004

Fatal Coal Truck Haulage Investigation Report  
Tug Valley Coal Processing  
Preparation Plant No. 1  
Aldrich Branch Impoundment Haulage Road  
Permit No. L-232

Region Three – Danville Office  
137 Peach Court, Suite 2  
Danville, West Virginia 25053  
Harry Linville, Inspector-at-Large

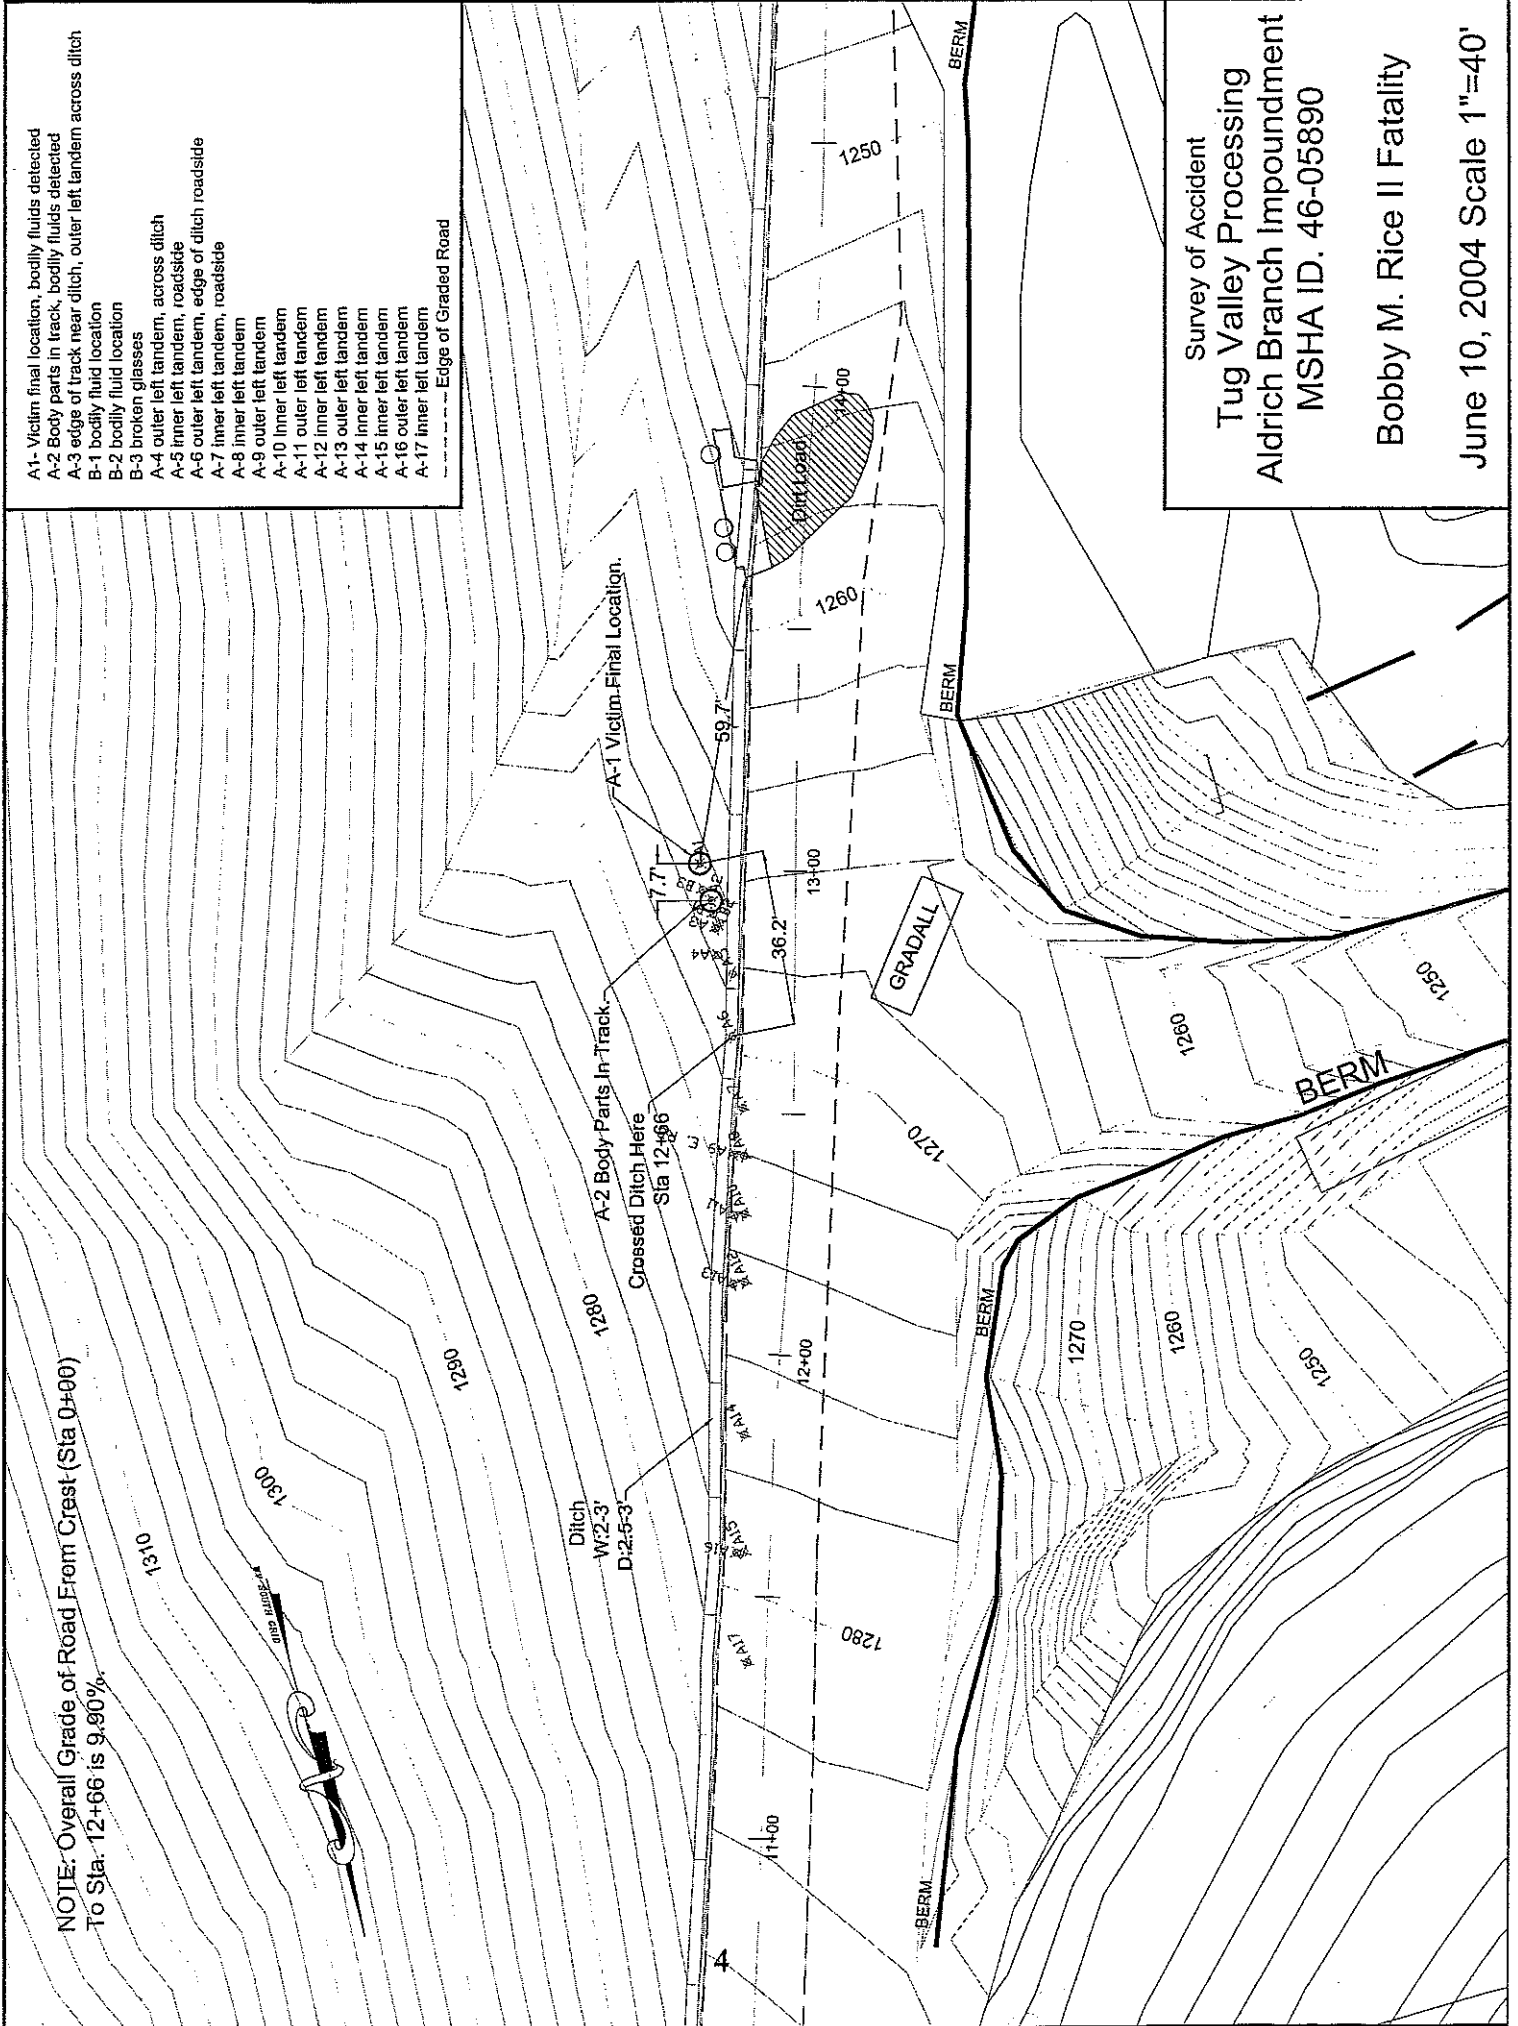
Survey of Accident  
 Tug Valley Processing  
 Aldrich Branch Impoundment  
 MSHA ID. 46-05890  
 Bobby M. Rice II Fatality  
 June 10, 2004 Scale 1"=40'

- A1- Victim final location, bodily fluids detected
- A-2 Body parts in track, bodily fluids detected
- A-3 edge of track near ditch, outer left tandem across ditch
- B-1 bodily fluid location
- B-2 bodily fluid location
- B-3 broken glasses
- A-4 outer left tandem, across ditch
- A-5 inner left tandem, roadside
- A-6 outer left tandem, edge of ditch roadside
- A-7 inner left tandem, roadside
- A-8 inner left tandem
- A-9 outer left tandem
- A-10 inner left tandem
- A-11 outer left tandem
- A-12 inner left tandem
- A-13 outer left tandem
- A-14 inner left tandem
- A-15 inner left tandem
- A-16 outer left tandem
- A-17 inner left tandem
- Edge of Graded Road
