West Virginia Office of Miners' Health, Safety and Training

October 24, 2003

**Report of a Roof Fall Fatality
(Underground Coal Mine)**

**Roblee Coal Company
Hackers Creek No. 1 Mine
Permit No. U-2001-00**

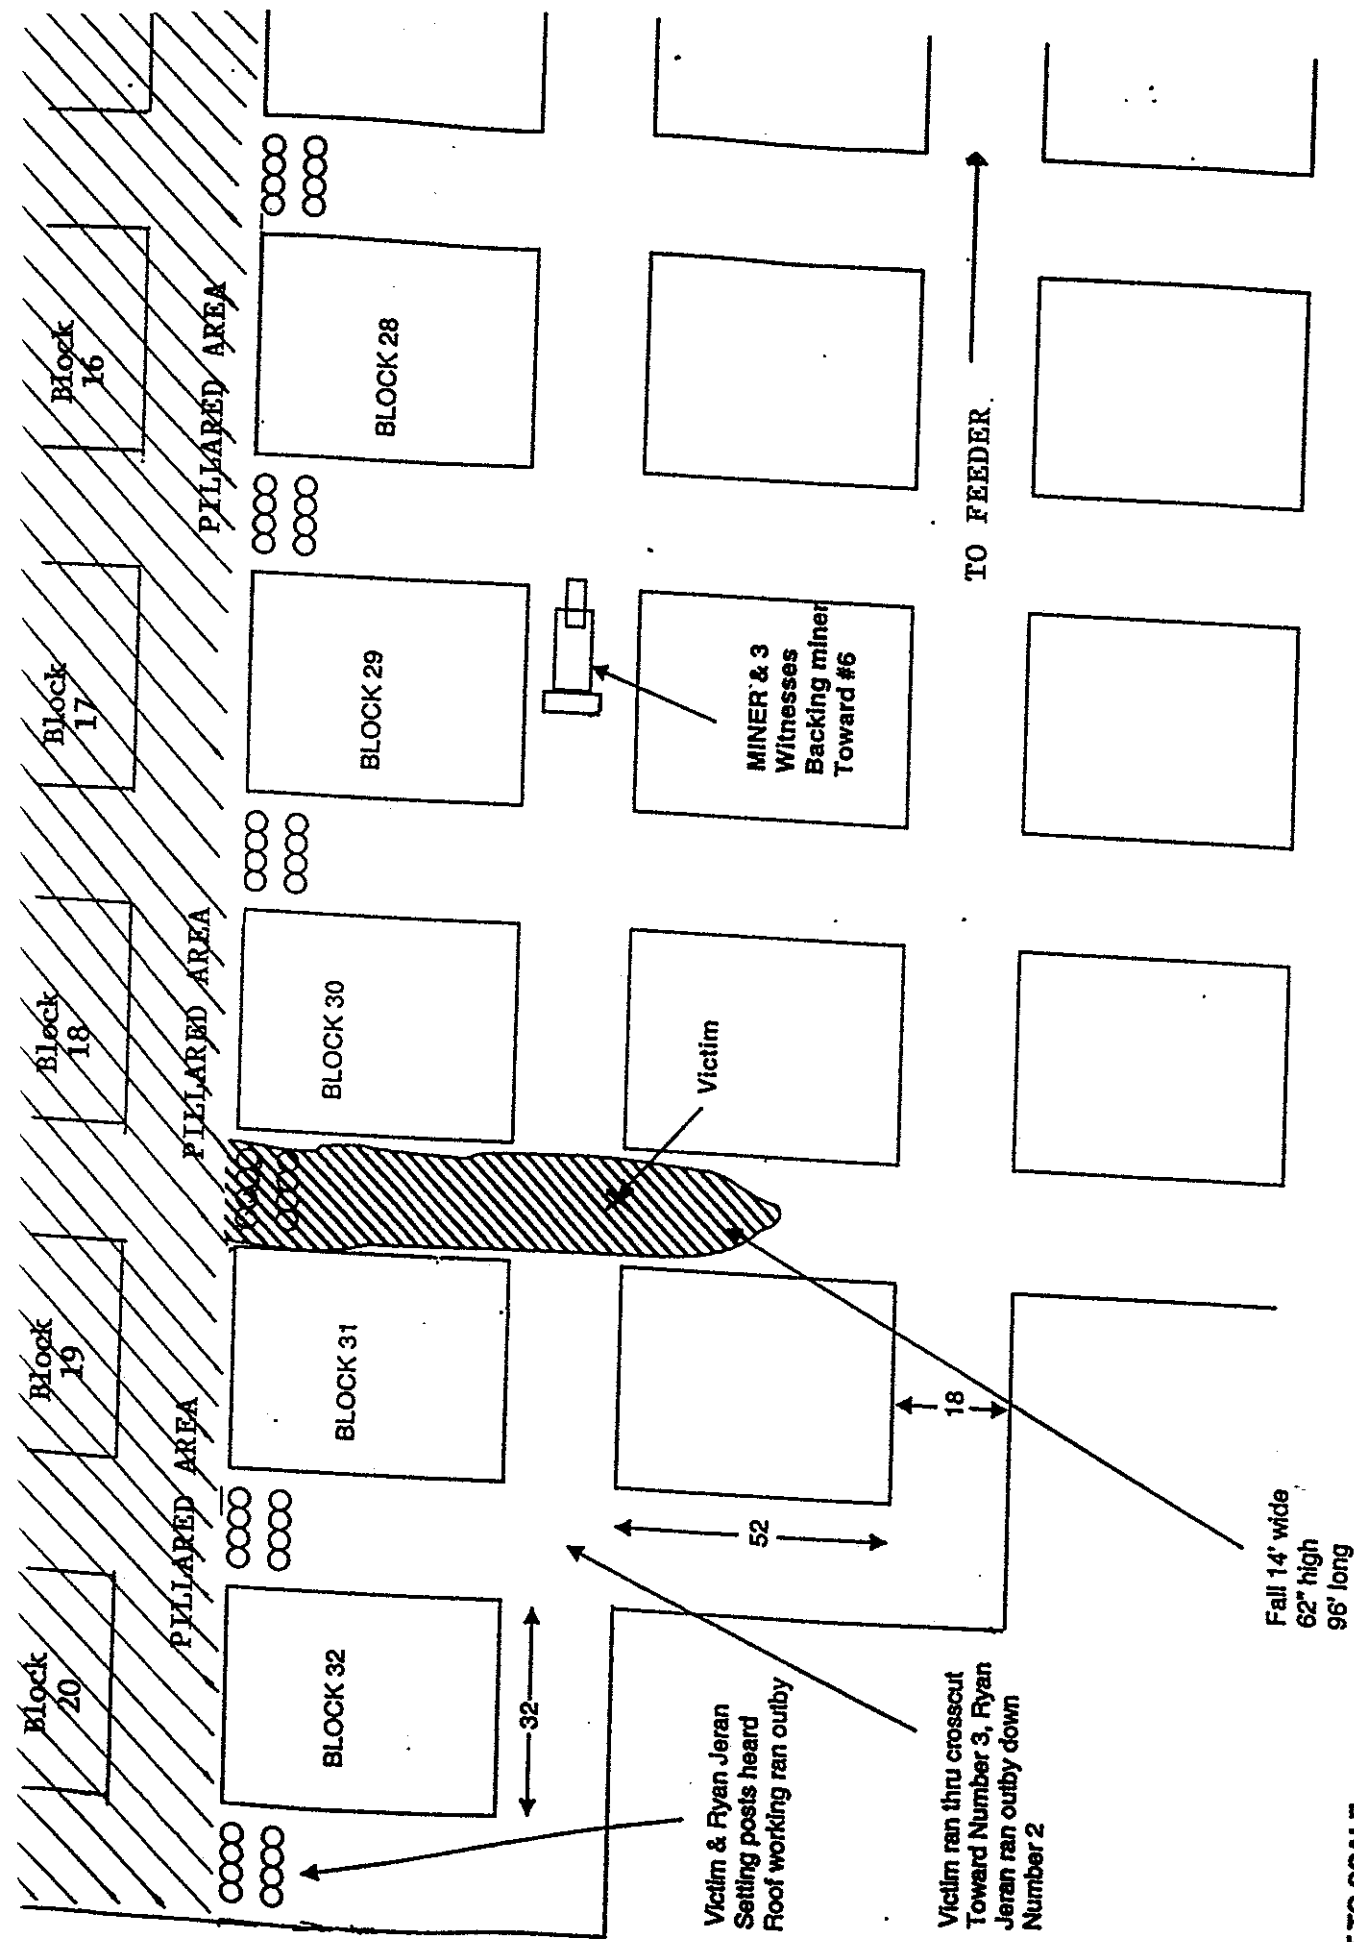
1-LEFT SECTION

- A surface crack was present in the mine roof along the left rib extending from the pillared area in the No. 3 entry for approximately 70 feet outby the last open intersection where the crack turns to the middle of the entry and extends another 140 feet where it ends in the corner of the right coal block. The investigation revealed approximately 3 metal straps had been installed in the No. 3 entry intersection. The approved roof control plan specified that additional supports would be installed when two or more parallel surface cracks are encountered in a working place.

- A roof fall was discovered in the No. 2 entry during the on-site investigation on 10/27/03. The fall is similar in characteristics to the roof fall involved in the fatal accident. The approximate measurements of the fall in the No. 2 entry are 50 foot long, 17 feet wide and 62 inches thick. There was also a surface crack observed in the No. 2 entry.

Richard Harlan was fatally injured by a roof fall while traveling through the last open intersection in the No. 3 entry. The roof fall started in the pillared area overriding breaker posts and extending outby and through the intersection along a surface crack for a distance of approximately 96 feet.

The roof control plan shall be revised to address current mining conditions. Management shall train all employees on the revisions of the roof control plan.
