Survivability/Re-Establish Marco VisorTrac

MAR-011807-A IMPERIAL MINE

One Connection Diagram of the VISORTRAC System

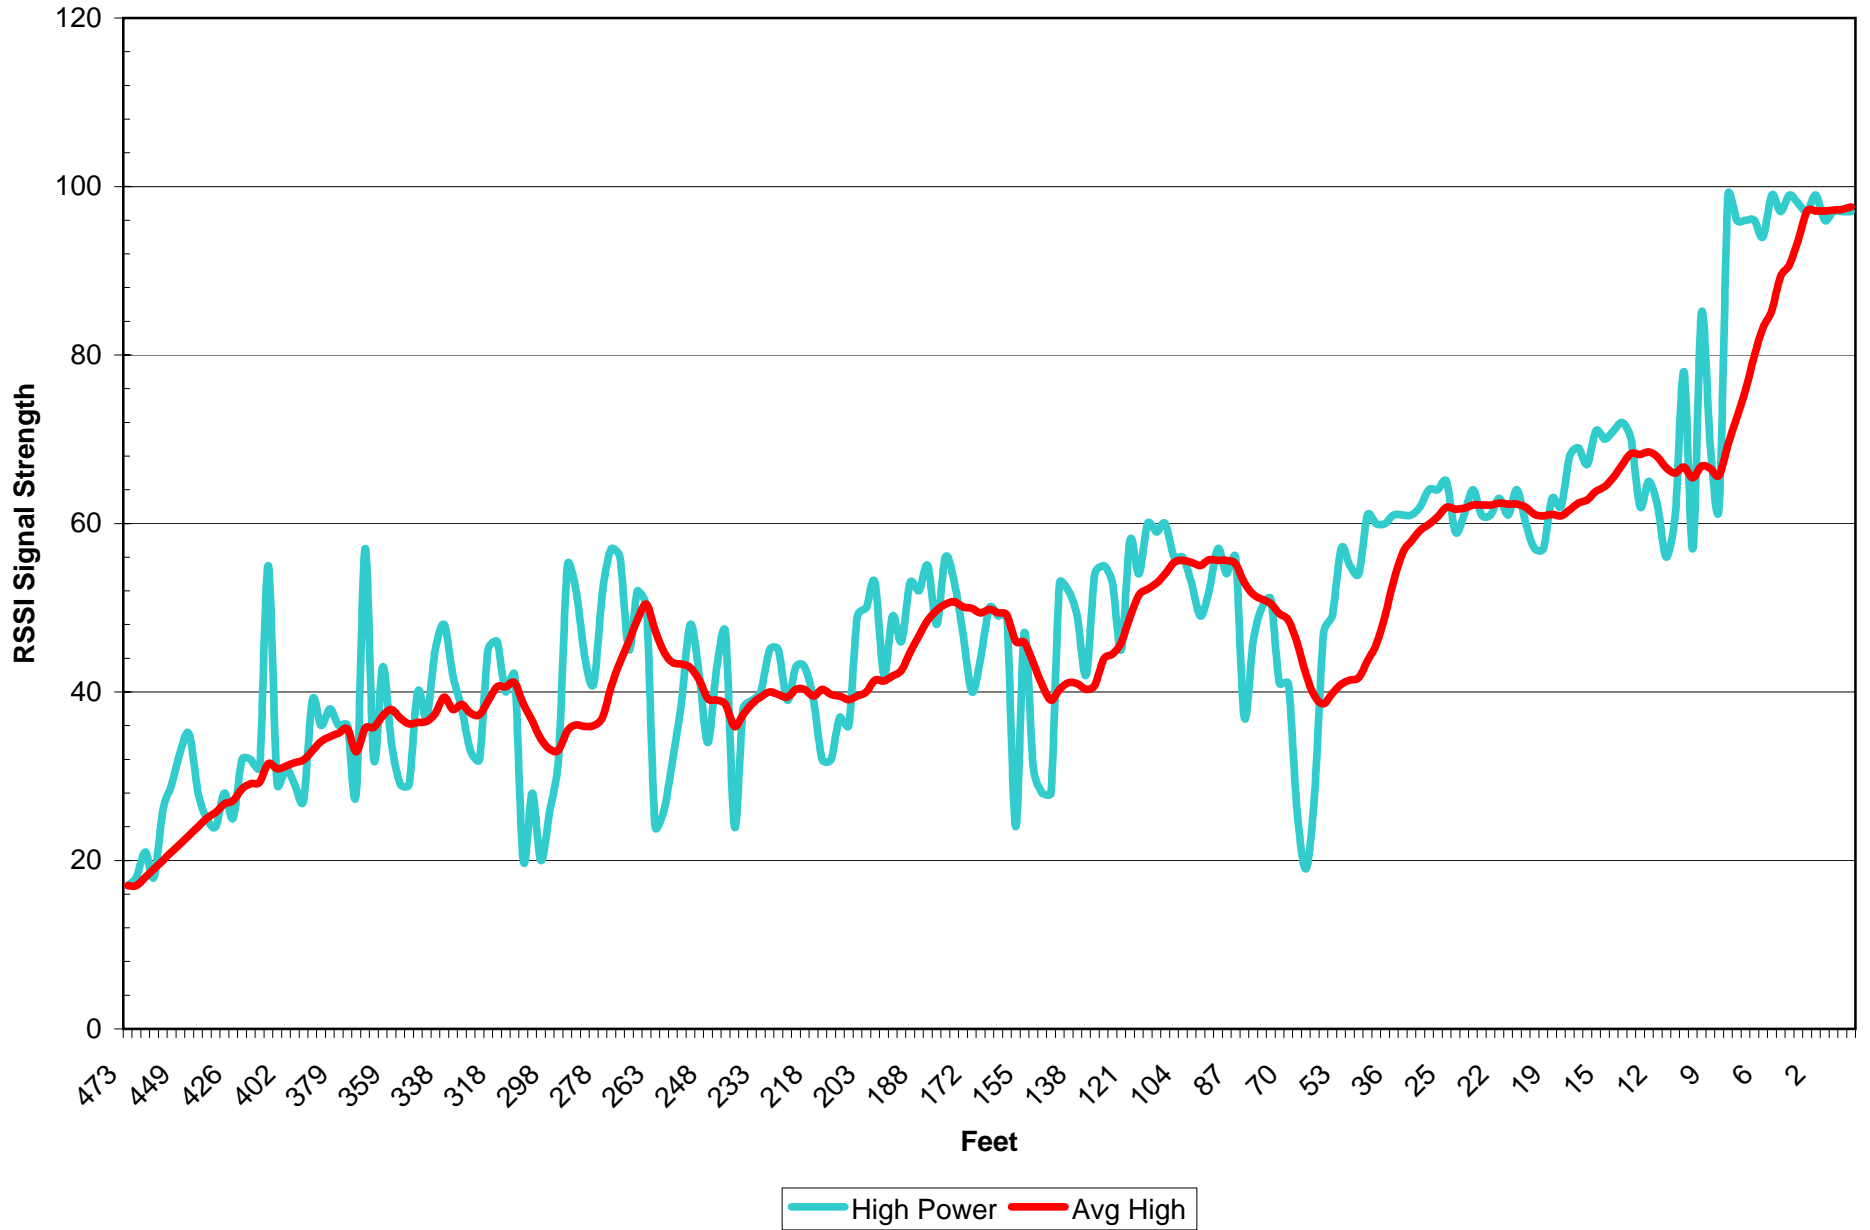
PRIM Distance In 6 Ft Height
ANR Mine in Virginia

Test in the travel way number 5 confirmed tracking signal out-by to number 4 block and in-by up to number 15 block.
