Mine Safety and Health Administration

Emergency Communication and Tracking Committee
Underground Communication and Tracking Systems Tests at
CONSOL Energy Inc., McElroy Mine

Report of Findings
June 13, 2006

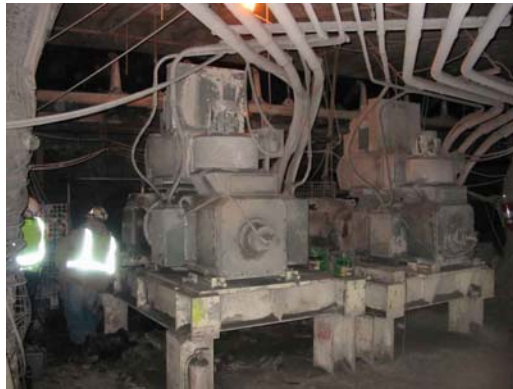
Figure 4: Belt Entry

The belt entry is also referred to as the #1 entry. The belt entry was measured to be approximately 16 ft wide and 6 ft high on average (note: Belt drive area had a roof cut as high as 30 ft). The belt entry in which tests were conducted ran parallel to the previously described 2,500 ft section of track entry. True line of sight could not be maintained throughout the belt entry test area because of elevation changes in the entry and the presence of belt line structures.

Intake air traveled through the entry. There were several areas of roof spalling, and rib sloughage was more prominent in this entry.

- conveyor belt and belt structure with control lines and switches
- wire mesh belt guards
- high voltage ac cables
- mine page phones and lines
- CO monitoring system
- roof bolts, straps, and wire mesh for roof control
- the #2 belt drive was located at the end of the 2,500-ft length of entry on the Conner's Run Portal side of the test area
- the #3 belt drive was located at the end of the 2,500-ft length of entry on the Fish Creek Portal side of the test area

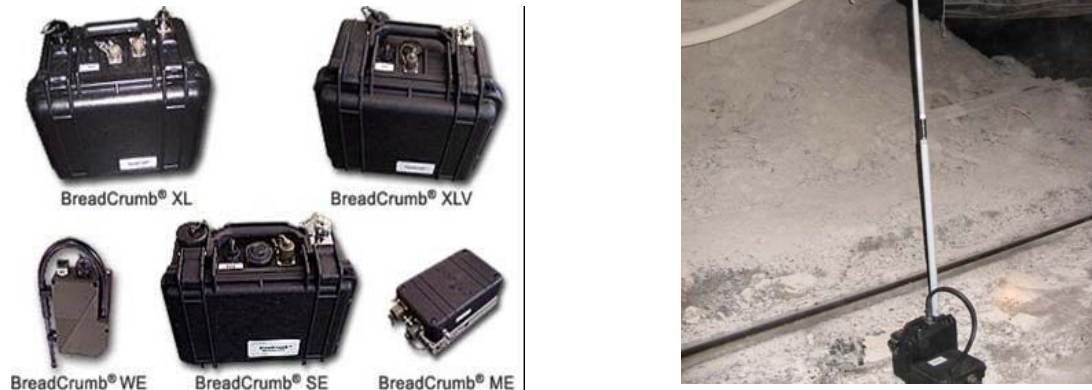
Figure 5: Rajant BreadCrumb™ Nodes

Rajant has developed hardware known as its Breadcrumb™ system that allows the deployment of a fully wireless LAN using the 802.11b protocol, known as WiFi, at 2.4

GHz. This is an ad-hoc mesh network and all nodes are portable and can operate on battery power. Voice communication for this test was through the use of a PDA and laptop PC running Voice Over IP software. Software running on a laptop PC that was connected to the base station node also provided signal strength information. For node to node communication tests, maximum range was exceeded when the signal strength fell below a usable level. Maximum range was then recorded as the distance associated with the point of last usable signal strength. In addition, each node had an LED to indicate whether or not successful network connectivity has been established. Maximum range of the PDA was exceeded when voice or text reception was lost. Maximum range was then recorded as the distance associated with the last successful voice or text communication.

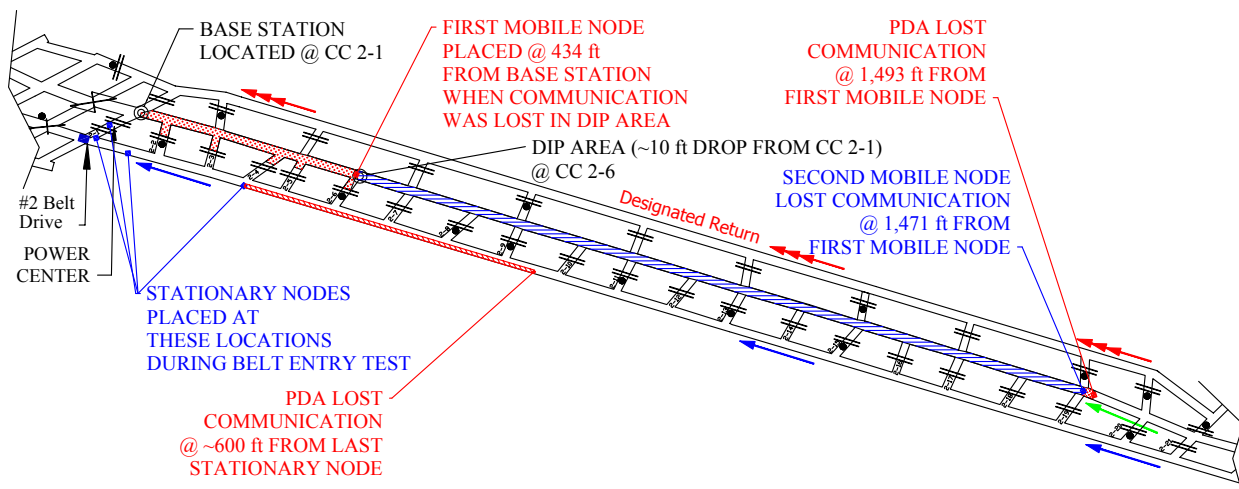
Figure 6: Rajant Track and Belt Entry Tests

The base station node and a laptop computer were set up near crosscut 2-1 in the track entry. A mobile node was taken down the track entry and lost communication with the base node as it moved through the dip in the track entry (@~500ft from base station). This mobile node was then placed in the dip area 434 ft from the base node. A second mobile node was taken down the track entry away from the first mobile node that was placed in the dip at 434 ft. At a point 1,378 ft from the first mobile node positioned in the dip area communication was established at 11 Mbps. At a point 1,471 ft from the first mobile node positioned in the dip area communication was reduced to 1 Mbps.

This test was repeated with a handheld PDA communicating with the first mobile node positioned at the point 434 ft from the base node. At a point 1,493 ft from the first mobile node positioned in the dip area, voice communication between the PDA and the first mobile node was lost.
